NATIONAL TRANSPORTATION SAFETY BOARD

Group Chairman's Factual Report

ERA14MA060

Attachment 2 – M7 Aerospace Service Bulletins (29 pages)

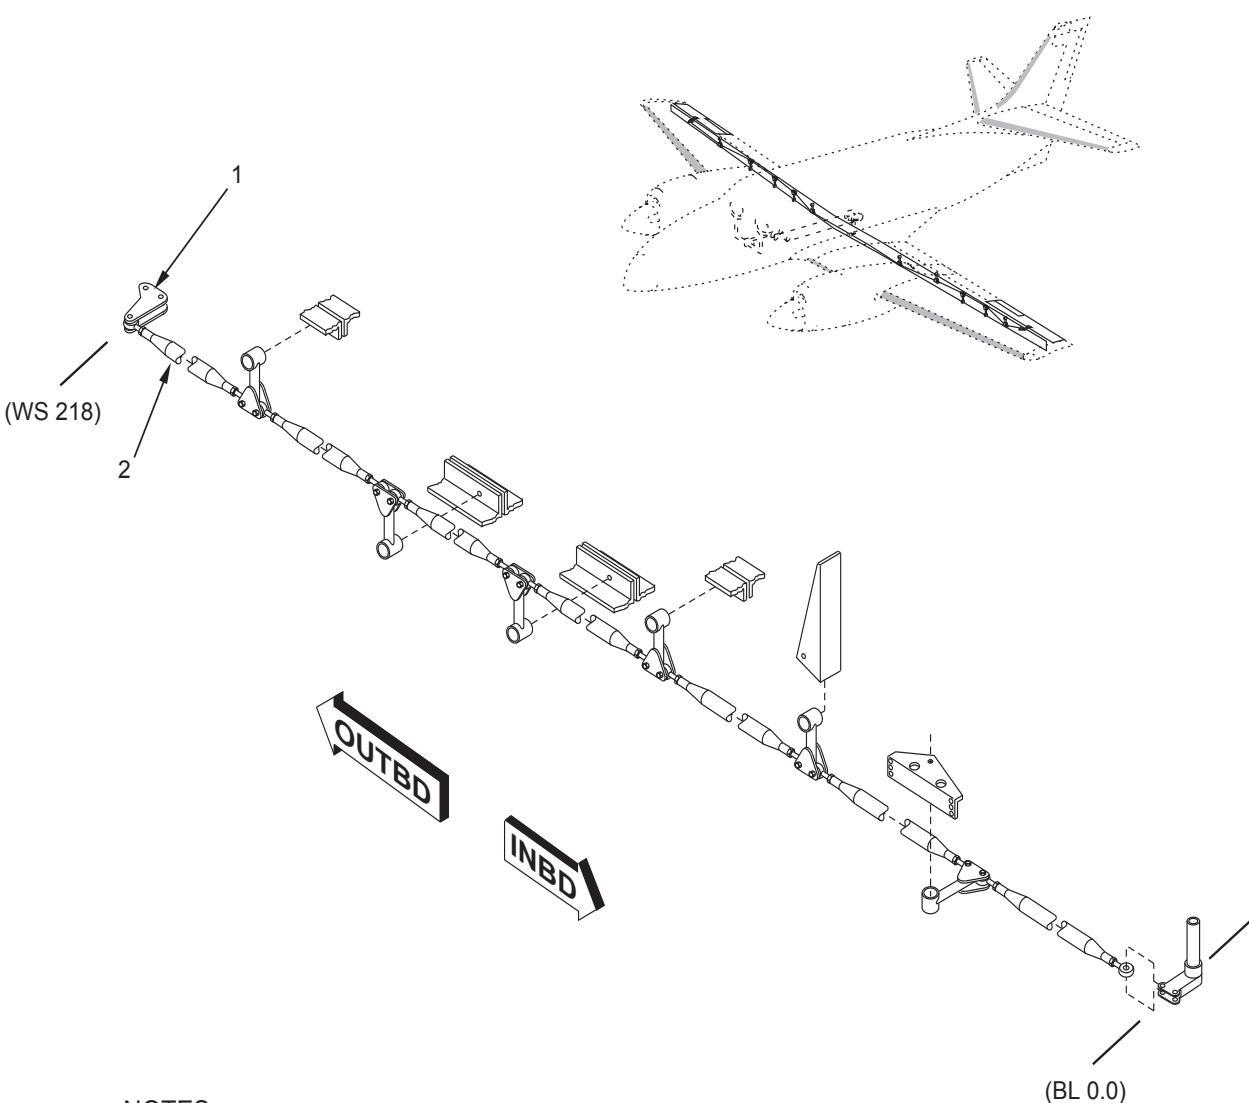
FIGURE 1 AILERON CONTROL TUBES (ALONG WING AFT SPAR)

1. Item 2 is the control tube that must be inspected and spherical rod end bearing torque checked.

- J. Disconnect the aileron control tube (the outboard most tube as shown Figure 1, item 2) from the aileron bellcrank at WS 217. Retain the hardware.
- K. Initially applying finger pressure, determine if the spherical bearing can be rotated within the outer race of the rod end bearing. Rotation of the bearing must be inplane. If the bearing moves freely and smoothly, without any sloppiness, the bearing may remain installed. Otherwise go to Step 3. and perform frozen bearing inspection. Go to Step 6 for optional rod end bearing replacement. (See Figure 7 for in-plane rotation definition)

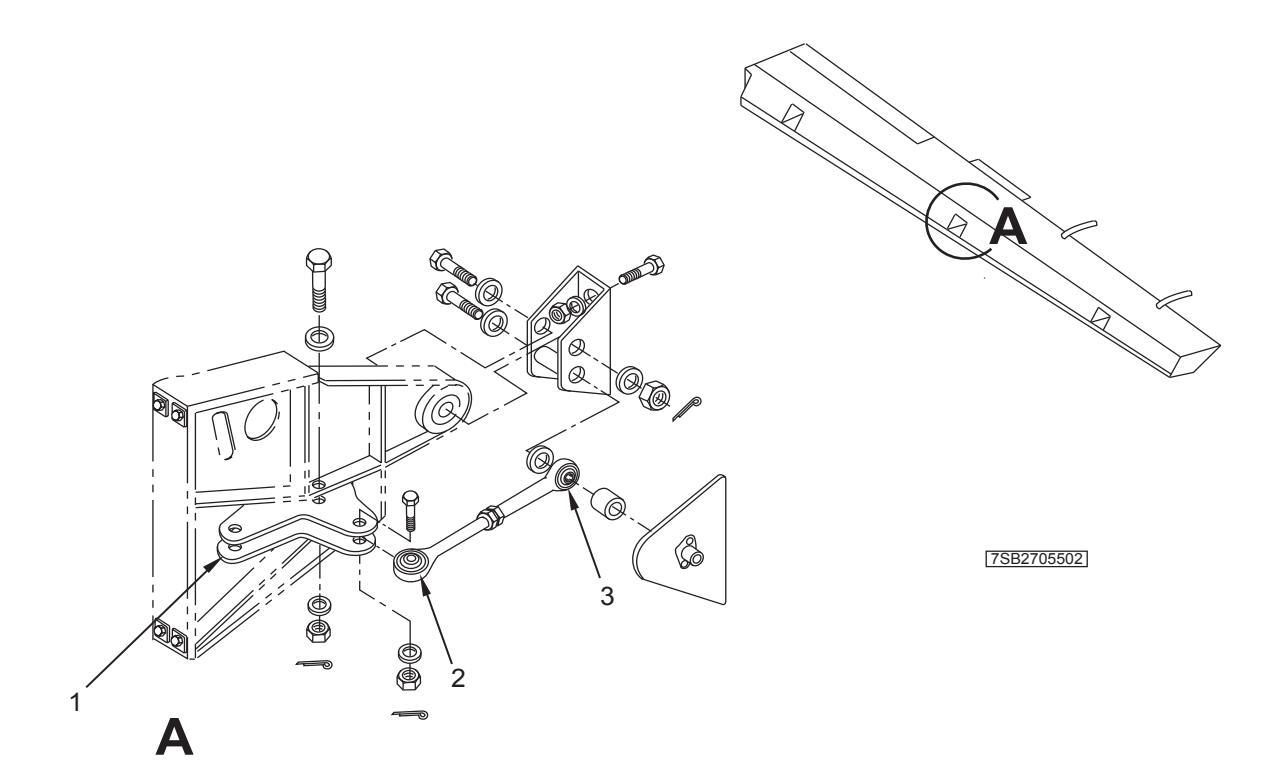
FIGURE 2 AILERON CONTROL LINK

- 1. Item 1 is the same as Item 1 in Figure 1.
- 2. Items 2 and 3 are the back-to-back sherical bearings that must be inspected and torque checked.
- 3. Item 2 is the male rod end bearing. (Bellcrank)
- 4. Item 3 is the female rod end bearing. (Aileron)

- H. Disconnect the aileron link (an assembly of male and female rod ends orientated 90 degrees to each other (see Figure 2, items 2 and 3). Disconnect the link from the aileron bellcrank at WS 217. Retain the hardware.

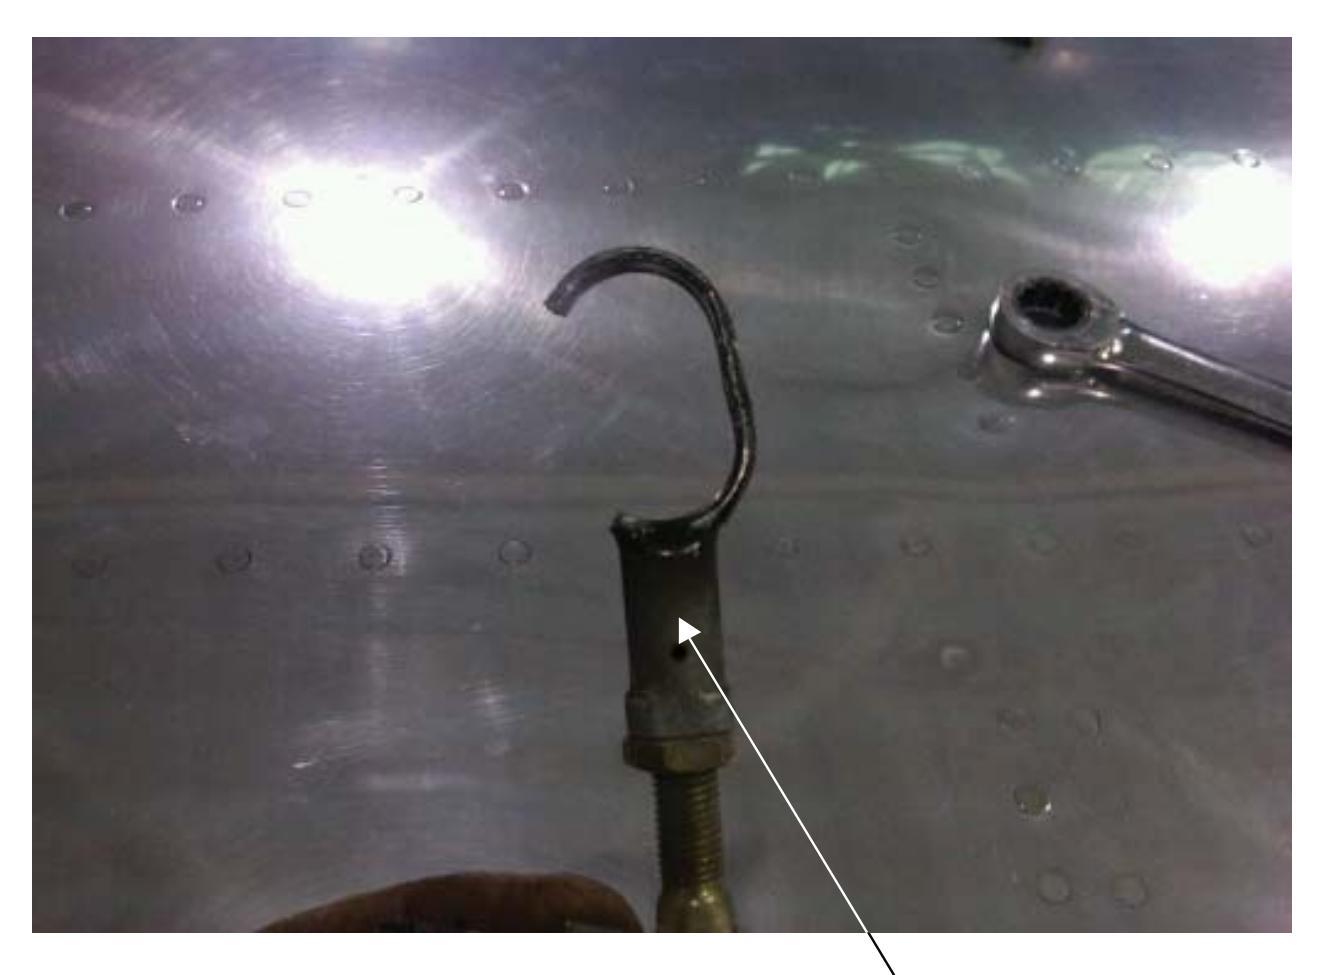
FIGURE 2 FAILED FEMALE ROD END BEARING

An operator recently experienced loss of Aileron Control on one wing which required the pilot to use full opposite aileron to maintain level flight. The loss of Aileron Control was a result of the female rod end bearing completely failing on the aileron link rod (see Figure 2), disconnecting the aileron control system to the aileron surface.

FEMALE BANJO BODY OF ROD END BEARING

- (2) Detail visual inspect using good light (at least 100fc) and 5X magnification the aileron link rod for signs of cracking in the banjo body, specifically where it is necked down around the bearing (see Figure 2). Detail visually inspect using good light (100fc) and 1.0-1.5X magnification the link rod for signs of contact with any part of the bellcrank or hinge bracket to which it is mounted. Scoring, gouges, bare metal, cracks, or other damage to the link rod, requires replacement of the link rod. Report all findings to M7 Aerospace Engineering at MetroTech@M7Aerospace. com. The link rod consists of female and male rod end bearing with a nut securing them together. Replacement parts are PN 27-32011-001 (male), PN 27-32011-003 (female), and PN AN316-5R nut.

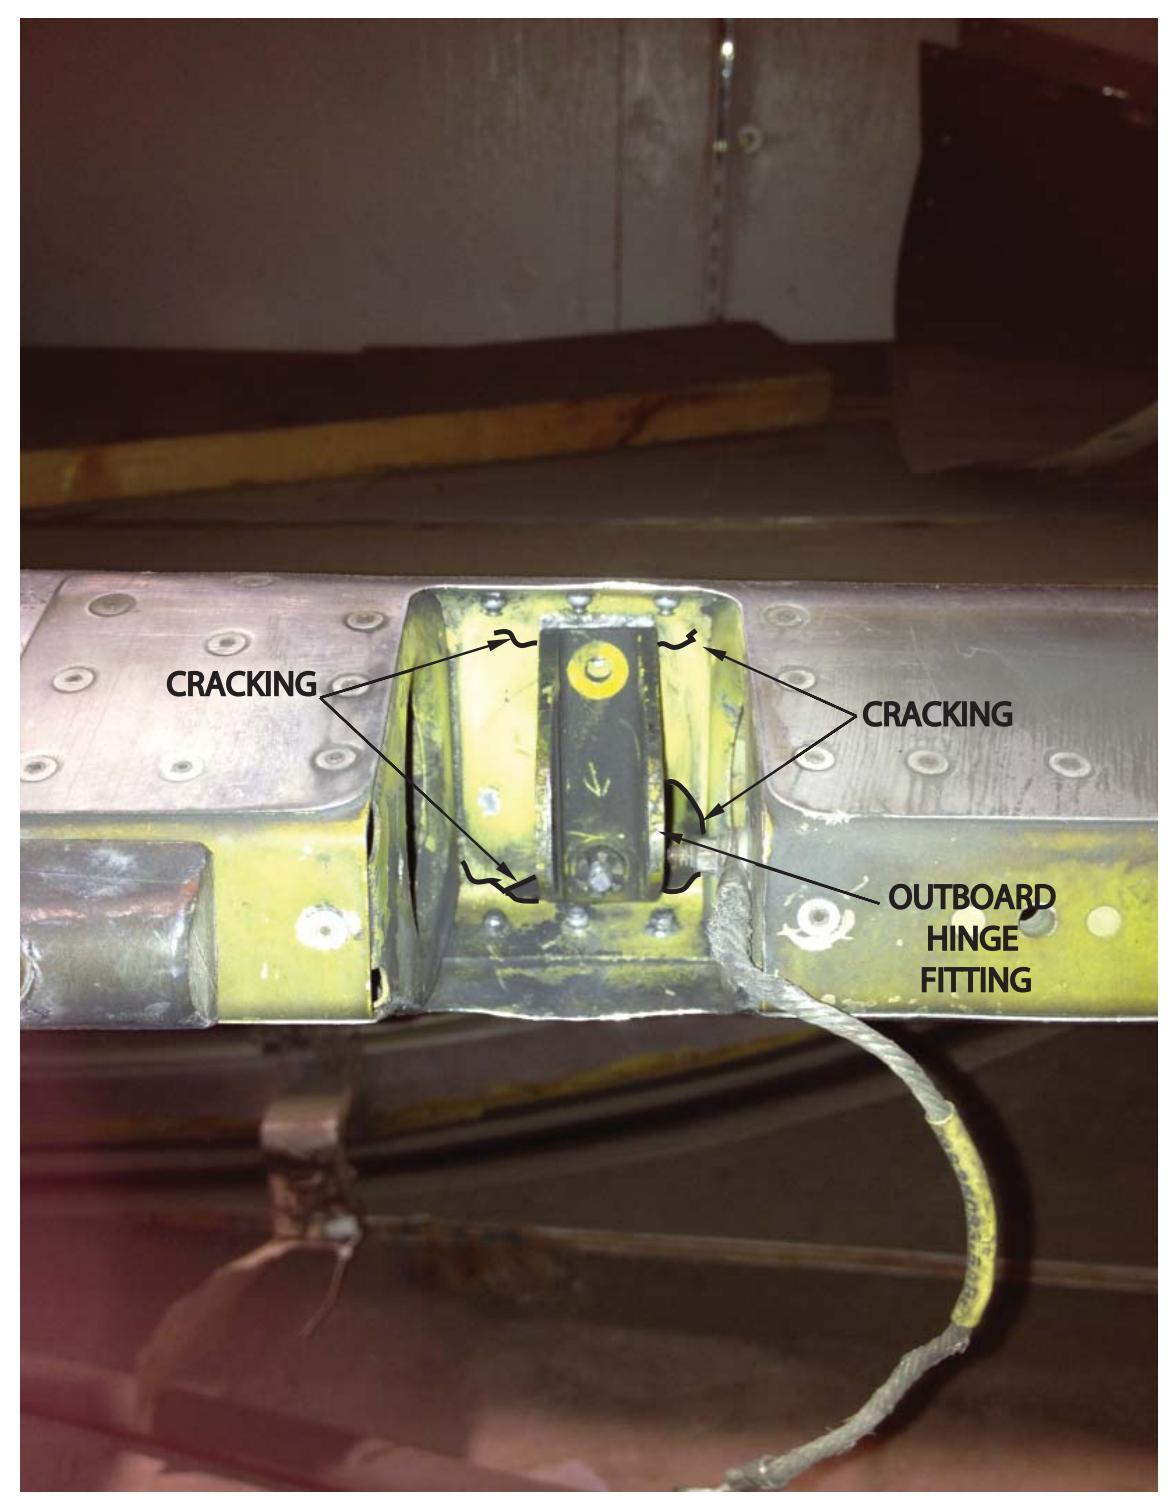
FIGURE 1 EXAMPLE OF SPAR WEB CRACKING VIEW LOOKING AFT AT AILERON SPAR (OUTBOARD HINGE SHOWN)

There have been limited reports of the RH aileron spar web cracking adjacent to the inboard, center, and outboard hinge fittings. M7 Aerospace is requesting operators to do an inspection of the LH and RH aileron spar webs for any cracks in the area of the inboard, center, and outboard hinge fittings. Operators are requested to contact M7 Aerospace LLC if any discrepancies are noted.

- B. Detail Visual Inspect (DVI*) the aileron spar web immediately either side of each hinge fitting by rotating the aileron to increase visibility of the spar web. Look for cracks emanating out from under the fitting, particularly in the upper and lower spar web radius. (See FIGURE 1). Optimum inspection viewing is looking down in aileron cutouts from above the aileron, using a mirror to aid in inspection.
