مديد محركته المحمد	- I I A A	- 12 - 12 - 12 - 12 - 12 - 12 - 12 - 12	and the case	A D
	- PRG	ALERT SERVICE BULLETIN		205-96-68
		Bell Helicopter 1941	DATE	08-01-9 6
· () 수 (E =			14 5 <u>7</u> 417	1 of 21

205A-1 MODEL AFFECTED: SUBJECT : TAIL ROTOR YOKE ASSEMBLIES P/N 212-010-704-ALL AND P/N 212-010-744-ALL INSPECTION OF; AND TRUNNION ASSEMBLIES P/N 212-010-738-001 INSPECTION OF, AND TRUNNION ASSEMBLIES P/N 205-012-716-001 212-010-703-001 REMOVAL AND P/N FROM SERVICE. All 205A Helicopters S/N 30001 thru 30228 HELICOPTERS AFFECTED : all spare yoke assemblies P/N and 212-010-704-ALL and 212-010-744-ALL with time since new (TSN) greater than zero (0). Part I Immediately upon receipt of this COMPLIANCE : Bulletin.

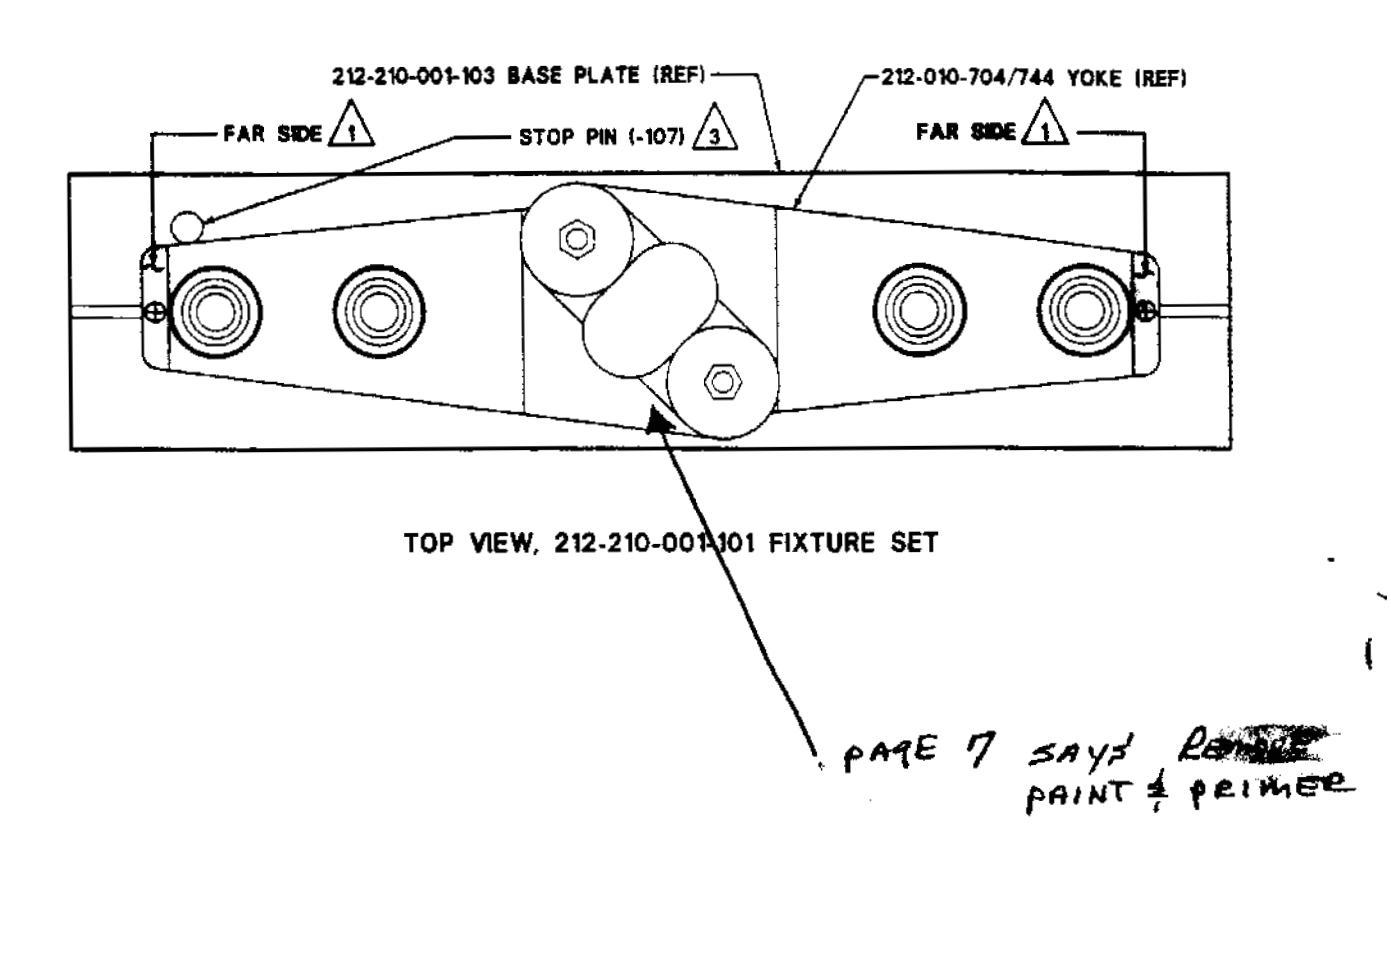
FIGURE 1

A PAINT AND PRIMER REMOVAL REQUIRED 3 YOKE MUST CONTACT STOP PIN WHILE MEASUREMENTS ARE TAKEN

- 6. Position fixture set P/N 212-210-001-101 on a suitable work bench (Figures 1 and 2) using two work aids approximately 7 inches in height. Insert dial indicators from below base plate with end of outer housing positioned between set screw and upper surface of the base plate. Ensure that plunger may be depressed flush with base plate prior to reaching end of travel, and lock indicator in place with set screw.

- 8. Position two bushings (-111) in counterbores at the center of base plate (-103). Place yoke assembly in fixture with trunnion bearing areas resting on bushings, with yoke leading edge contacting stop pin (-107). Install bolts from below plate passing through lower bushings and yoke trunnion bearings. Place two bushings (-109) over bolts against yoke. Install washers and nuts. Torque nuts 50 to 60 inch pounds. Ensure yoke assembly remains in contact with stop pin (-107).

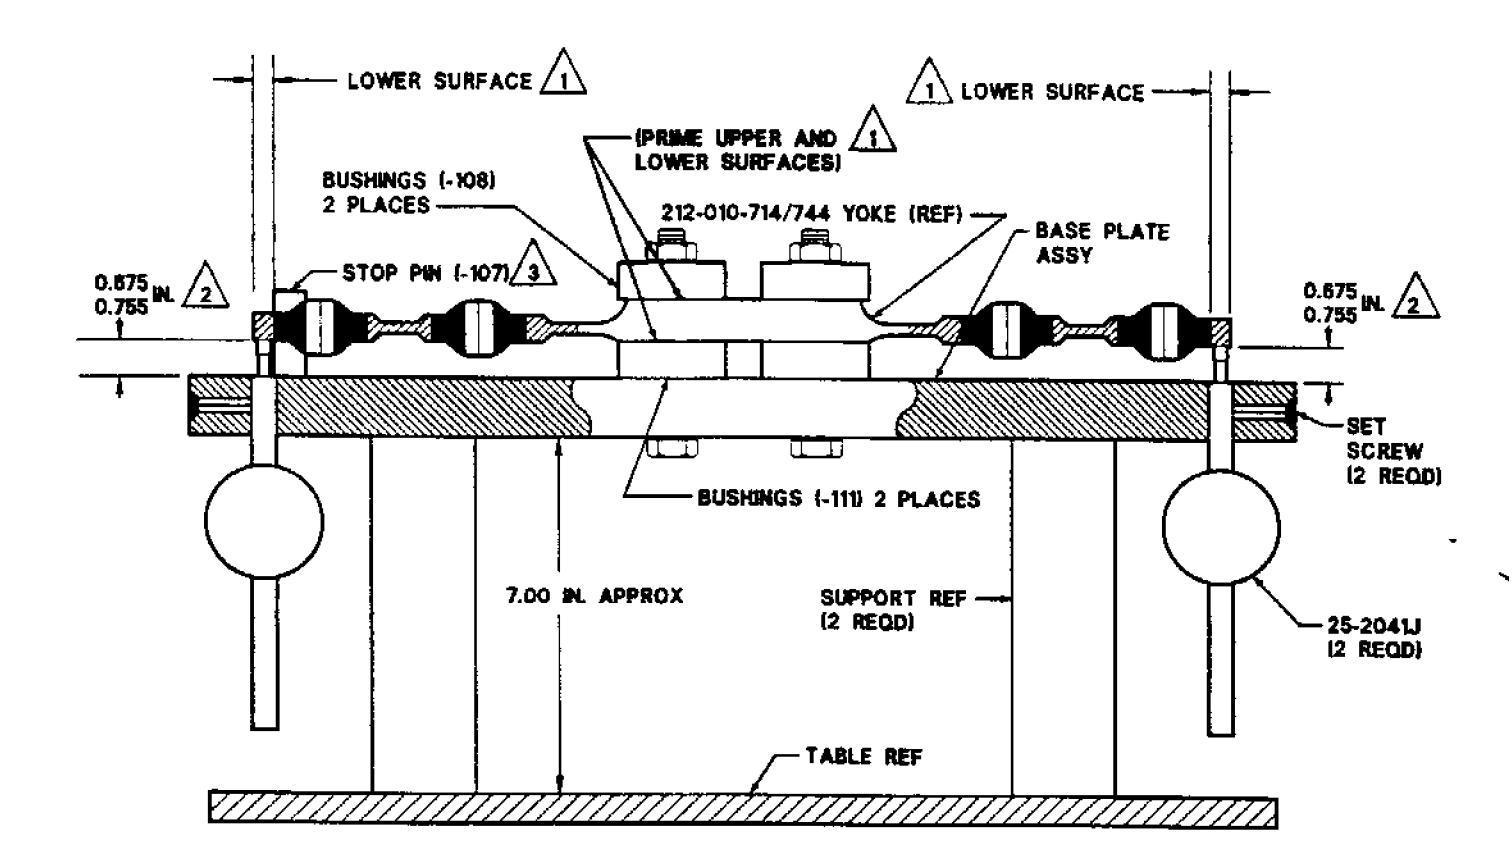
FIGURE 2

SIDE VIEW, 212-210-001-101 FIXTURE SET

3 YOU MUST CONTACT STOP PIN WHILE MEASUREMENTS ARE TAKEN

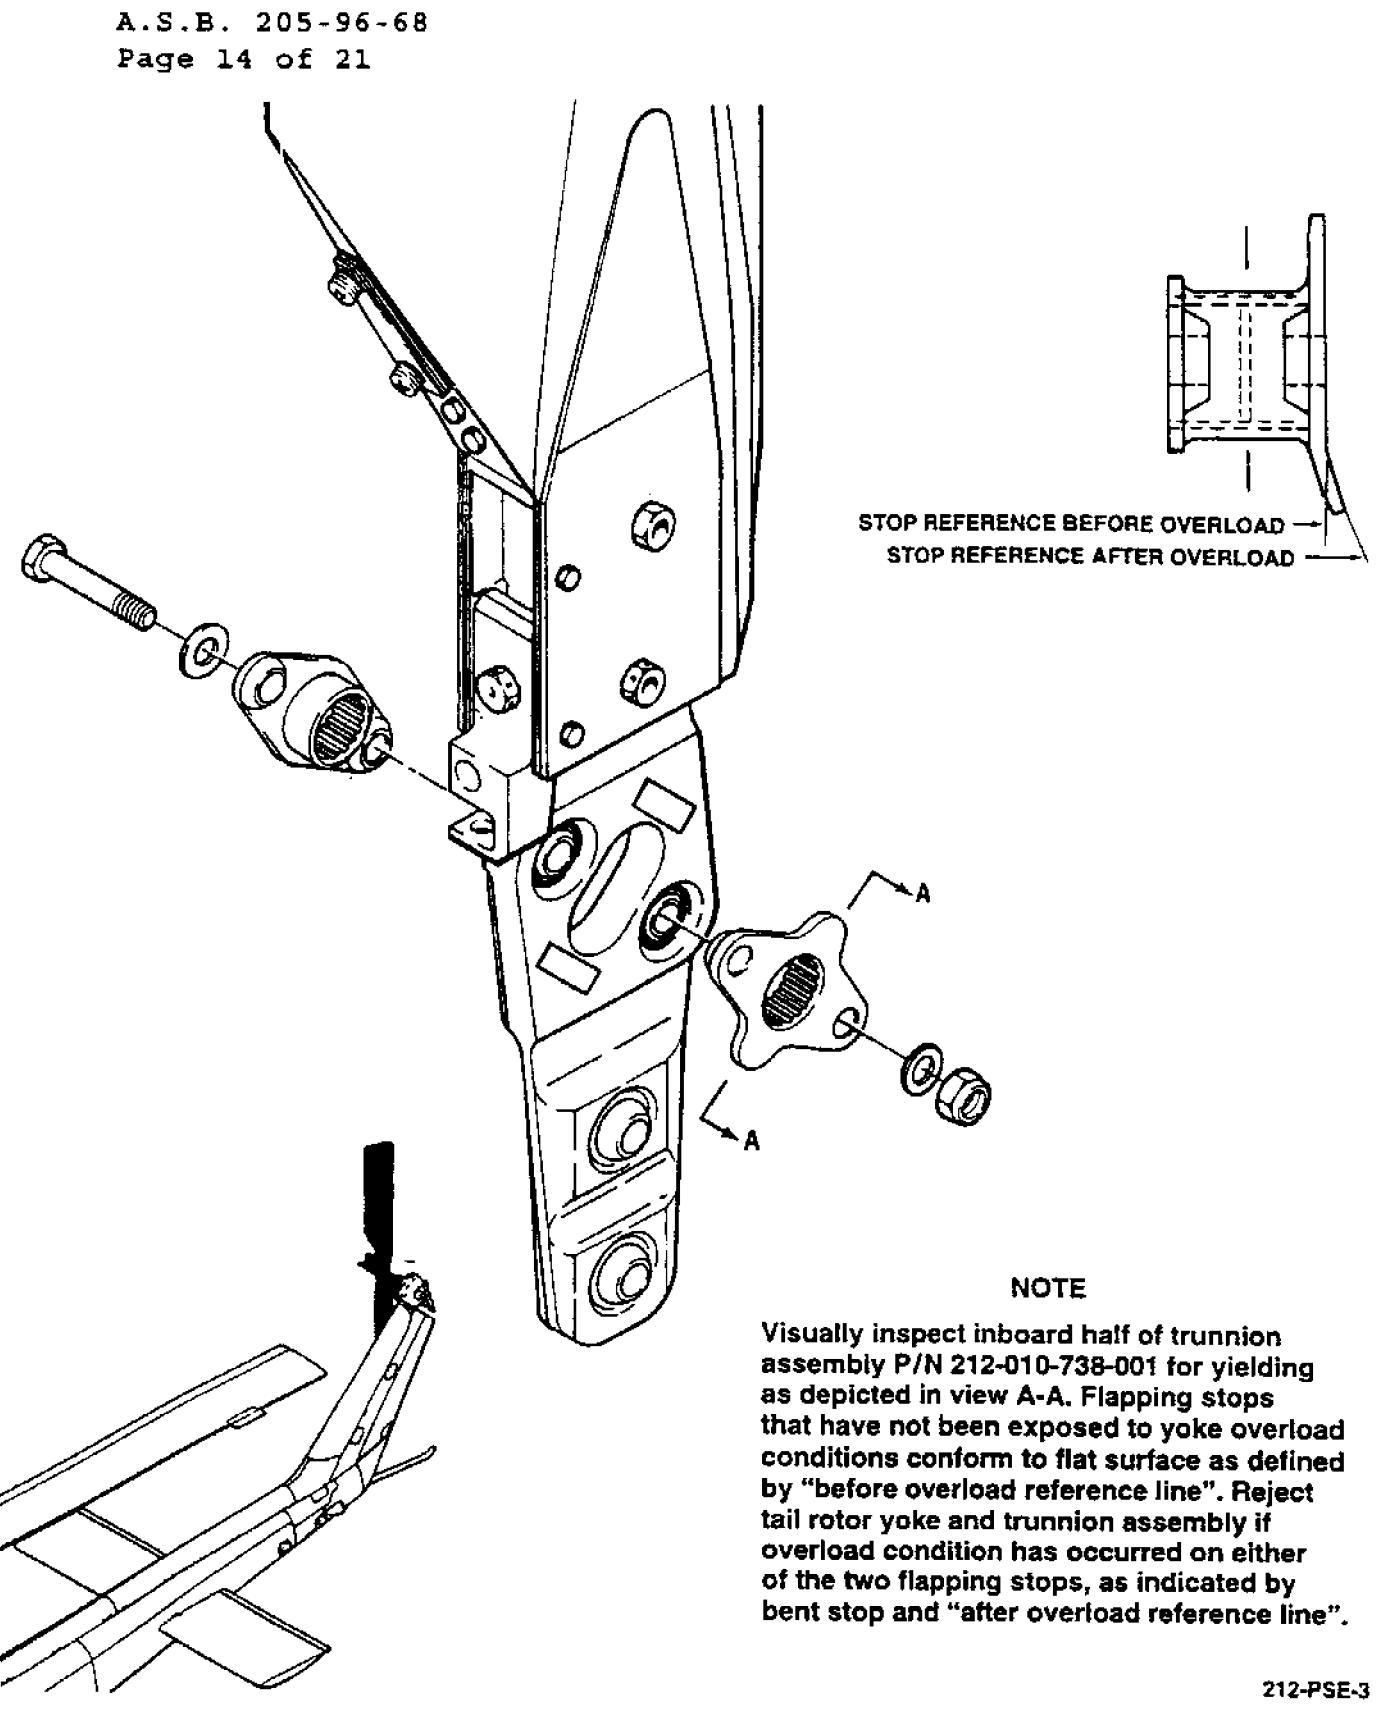
FIGURE 3

1. Gain access to the tail rotor assembly using a maintenance stand or other means to allow close viewing of the trunnion assembly. Perform visual inspection of flapping stops for deformation to determine if the tail rotor yoke assembly may have been exposed to excessive bending loads, Figure 3. Gently place the tail rotor yoke against one flapping stop, allowing full view of the opposite stop. Repeat in opposite direction to allow viewing of remaining stop. A.S.B. 205-96-68 Page 10 of 21

- a. If no deformation/bending is detected upon inspection of each flapping stop, return helicopter to service.
- b. If either flapping stop is determined to be deformed/bent as depicted in Figure 3, the yoke assembly and trunnion assembly is no longer serviceable and must be removed from helicopter and discarded.
- 2. Make entry in the helicopter historical records indicating compliance with this portion of this Alert Service Bulletin.
