SR2X Service Bulletin

Number:
 SB2X-32-22

# SNS SUBJECT: 32-20 NOSE GEAR - Nose Landing Gear Strut Assembly Inspection

# SNS SUBJECT: 32-20 NOSE GEAR - Nose Wheel Shimmy Reduction

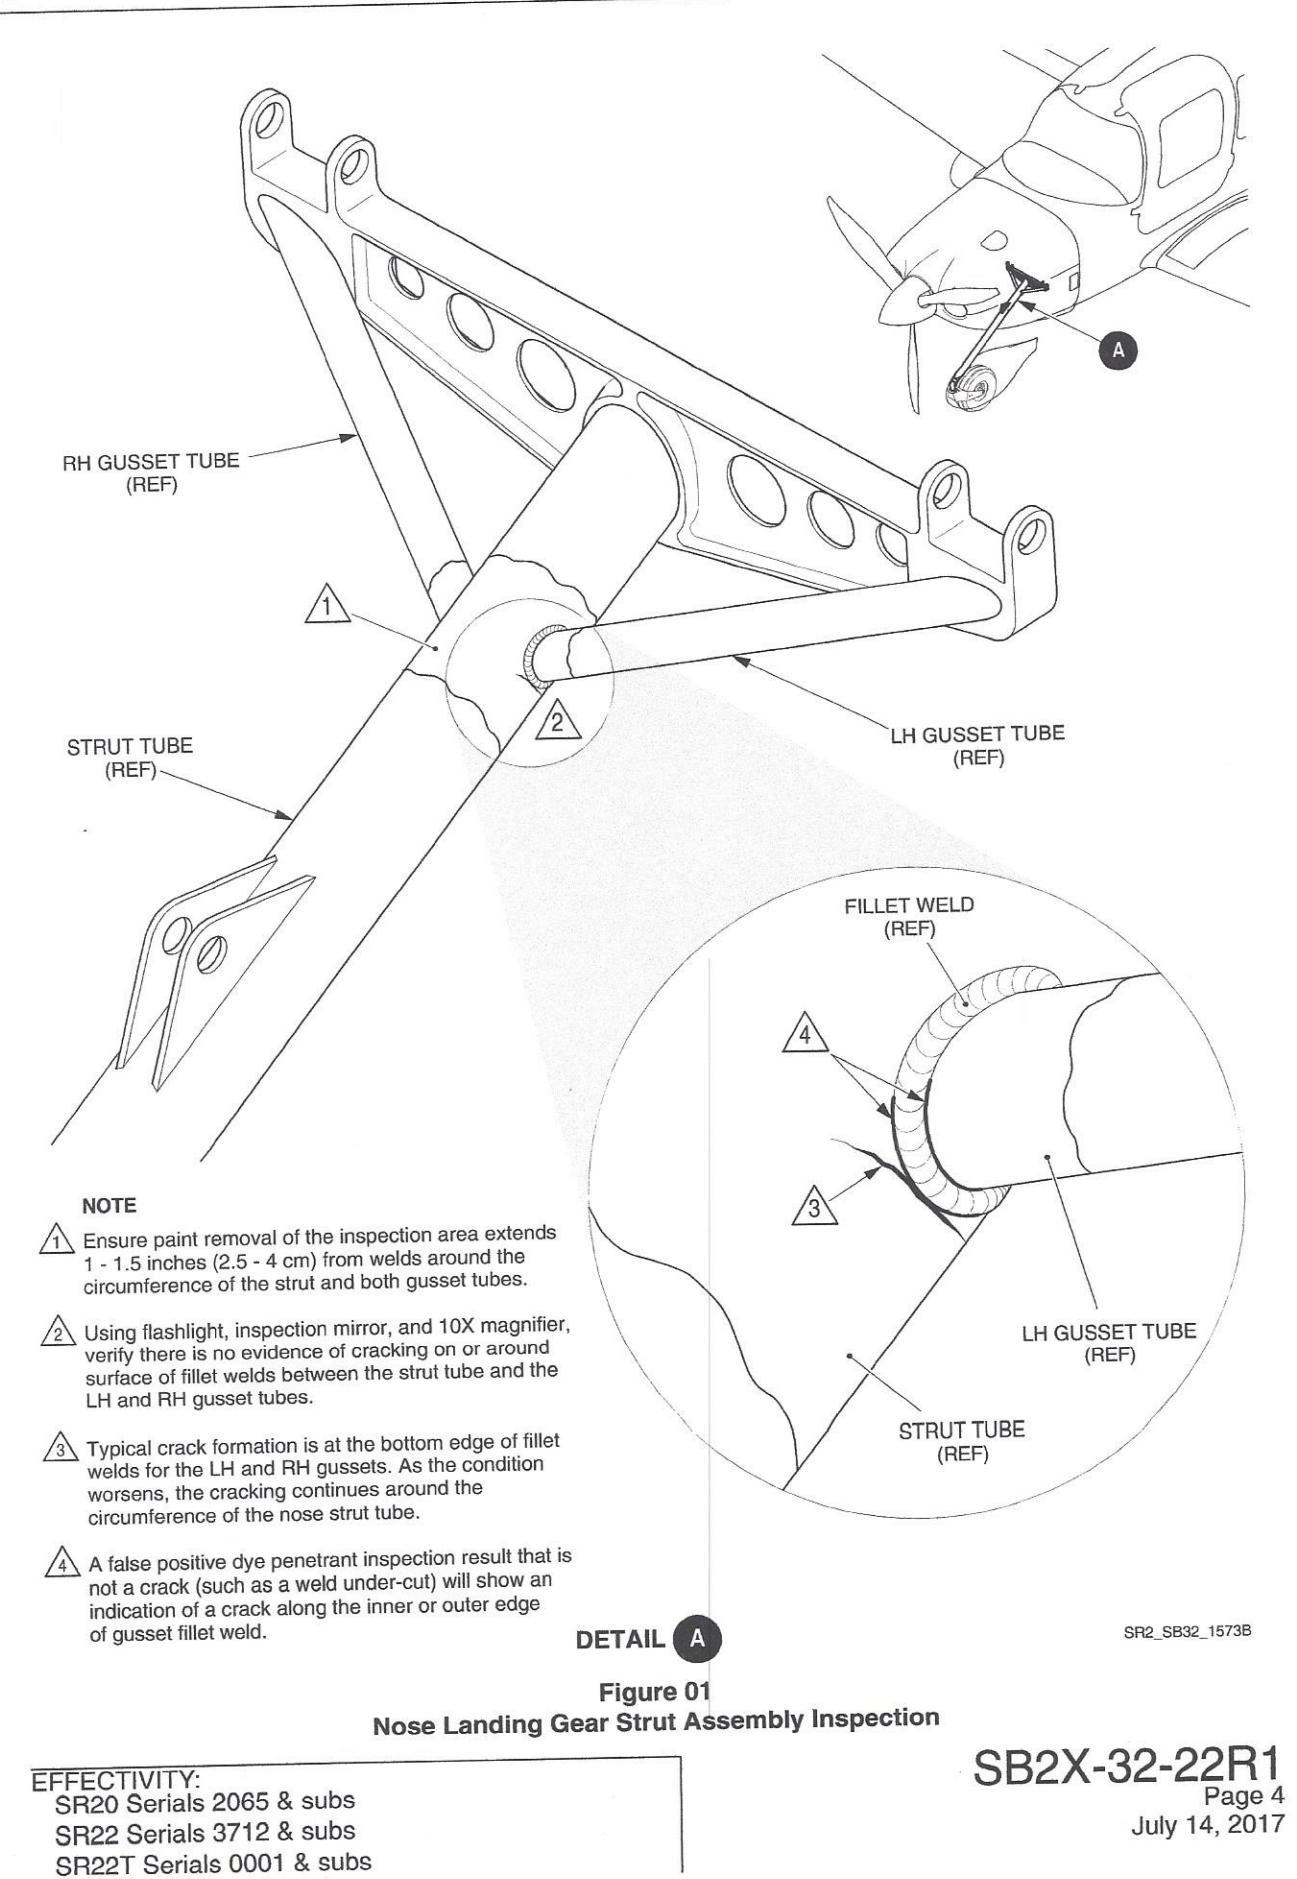
Cracks have been discovered on some nose landing gear strut assemblies at the fillet welds between the strut tube and the LH and RH gusset tubes. This Service Bulletin contains instructions for the inspection of the nose landing gear strut assembly.

# WARNING: If left uninspected, cracks in the strut assemblies may lead to a collapsed nose landing gear.

A false positive dye penetrant inspection result that is not a crack (such as a weld under-cut) will show an indication of a crack along the inner or outer edge of gusset fillet weld.

Note: Ensure paint removal of the inspection area extends 1 - 1.5 inches (2.5 - 4 cm) from welds around the circumference of the strut and both gusset tubes. (See Figure 01)

(6) Using flashlight, inspection mirror, and 10X magnifier, verify there is no evidence of cracking on or around surface of fillet welds between the strut tube and the LH and RH gusset tubes. (See Figure 01)

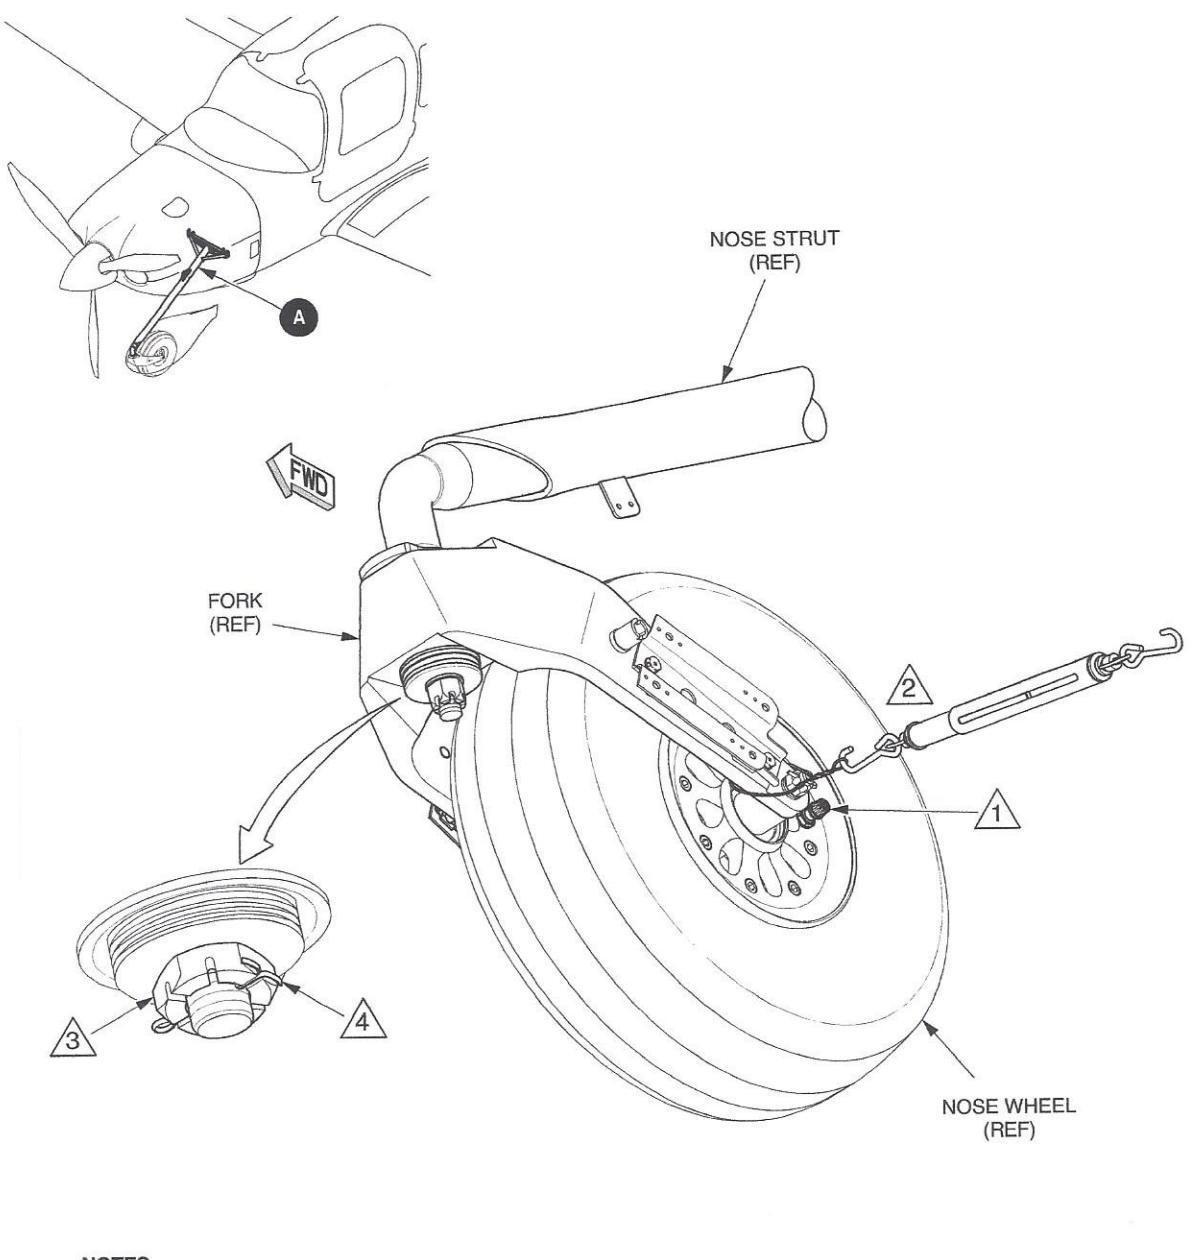
Figure 01 Nose Wheel Shimmy Reduction

On affected airplanes, nose wheel shimmy may exist on aircraft equipped with Beringer wheels. *Nose wheel shimmy* is defined as "a lateral oscillation or wobble of the NLG resulting in a shaking feeling throughout the cabin of the aircraft that can vary in intensity." This is normally encountered during the landing roll-out and will subside as speed is reduced. Although less common, NLG shimmy may also be present during the take-off roll, or during high speed taxi.

These shimmy events can be greatly reduced or eliminated by lowering the nose tire pressure and increasing the force required to rotate the nose wheel fork by increasing the torque on the (NLG) spindle nut.

Adjust NLG tire pressure to 40 - 50 psi (276 - 344 kPa).

Attach spring scale to axle.

Torque castellated spindle nut so a constant force of more than 49 lb (22.2 kg) is required to rotate nose wheel fork and wheel assembly. Loosen castellated spindle nut and re-torque so a constant force of 30 - 35 lb (13.6 - 15.9 kg) is required to rotate nose wheel fork and wheel assembly.

A Install new cotter pin as shown.

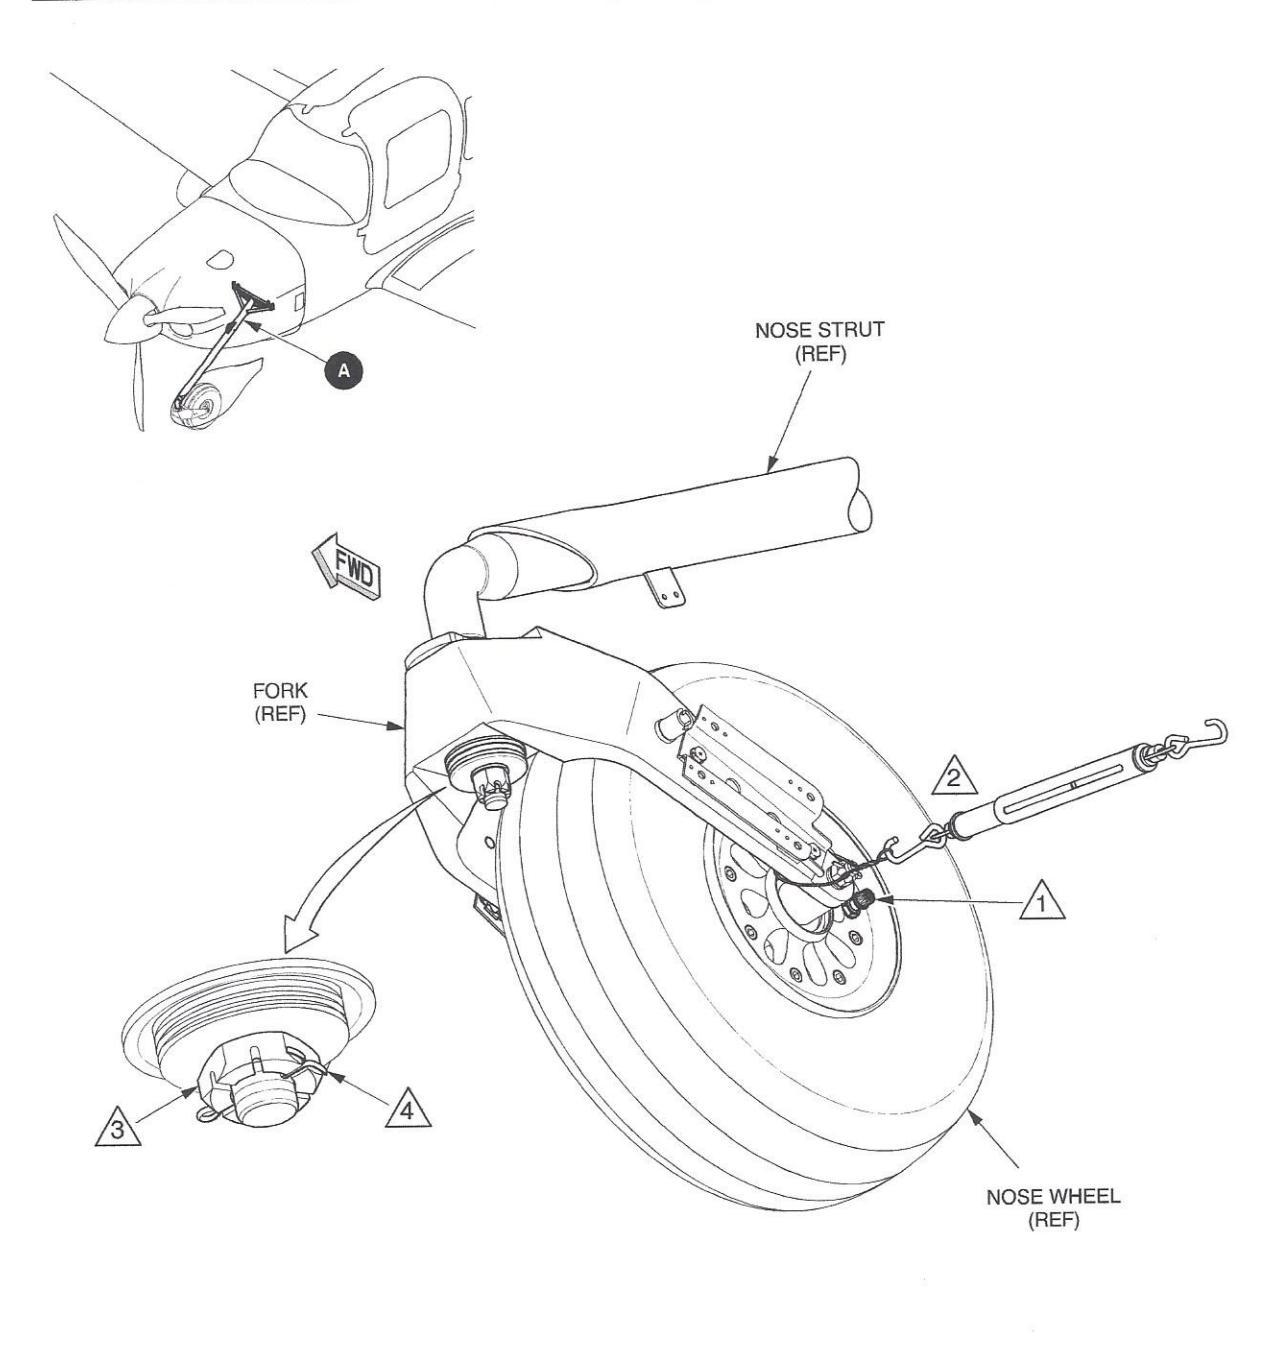
On affected airplanes, nose wheel shimmy may exist on aircraft equipped with Beringer wheels. *Nose wheel shimmy* is defined as "a lateral oscillation or wobble of the NLG resulting in a shaking feeling throughout the cabin of the aircraft that can vary in intensity." This is normally encountered during the landing roll-out and will subside as speed is reduced. Although less common, NLG shimmy may also be present during the take-off roll, or during high speed taxi.

These shimmy events can be greatly reduced or eliminated by lowering the nose tire pressure and verifying the force required to rotate the nose wheel fork.

Adjust NLG tire pressure to 30 - 35 psi (207 - 241 kPa).

A Loosen castellated spindle nut and re-torque so a constant force of 20 - 25 lb (9.1 - 11.3 kg) is required to rotate nose wheel fork and wheel assembly.
