**Correspondence Concerning
American Airlines Flight 903
Accident of May 12, 1997**

December 2, 2002

Chronology of Significant Events related to AAL 903
Compiled by Airbus
December 2, 2002

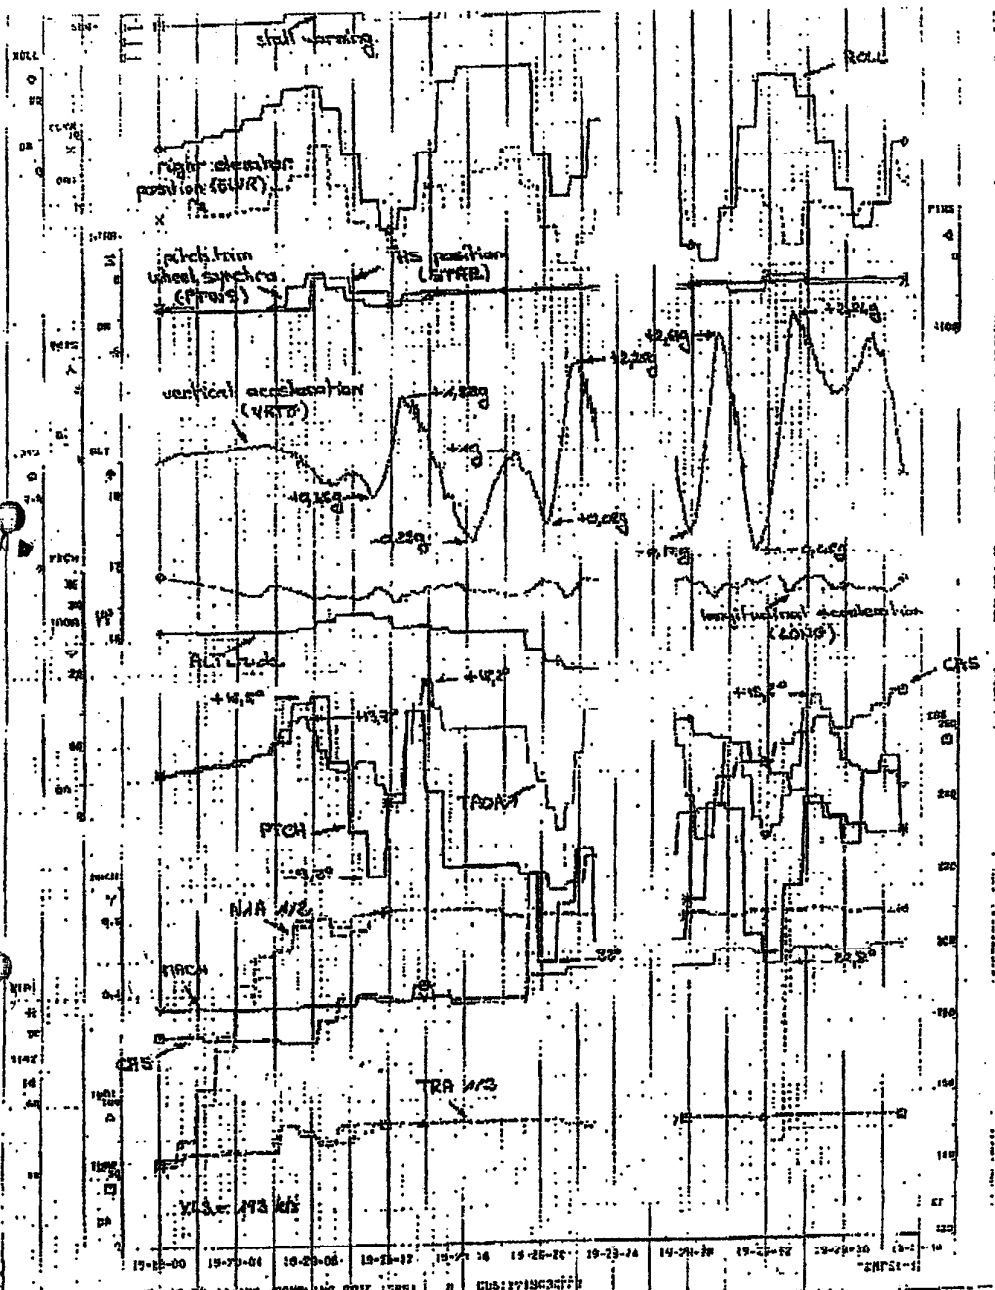
FIGURE 2

FLIGHT V1903 - INBURLENZ - AMERICAN AIRLINES
