ERA13FA273

Manchester, Kentucky

Bell Helicopter 206 L-1; N114AE

NTSB ENGINE EXAMINATION

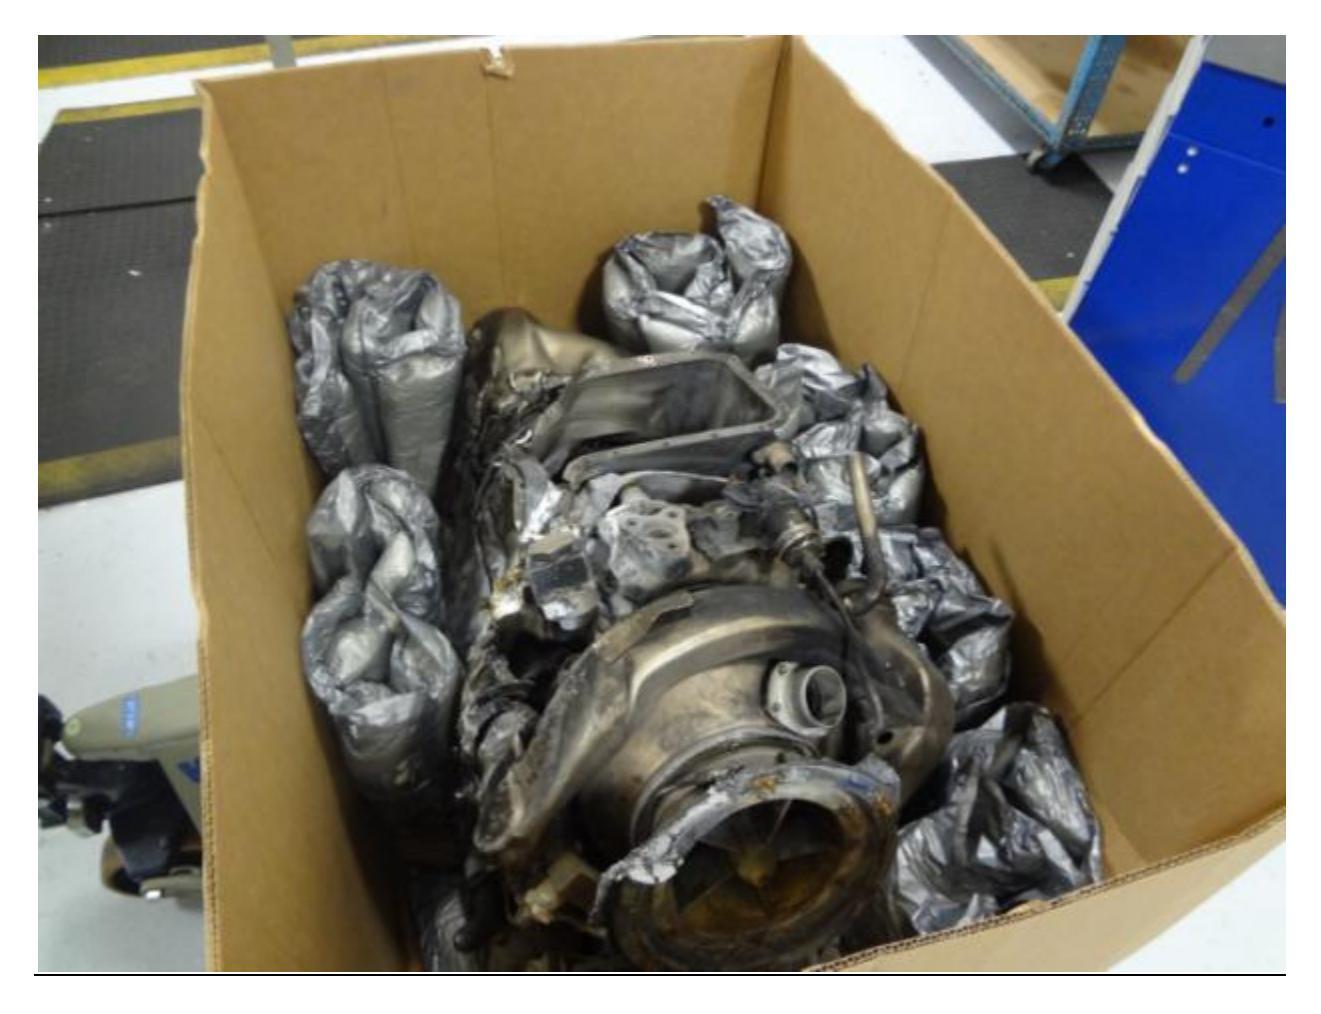
Photo 1: Engine in Box After Opened

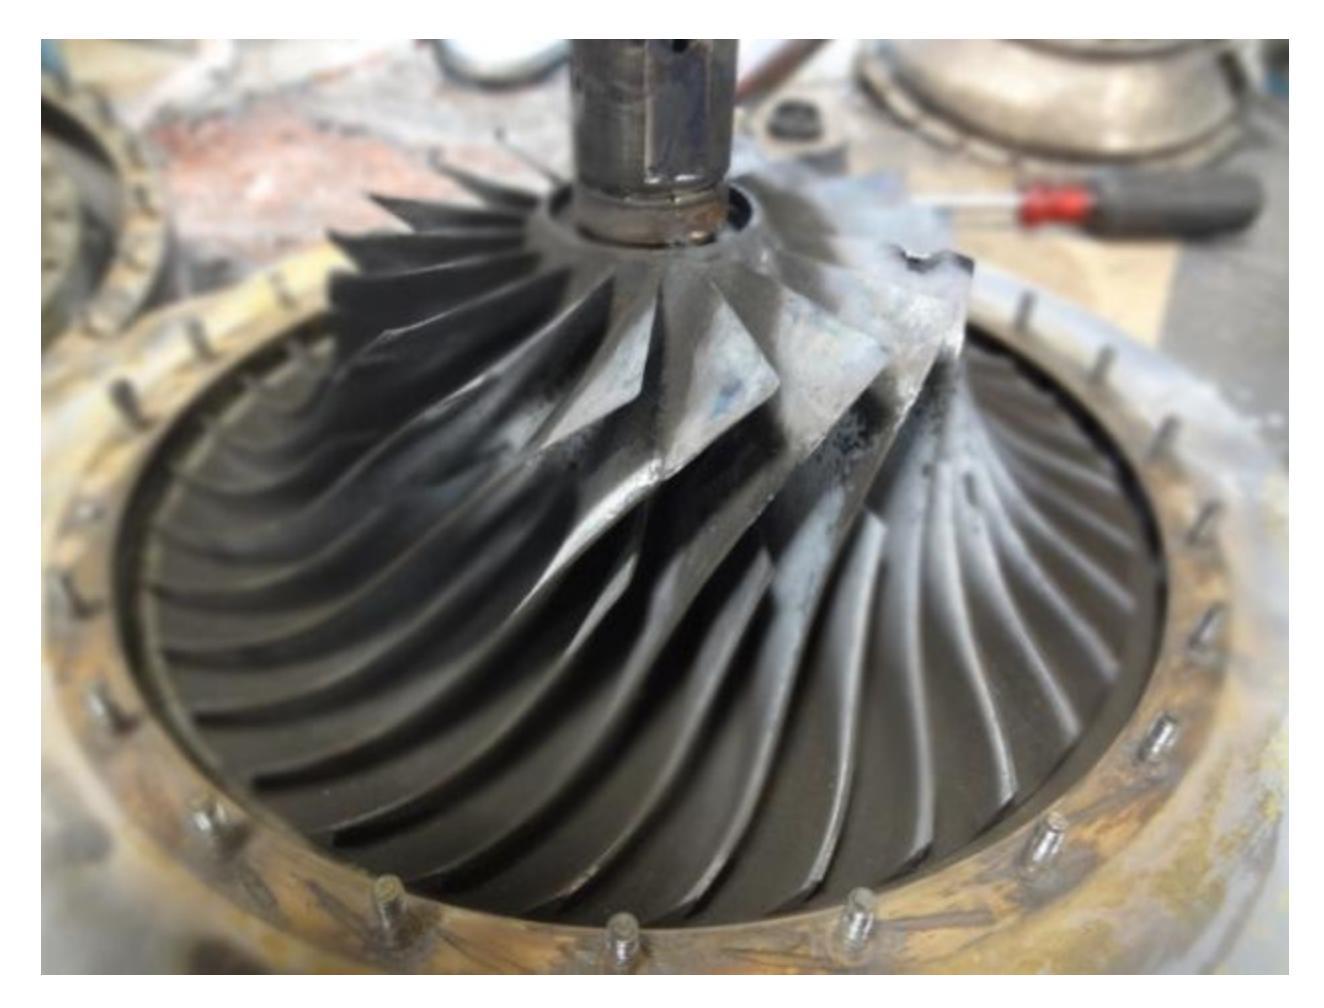
The impeller and shroud were removed for examination. The impeller blades exhibited soft damage and rub marks to several blades. The shroud, after wiped clean of soot, revealed score marks around the circumference with the deepest around the 2 to 4 o'clock position. The No. 2, No. 2 $\frac{1}{2}$, No. 3, and No. 4 bearings were rotated and exhibited minimal resistance which was a result of the thermal damage. The No. 3 and No. 4 bearing remained in place in the pinion gear. The power turbine to compressor coupling exhibited torsional fracture marks at the connection point with the spur adaptor gear shaft, consistent with rotation during the accident sequence.

Photo 2: Impeller

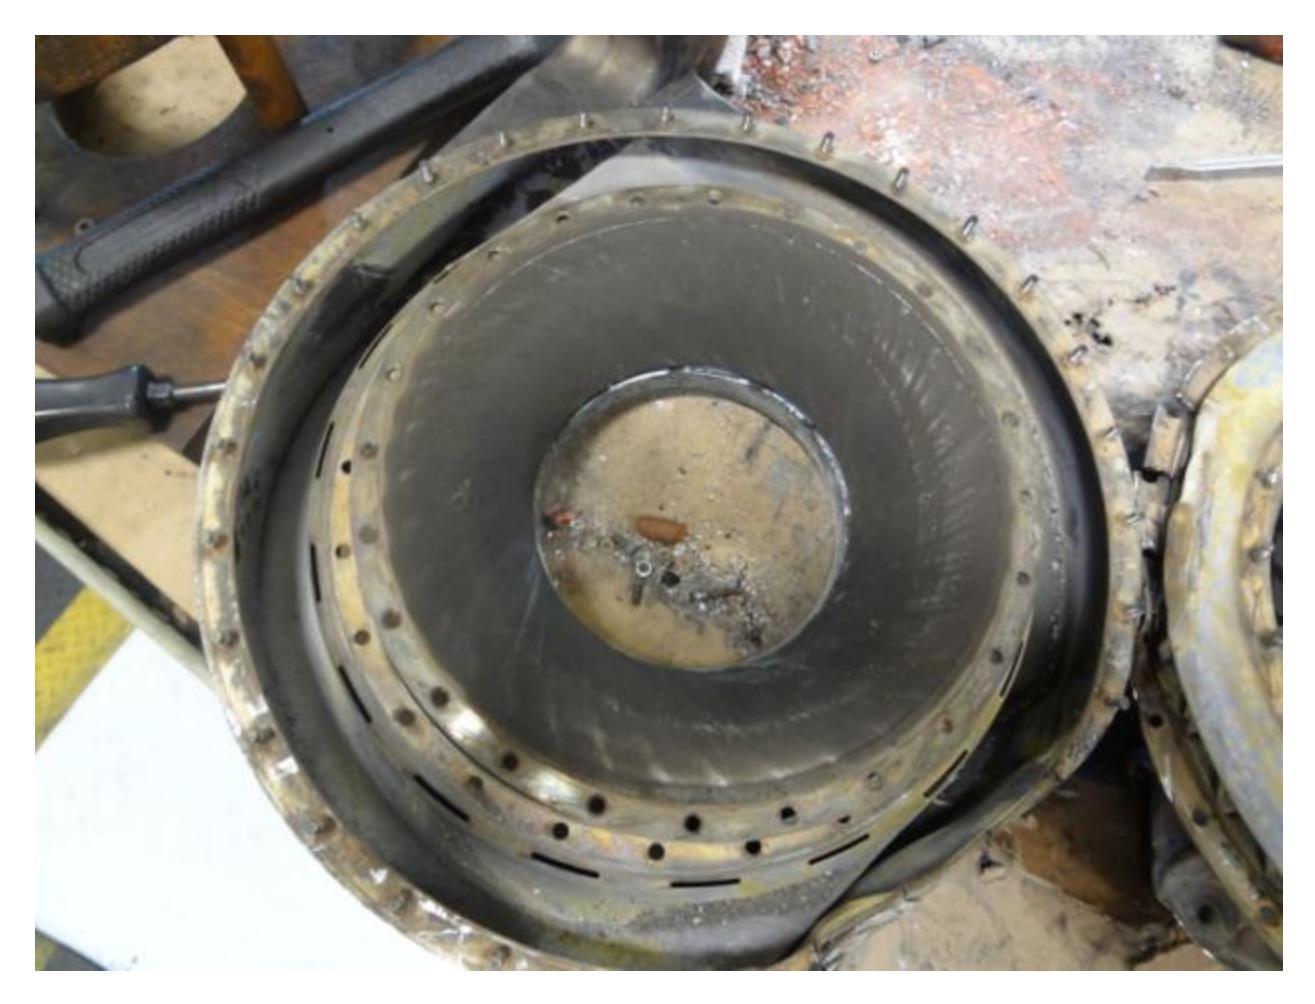
Photo 3: Impeller Shroud

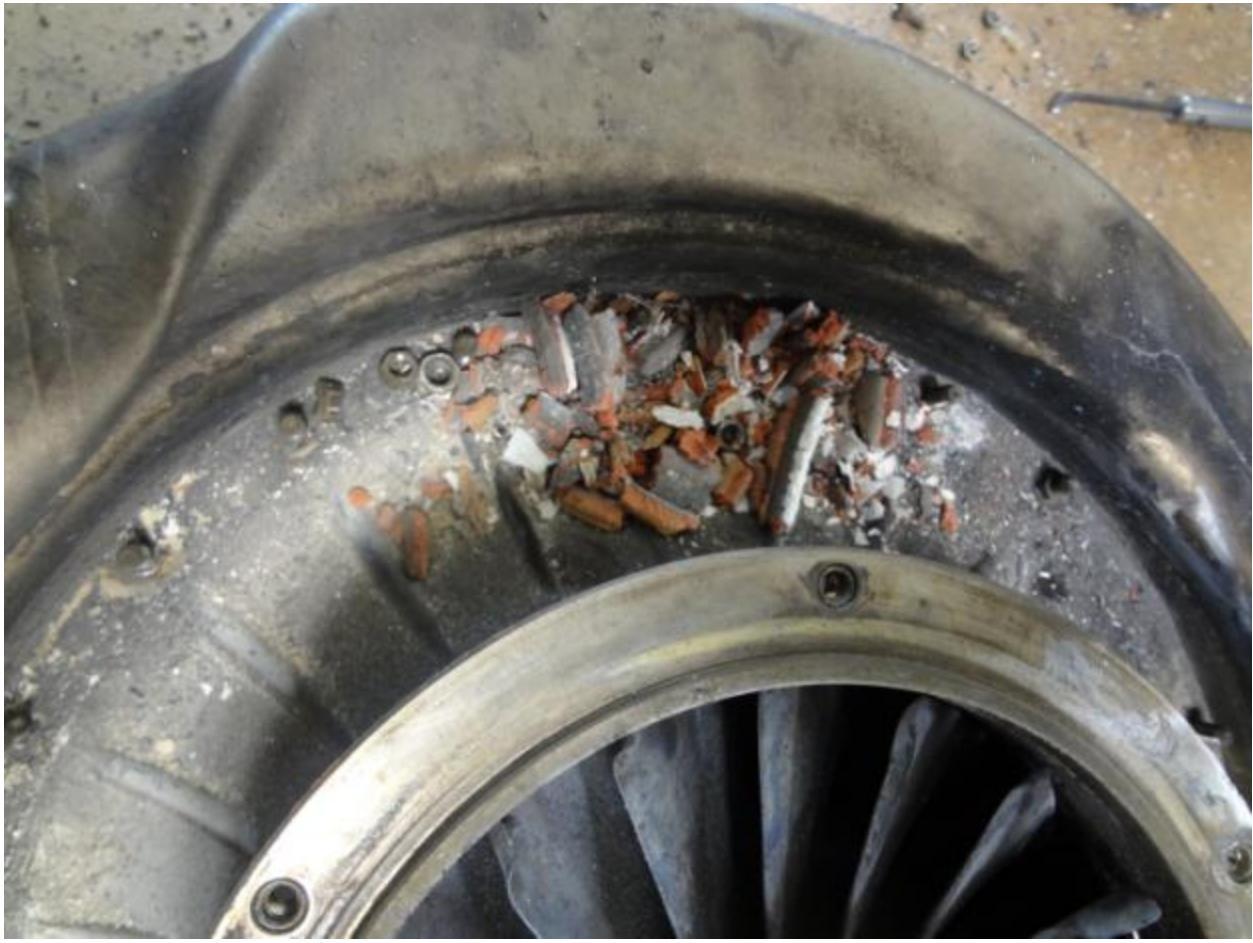
Photo 4: Shroud Gasket as Found

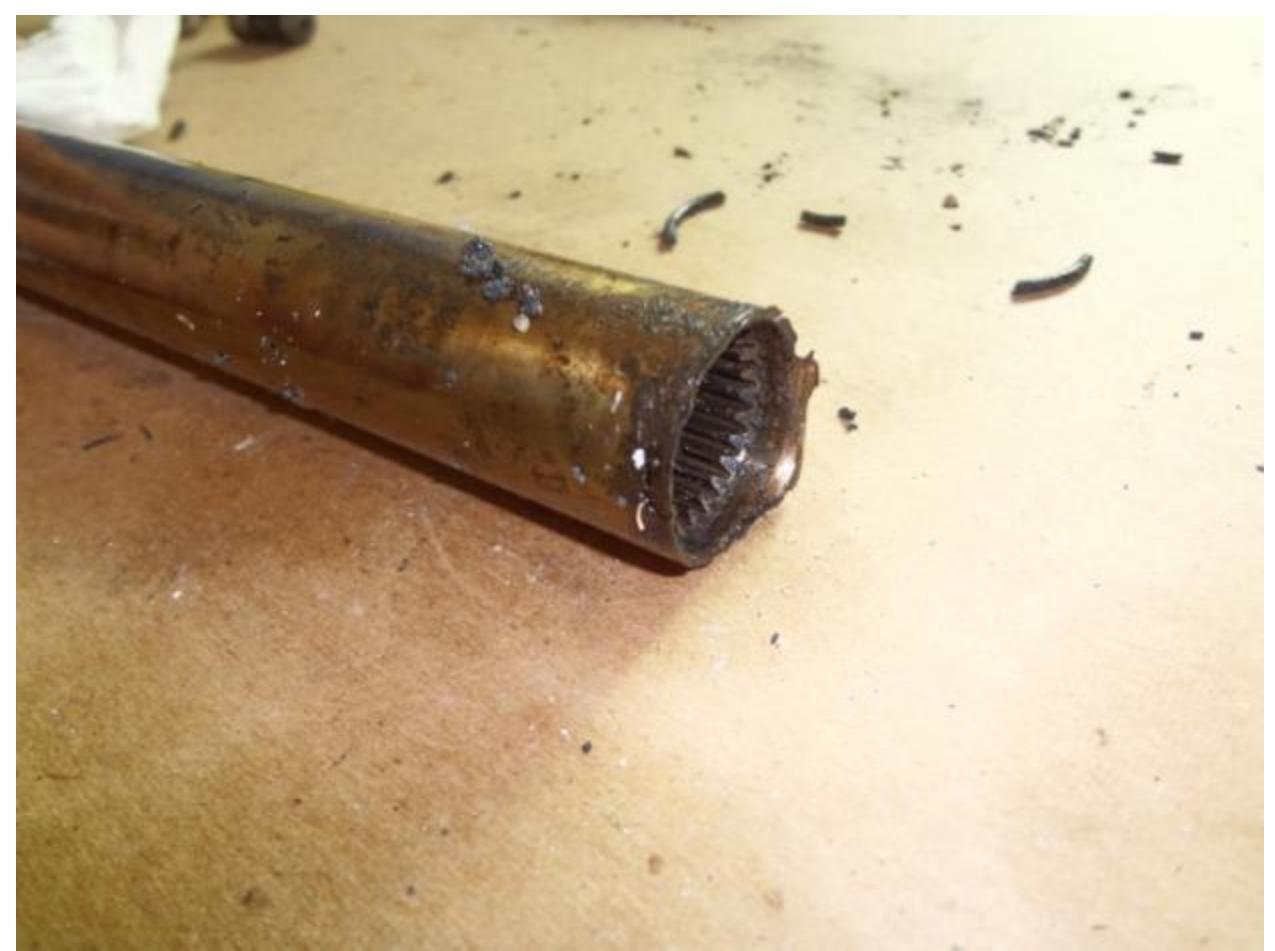
Photo 5: Power Turbine - Compressor Coupling

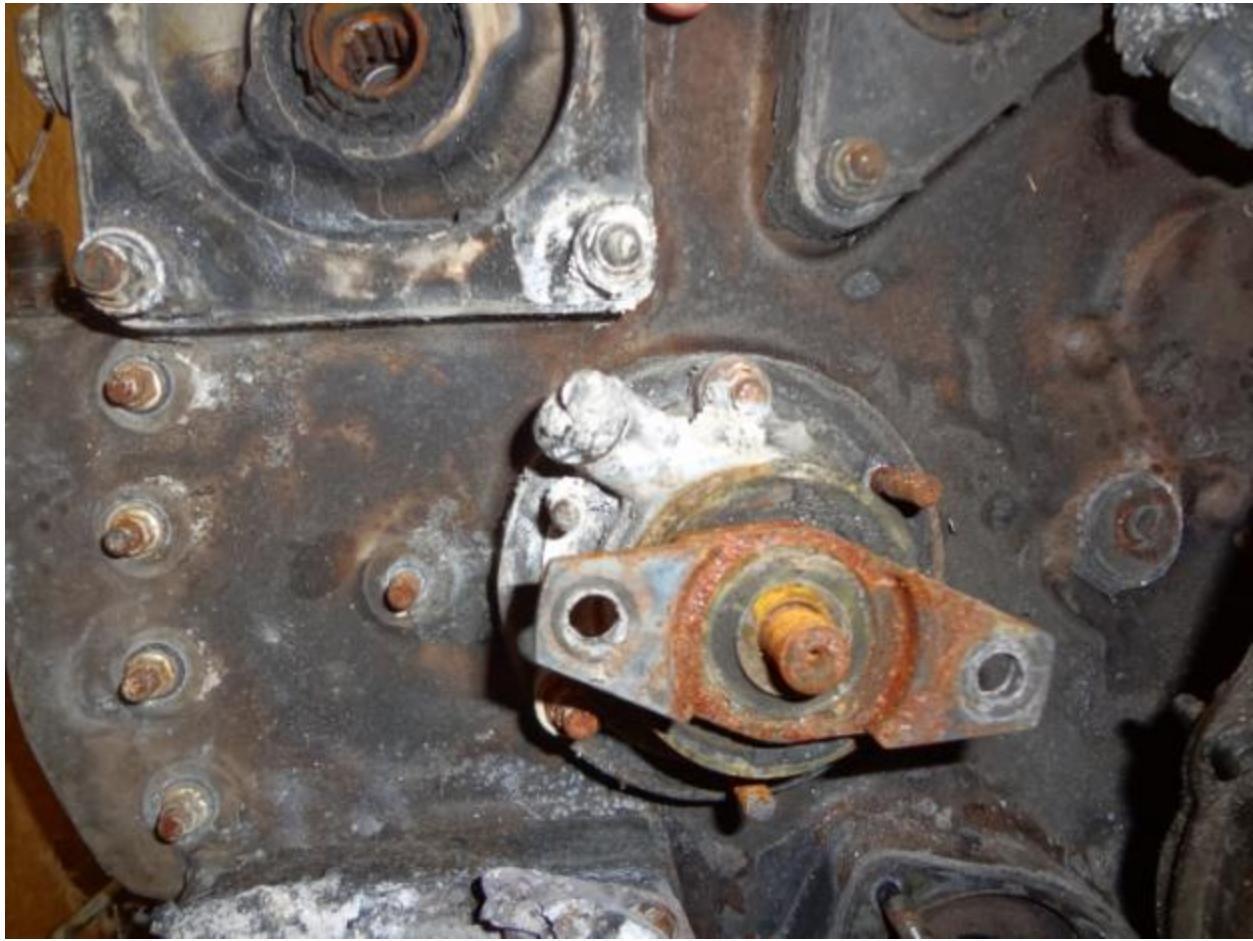
The accessory gearbox was removed and exhibited extensive thermal damage. No evidence of preimpact malfunctions or abnormalities were noted.

Photo 6: Rear side of Accessory Housing

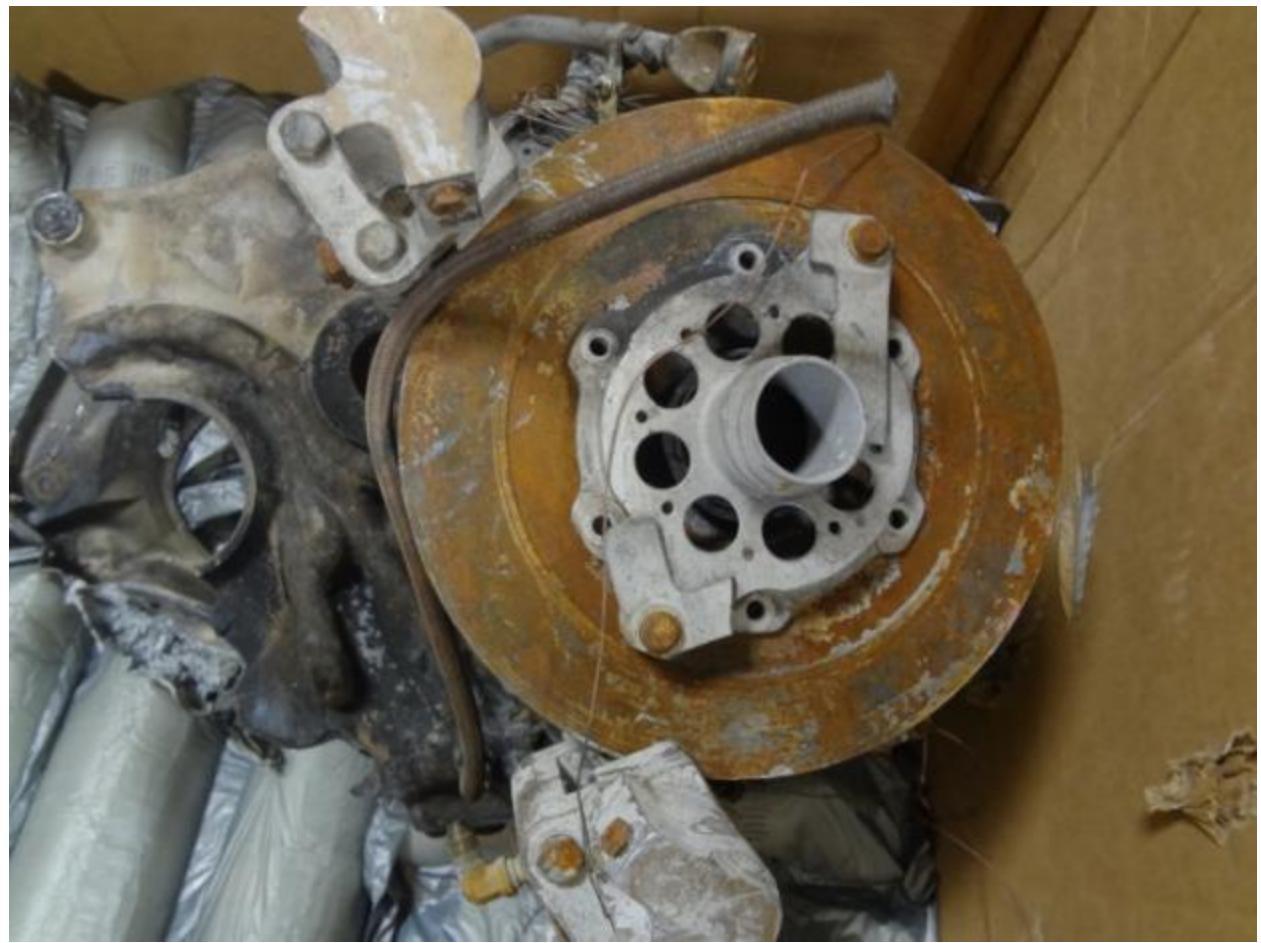
Photo 7: Front Side of Accessory Housing

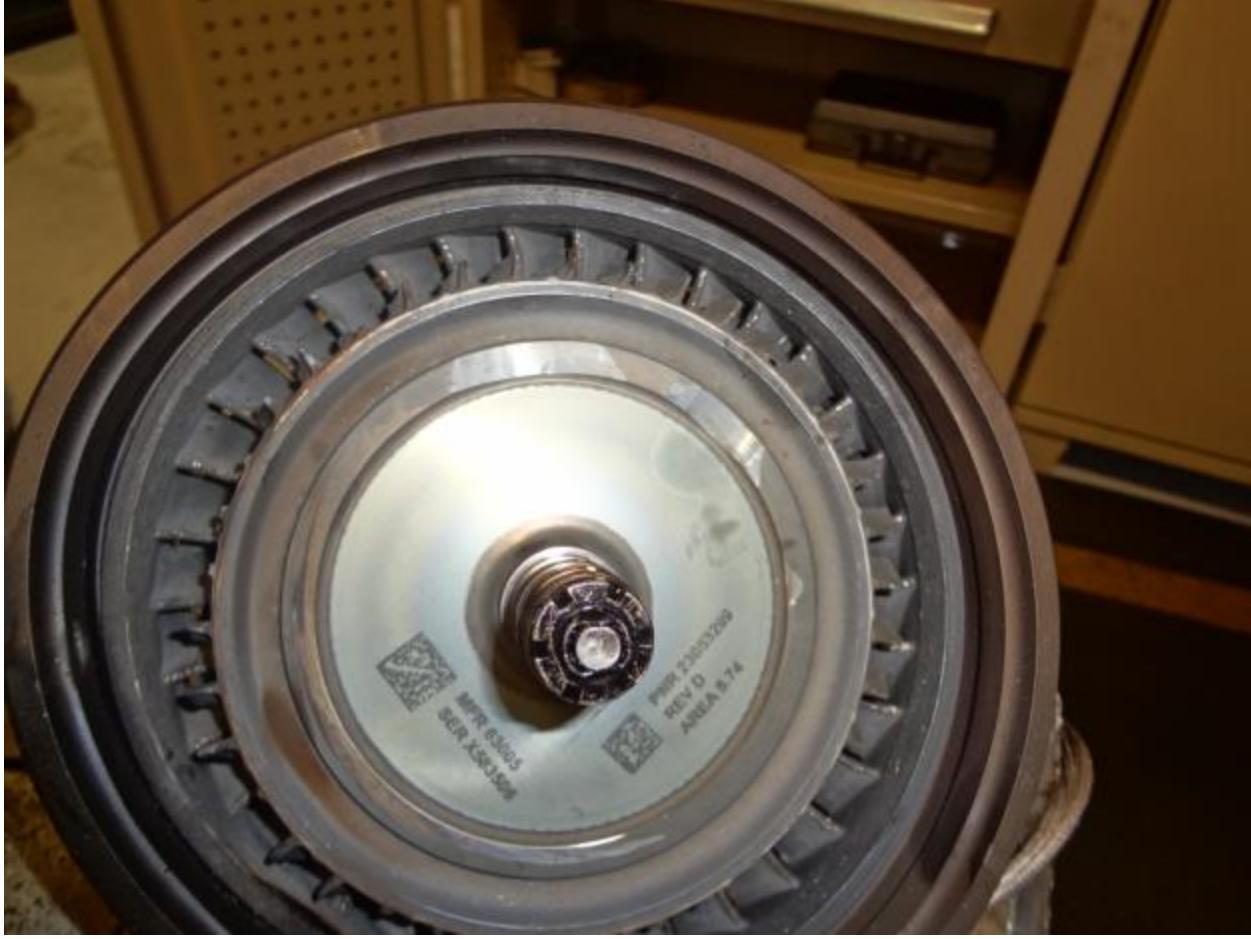
1st stage was removed and the No. 6 Bearing was examined and rotated smoothly by hand. All 8 bearing dampers were in place. All 1st stage blades were fractured near the blade root.

Photo 8: 1st Stage Turbine

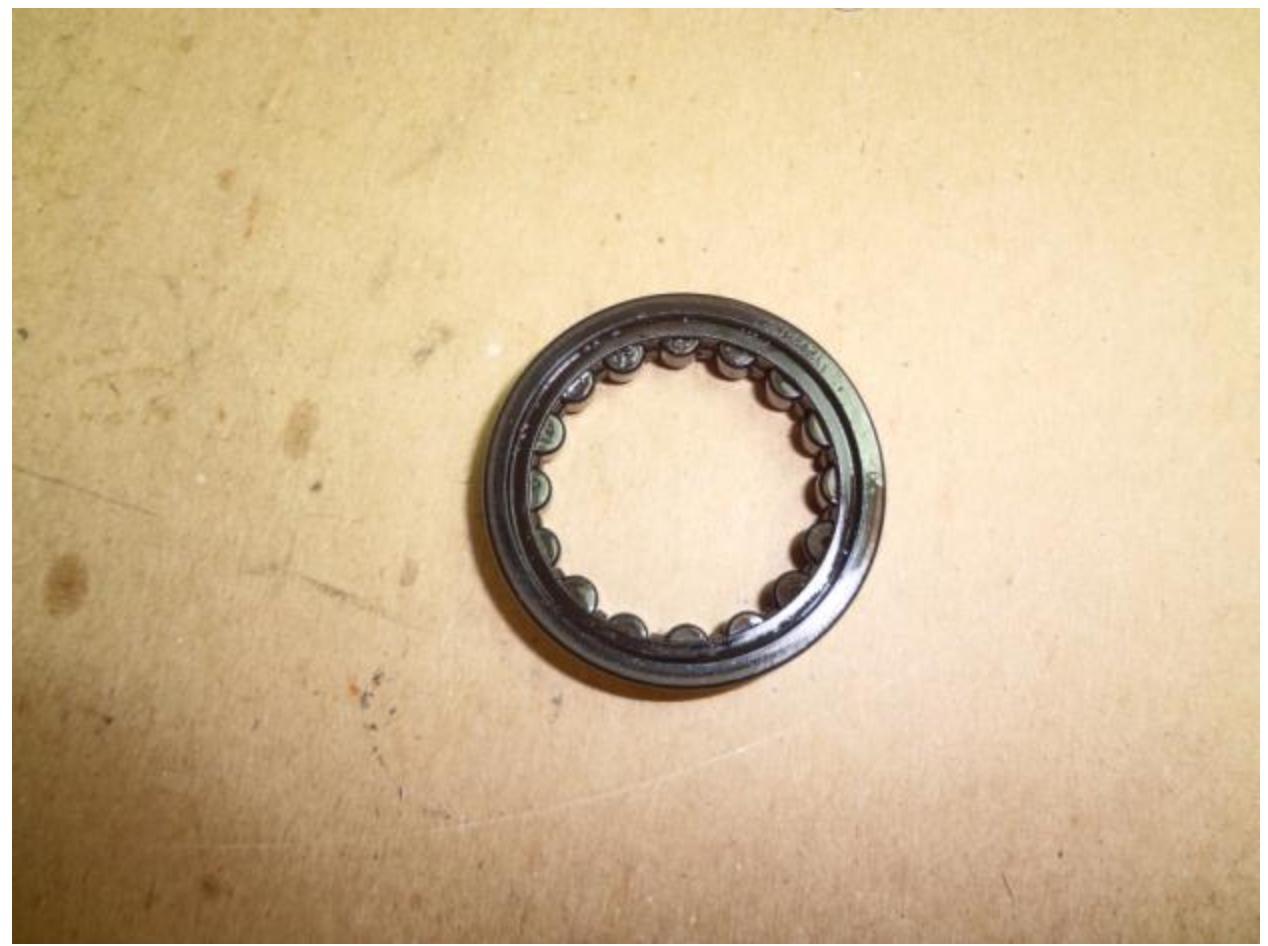
Photo 9: No. 6 Bearing after Removal

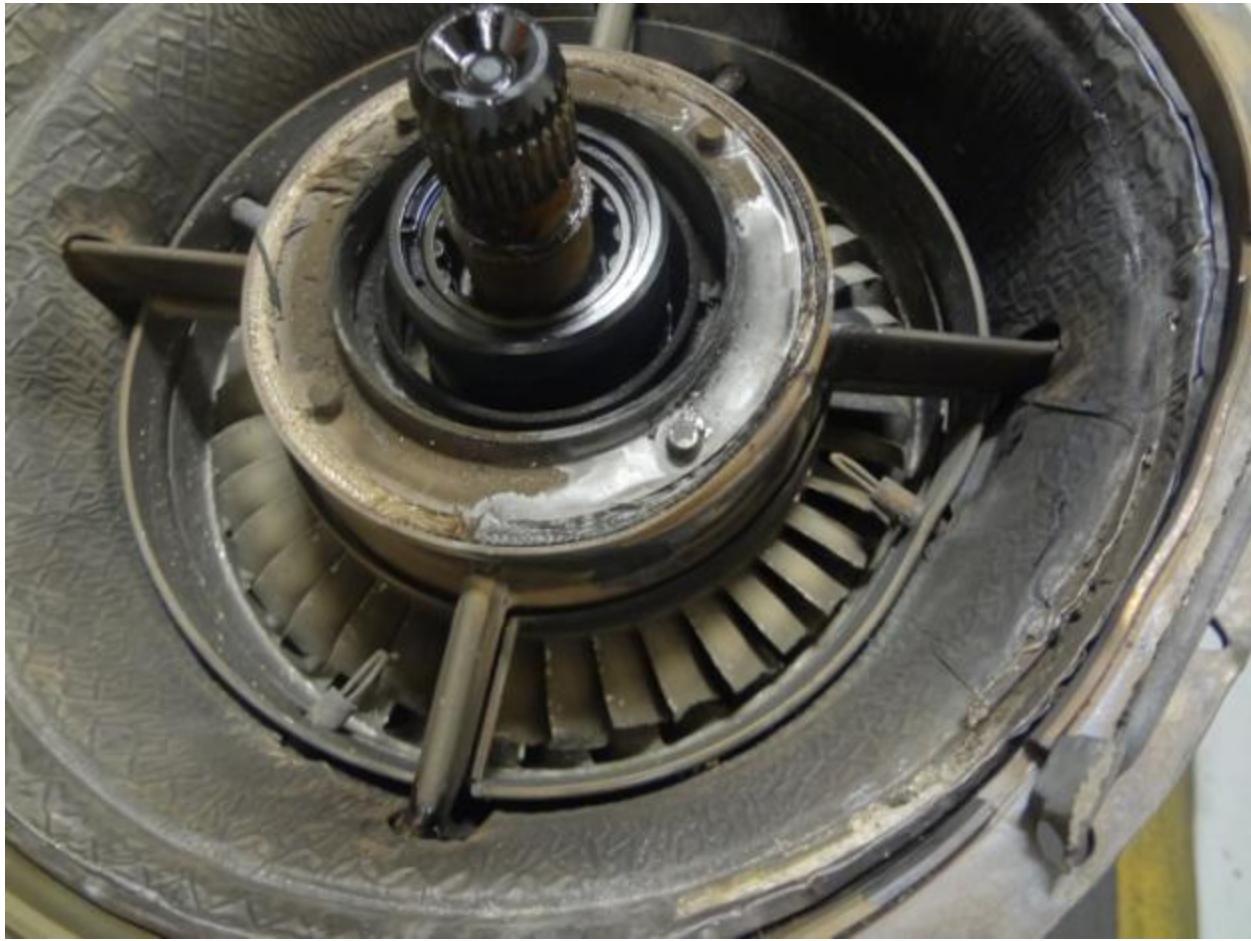
2^{nd} stage turbine The 2^{nd} stage was examined in place and exhibited numerous rotation scoring marks as well as evidence of FOD damage. Numerous blade tips exhibited hard damage and some blade tip fractures.

Photo 10: 2nd Stage Blades as Found

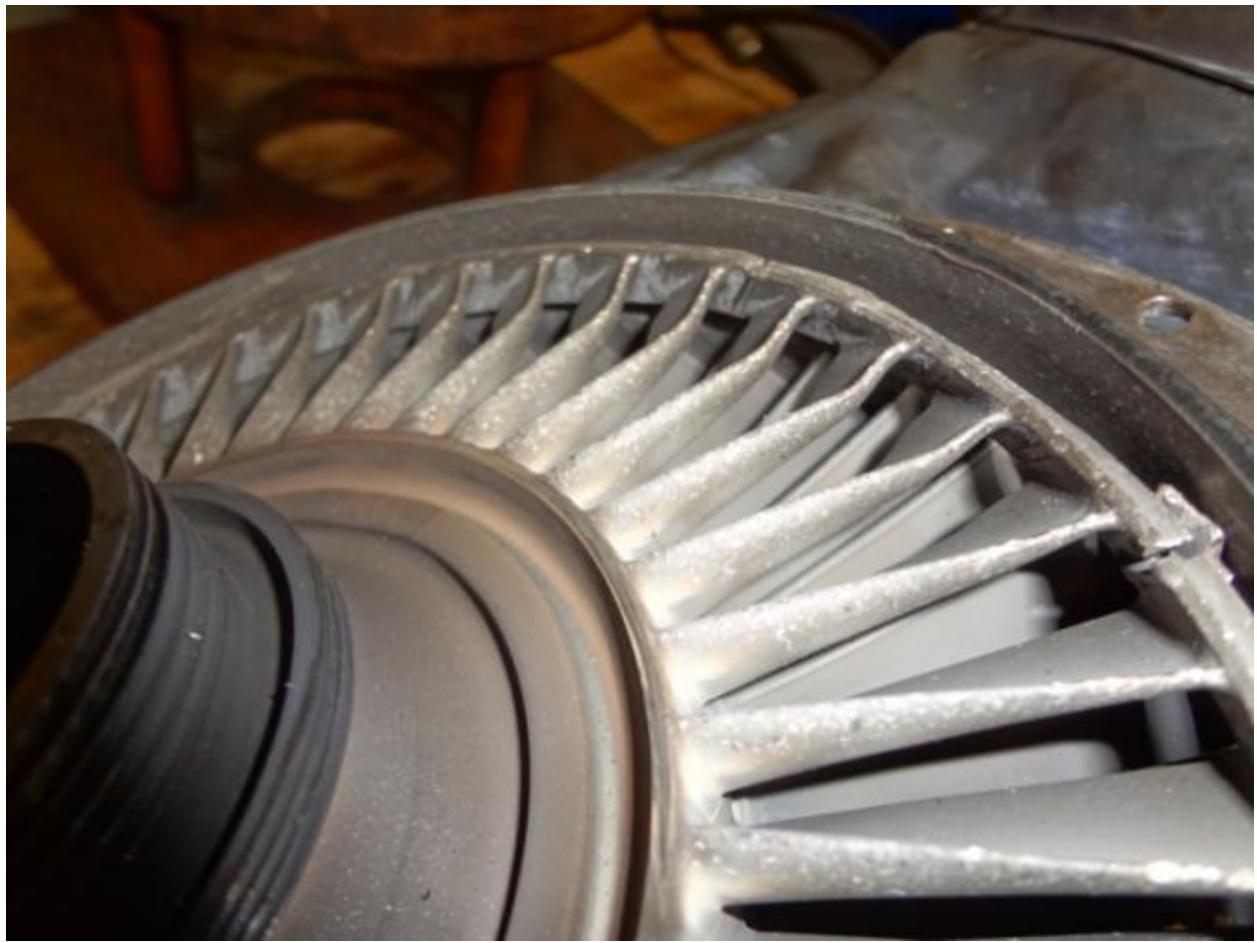
$\underline{3^{rd}}$ stage turbine The 3^{rd} stage wheel and nozzle were separated, examined, and exhibited blade FOD and score marks on the blades. The wheel was also deformed on the right side along approximately onefourth of the circumference.

Photo 11: 3rd Stage Blades with Scoring on Outer Circumfrence

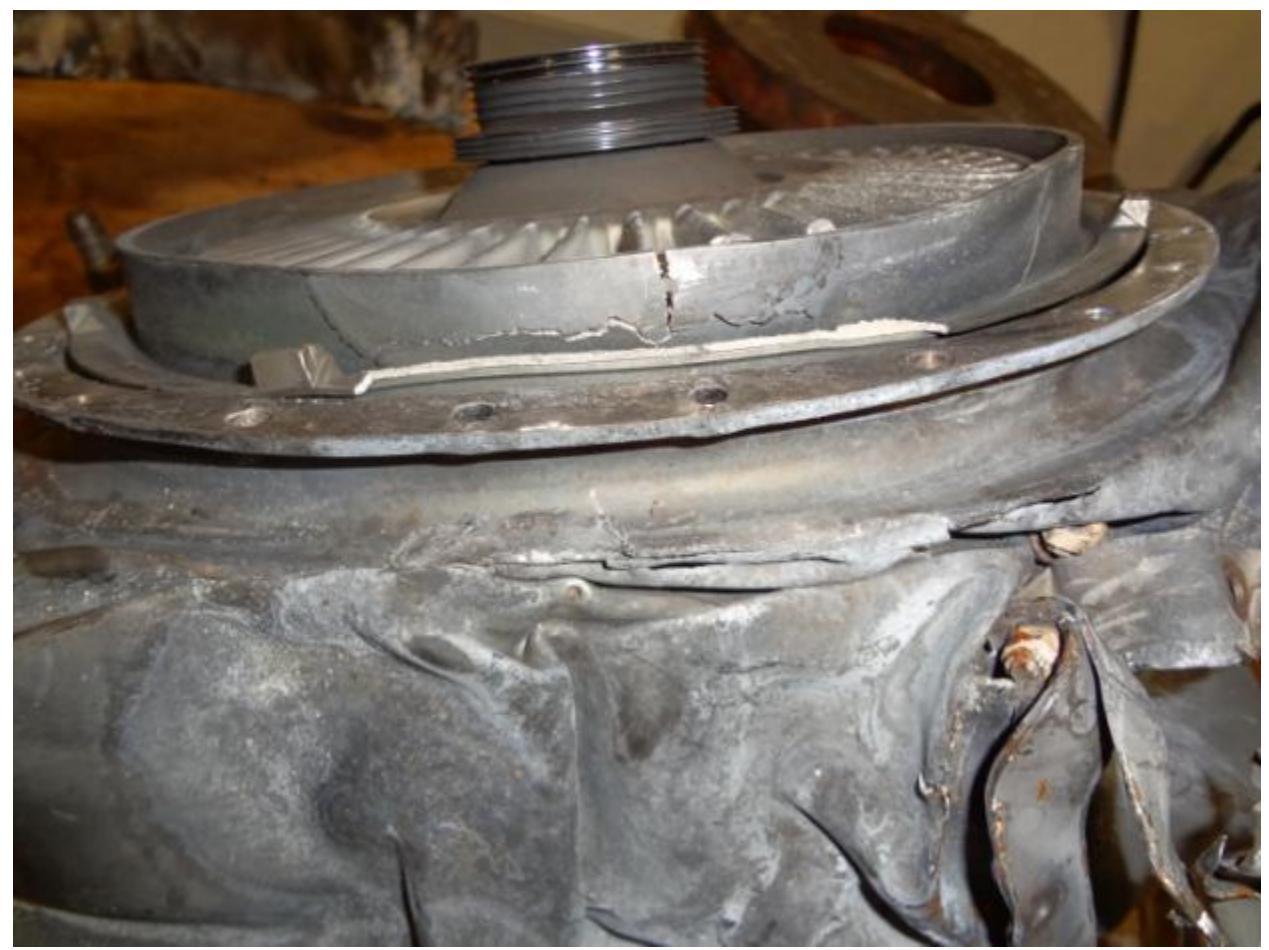
Photo 12: 3rd Stage Wheel with Impact Damage

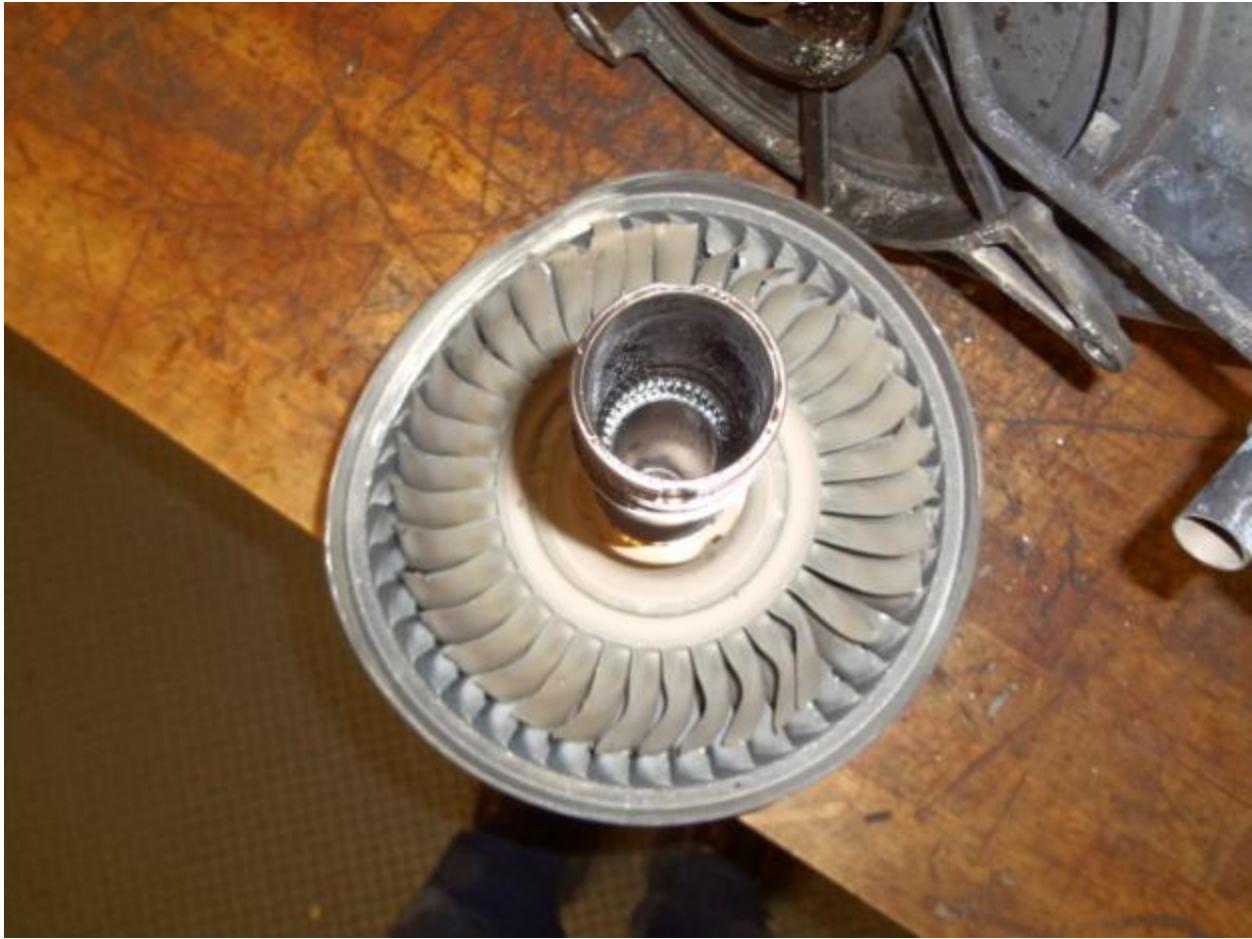
<u>4th stage turbine</u> The 4th stage turbine was examined and indicated blade to vane contact as well as scoring witness marks along the outside circumference. Numerous blades exhibited fracture marks and the vanes exhibited gouge marks from blades.

Photo 13: 4th Stage Turbine Wheel as Viewed after Separation

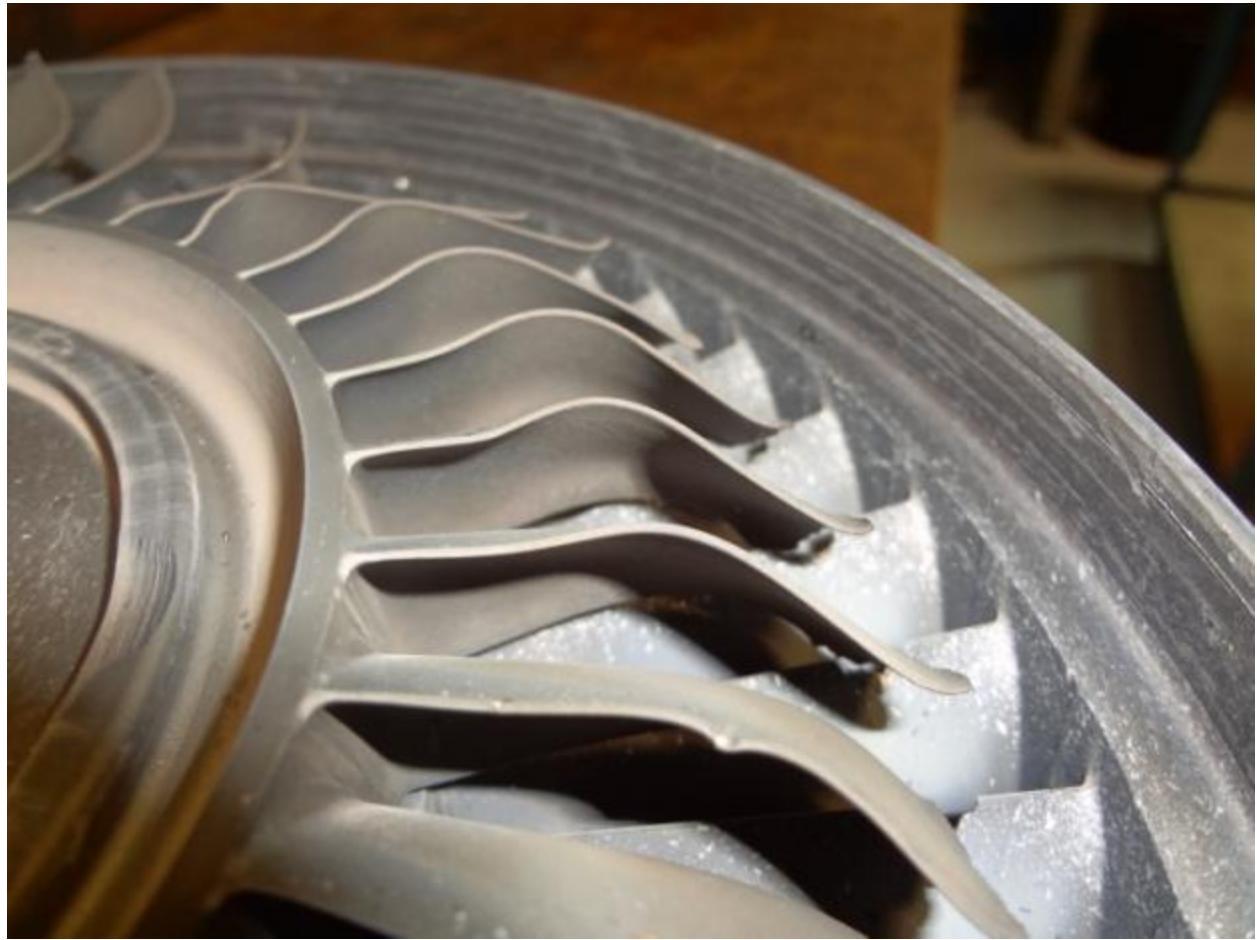
Photo 14: 4th Stage Blade to Vane Contact

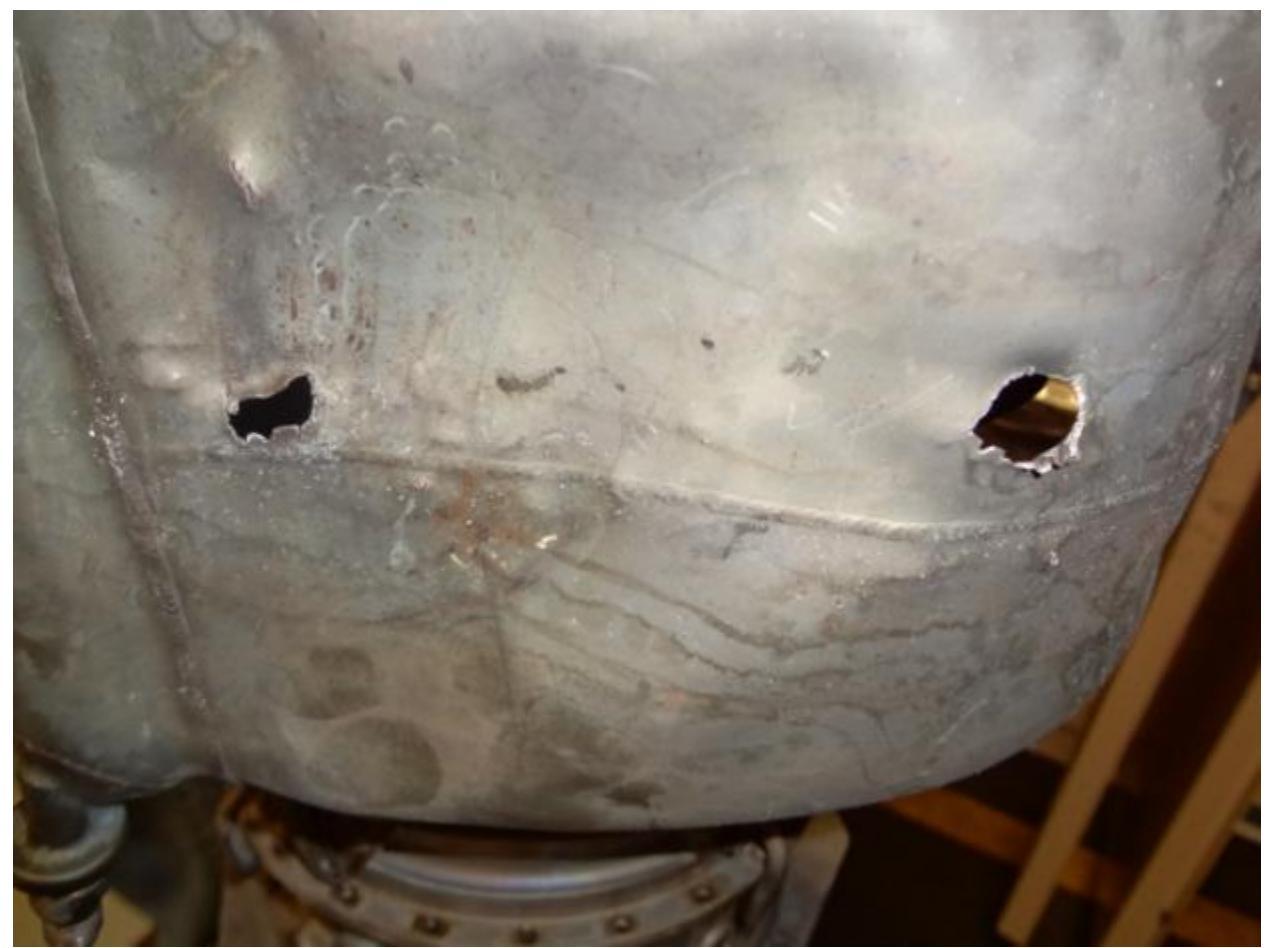
The exhaust collector was removed and the No. 5 bearing was examined. All ball bearings and races for the No. 5 bearing were noted as in place and lubricated. The No. 8 bearing was examined and all ball bearings and races appeared to be in place and the bearing was lubricated. The No. 8 bearing rotated smoothly by hand with no resistance noted. The exhaust collector outer case exhibited numerous exiting marks around one-half of the circumference.

Photo 15: Exit marks on Exhaust Case

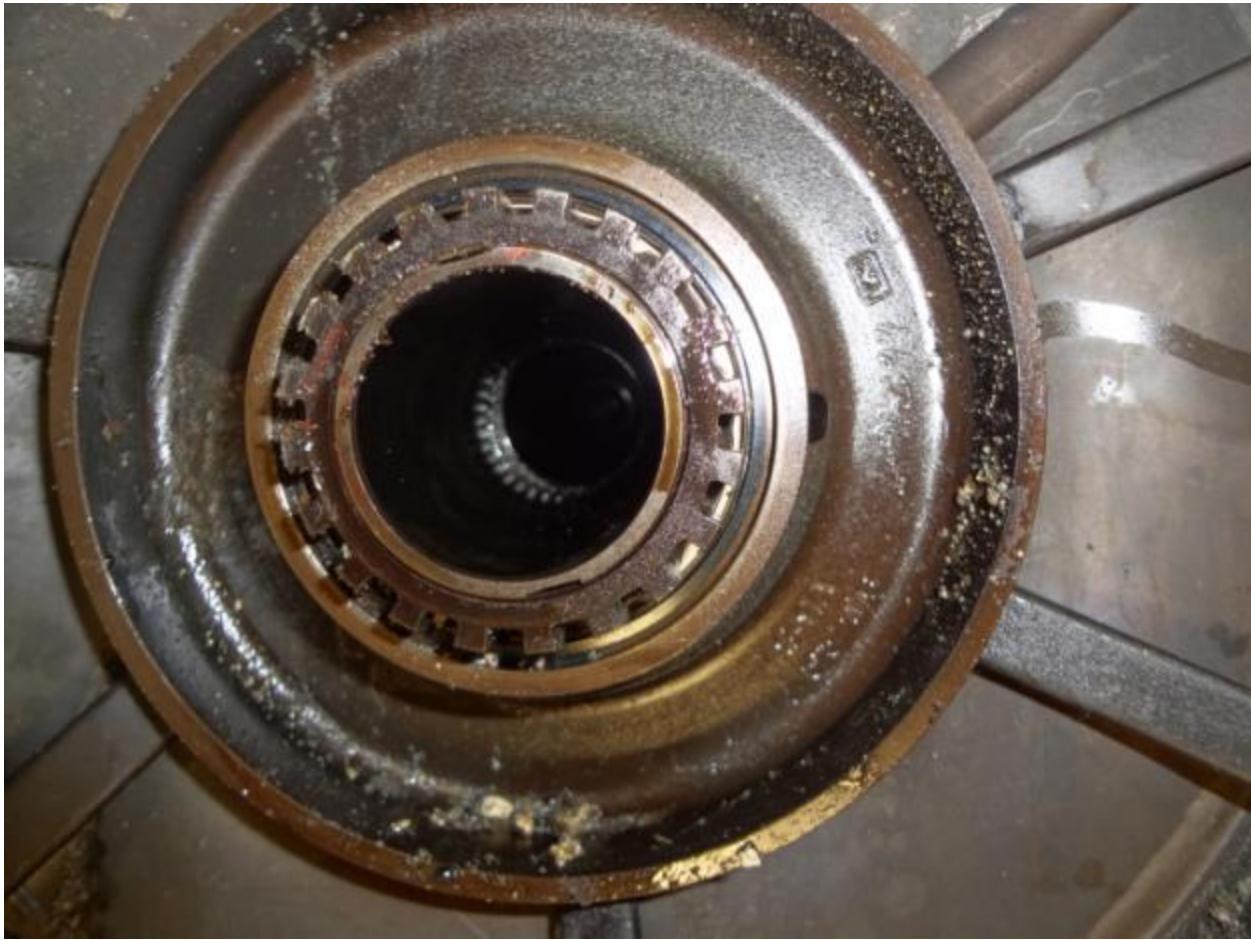
Photo 16: No. 5 Bearing as Found

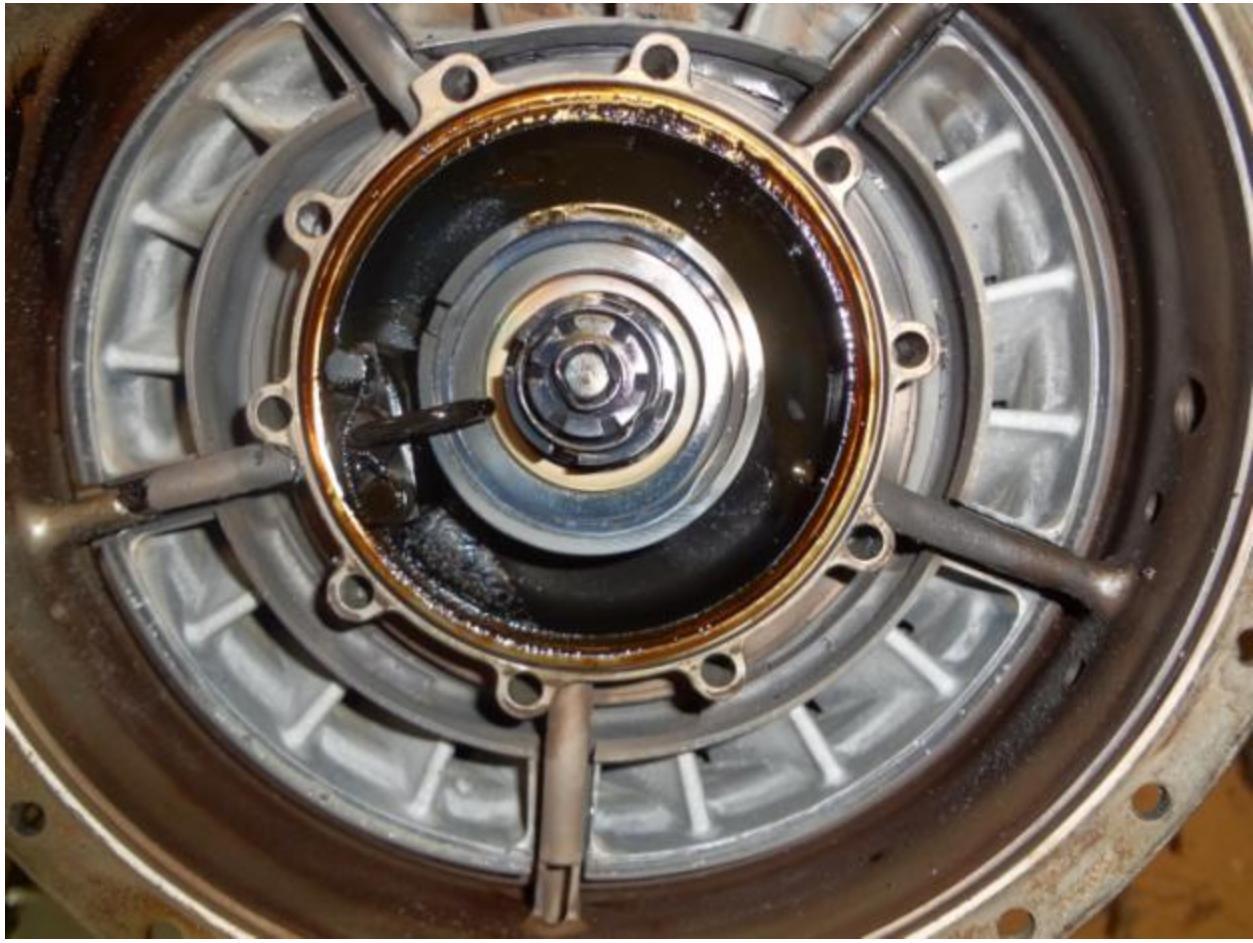
Photo 17: No. 8 Bearing as Found

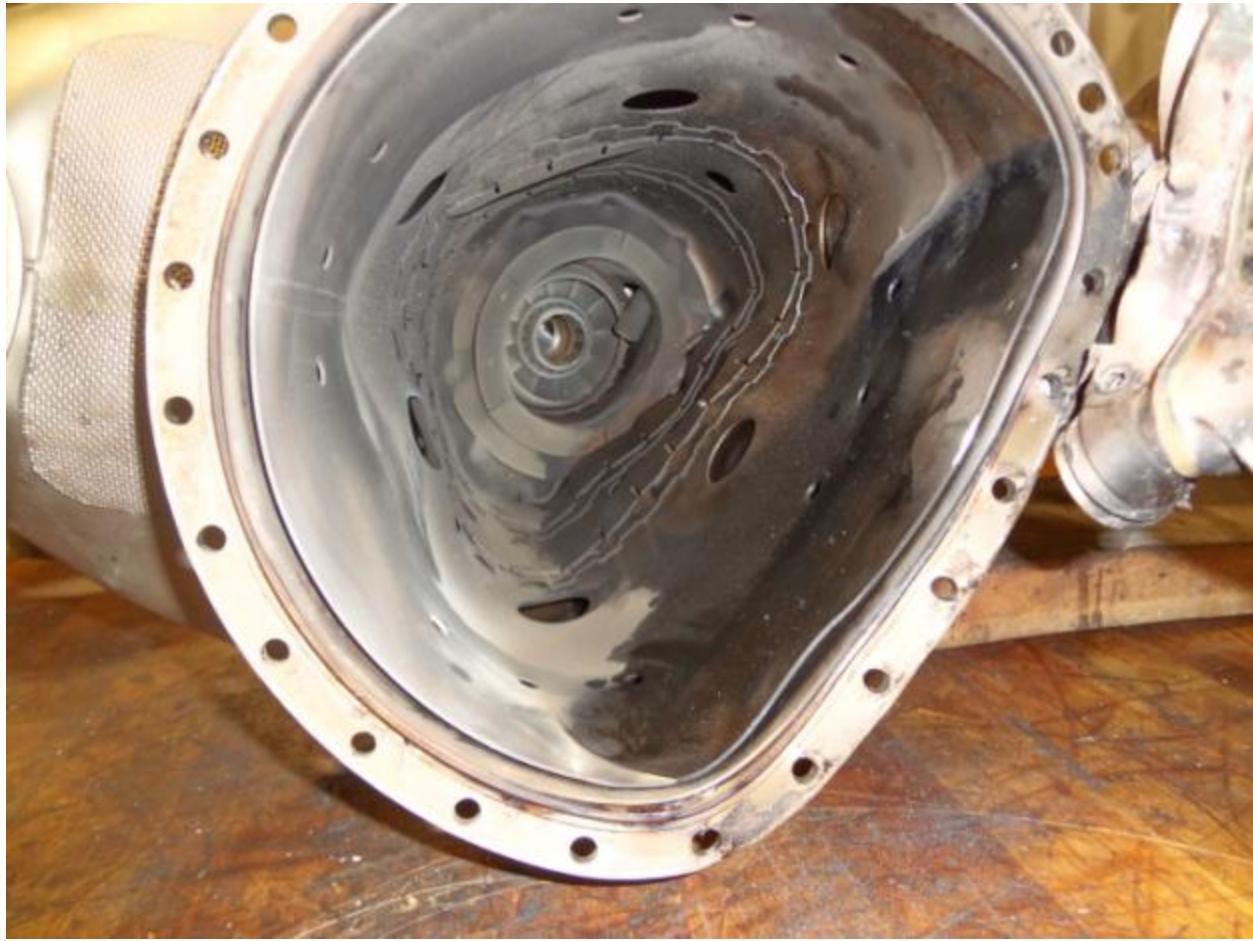
The combustion outer case was removed and examined. The combustion liner exhibited impact damage on the right side as viewed from the rear of the engine. The fuel nozzle was examined and contained 5 $\frac{1}{2}$ shims at the combustion case. The fuel screen was free of debris. The fuel nozzle's part number was vibropeened and the manufacturer could not be confirmed at the time of the exam.

Photo 18: Interior of Combustion Case Liner
