ERA13FA273

Manchester, Kentucky

Bell Helicopter 206 L-1; N114AE

NTSB ENGINE EXAMINATION

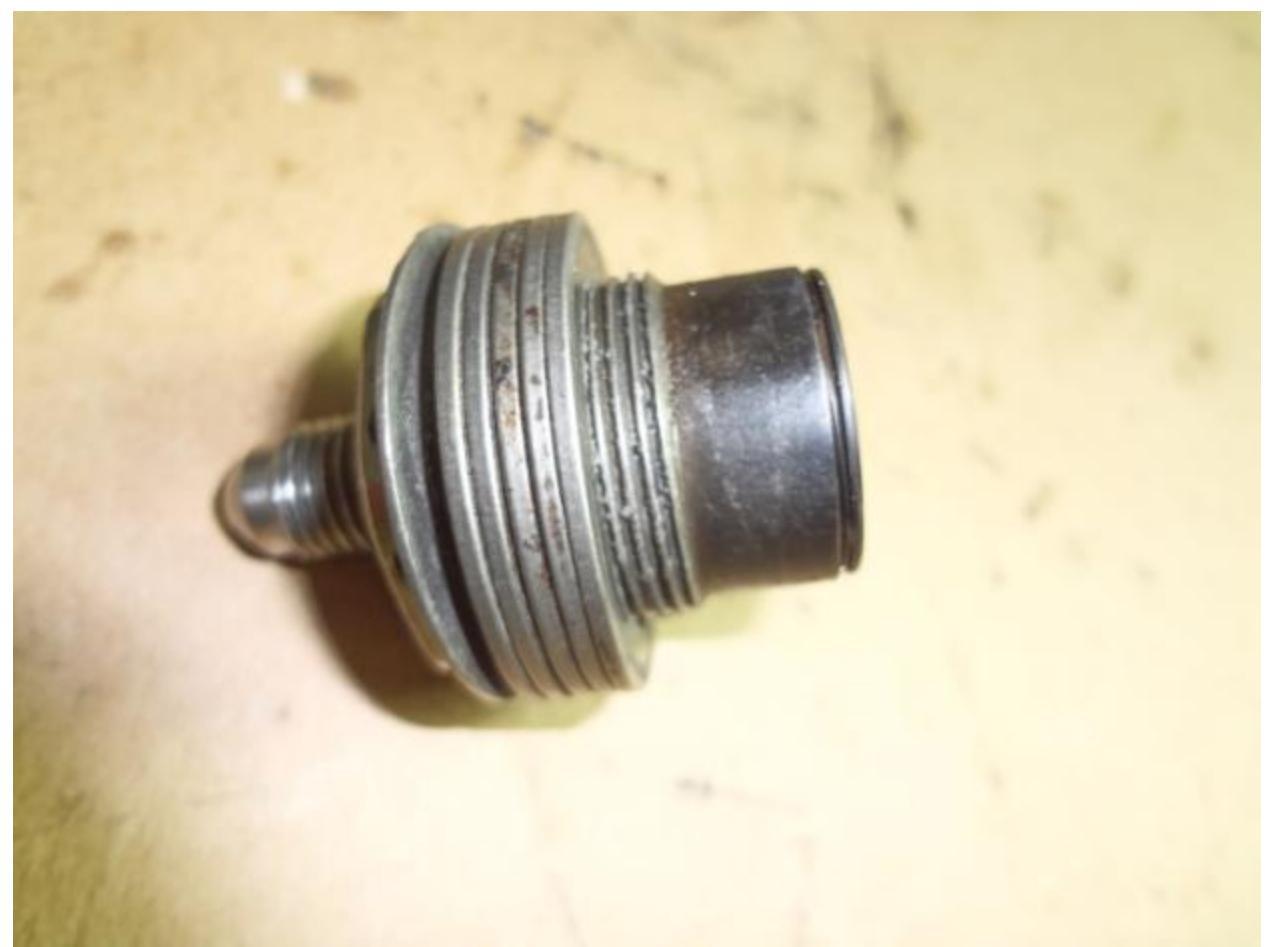
The combustion outer case was removed and examined. The combustion liner exhibited impact damage on the right side as viewed from the rear of the engine. The fuel nozzle was examined and contained 5 $\frac{1}{2}$ shims at the combustion case. The fuel screen was free of debris. The fuel nozzle's part number was vibropeened and the manufacturer could not be confirmed at the time of the exam.

Photo 19: Fuel Nozzle with 5 1/2 shims after Removal

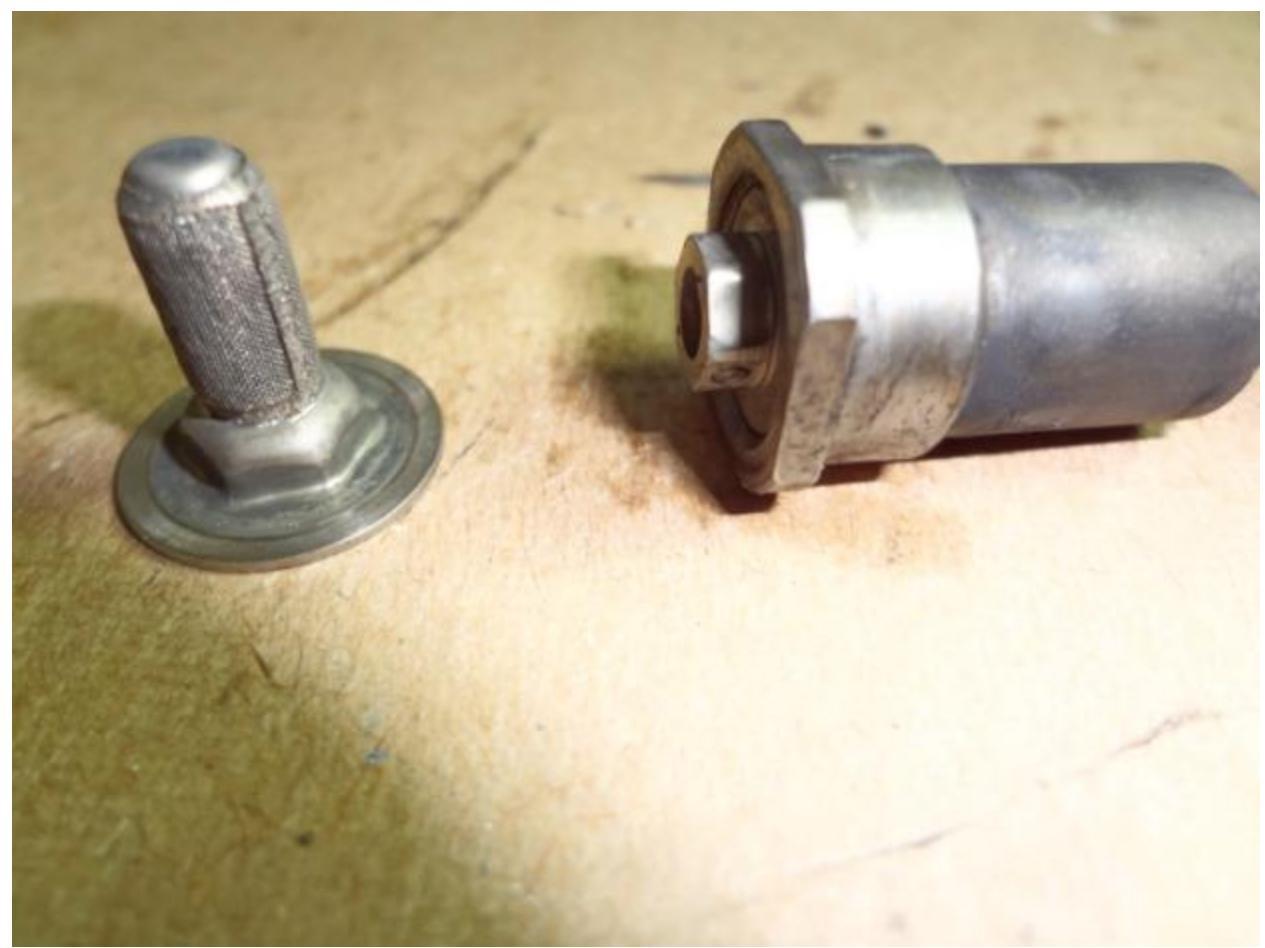
Photo 20: Fuel Screen
