NATIONAL TRANSPORTATION SAFETY BOARD

Enhanced Ground Proximity Warning System

Specialist's Factual Report By Bill Tuccio, Ph.D.

Location:Santa Monica, CADate:September 29, 2013Aircraft:Cessna 525ARegistration:N194SJOperator:PrivateNTSB Number:WPR13FA430

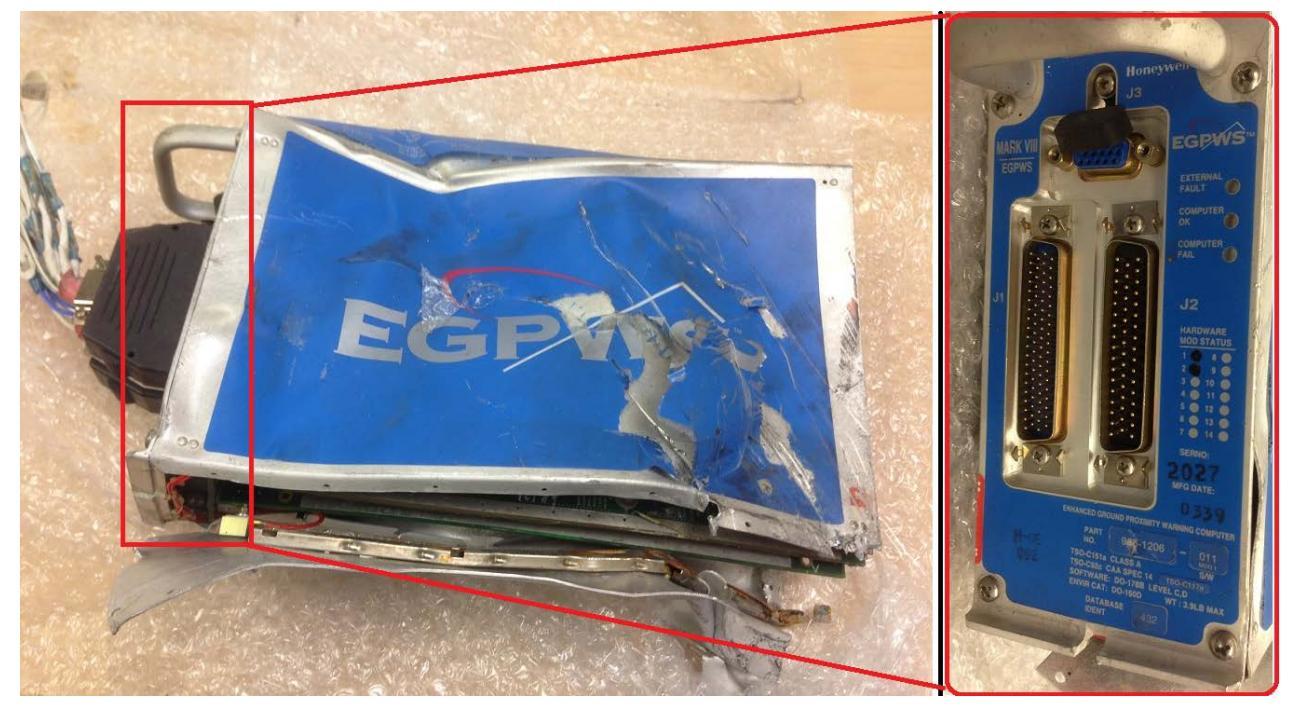
The device was damaged in the event. The extent of the damage is shown in figure 1, with the side data plate expanded. The device was disassembled, and the internal board containing the NVM was found to be intact, as shown in figure 2. Figure 2 also annotates the U24, U25, and U23 NVM chips (from left to right in figure 2). Under NTSB supervision, the EGPWS manufacturer desoldered the three NVM chips. The U24 and U25 chips were imaged and decoded by the manufacturer; the U23 chip was not necessary for the decoding.

Figure 1. Damaged exterior of EGPWS.

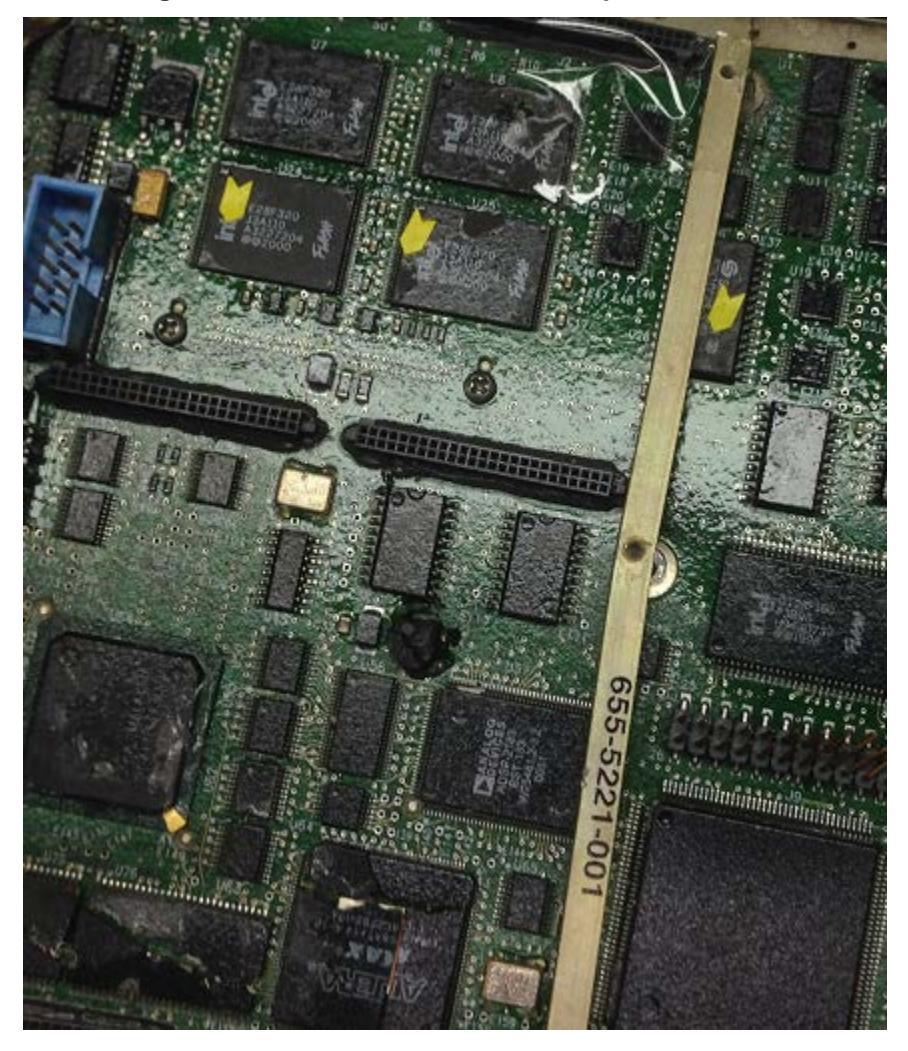
Figure 2. Internal board with NVM chips annotated.
