DOCKET NO. SA-539

EXHIBIT NO. 17-A

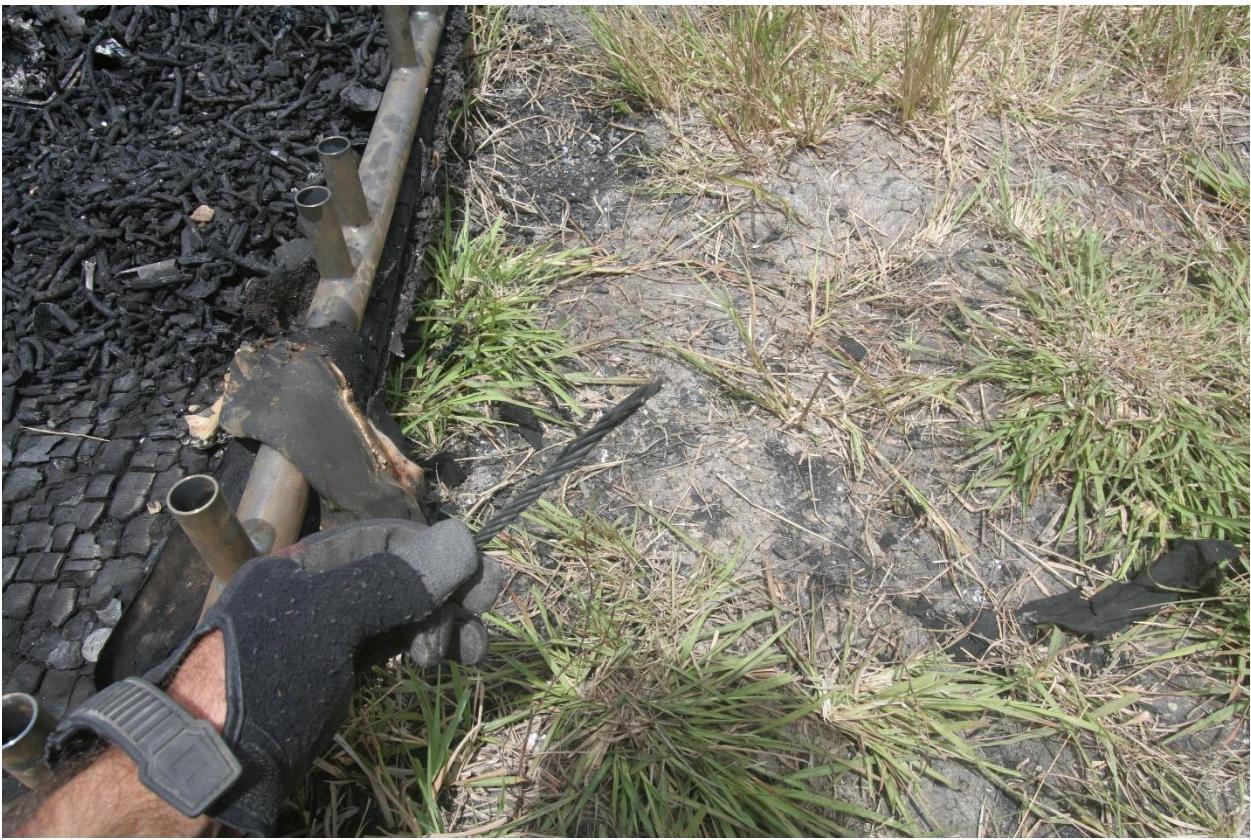
Figure 2 - Example of basket support cable that exhibited strand fusing at severed end.

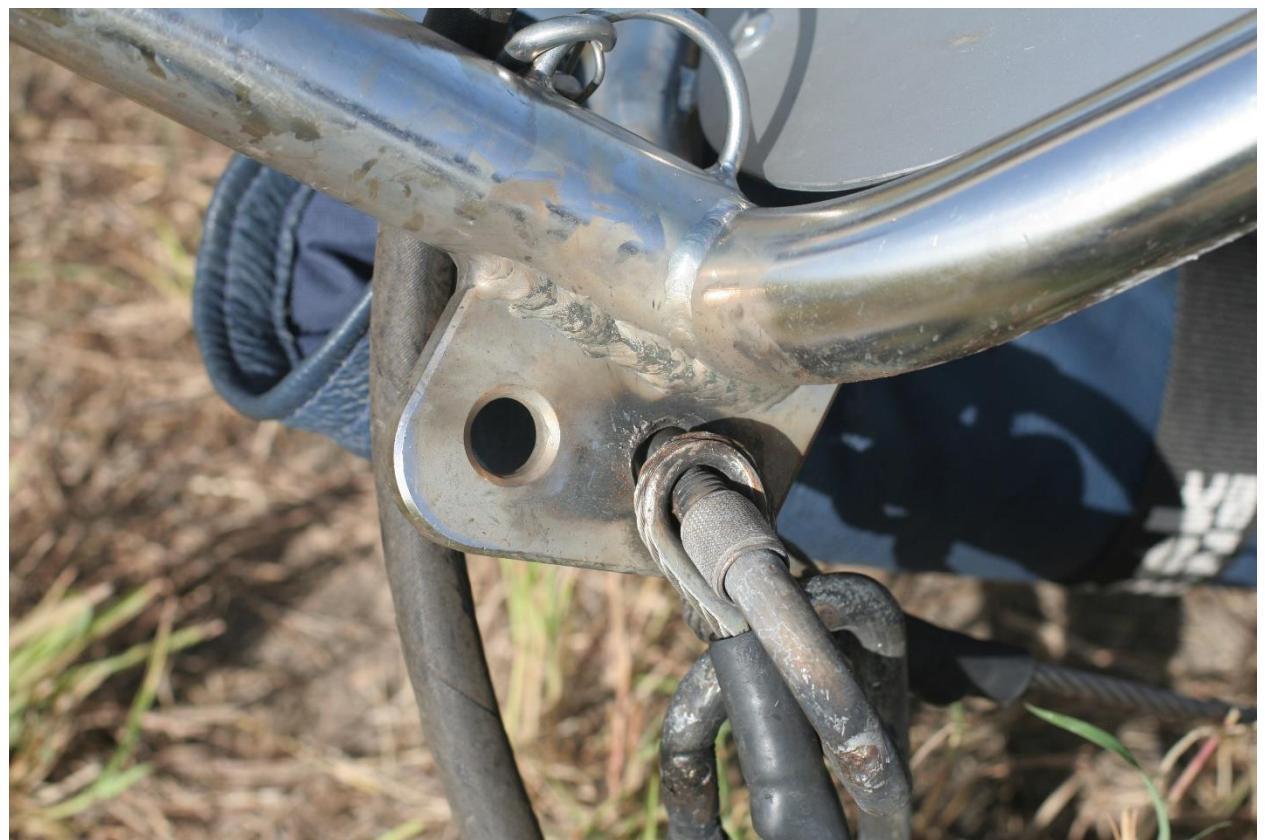
Figure 3 - Electrical arcing damage on carabiner and burner frame attachment point.

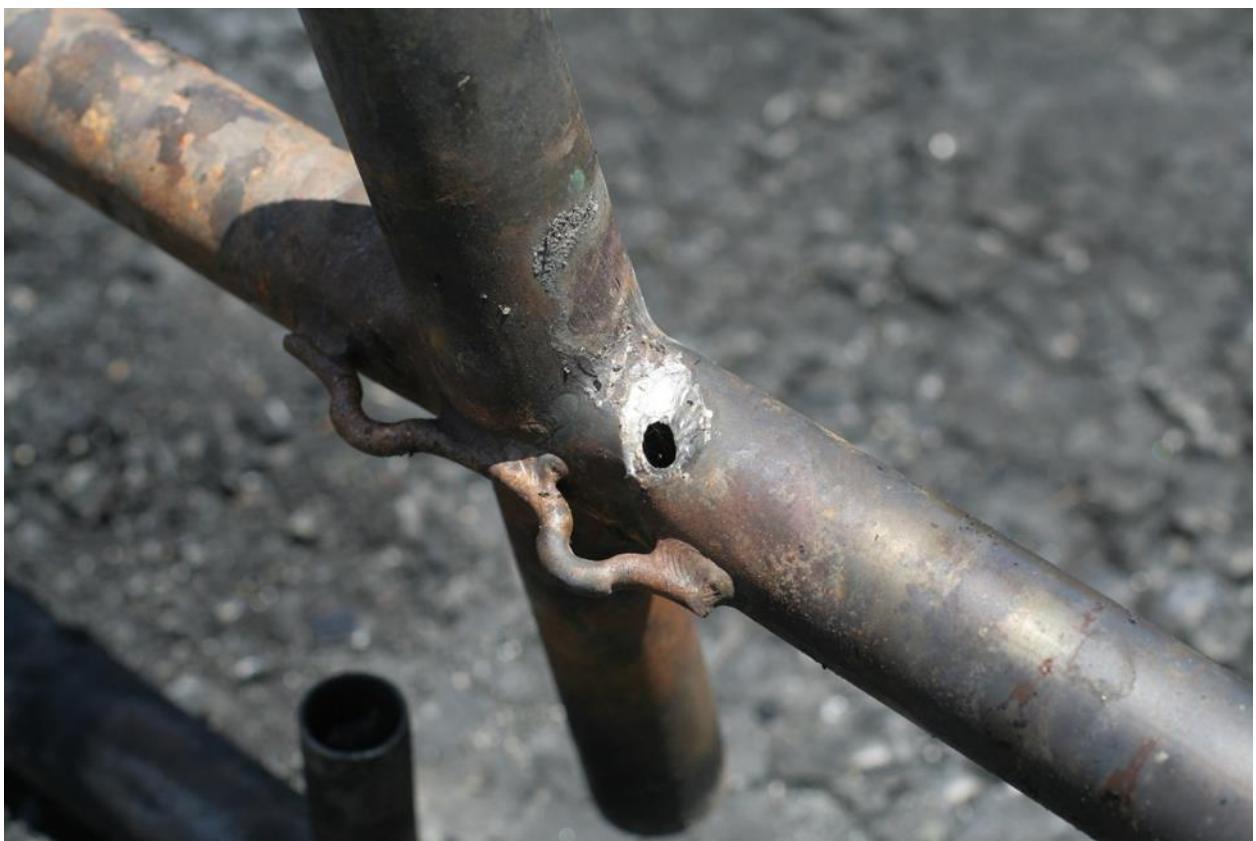
Figure 4 – Electrical arcing damage on forward left side of upper basket frame.

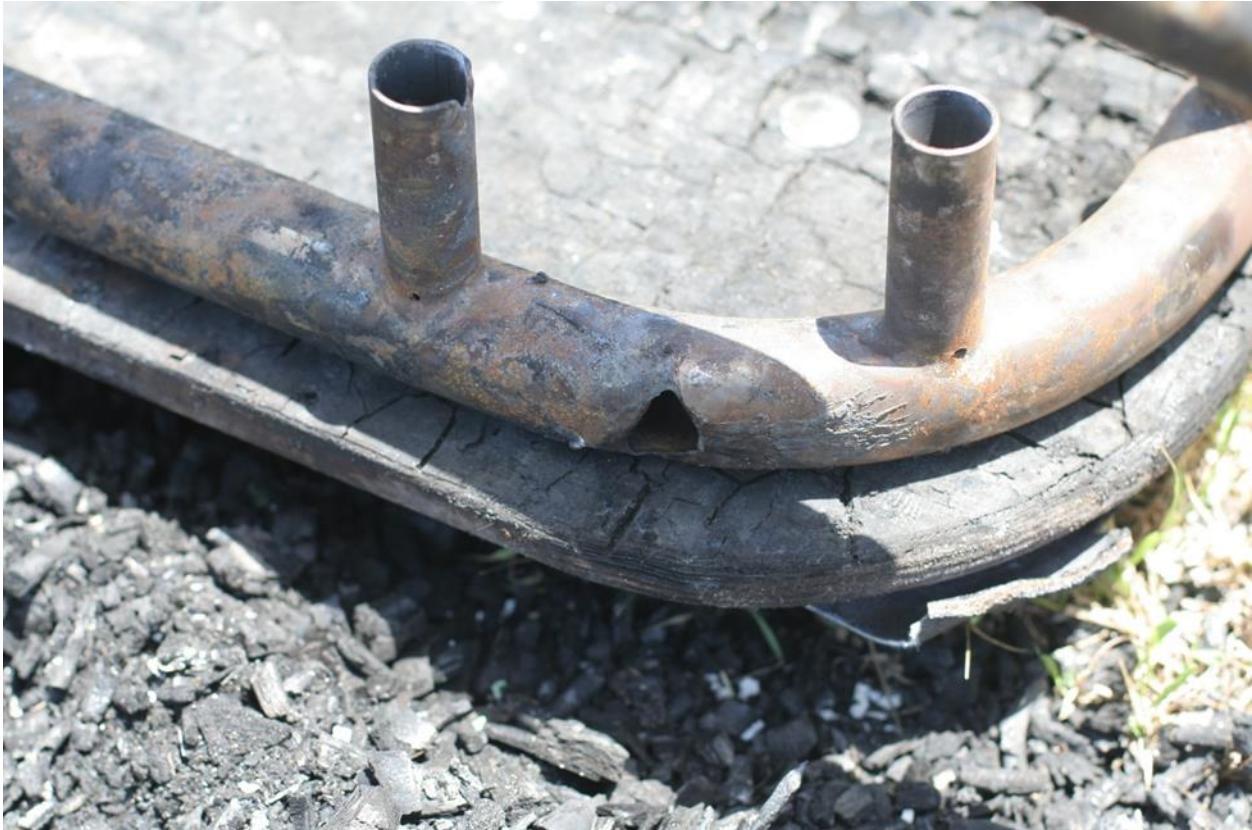
Figure 5 – Electrical arcing damage on forward left corner of the lower basket frame.

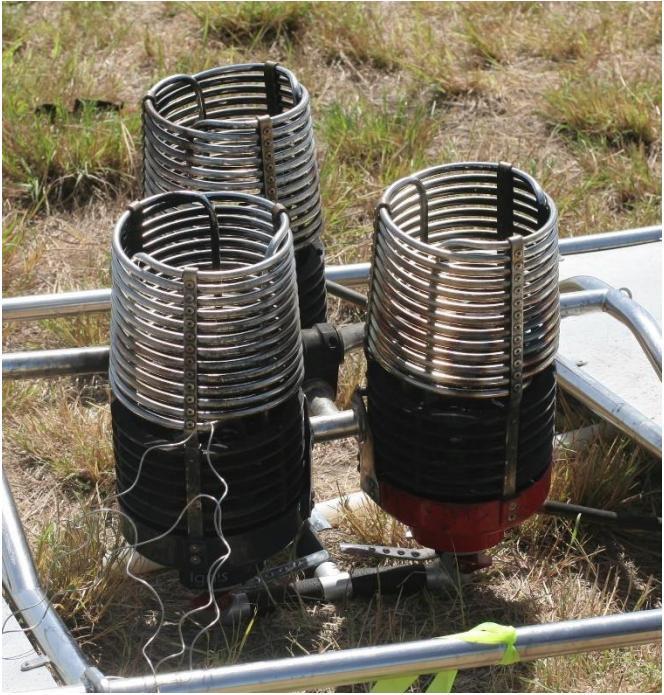
Figure 6 - The three burners. Levers and valves are at the bottom.

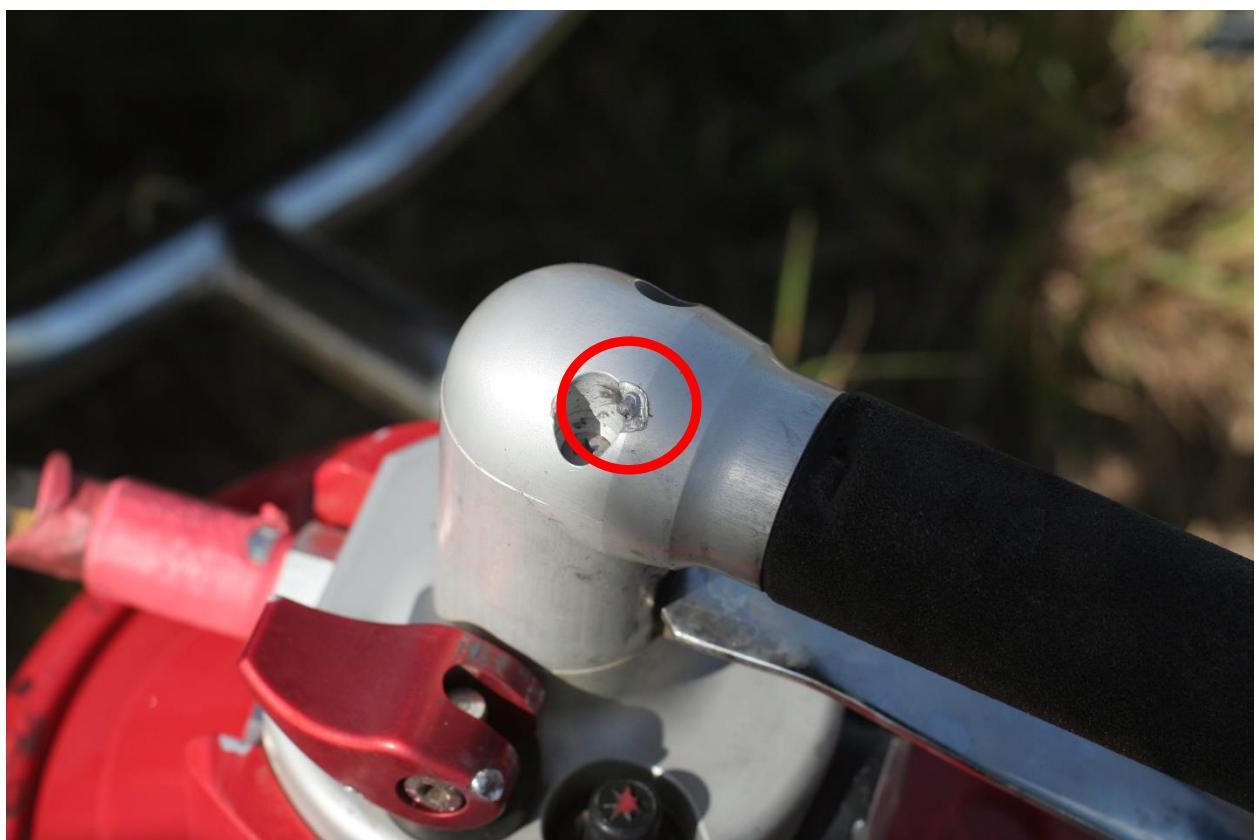
Figure 7 - Electrical arcing evidence found on underside of the red burner.

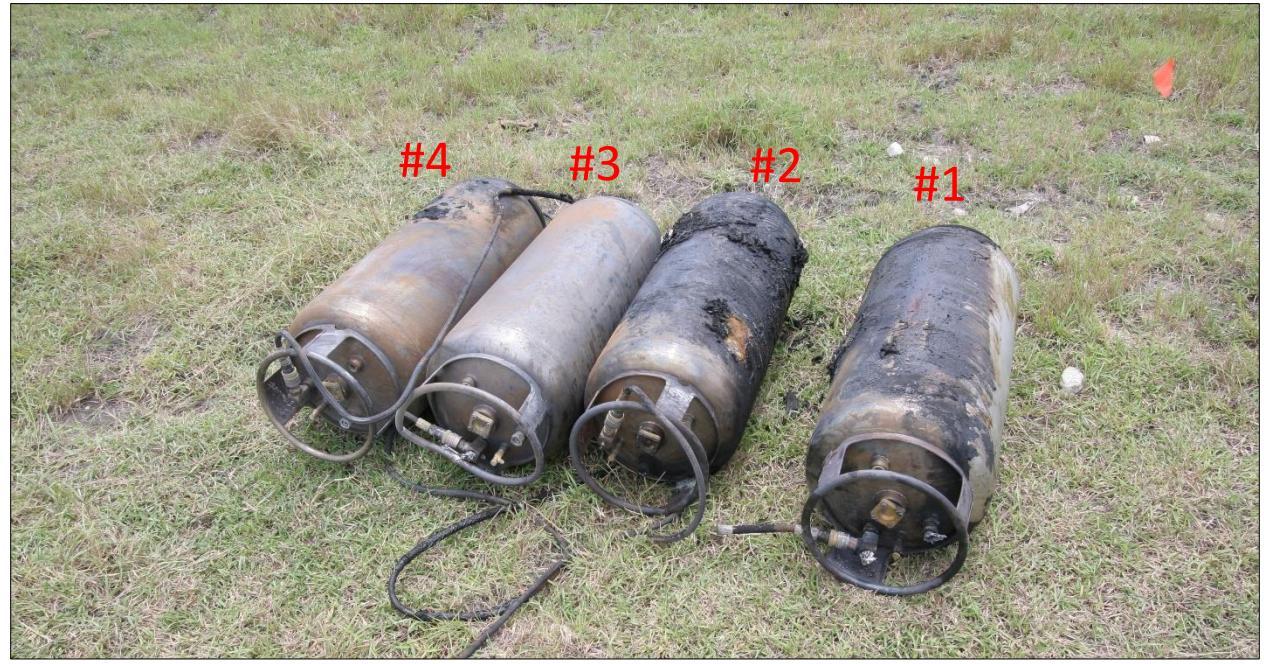
Figure 8: Fuel Cylinders, as numbered.

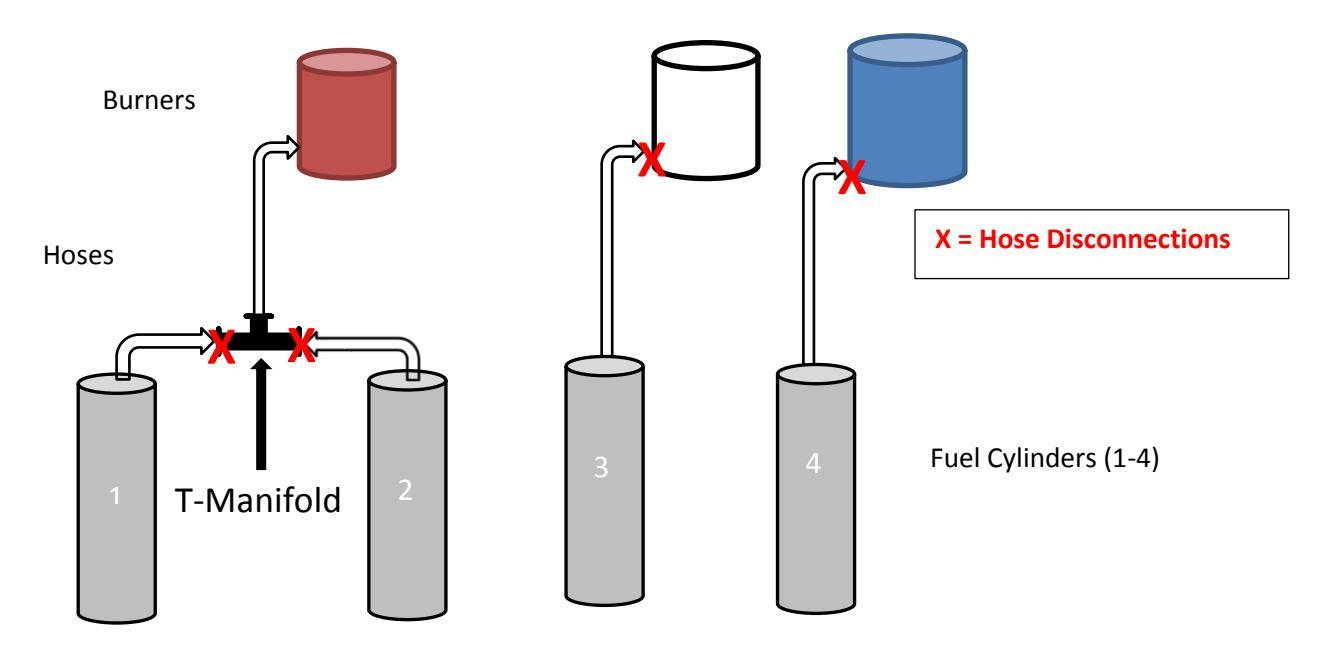
2.6 Envelope Load Cables - Description and Examination

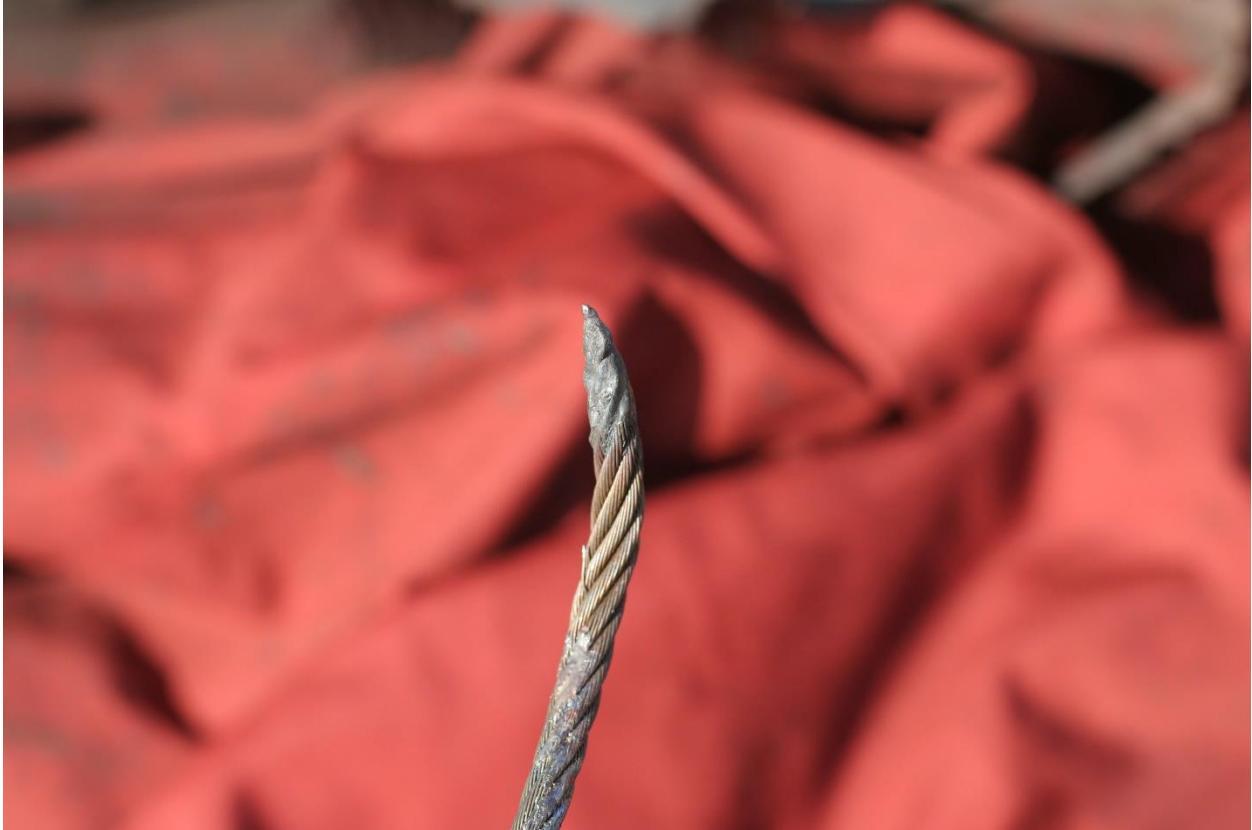
Figure 9: Severed end exhibiting strand fusing on cable attaching burner frame to envelope. This cable was one of the cables on the forward side of the balloon. Note envelope in background.

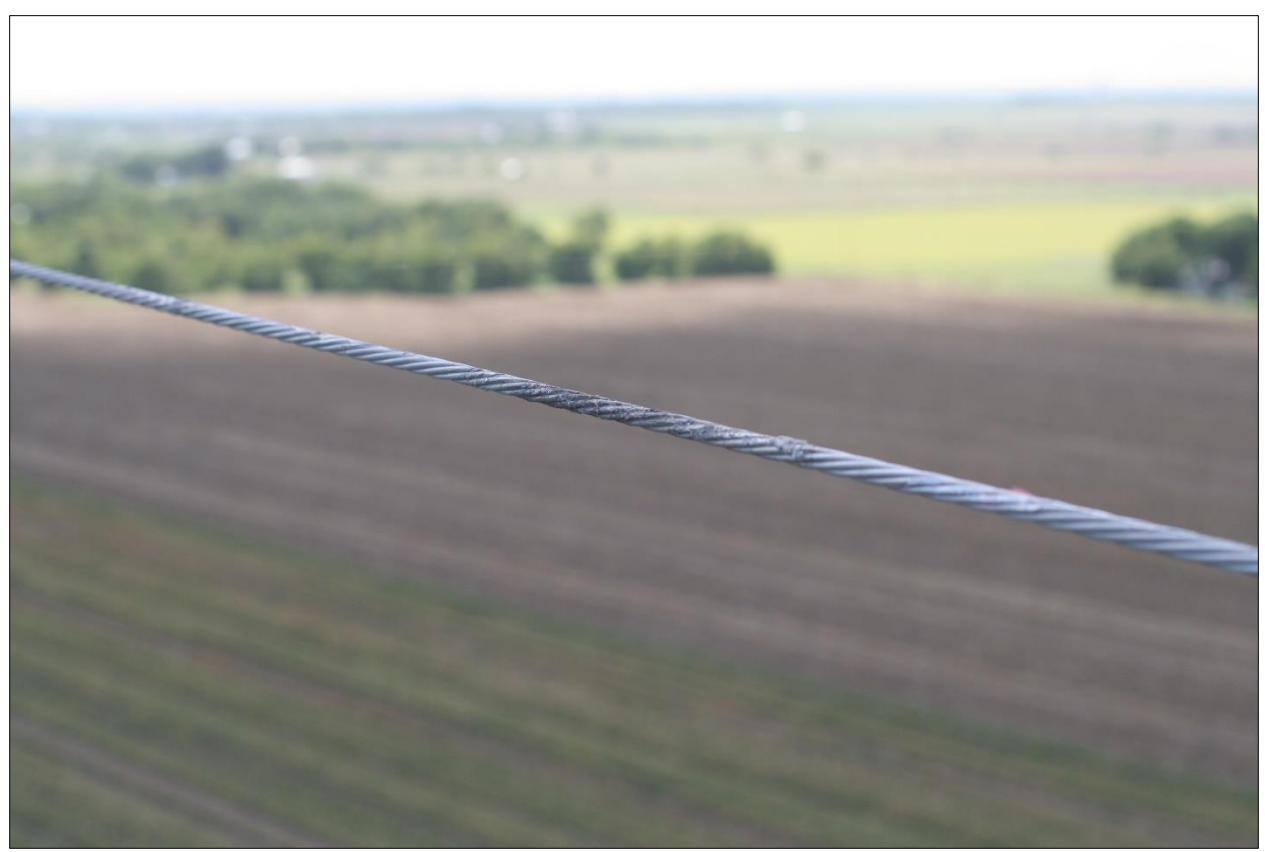
Figure 11: Example of Static Line (East) electrical arcing damage

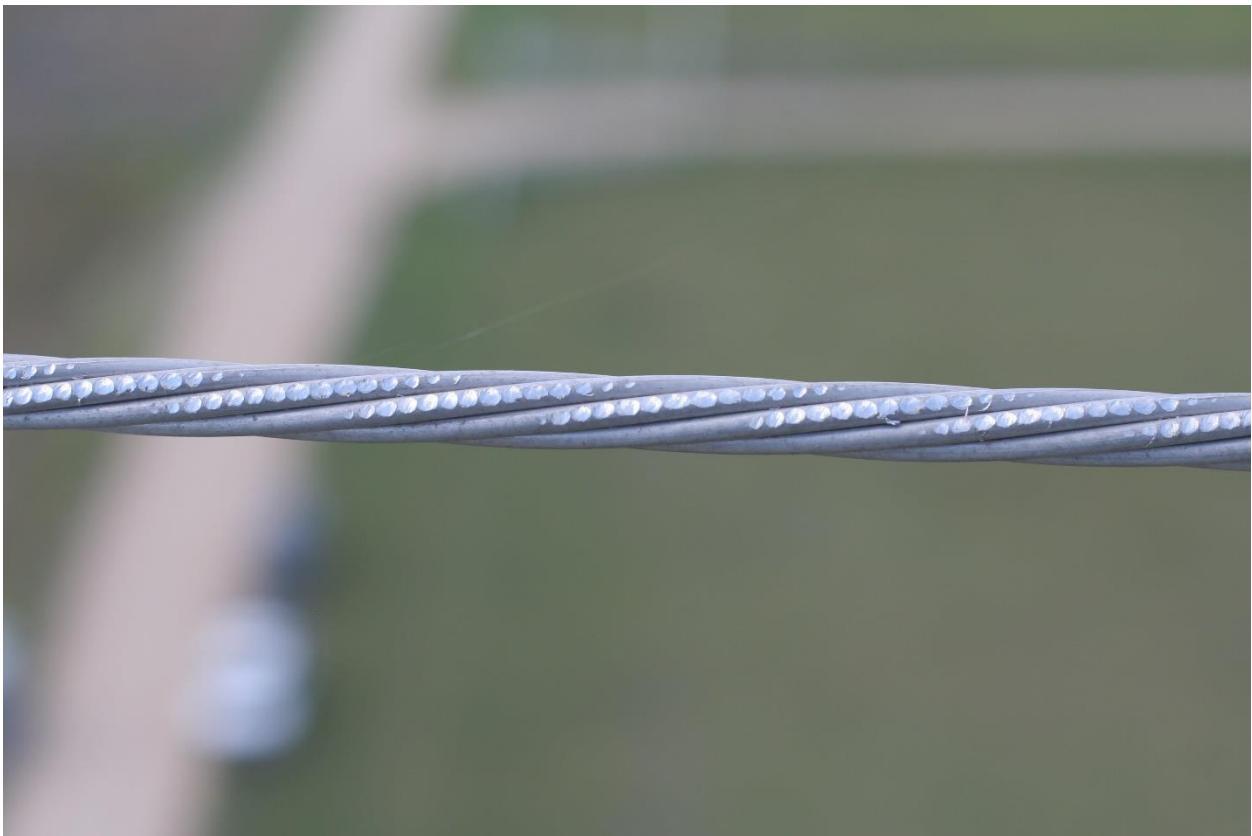
Figure 12: An example of static line (East) abrasion/mechanical damage.

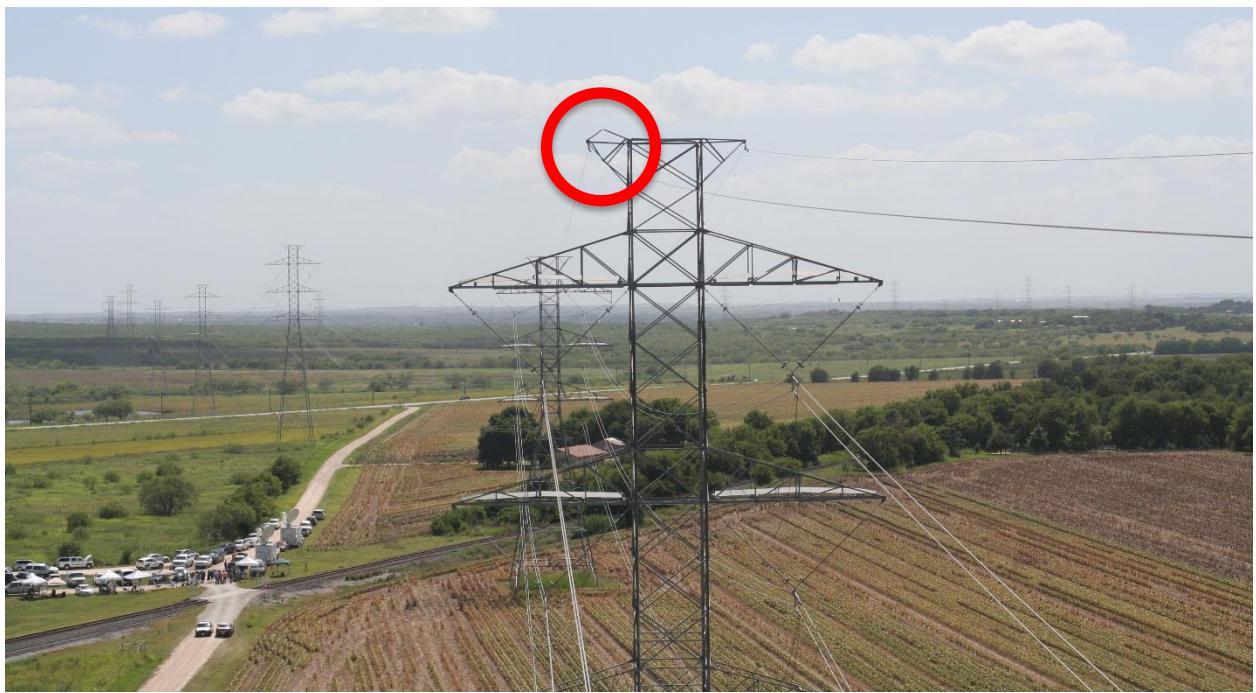
Figure 13: Structural support for East Static Line with exhibited deformation.

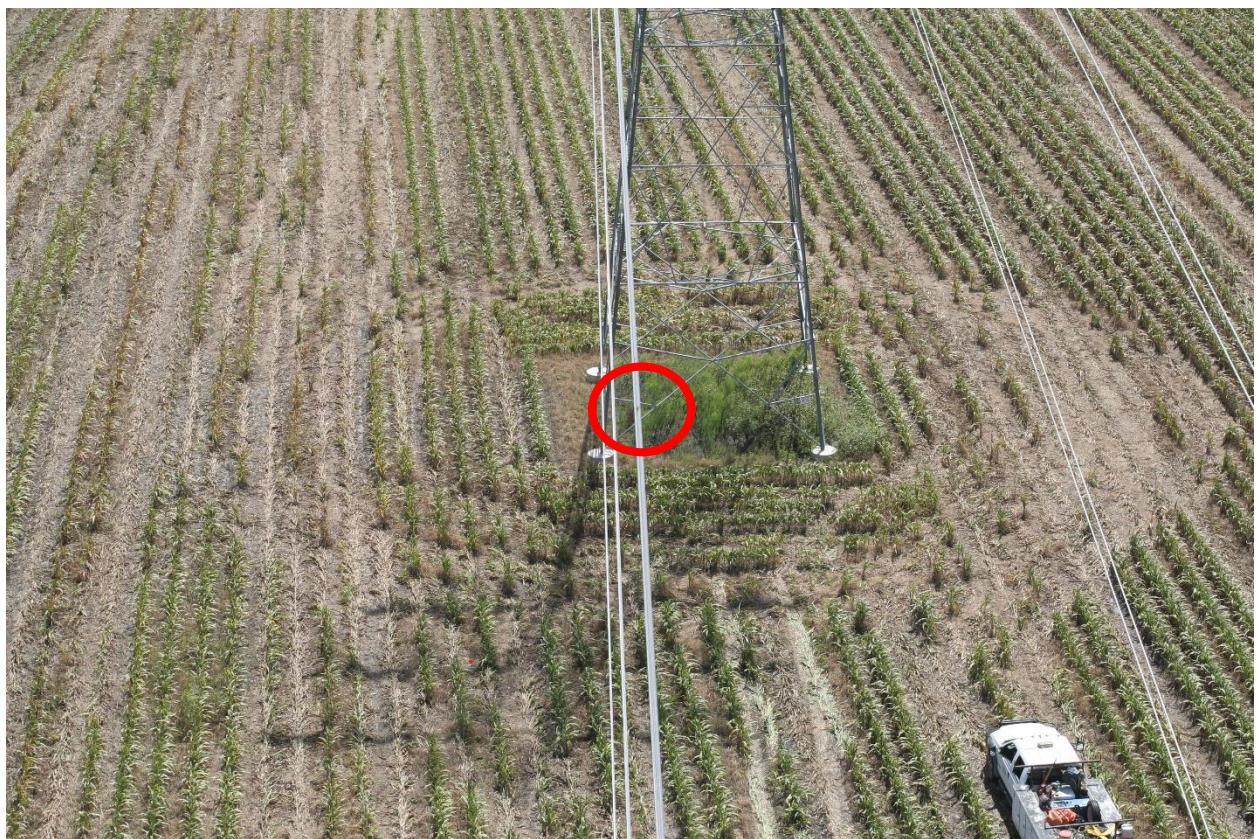
Figure 14: Indication of arcing damage on top cable of 3rd-phase cable pair (East).

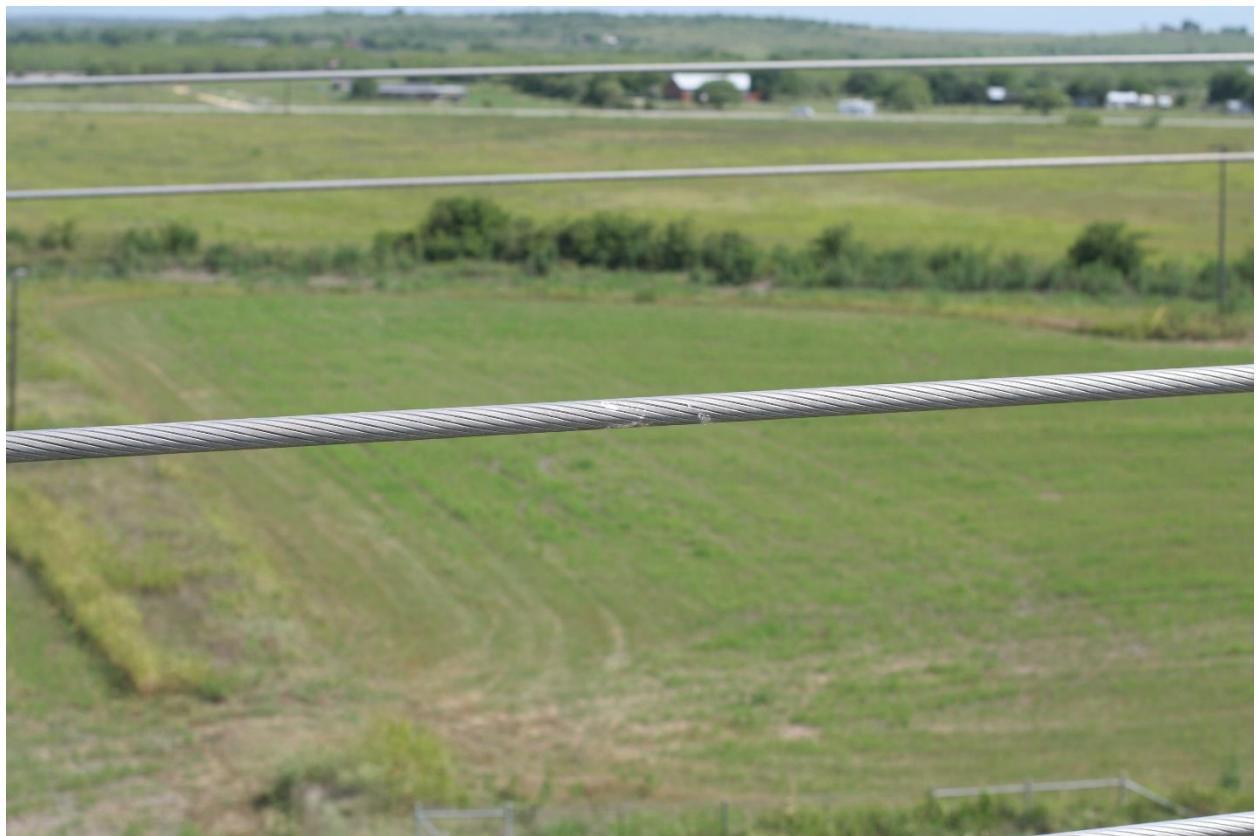
Figure 15 - Evidence of re-solidified metal on cable.

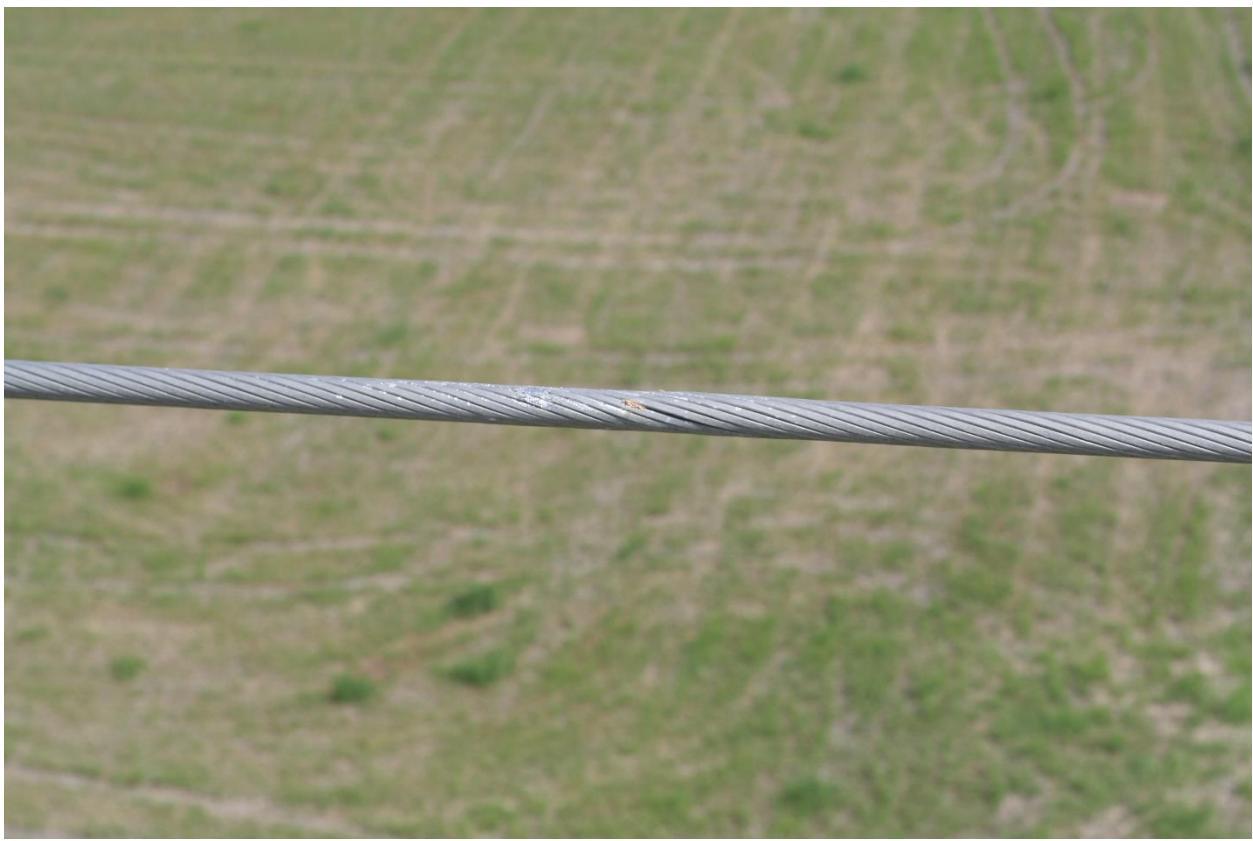
Figure 16: Arcing damage on 2nd-phase cable. (West)

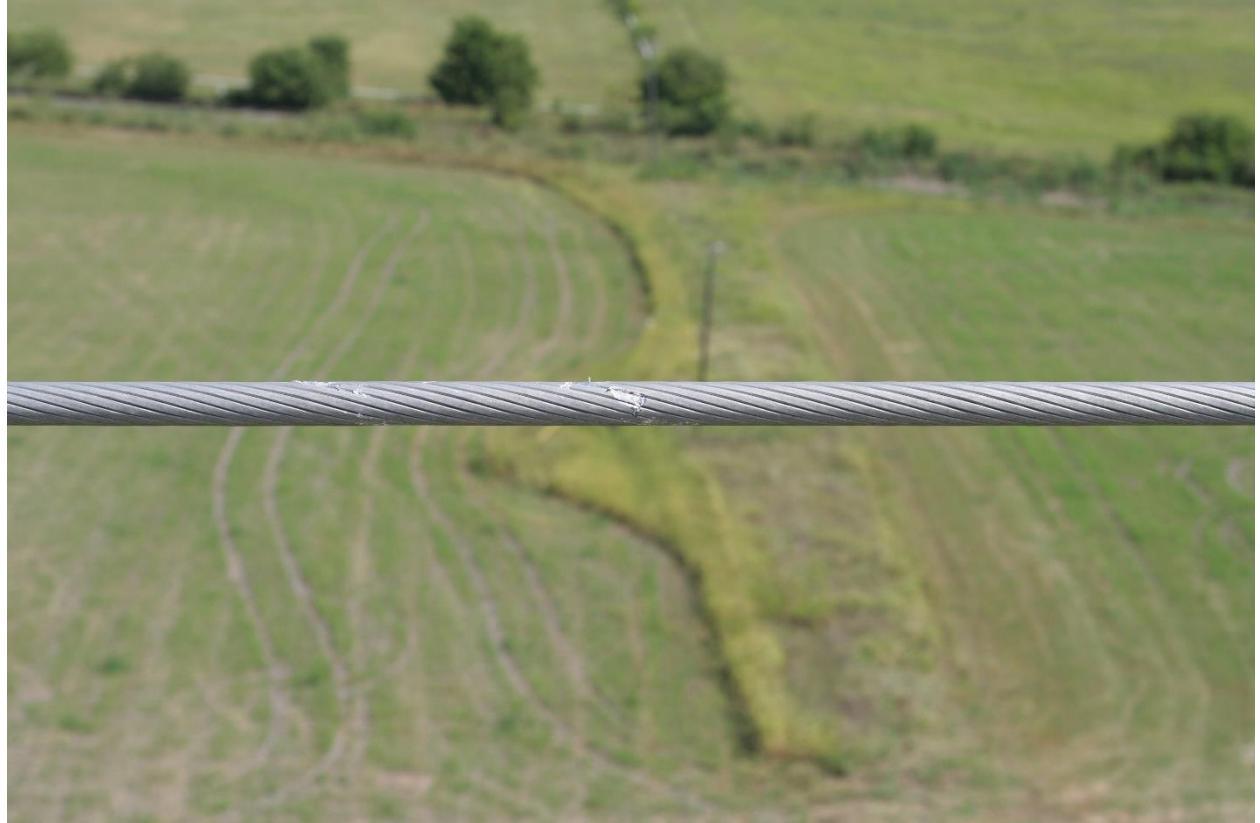
Figure 17: Arcing damage on 2nd-phase cable (West).

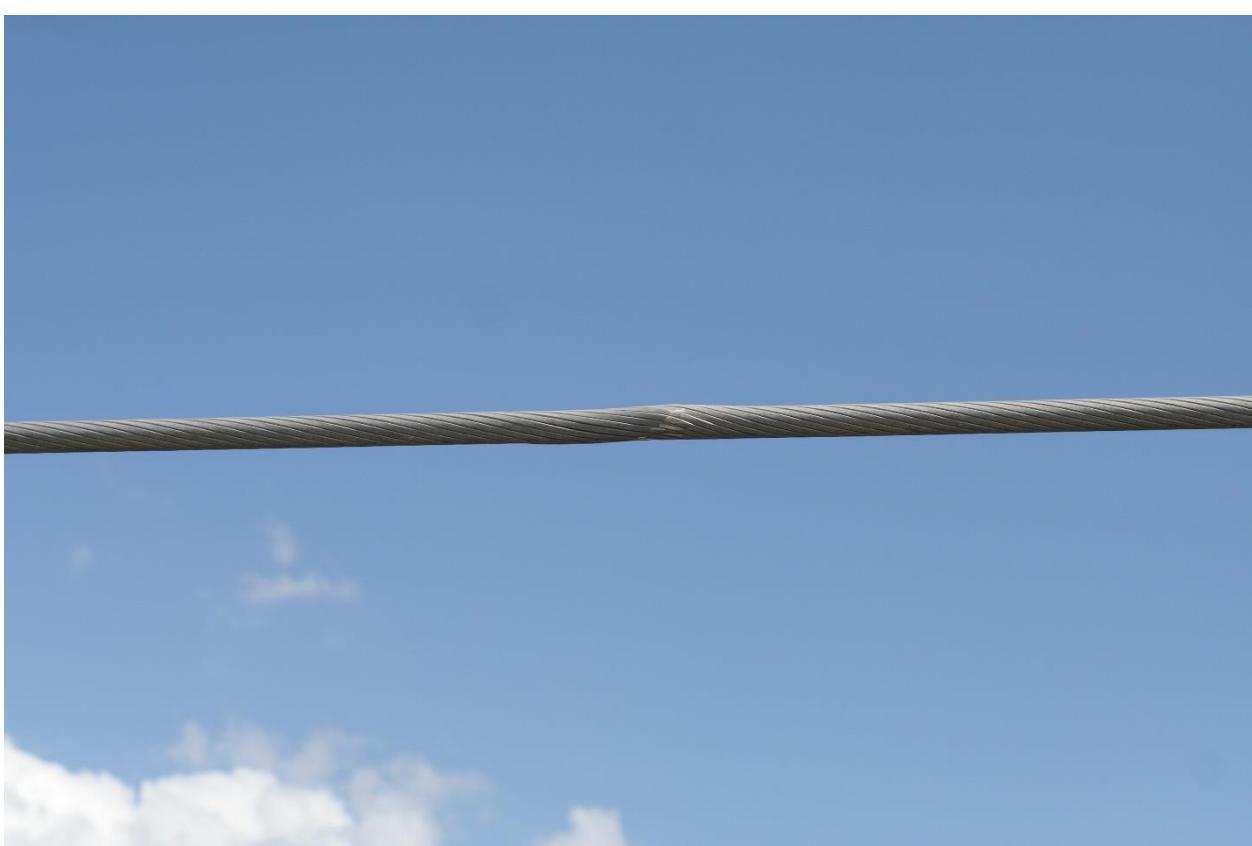
The top cable of the 3rd-phase pair exhibited a kink/deformation. See Figure 18.

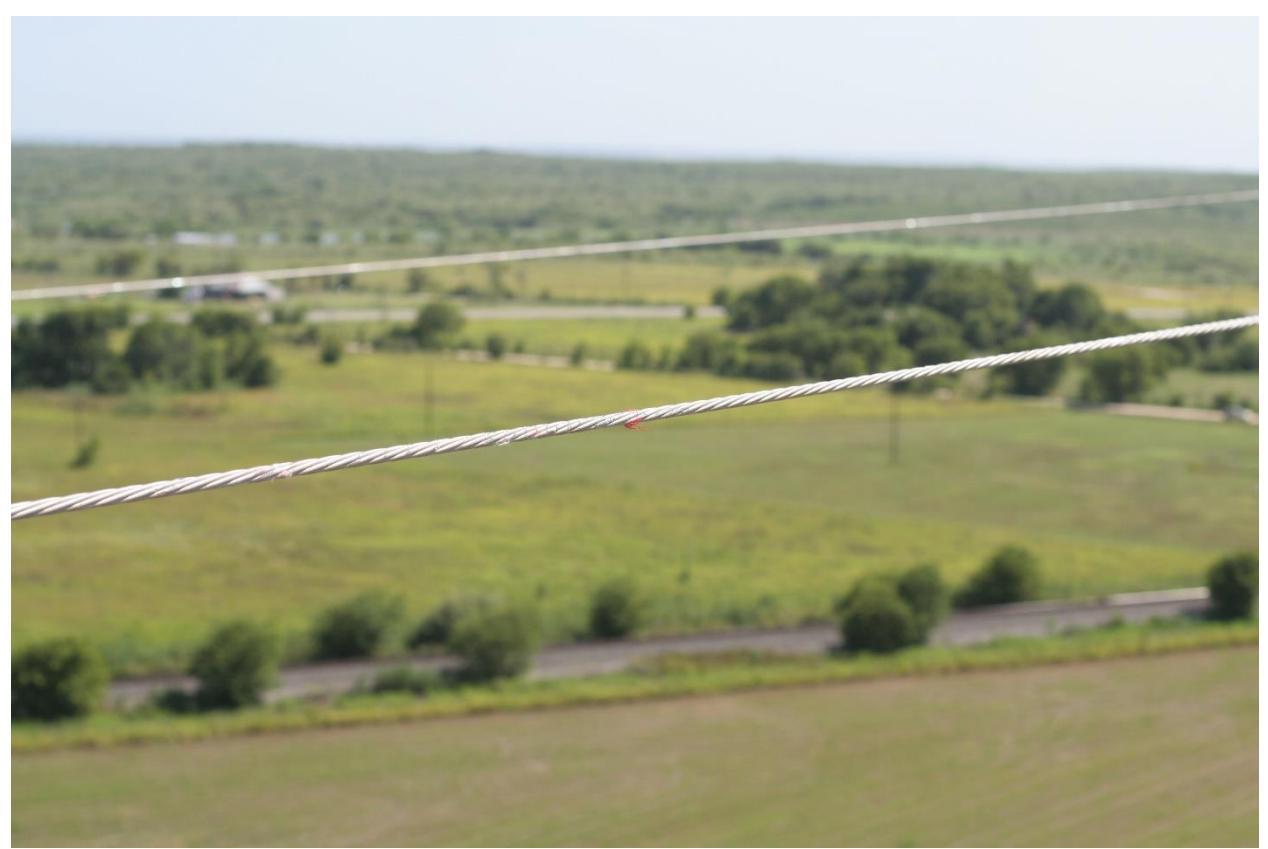
Figure 19: Evidence of contact and a portion of red fabric on West Static Line.
