National Transportation Safety Board Railroad Accident Brief Derailment of Metro-North Railroad Commuter Train Rye, New York

Accident Summary

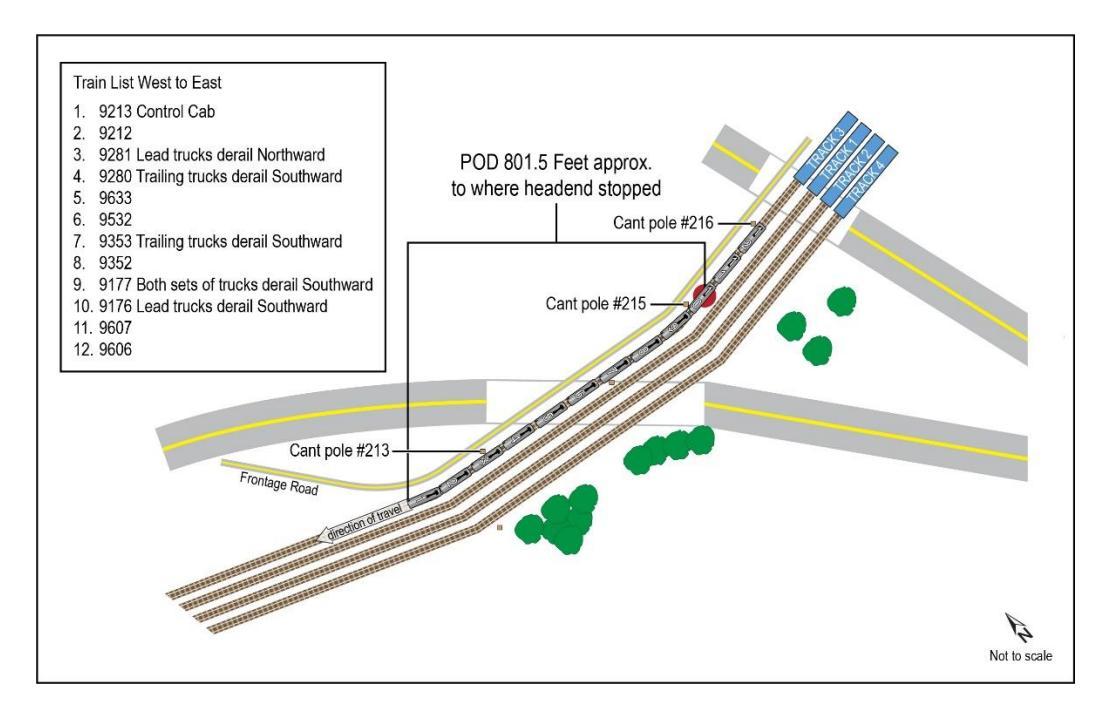
Figure 1: Site sketch of derailment area

The FRA track inspector and FRA rail integrity specialist in conjunction with the NTSB inspected/examined main track 3 between catenary 208 and catenary 220. No track exceptions were taken to the undisturbed track conditions. In addition, 50-foot incremental photographs were taken by the FRA through the derailment site. A sketch of the accident site was prepared indicating the derailed cars, tracks, and other pertinent features. See figure 1 for the sketch. About 900 feet of track was replaced on main track 3.

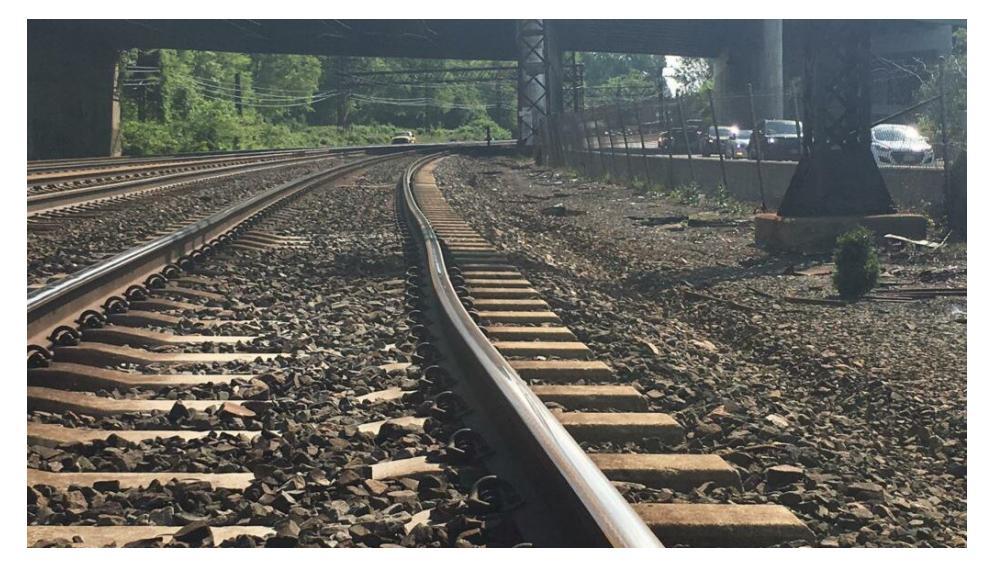
Figure 2: Pre-accident view looking west towards catenary 215 on track 3 towards the rail misalignment.

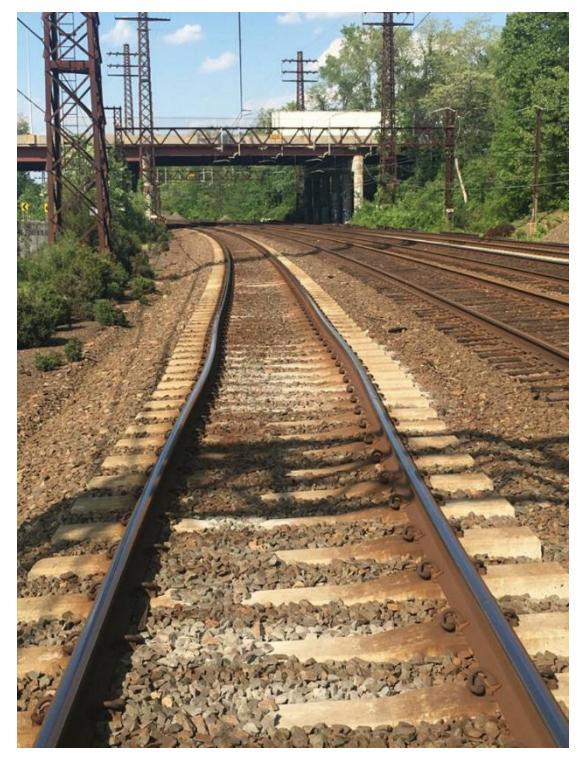
Figure 3: Pre-accident view looking east towards catenary 215 on track 3 towards the rail misalignment

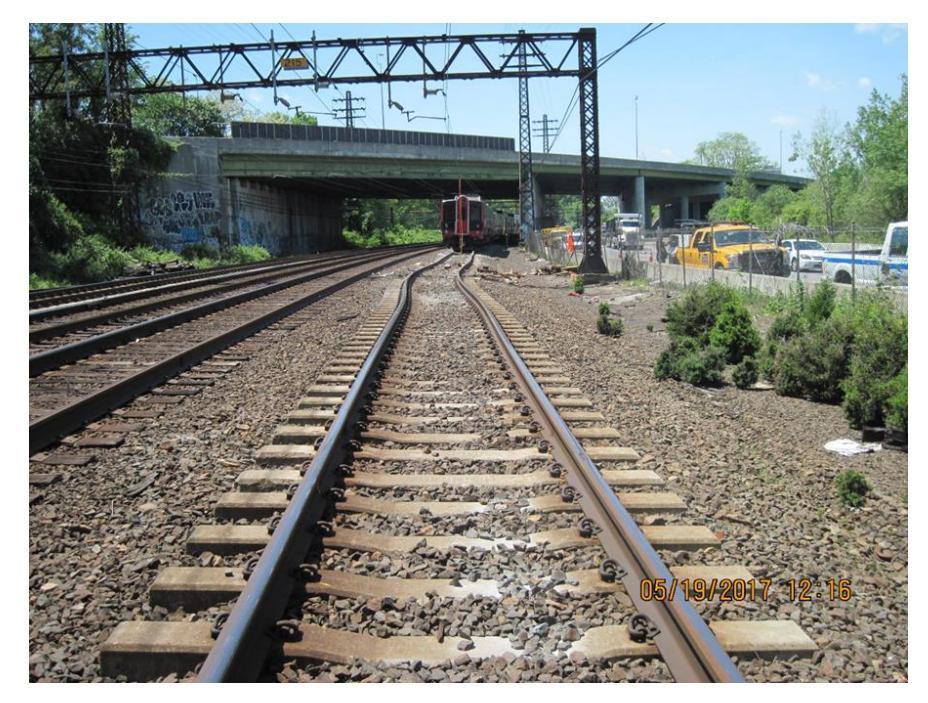
Figure 4: Postaccident view looking west towards catenary 215 on track 3 towards the rail misalignment
