Date of Accident:	February 3, 2014
Location:	Bellevue, Tennessee
NTSB File No.:	ERA14FA112
Aircraft:	Gulfstream Commander 690C
Registration No.:	N840V
Serial No.:	11727
Operator:	per the FAA registry:
	Mid Kansas Agri Co.
	Pawnee Rock, KS 67567-9510
Written by:	Dan Boggs Air Safety Investigation Manager Rev. 1 by Les Doud - Air Safety Investigator
Date:	February 11, 2014 Revision 1 - February 15, 2016

PROPELLER TEARDOWN REPORT

Location:	AMF air salvage, S	pringfield TN
Propeller Model:	HC-B3TN-5NL with	LT10876ANS(B)-2Q blades
Representatives:	Dan Boggs Jay Eller Luke Schiada	Hartzell Propeller Inc. Honeywell NTSB

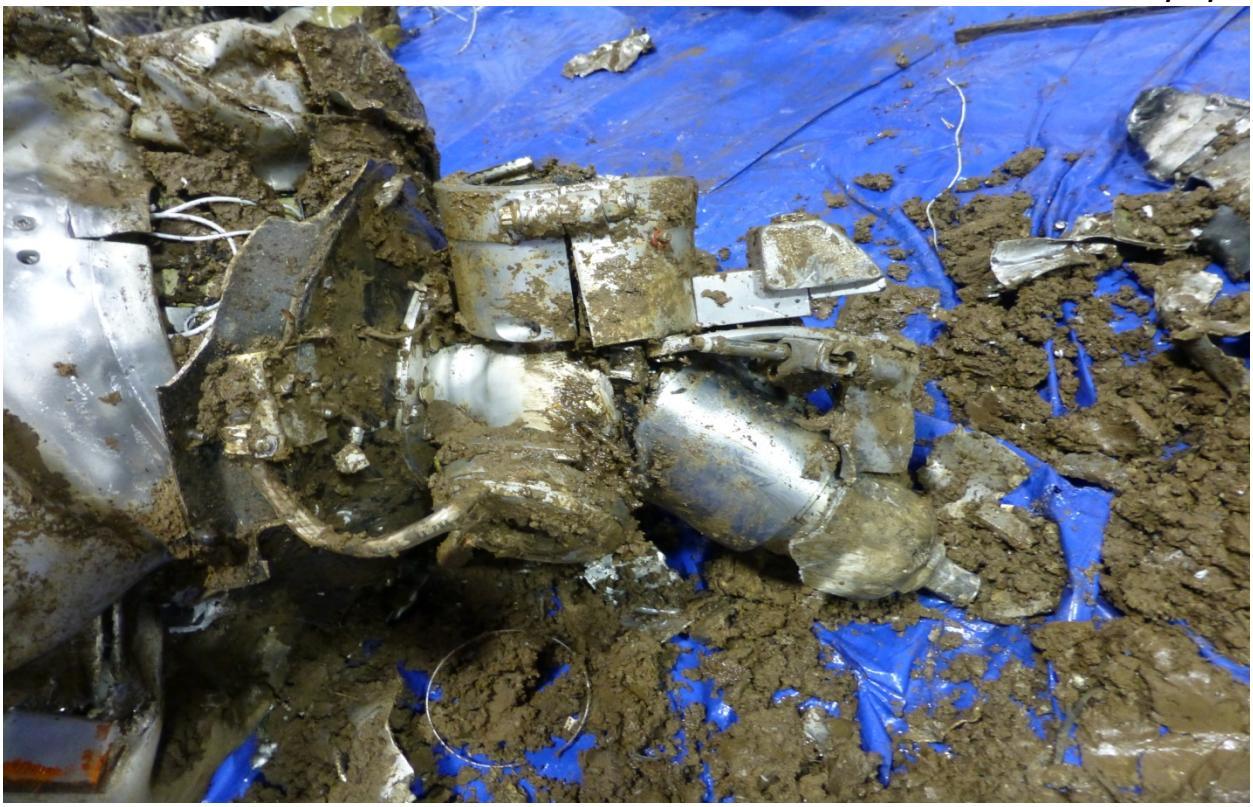
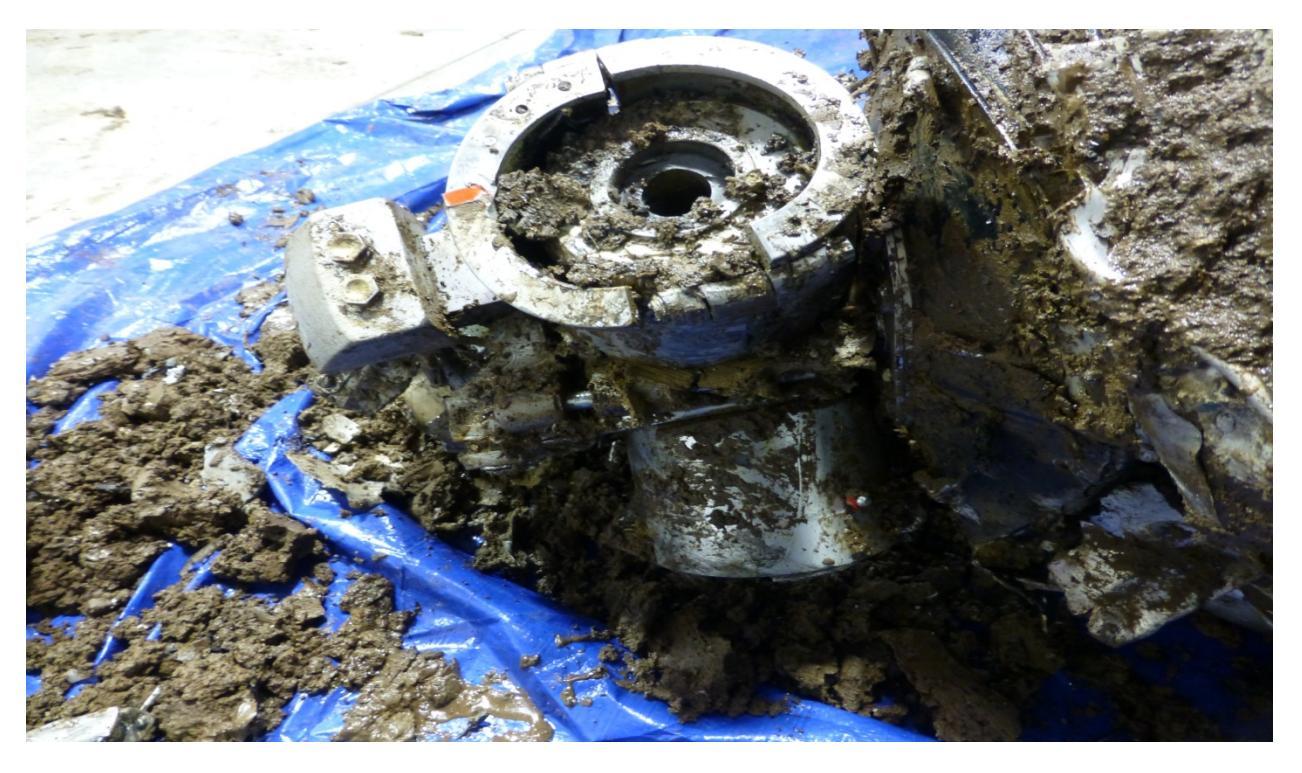
The propeller was still attached to the gearbox; however the gearbox had separated from the engine. All three blades were fractured off. The spinner was missing. The cylinder housing was bent due to impact. The clamps and counterweights had fractured bolts and half of a clamp was missing. The propeller was too dangerous to remove the cylinder and feathering spring assembly off the hub. The propeller was left on the gearbox for the teardown. The mounting bolts could not be accessed due to impact damage.

Photo #1, left propeller as received.

Photo #2, left propeller as received.

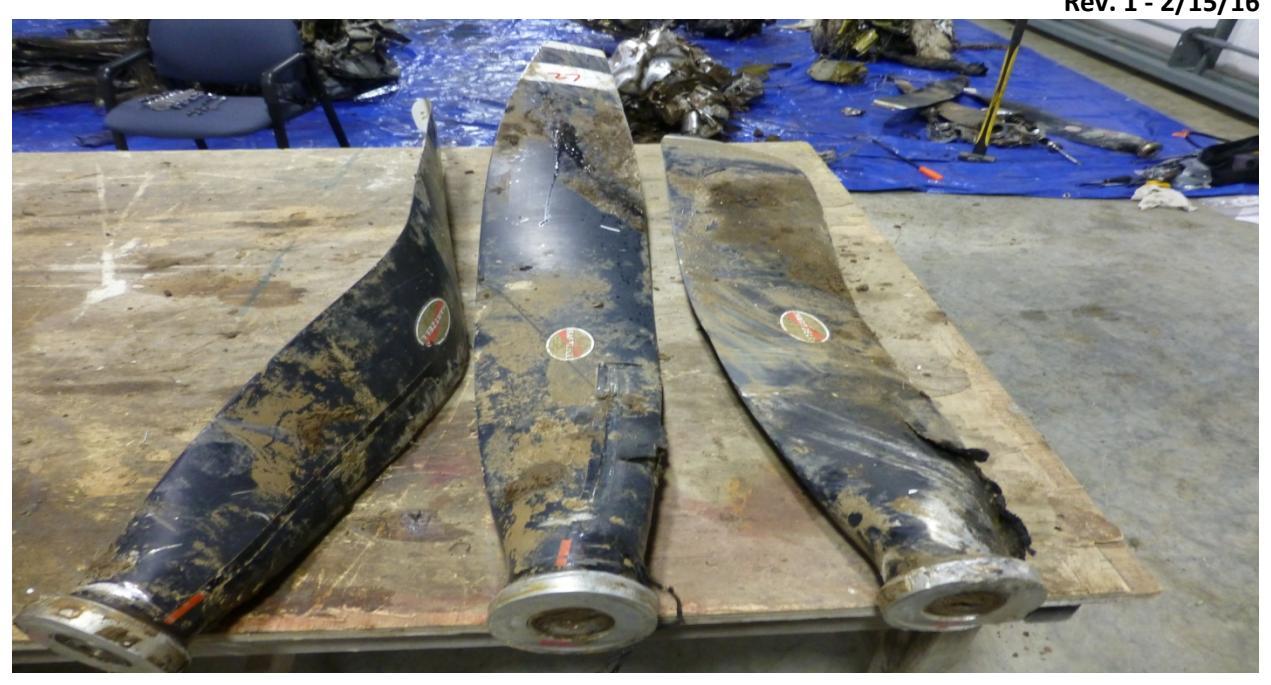
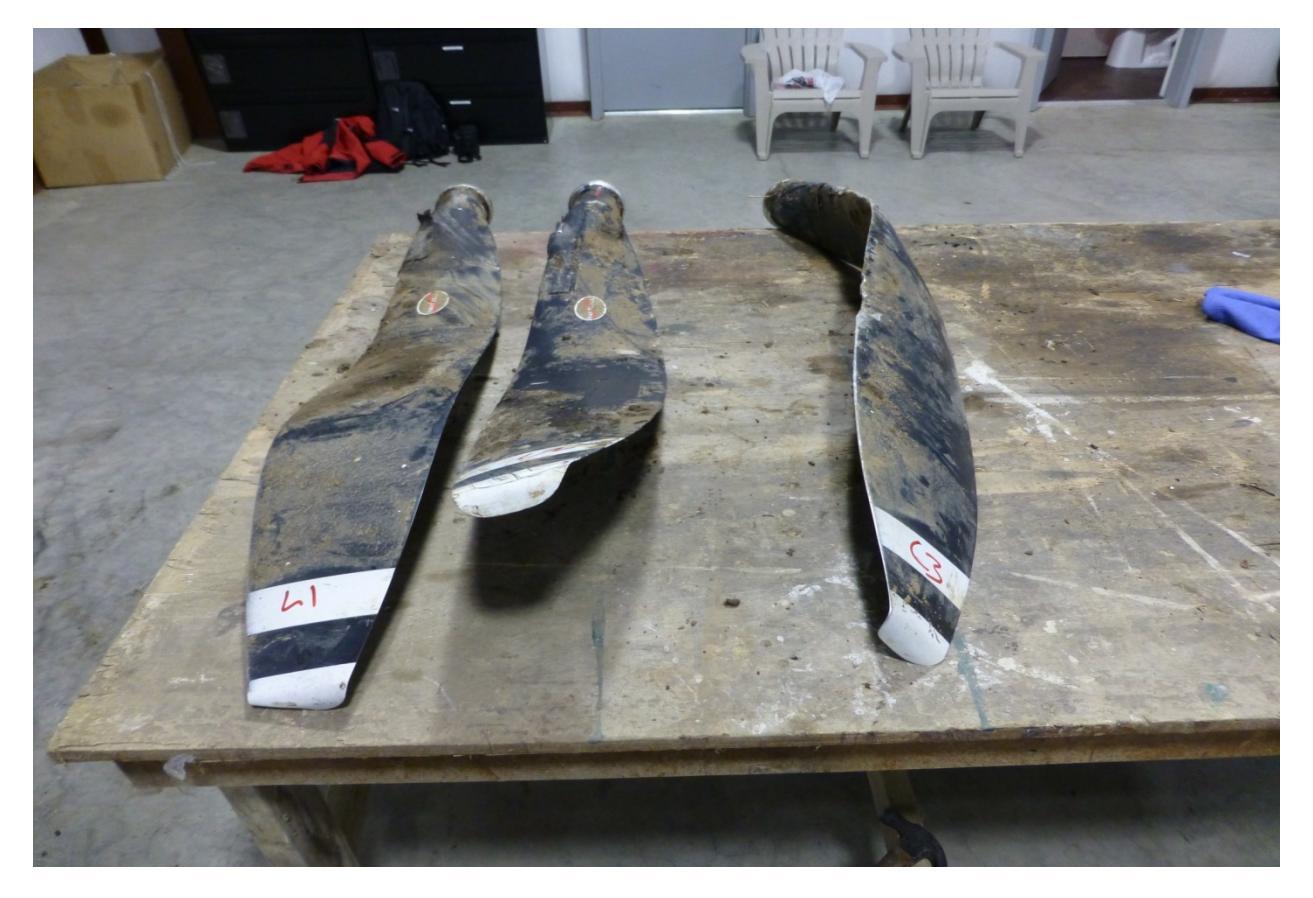
Blade # 1 paint, camber side paint, flat side bend twist	 scratches, gouges and rotational scoring. scratches, gouges. bent forward midblade, bent aft at the tip. none.
trail edge damage butt impression	 gouges midblade to tip. none. hub ring at the 3 o'clock from leading edge.
Blade # 2 paint, camber side paint, flat side bend twist lead edge damage trail edge damage butt impression	 scratches, gouges. scratches, gouges. bent forward at midblade. none. none. none. hub ring at the 3 o'clock from leading edge.
Blade # 3 paint, camber side paint, flat side bend twist lead edge damage trail edge damage butt impression	 scratches, gouges. scratches, gouges. bent aft midblade to tip. twist aft at tip. scratches. gouges midblade to tip. hub ring at the 12 o'clock from leading edge.

Photo #3, left propeller blades.

Photo #4, left propeller blades.

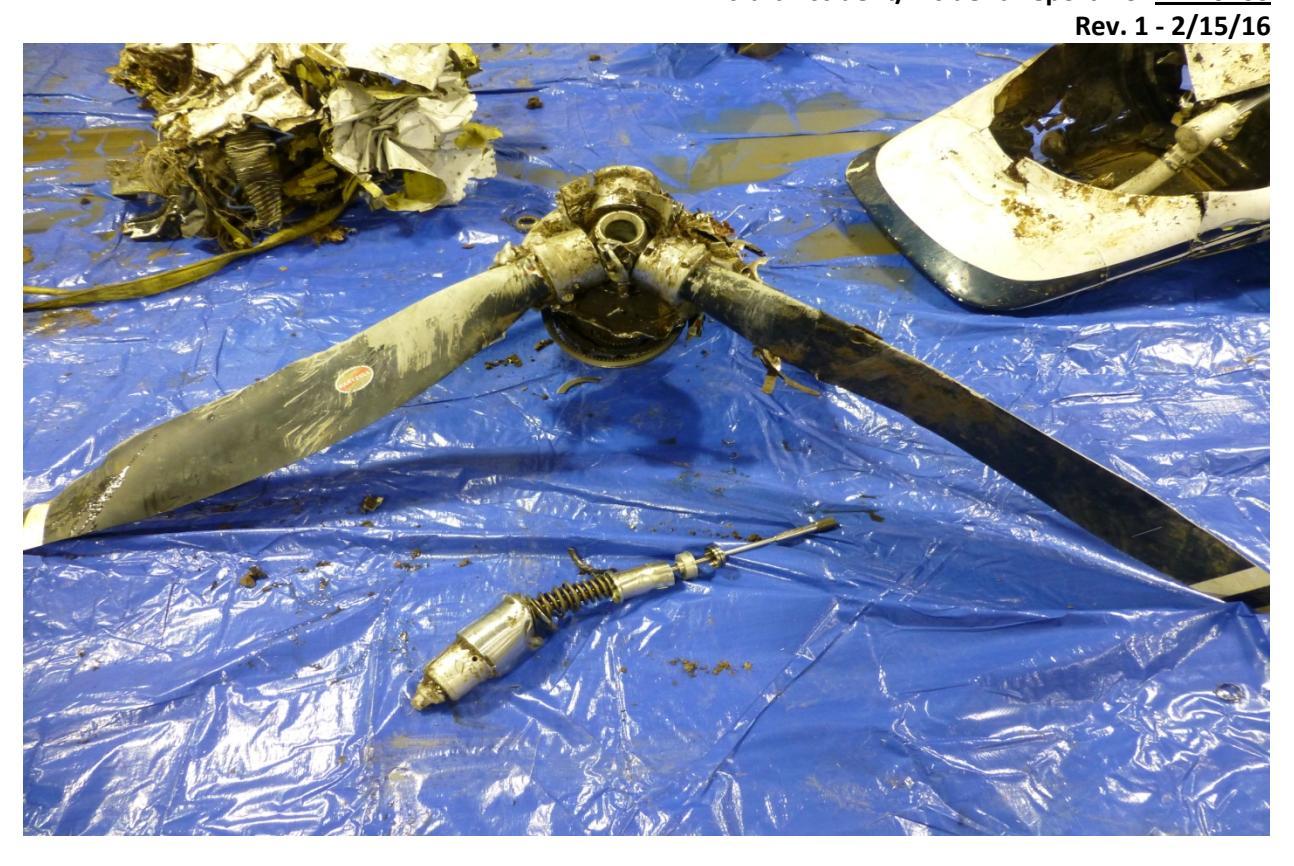
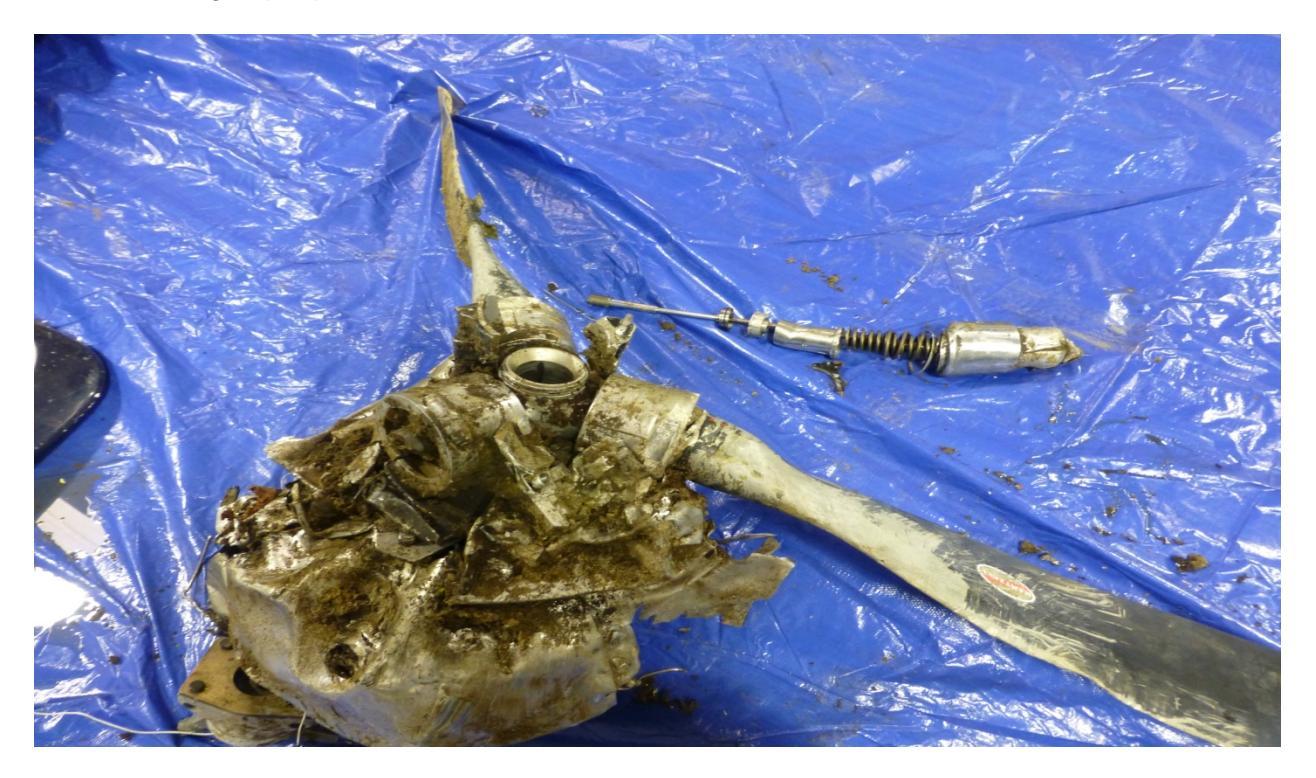
The propeller was attached to the gearbox; however the gearbox had separated from the engine. One propeller blade was fractured off the hub. The cylinder and feathering spring assembly was fractured off the hub and loosely hanging on the propeller. The propeller was not removed from the gearbox due to damage of the spinner bulkhead blocking access to the mounting bolts.

Photo #5, right propeller as received.

Photo #6, right propeller as received.

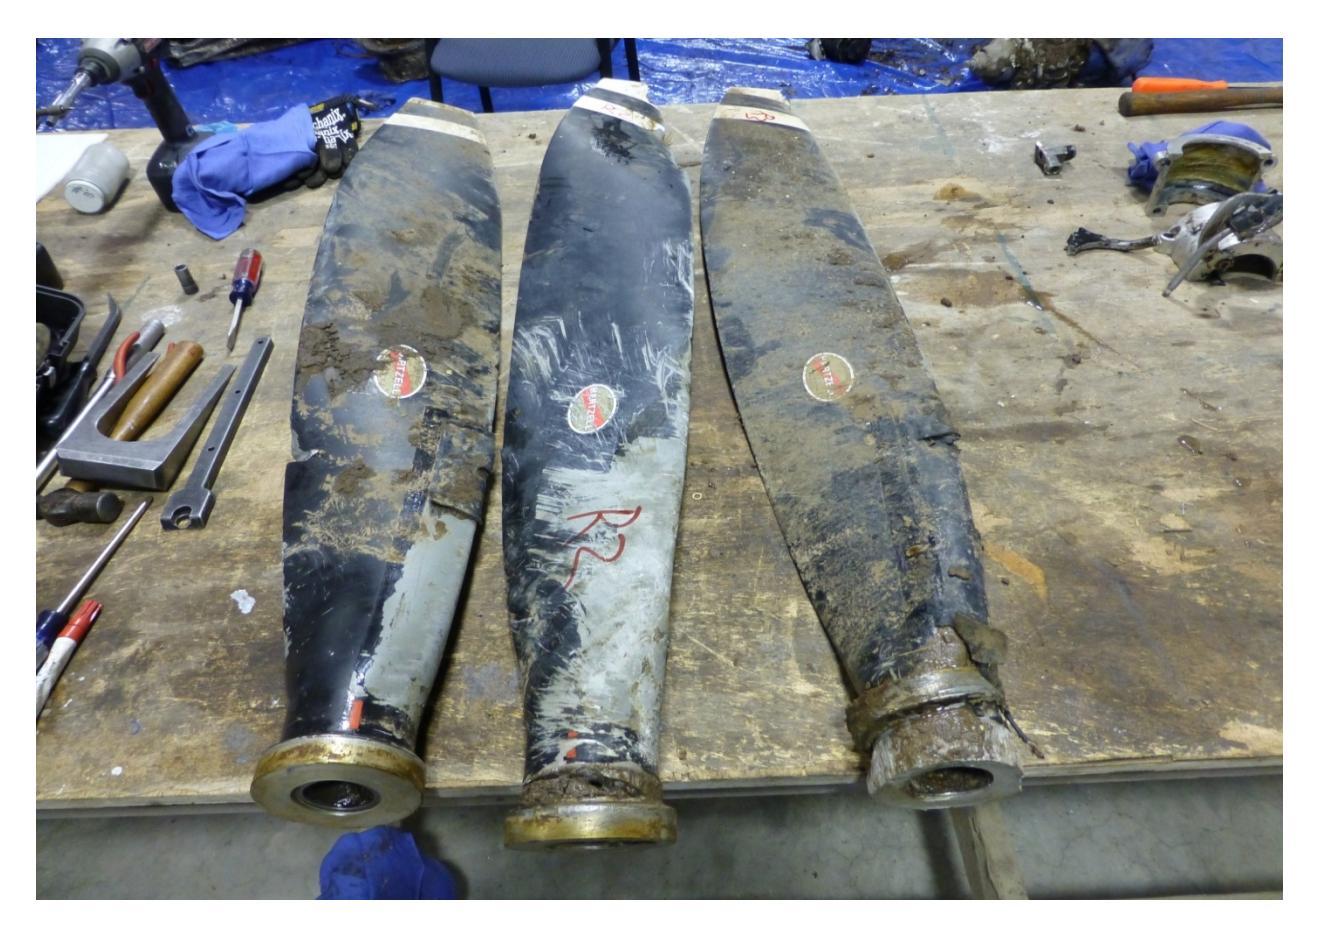
Blade # 1 paint, camber side paint, flat side bend twist lead edge damage trail edge damage butt impression	 scratches, rotational scoring. scratches. none. none. nicks and gouges at midblade. tear approximately 20" from the base. hub mark at the 12 o'clock position.
Blade # 2 paint, camber side paint, flat side bend twist lead edge damage trail edge damage butt impression	 scratched, rotational scoring. scratched, rotational scoring. bent aft at tip. Tip torn off. none. gouges and bends. Q-tip un-bent/flattened, portion of tip approximately 1"x2" along leading edge fractured. tear approximately 24" from base. hub mark at the 3 o'clock position.
Blade # 3 paint, camber side paint, flat side bend twist lead edge damage trail edge damage butt impression	 scratches. scratches. Tip bent. none. nicks and gouges at tip. Q-tip partially un-bent, portion of tip approximately 1"x1" along leading edge fractured. dents. butt ring was torn off.

Photo #7, right propeller blades.
