NATIONAL TRANSPORTATION SAFETY BOARD Office of Aviation Safety Aviation Engineering Division Washington, DC 20594 DATE

STRUCTURES/FLIGHT CONTROLS

EXAM

NTSB Case No.: ERA13FA273

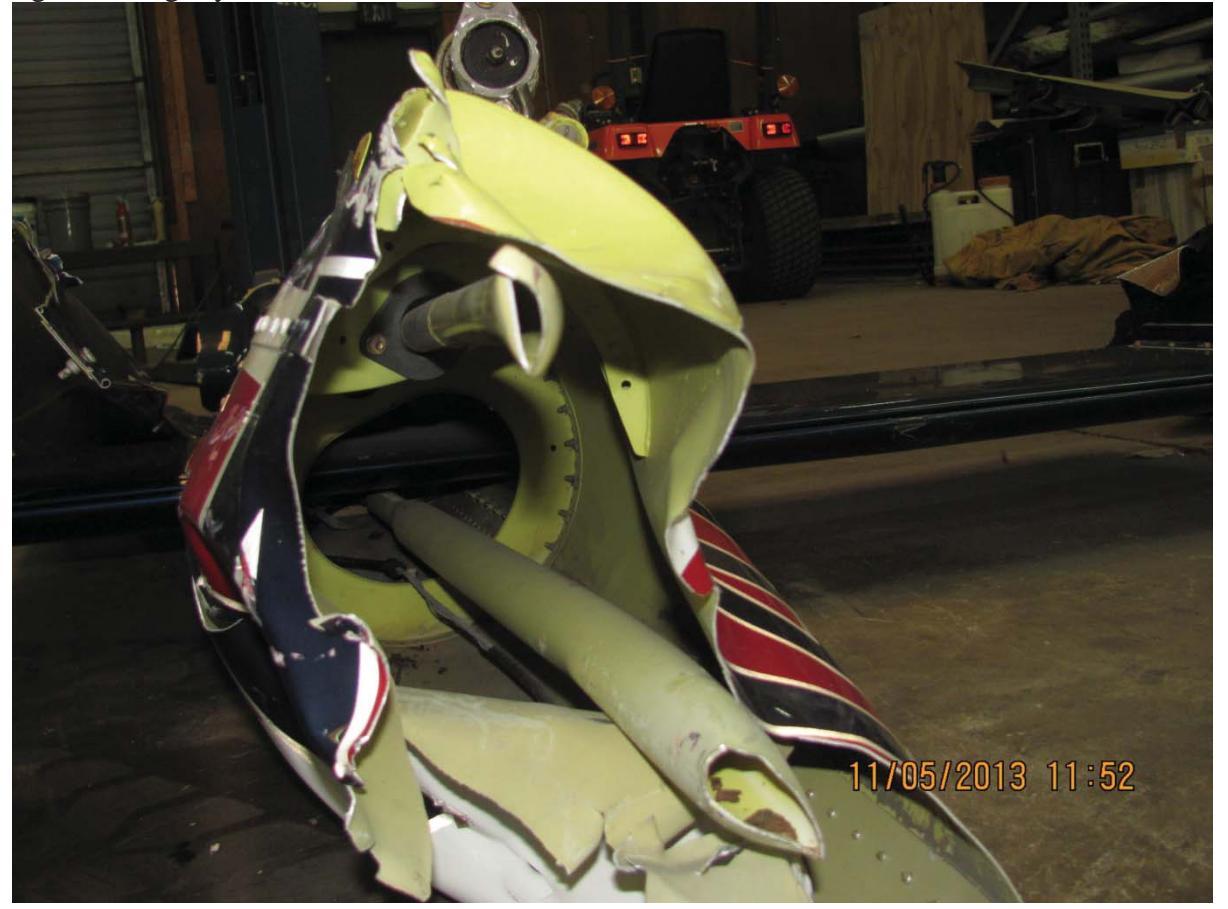
The tail boom was separated about 16 inches aft of the fuselage/tailboom intersection. The boom separated in bending, with the direction of bending as if the rotor section moved to the

right and slightly down.

<u>Photo 1</u> View looking aft. There is compression damage on the right side of the boom (the left side in the photo), tension damage on the left side (the right side in the photo), and the two tubes are bent to the right at their fracture points.

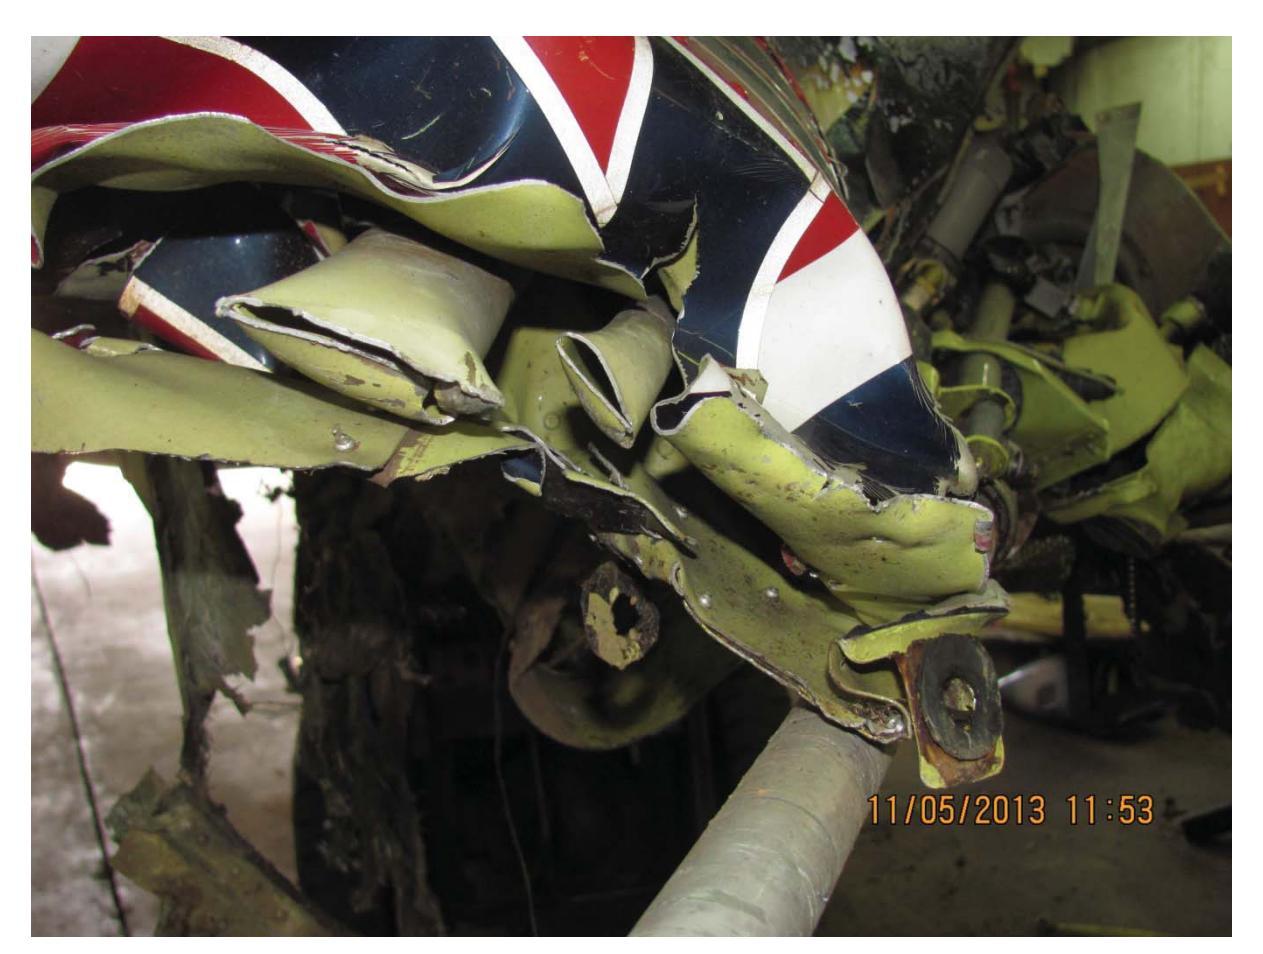
<u>Photo 2</u> View looking forward. The vertical plane is about 45 degrees to the left. There is tension damage on the left side. The two tubes are bent to the right at their fracture points. The fractures of the forward section match the fractures of the aft section.

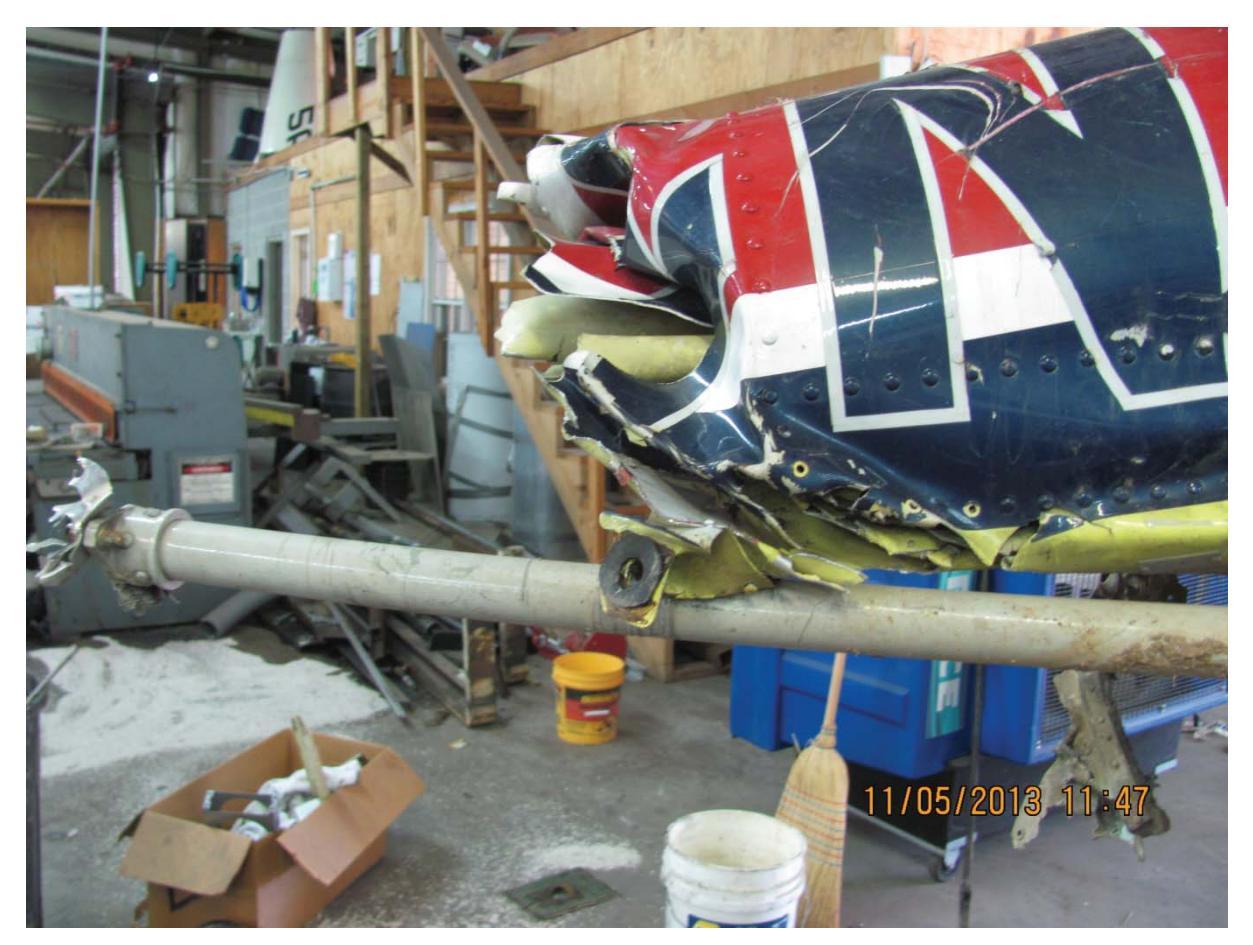
<u>Photo 3</u> The boom fracture is mid-span of the number 2 driveshaft section.

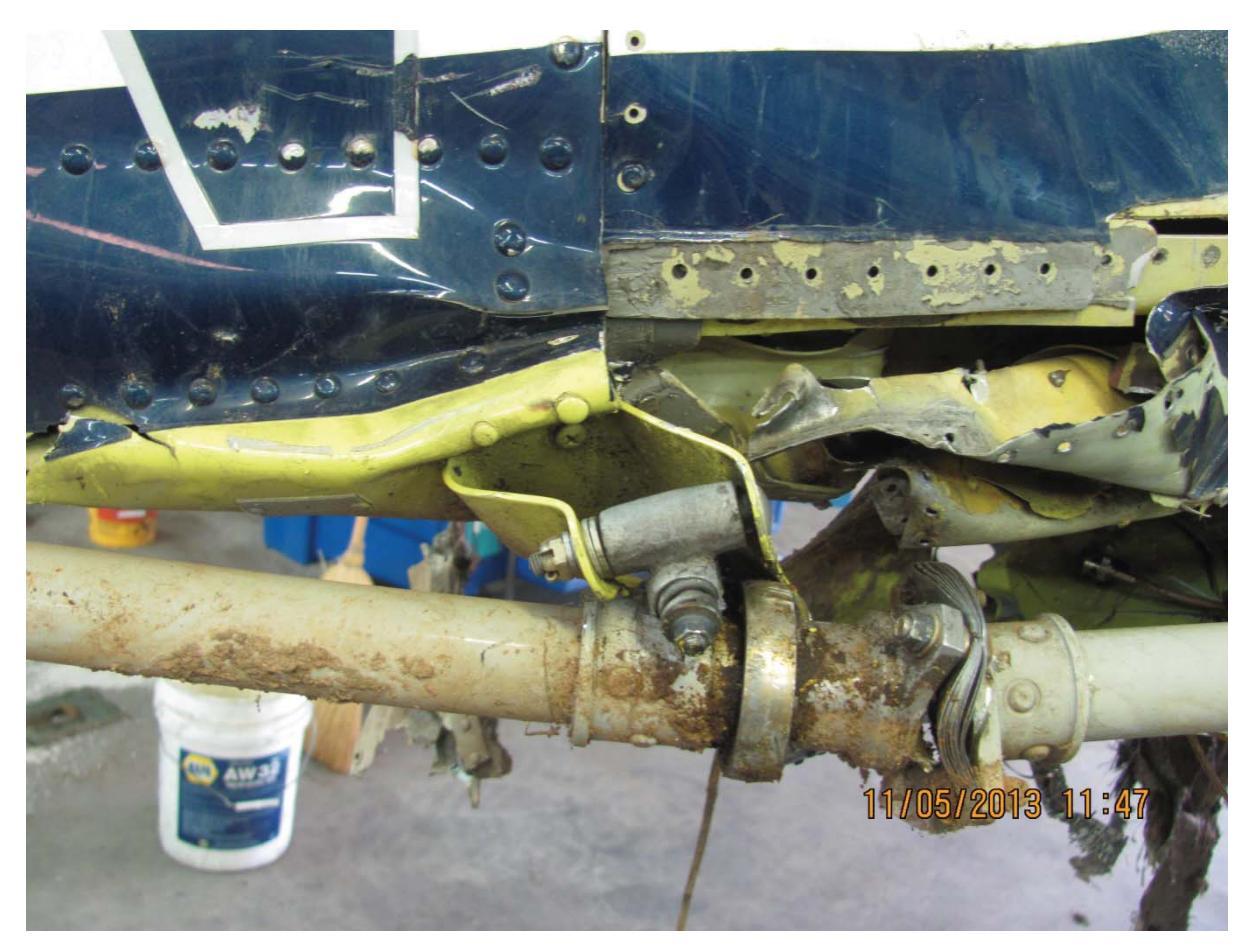
<u>Photo 4</u> View looking to the right shows the number 1 hangar bracket bent forward. The bracket is on the forward section of the tail boom.

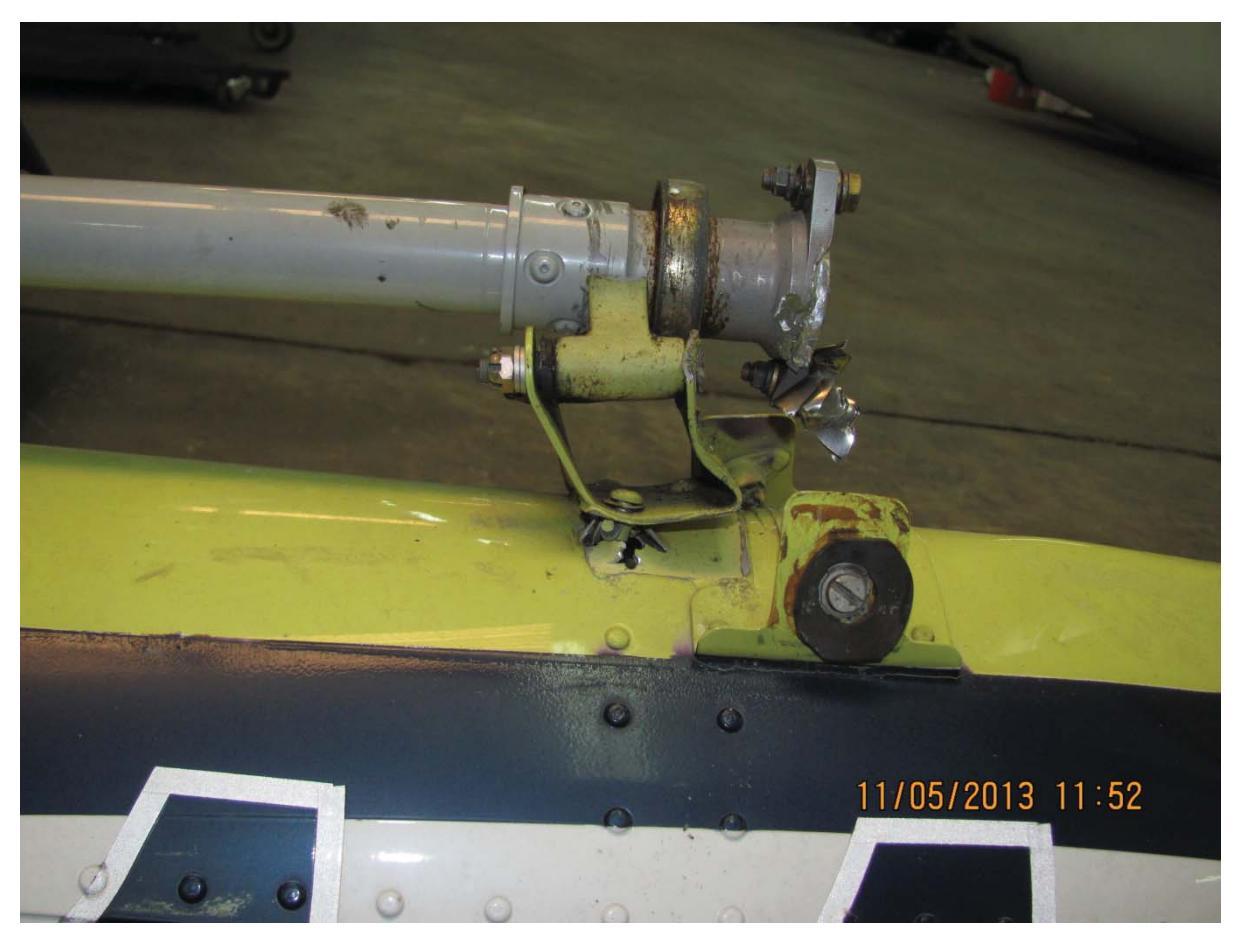
<u>Photo 5</u> View looking to the left shows the number 2 hangar bracket bent aft. The bracket is on the aft section of the tail boom.

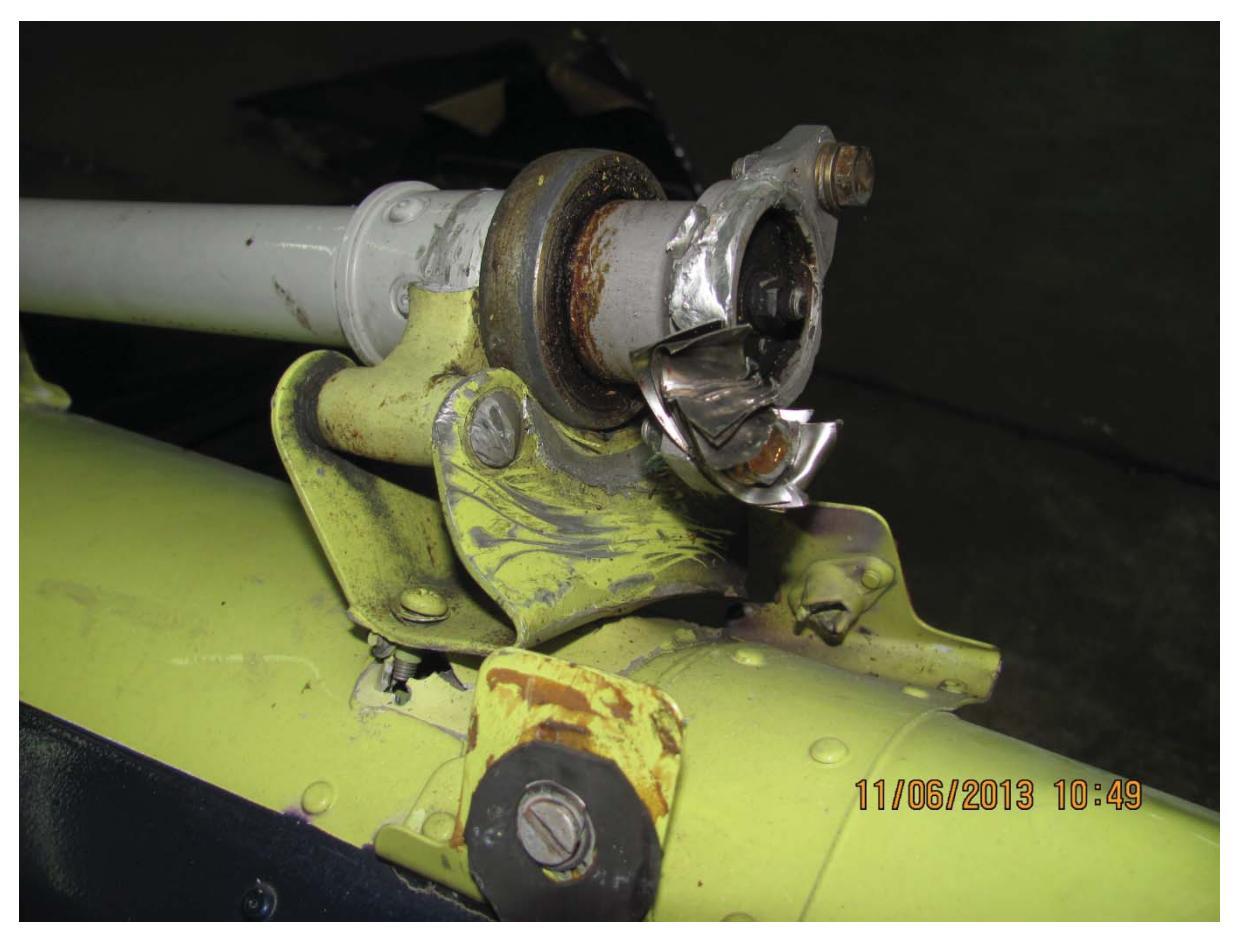
<u>Photo 6</u> Scoring marks on hangar bracket match the threads and nuts on the drive shaft. The Thomas Coupling remnants are bent forward.

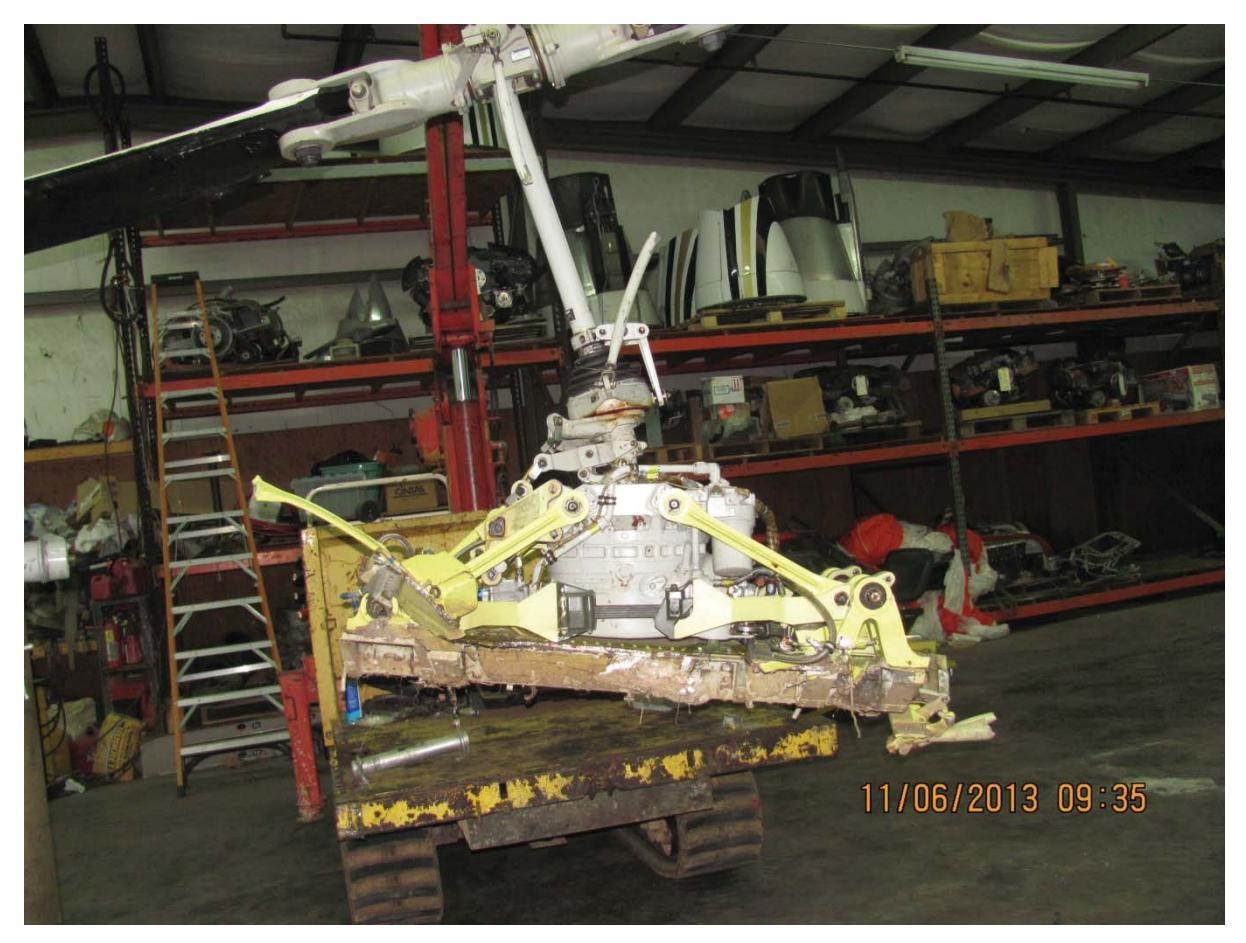
The main rotor blades, hub, mast, transmission and upper deck separated from the helicopter as a unit. The mast was bent in two places. At the upper end, the mast was bent just below imprints left by the mast stops that are attached to the rotor hub. The bend was about 5 degrees. The bend at the lower portion of the mast was below the swash plate. The bend was about 20 degrees and was in plane with the upper bend.

<u>Photo 8</u> The mast is bent about 20 degrees from vertical using the transmission as the reference. At the upper end, the bend is about 5 degrees back toward vertical.

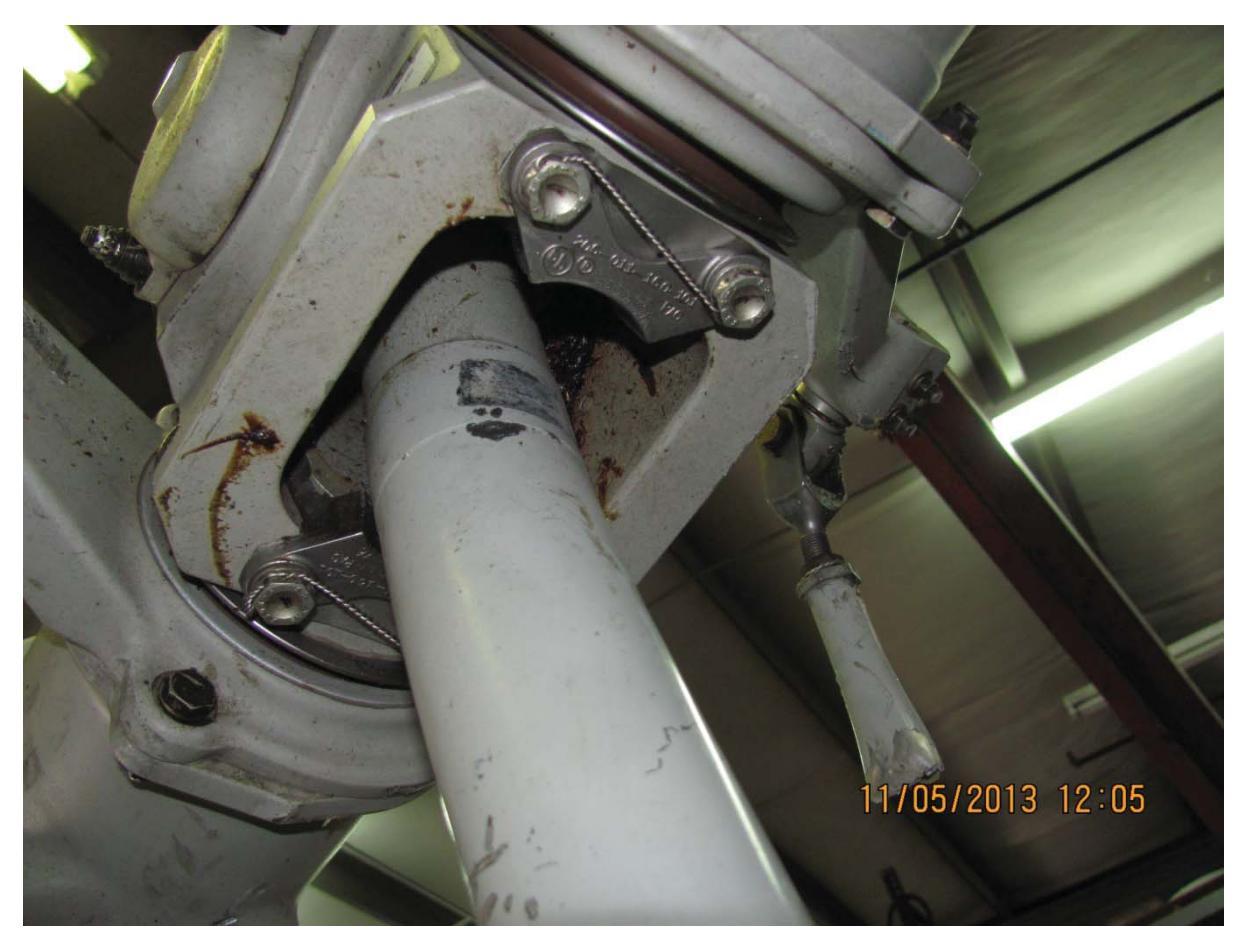
<u>Photo 9</u> Both stops contacted the mast. This side shows a distinct impression and gouging in the metal.

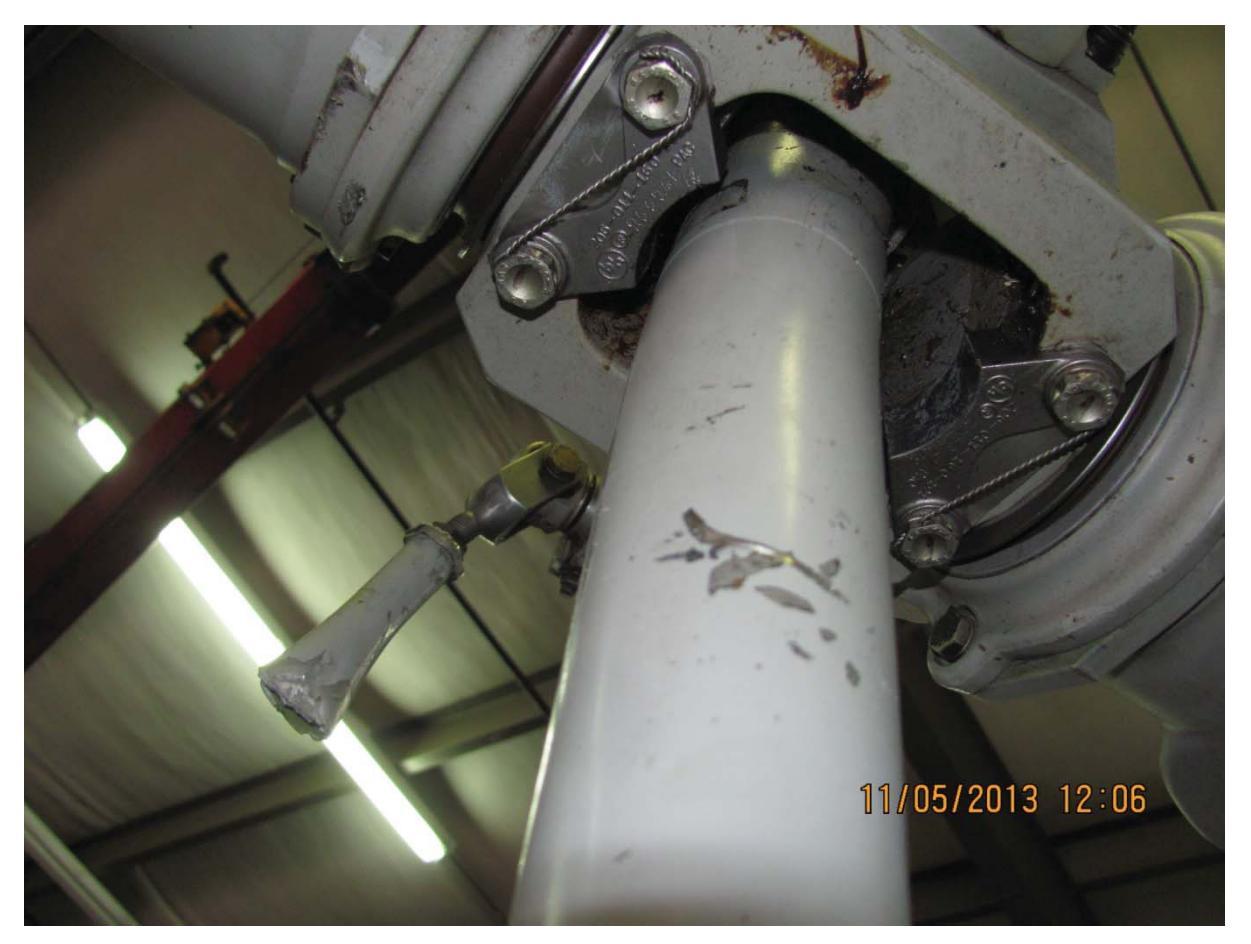
Photo 10 Mast contact at stop.

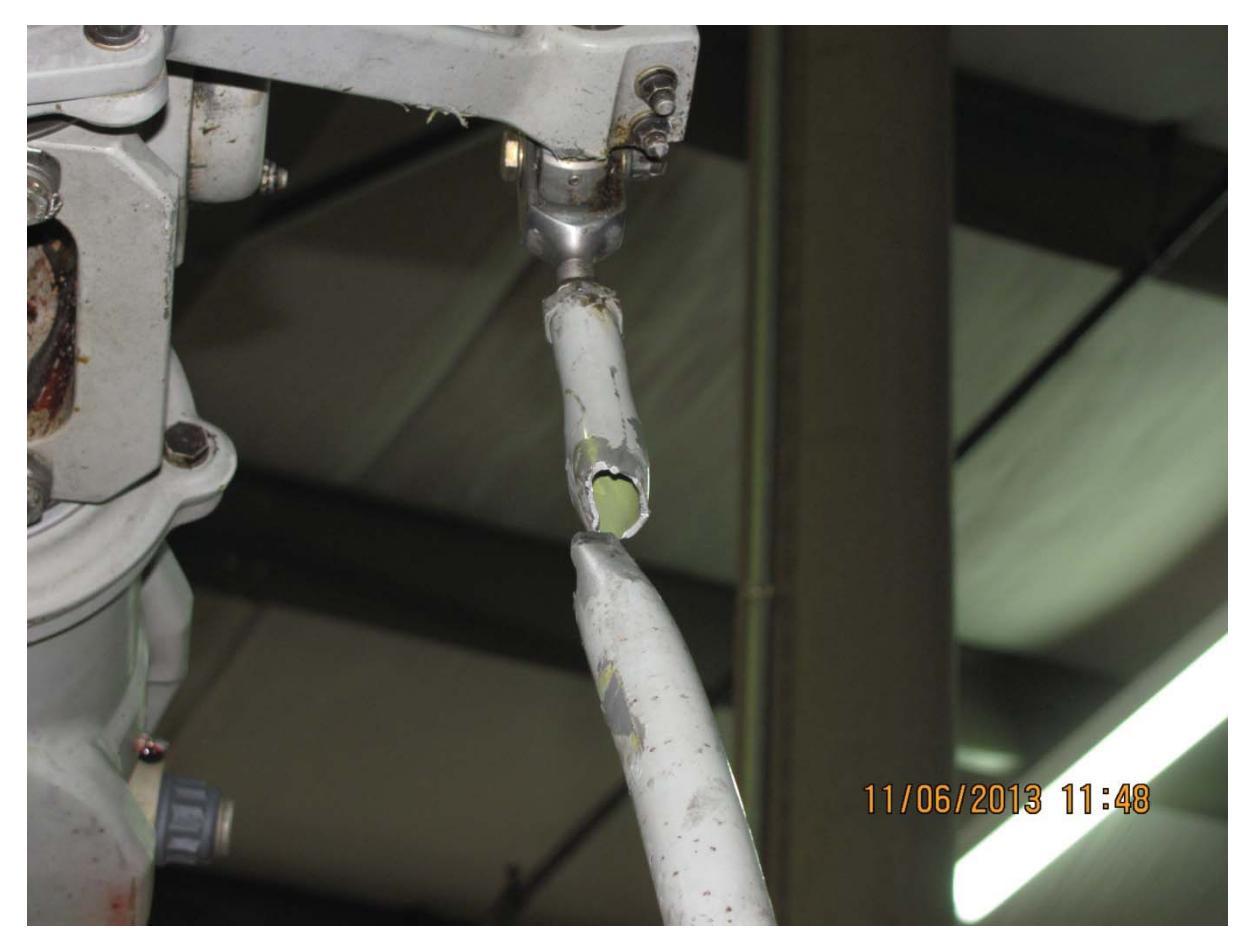
<u>Photo 11</u> The pitch change link was fractured. The damage was consistent with a bending overload. The lower portion separated from the swash plate and was found near the tail boom.

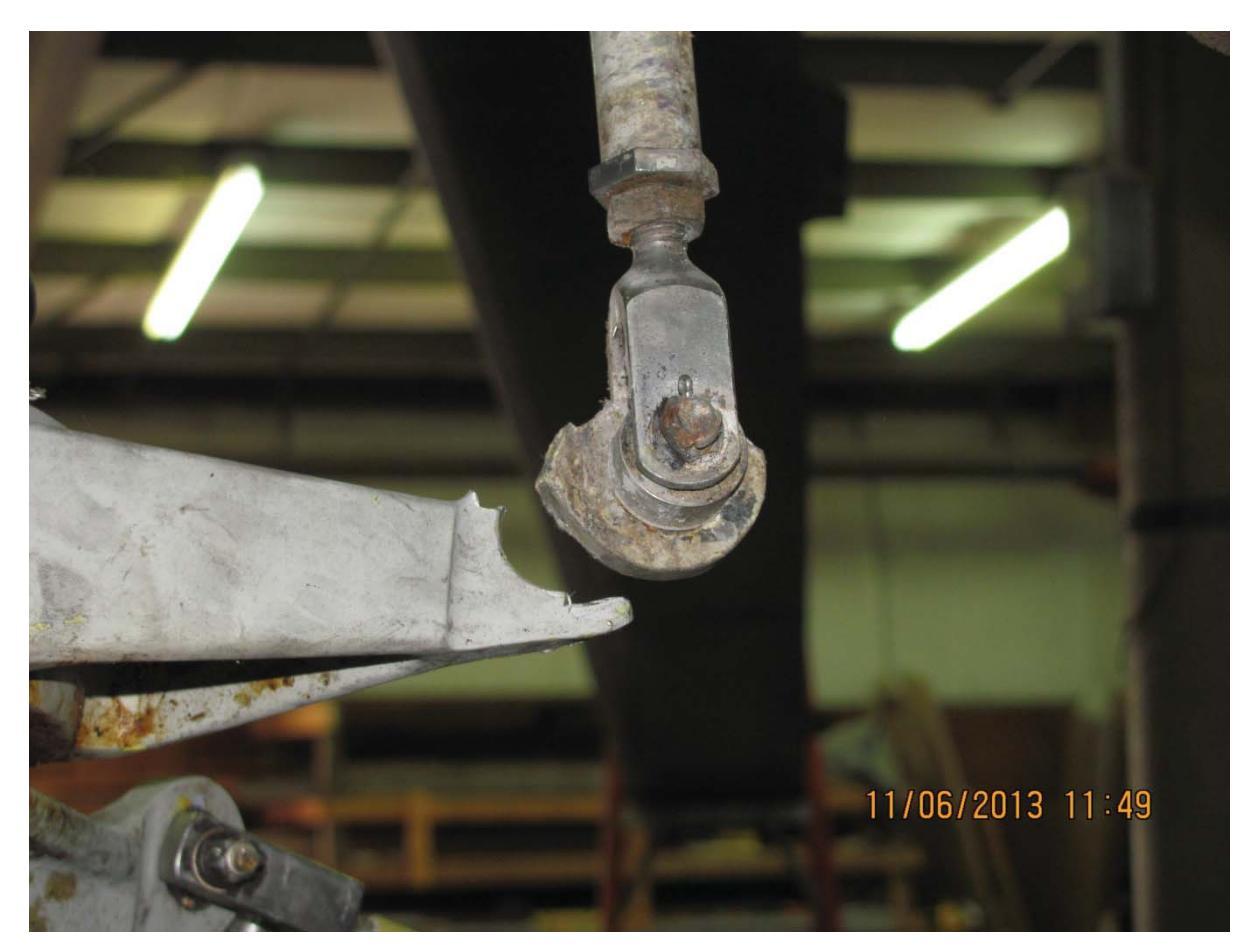
<u>Photo 12</u> The lower portion of the pitch change link. A section tore from the swash plate and the section remained with the link. The fracture at the thin portion was consistent with tension overload. The fracture at the thicker, lower portion was also consistent with tension and some bending in the area.

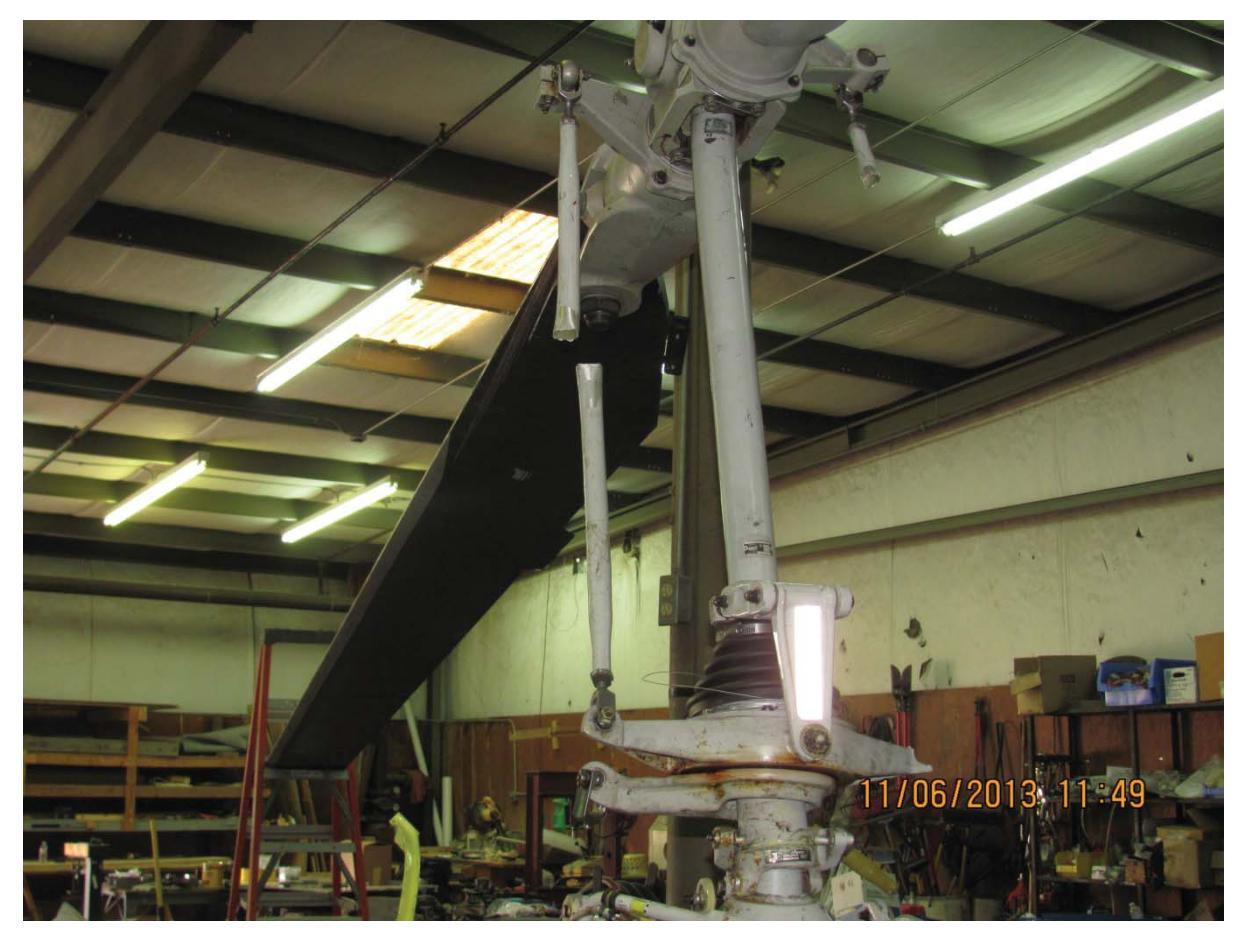
<u>Photo 13</u> The change link separated in bending overload.

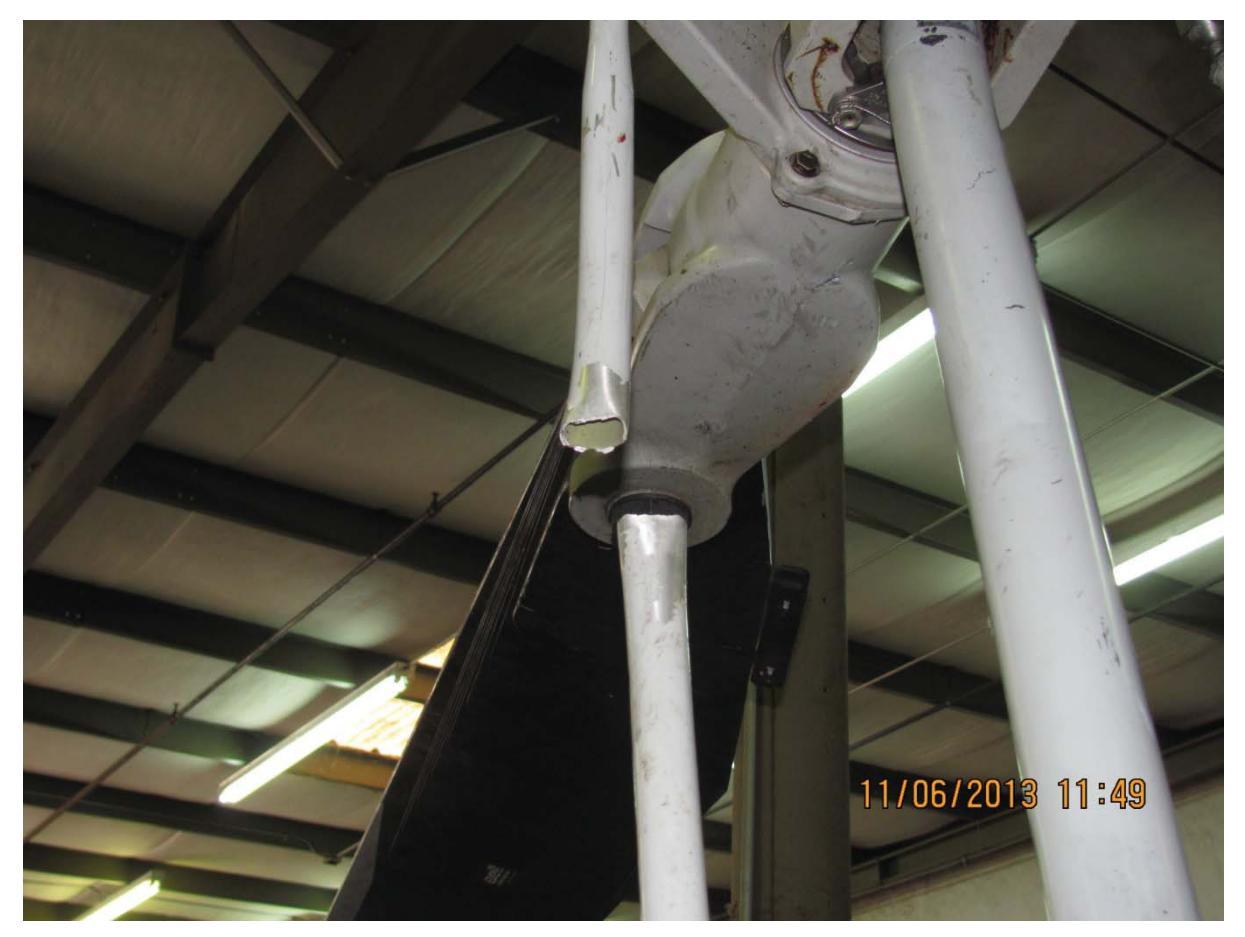
<u>Photo 14</u> The pitch change link separated in bending overload.

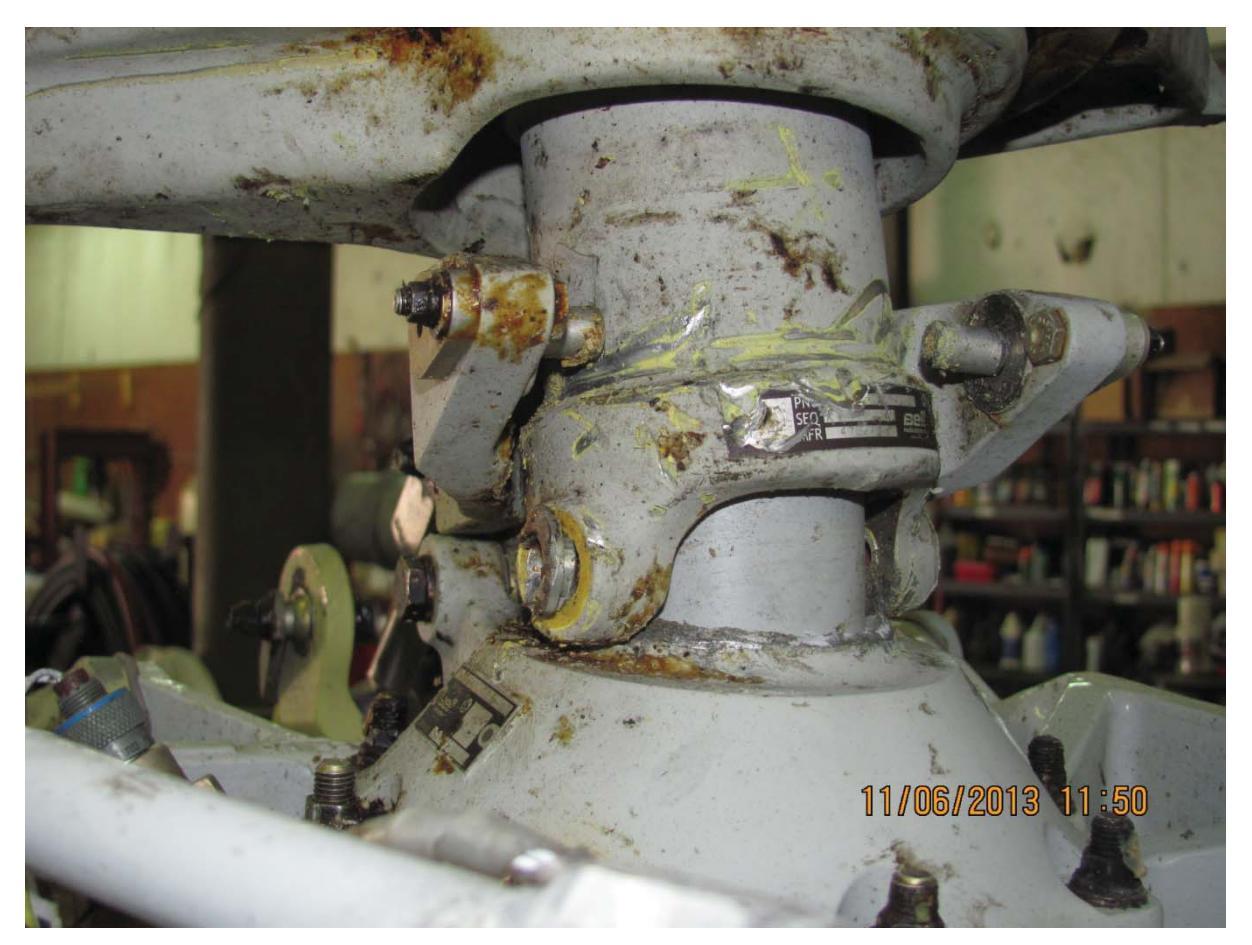
The collective sleeve separated from the collective lever pins and was free to slide. One of the pins was bent slightly upward. The second pin appeared to remain in a normal orientation. The two pin bushings were severely gouged in a downward direction, as if the pins were moving in a downward direction.

<u>Photo 15</u> The collective lever pivot pins had separated from the bushings and were found above the bushings. However, the right pin or arm was bent slightly upward. The bushing was gouged in a downward direction. The top portion of the gear box casting was damaged by the casting that holds the bushings.

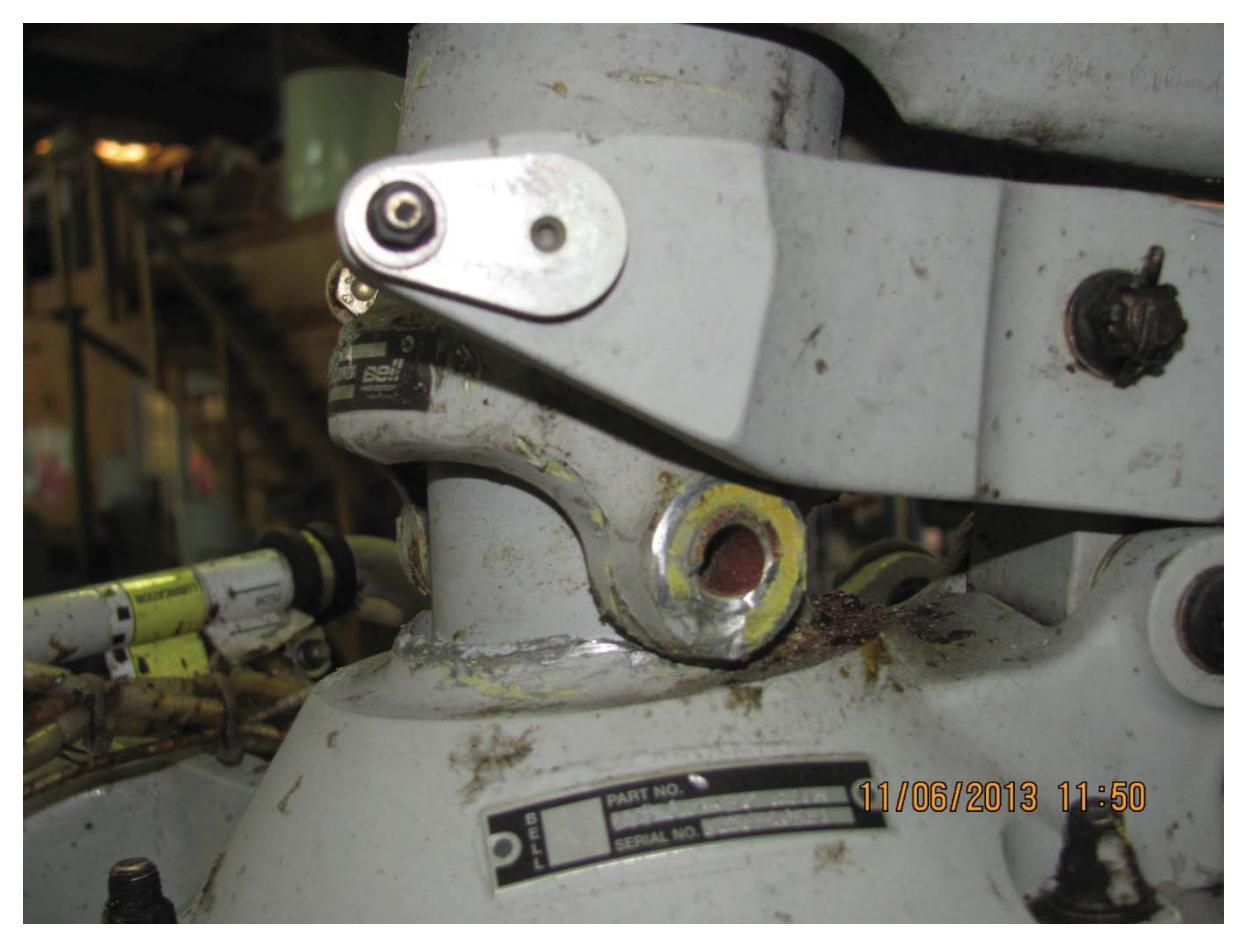
<u>Photo 16</u> The right bushing was gouged in a downward direction.

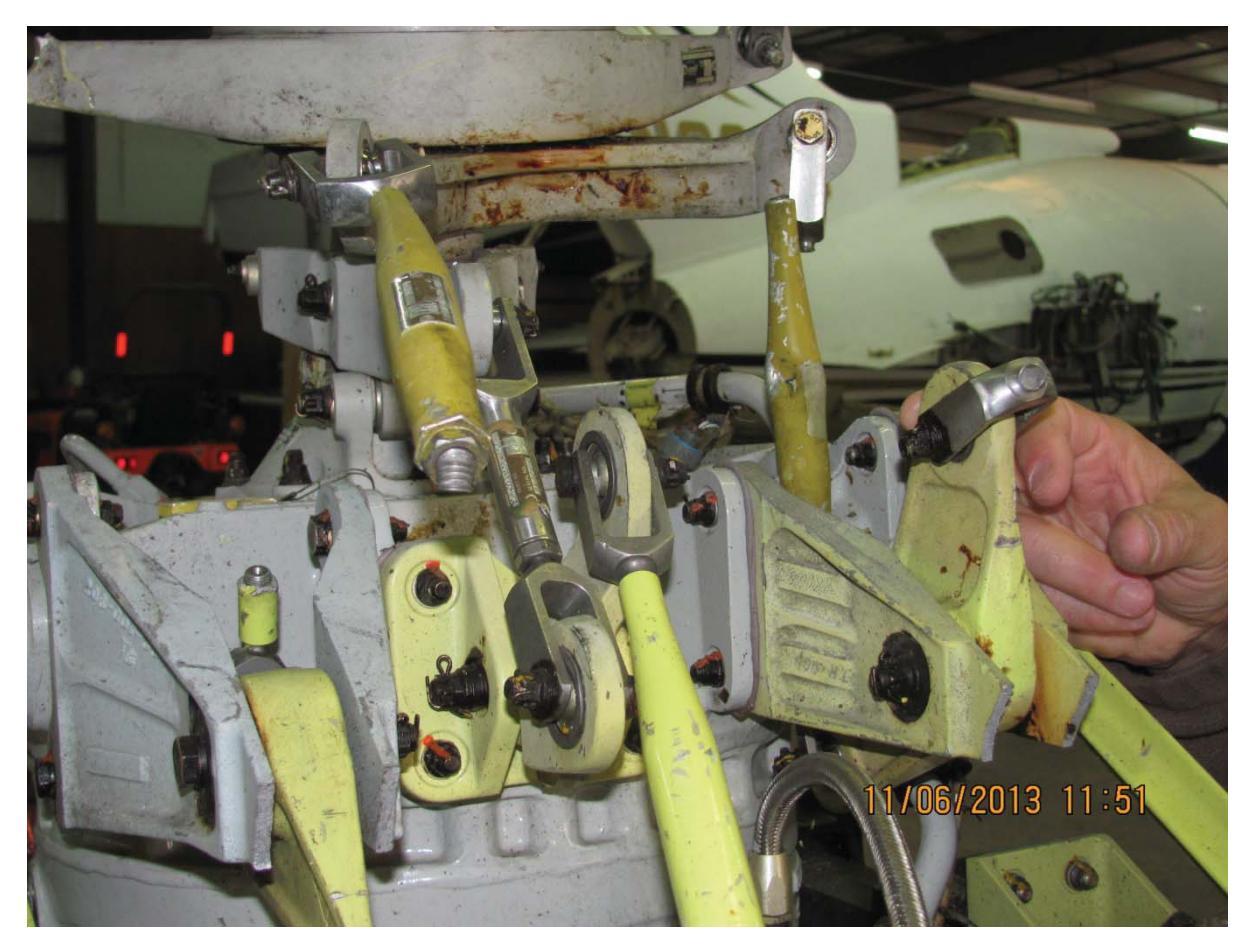
The linkages that attach to and move the swash plate were separated in bending overload.

<u>Photo 17</u> The linkages that attach to the bell cranks and swash plate were fractured. The fractures were consistent with static bending overload. The transmission was free to rotate by moving the K-flex attach fitting.

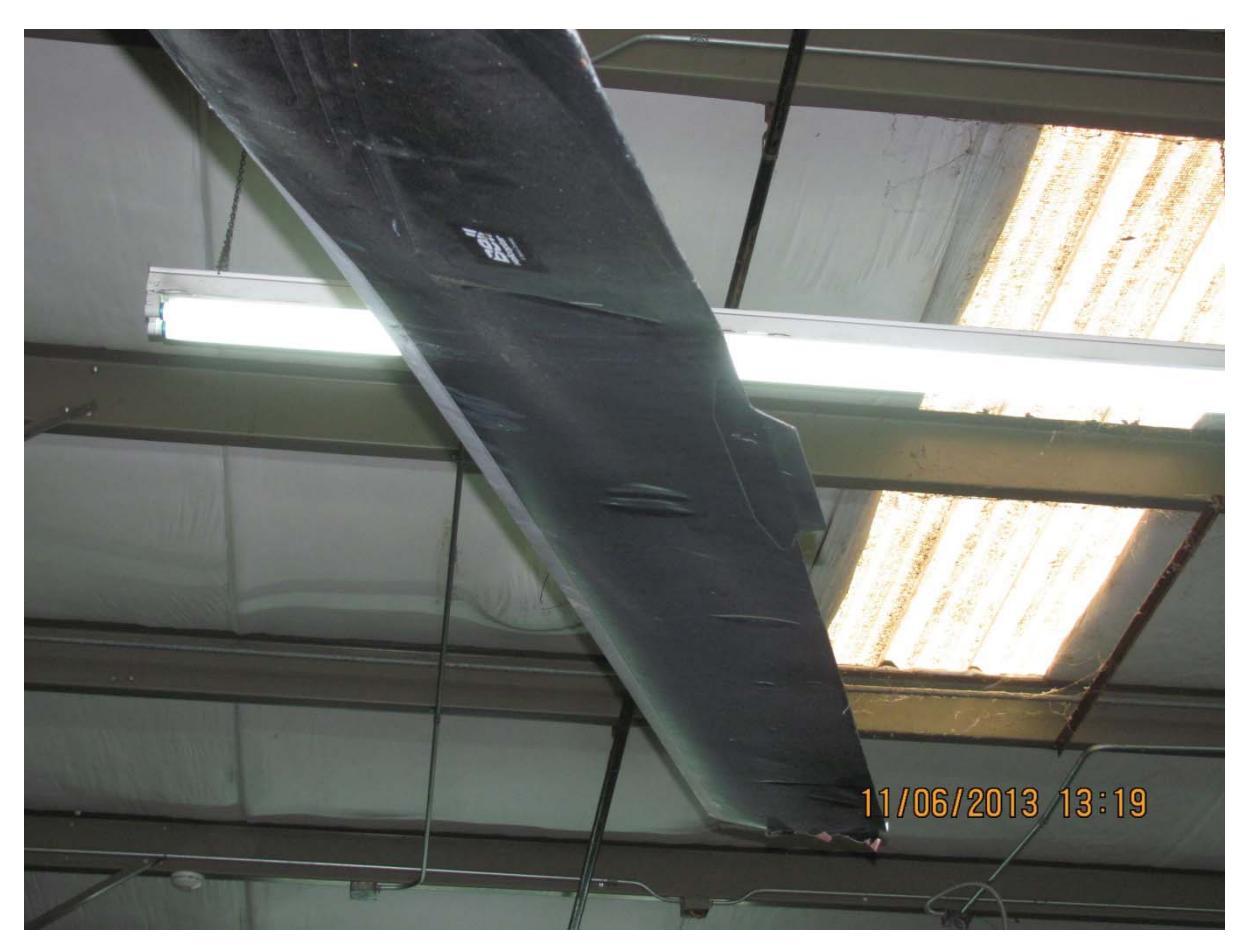
Both main rotor blades remained attached to the hub. One blade remained intact; the other was separated about 149 inches from the mast. The forward portion of the fracture was along a line generally perpendicular to the span and curving inboard toward the aft end. The separated tip was found next to the blade. The blade exhibited a general permanent bending just inboard of the trim tab.

<u>Photo 23</u> The blade was fractured at 149 inches from the mast. A downward bend was located just inboard of the trim tab. The lower surface had a compression wrinkle at the area of the bend, depicted in the photograph.

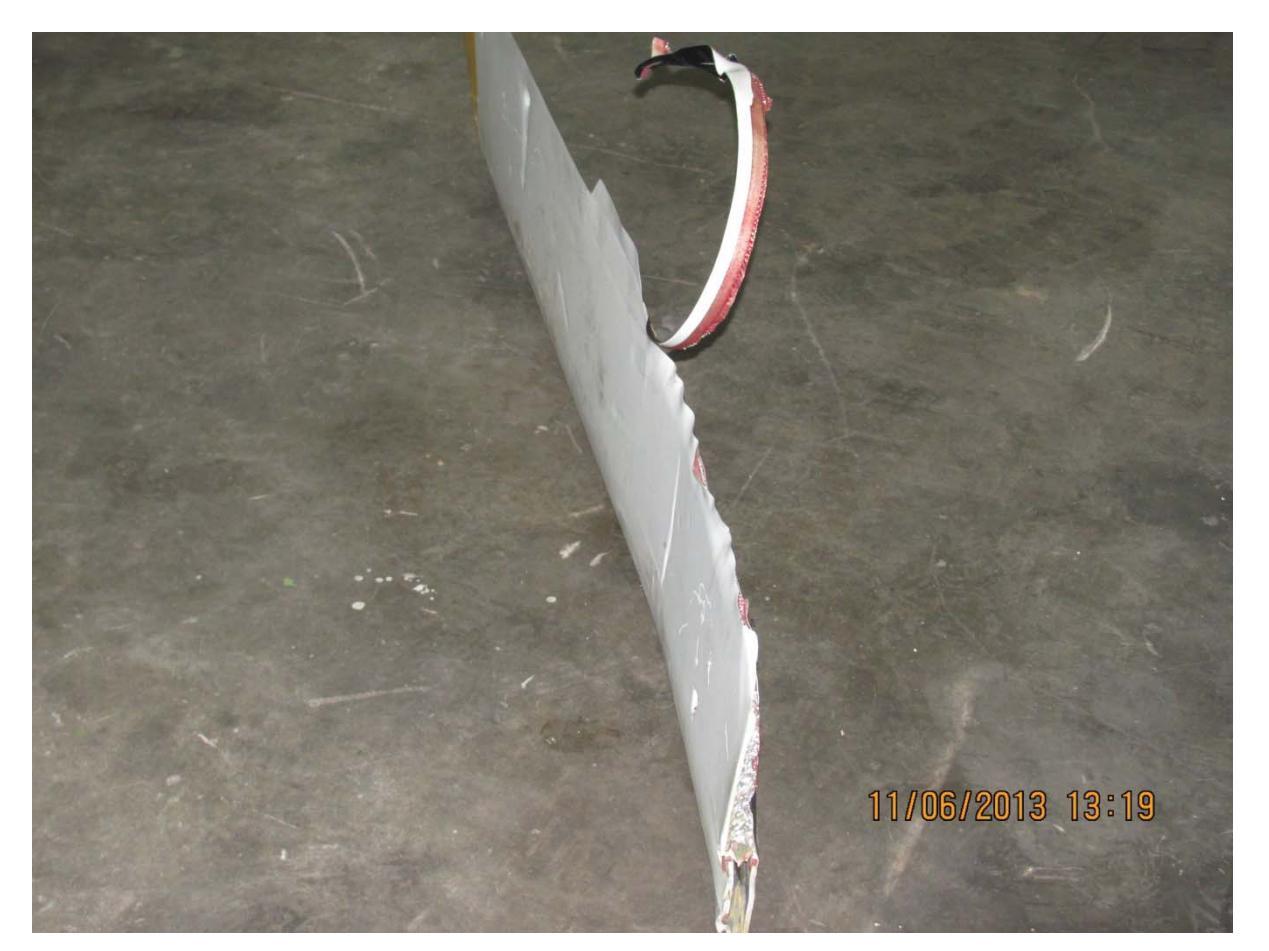
<u>Photo 24</u> The outboard section that separated had a general upward bending in the first half of the section. The fracture surfaces were consistent with static overload and the bending was consistent with the tip moving in an upward direction.
