NATIONAL TRANSPORTATION SAFETY BOARD Office of Aviation Safety Aviation Engineering Division Washington, DC 20594 DATE

STRUCTURES/FLIGHT CONTROLS

EXAM

NTSB Case No.: ERA13FA273

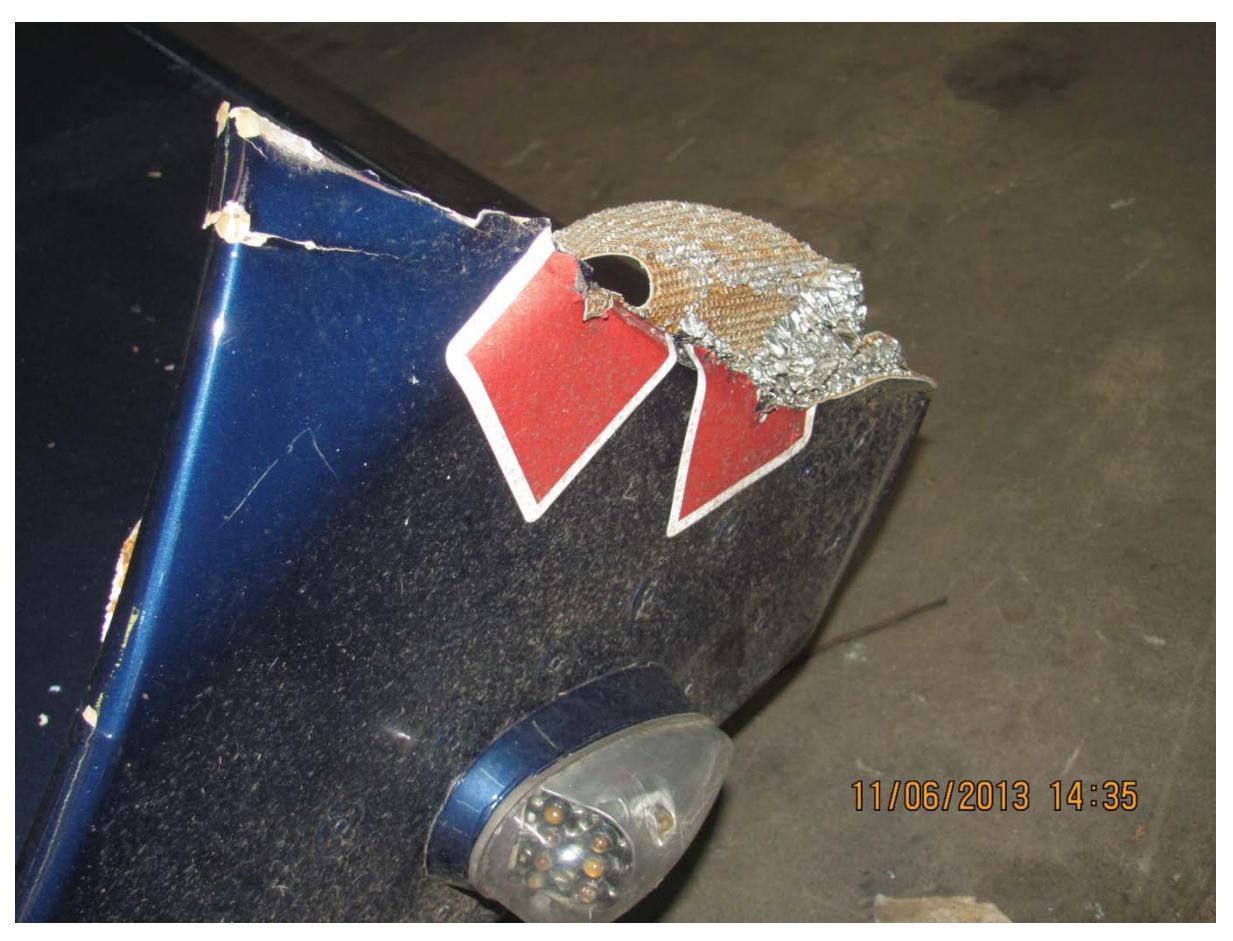
<u>Photo 26</u> The left winglet was fractured when found on-scene; however, the tip was still attached when found.

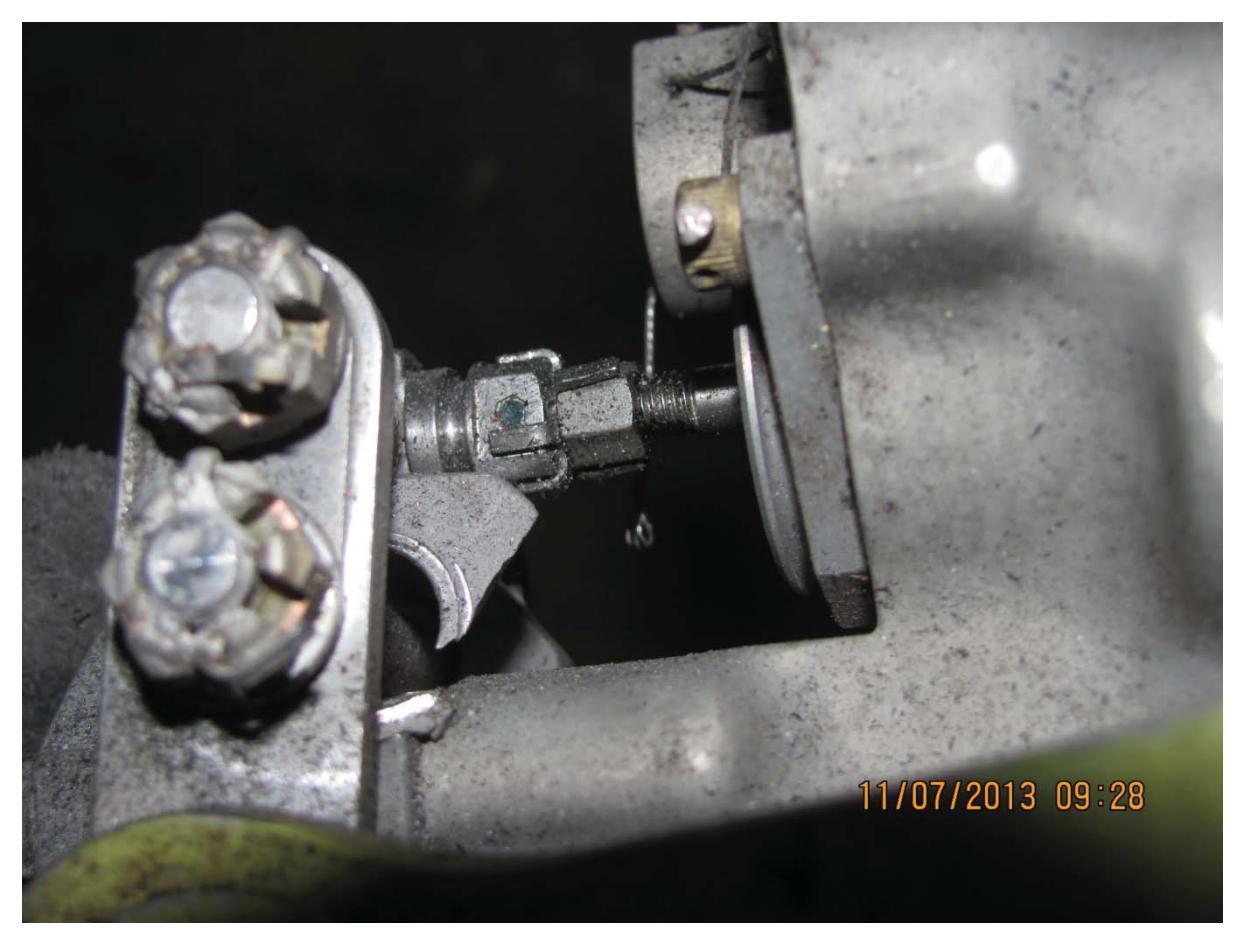
<u>Photo 46</u> Actuator 1 – Collective Pitch Hydraulic Actuator - with Separated

Hydraulic Piston
