NATIONAL TRANSPORTATION SAFETY BOARD OFFICE OF AVIATION SAFETY WASHINGTON, D.C. 20594

Manufacturing Data and Manufacturing Cell Group Factual Report

A. <u>INCIDENT:</u> DCA13IA037
 LOCATION: Boston, Massachusetts
 DATE/TIME: January 7, 2013, about 10:21 AM EST¹
 AIRCRAFT: Japan Airlines Boeing 787, JA829J, Line Number 84

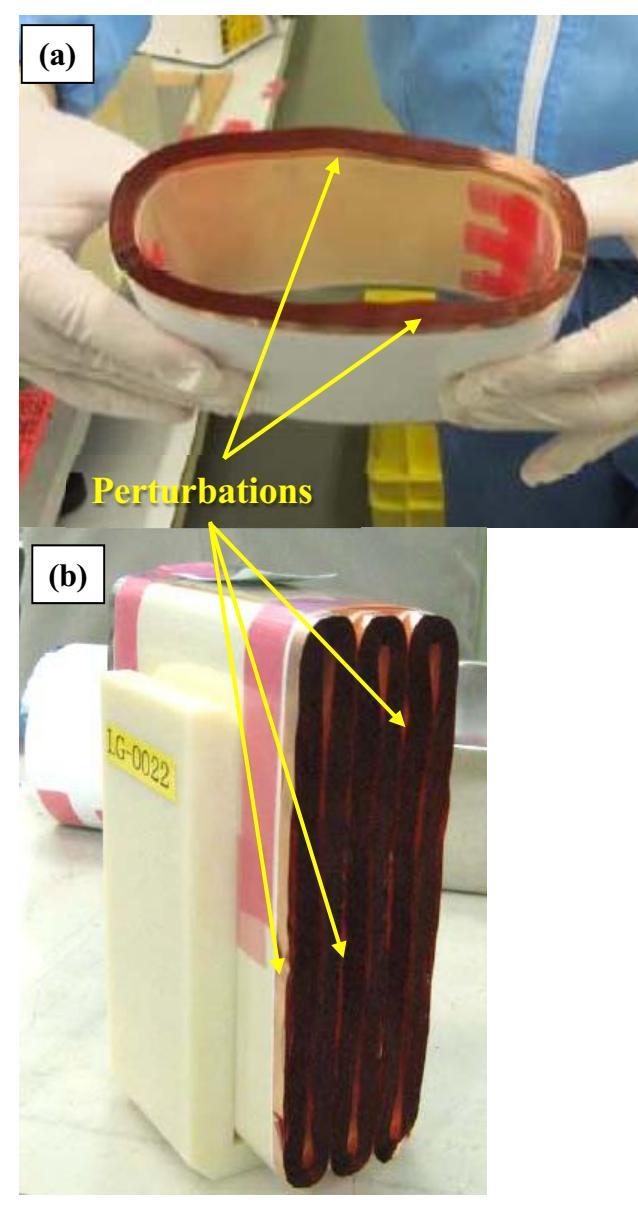
The hand flattening pre-forming process created what appeared to be perturbations⁷ of the electrode foil in the manner depicted in Figure 3 during the assembly, which captures the observations of the final three jellyroll flattening process.

Figure 3 – Images of the jellyroll flattening process showing (a) hand flattening and (b) the three-electrode assembly after final flattening and taping.
