NATIONAL TRANSPORTATION SAFETY BOARD

MATERIALS LABORATORY FACTUAL REPORT

:	Oldenburg, Indiana
:	December 16, 2017
:	Cessna T210M, N761YZ
:	CEN18FA053
:	Timothy Sorensen, ASI-CEN
	::

Report No. 18-028

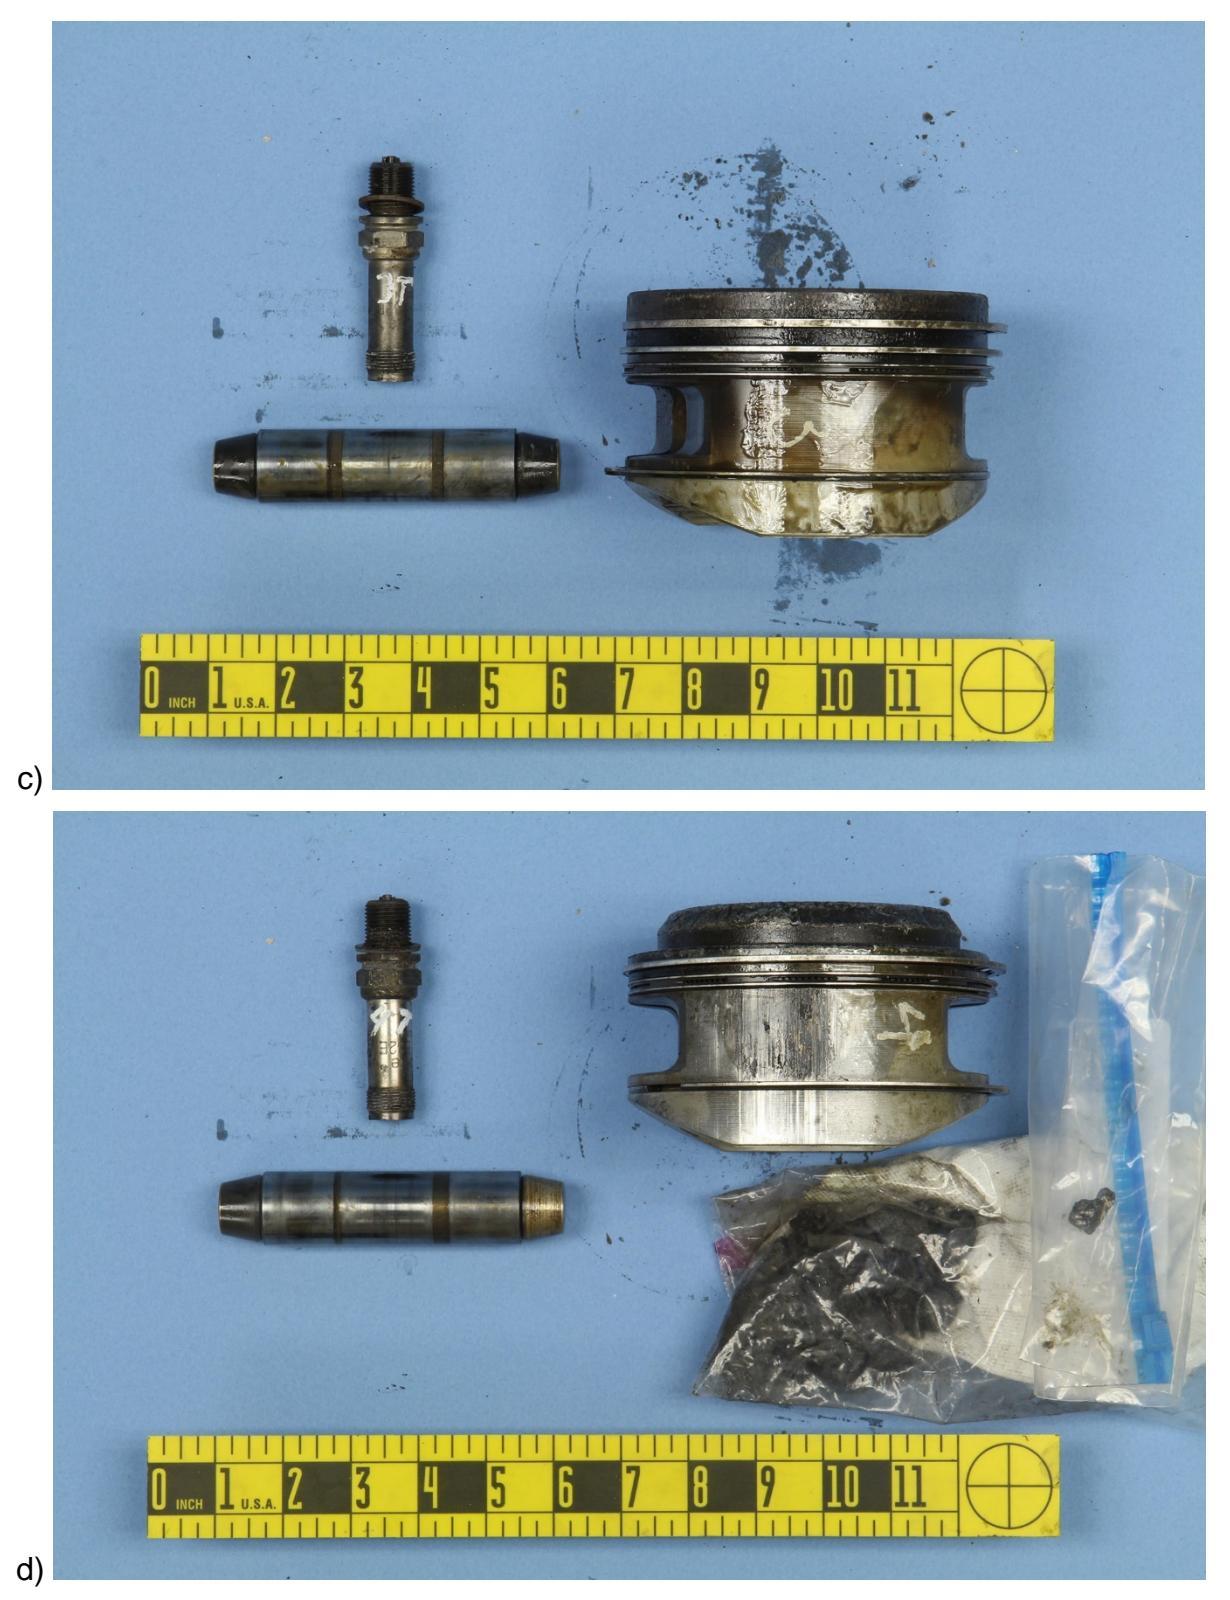
As seen in figure 1d, figure 4a and figures 5a-d, the top land, outer region of the piston crown, top compression ring, and the Ni-Resist insert had separated from the rest of the piston around the entire perimeter. The fracture through the top of the piston was oriented at an approximately 53° angle to the crown, as indicated by the red dashed line on the schematic in figure 3 and as visible in the 90° rotating views in figures 5a-d. The piston top land region, insert, and top compression ring were all fractured into multiple pieces. The size and shape of the fragments were used to sort the pieces by component. The sorted insert fragments, piston fragments, and ring fragments are shown in figures 6a-c, respectively. An estimated 80% to 90% of the insert and piston material was recovered while approximately 70% of the ring was recovered.

Figure 1 (cont.): c) image of the number 3 cylinder piston, piston pin, and upper spark plug; d) image of the number 4 cylinder piston, piston pin, upper spark plug, and bag containing piston, insert, and ring fragments;

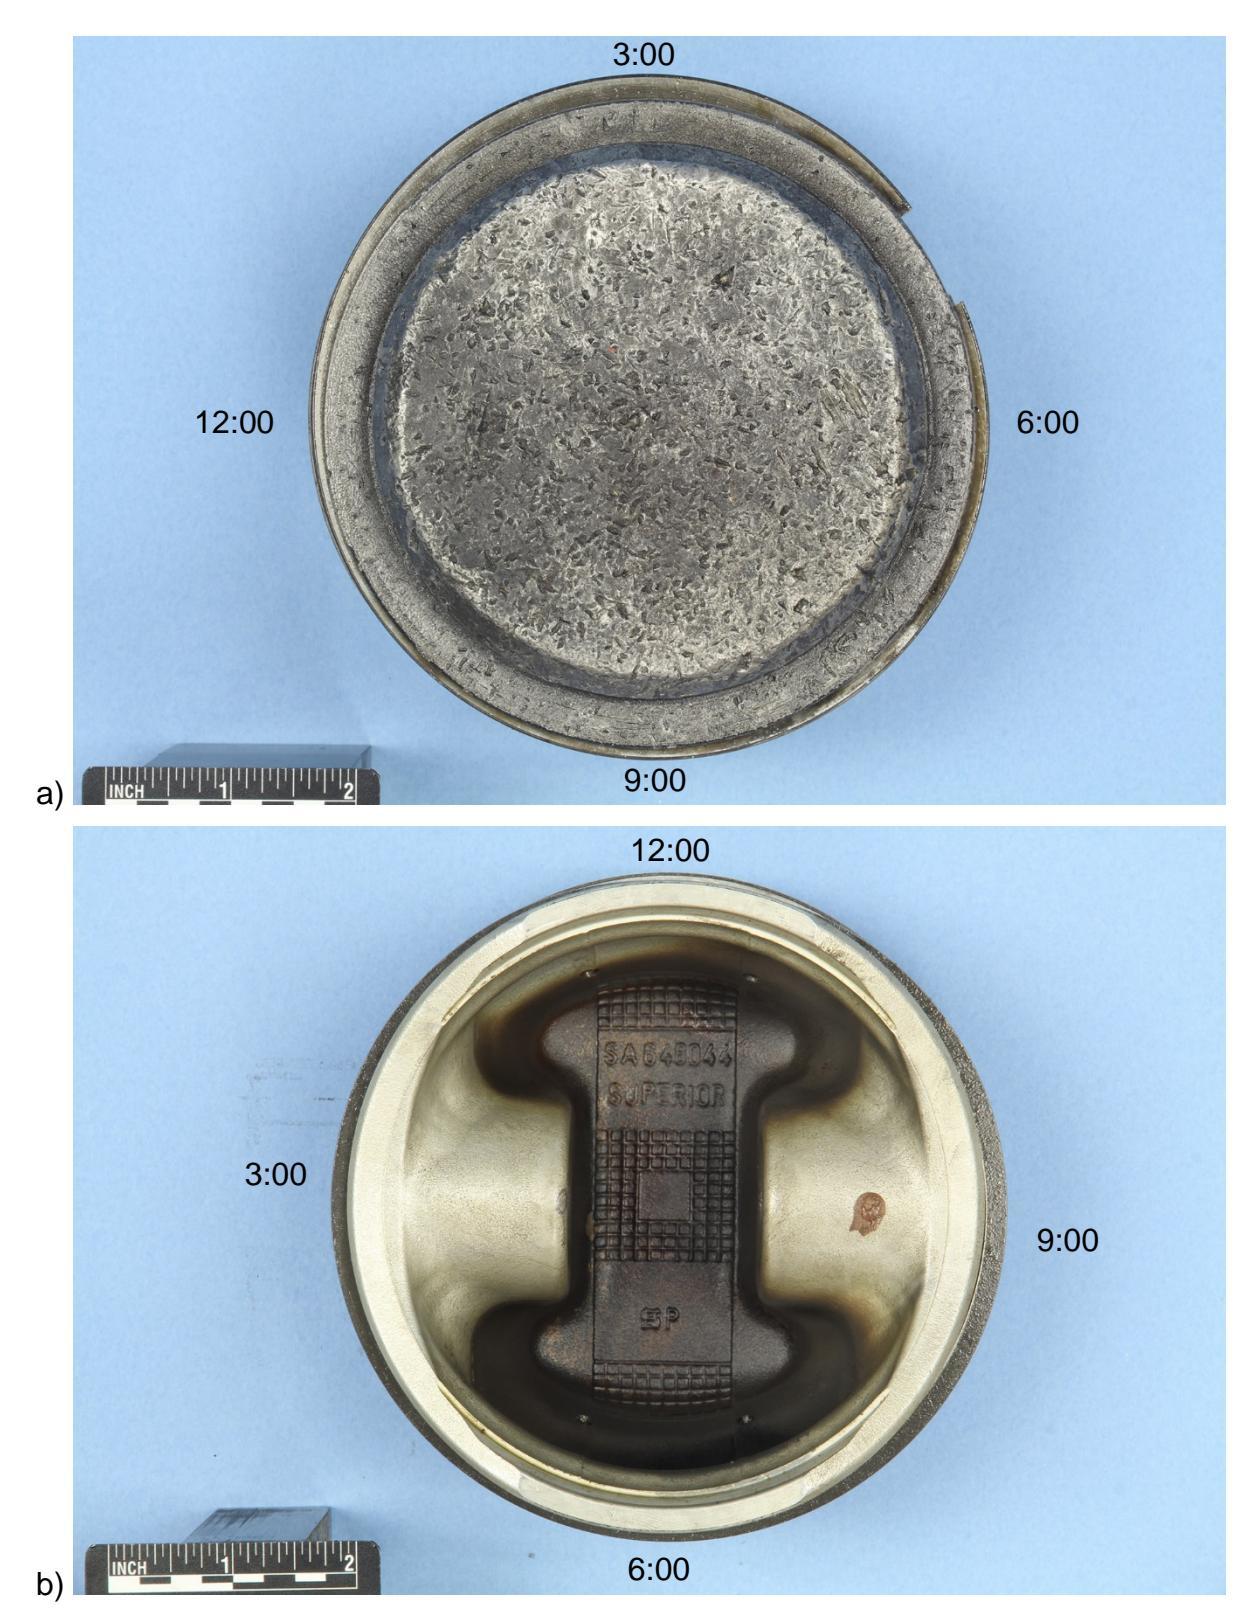
Figure 4: a) Crown side of the number 4 piston and b) underside of the number 4 piston.

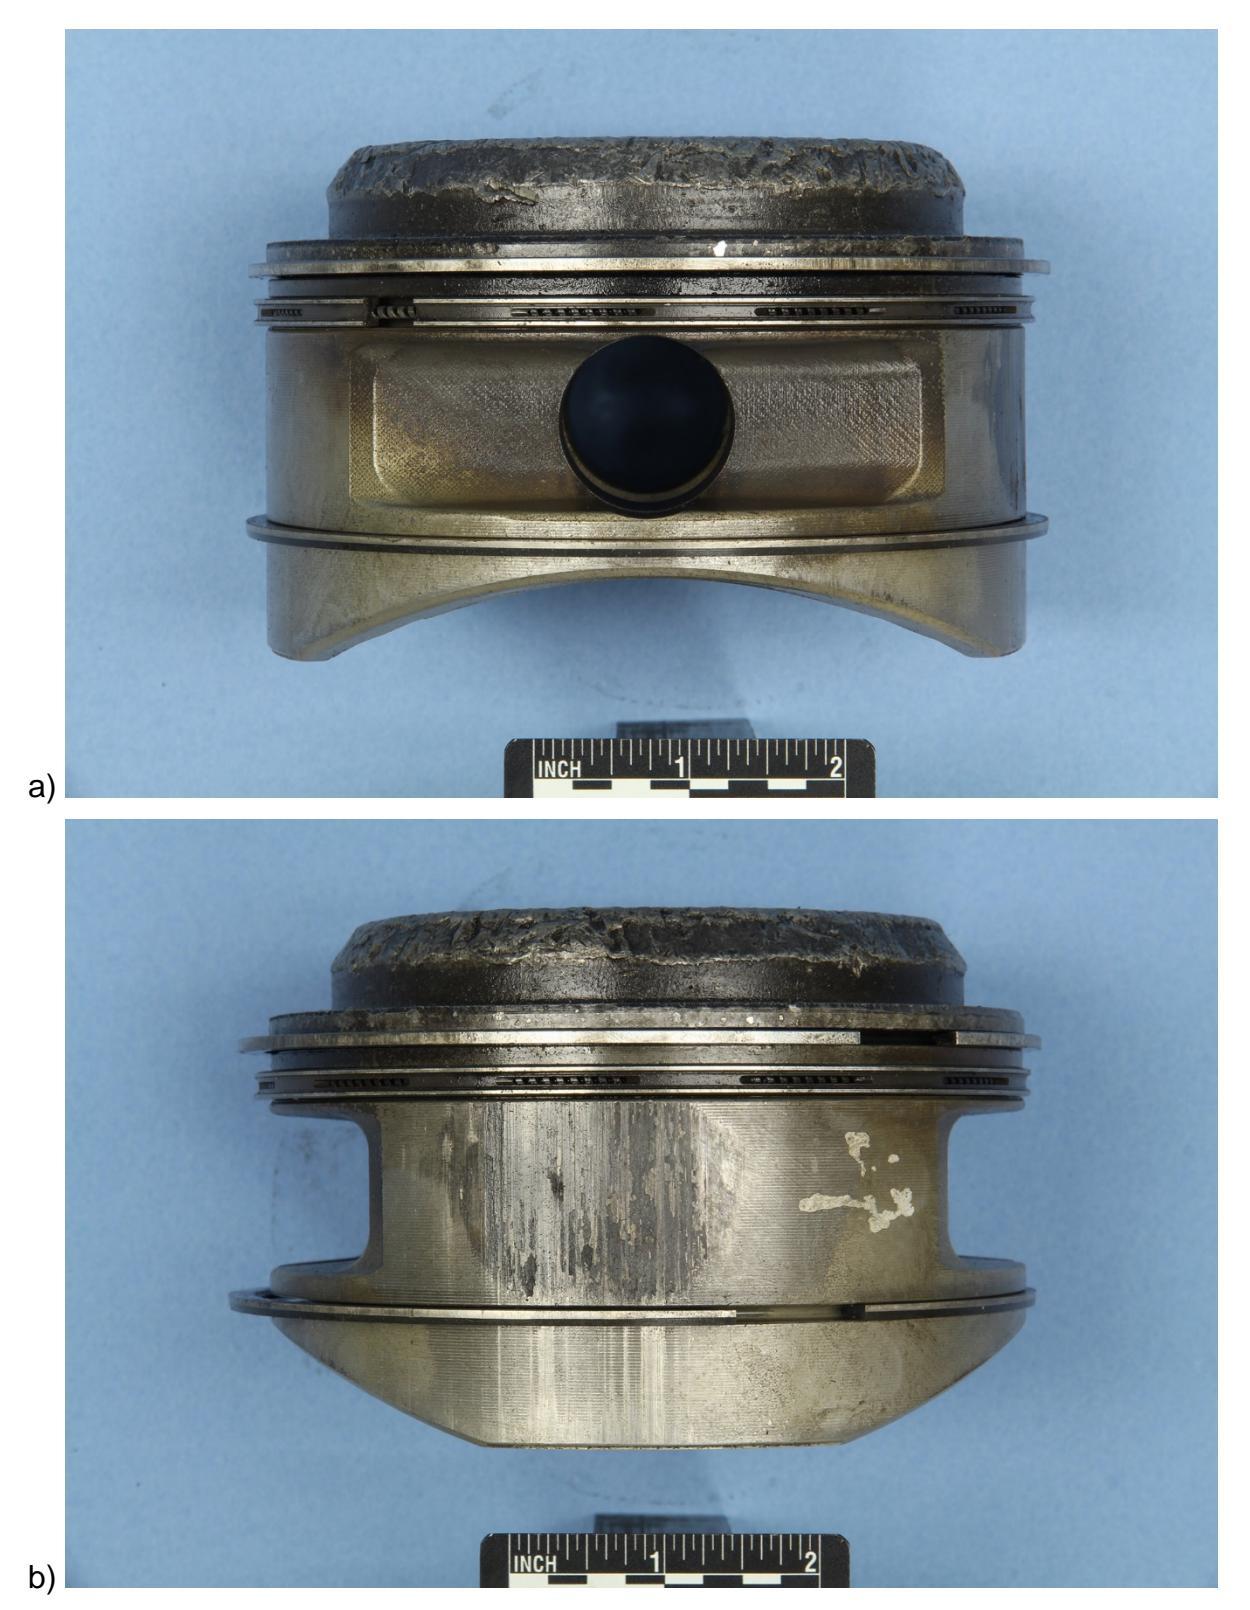
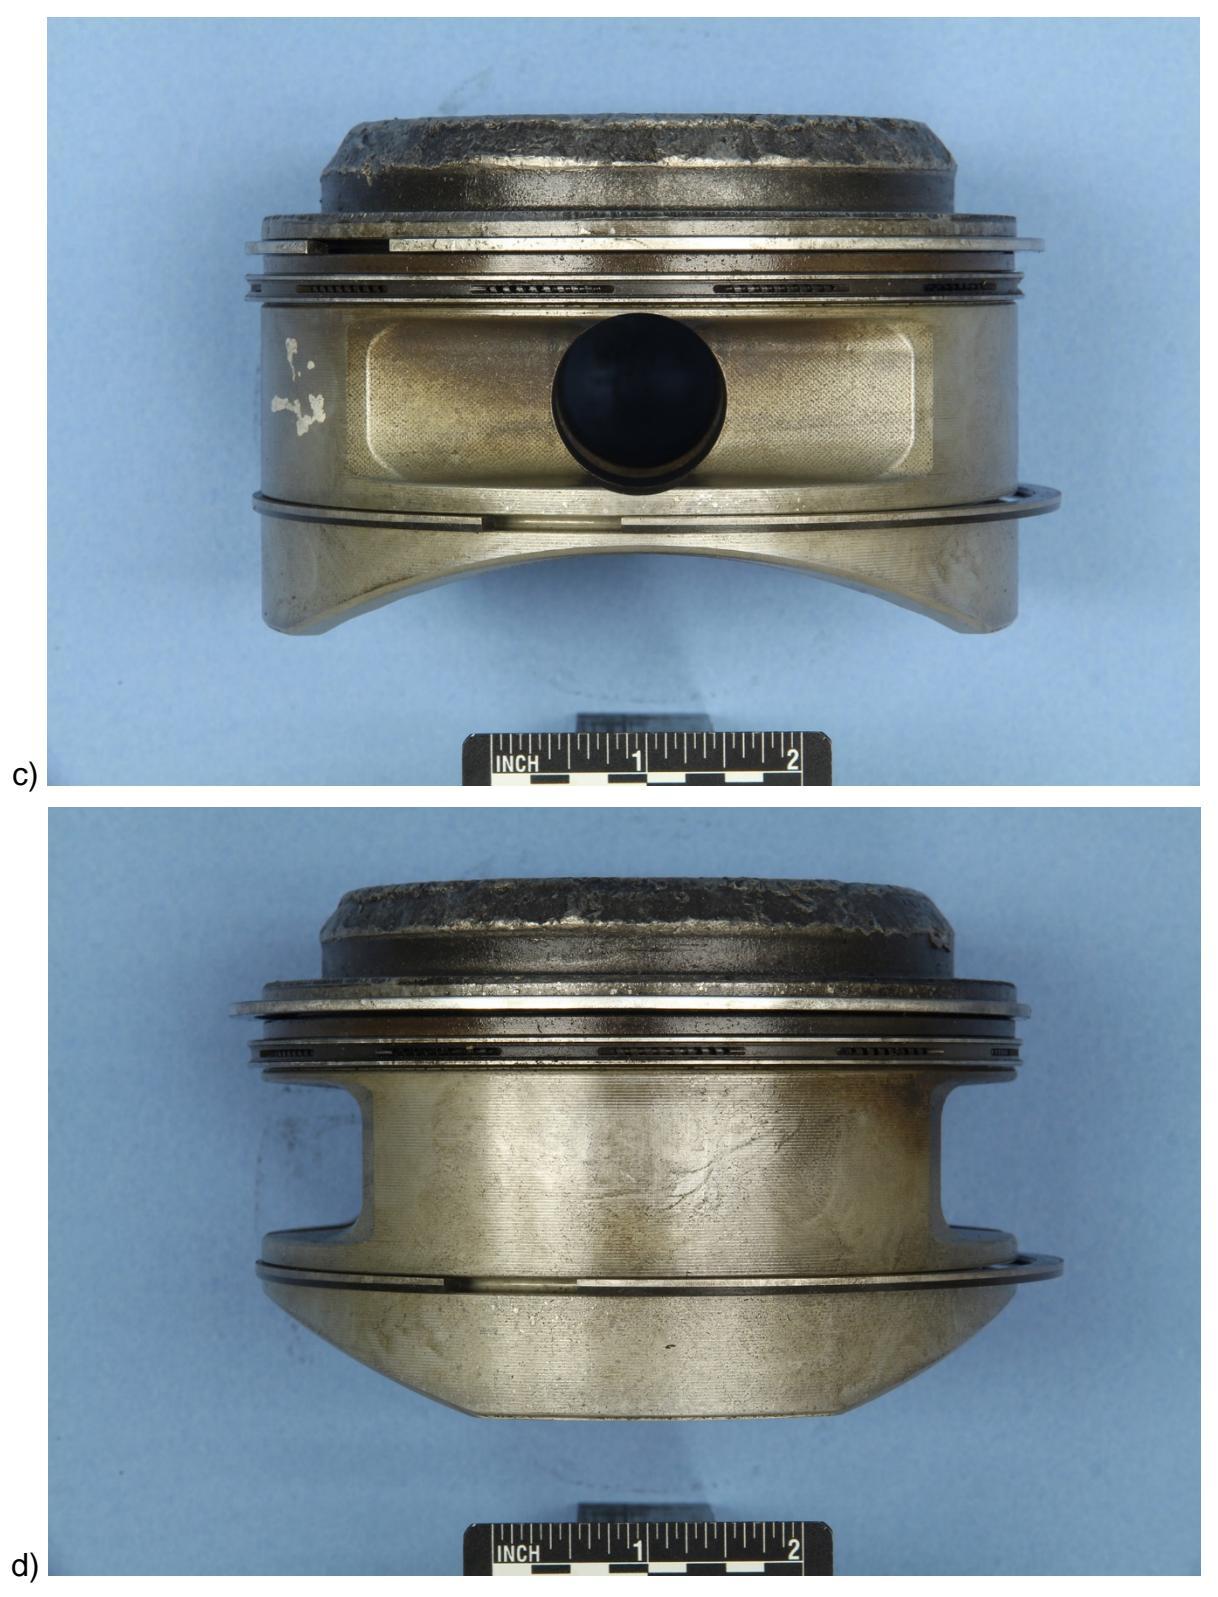
The piston skirt exhibited an approximately 2-inch wide by 1.3-inch high scuff mark on one side, as seen in figure 5b. There was a corresponding scuff mark on the interior cylinder wall, as seen in figure 9. For reference purposes, the piston and cylinder were assigned clock orientations as if viewing the assembled engine outboard looking inboard. In that orientation, the scuff marks were located between the 6:00 and 7:00 positions.

Figure 5: Side view images of the number 4 piston: a) 9:00 position; b) 6:00 position;

Figure 5 (cont.): c) 3:00 position; and d) 12:00 position.

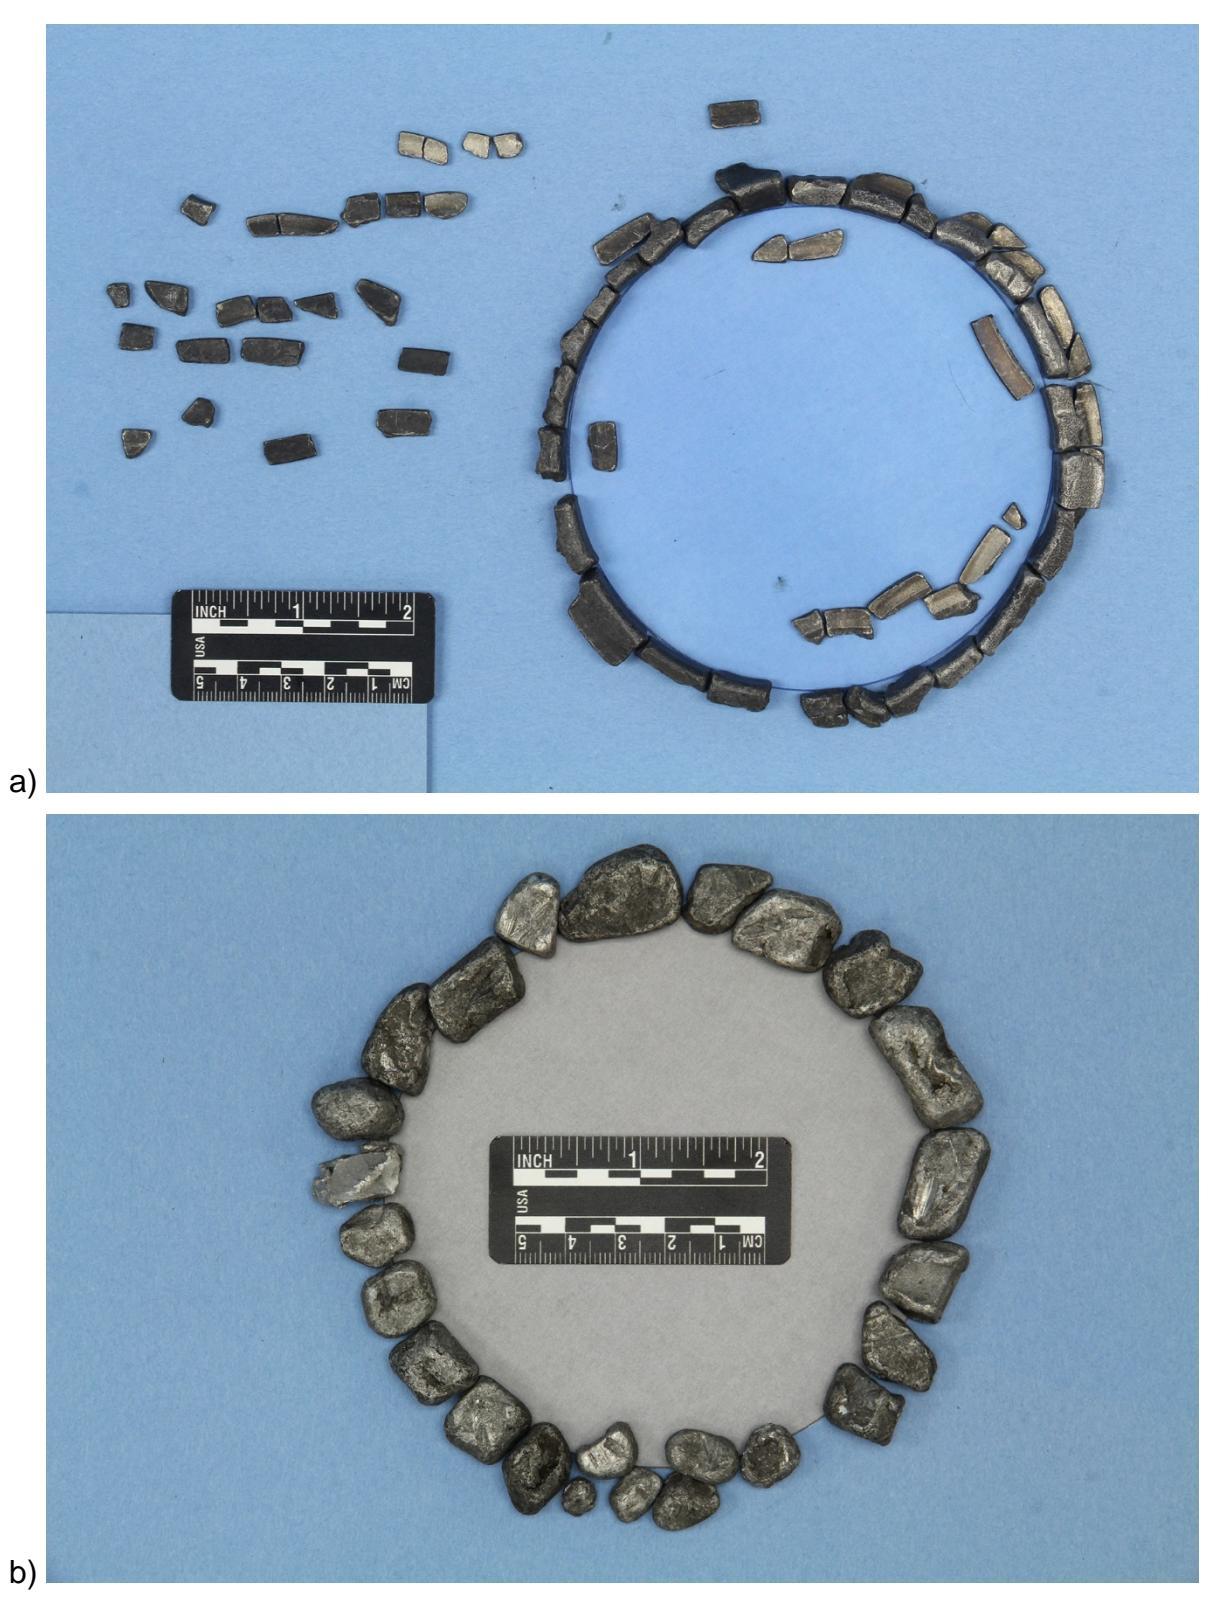
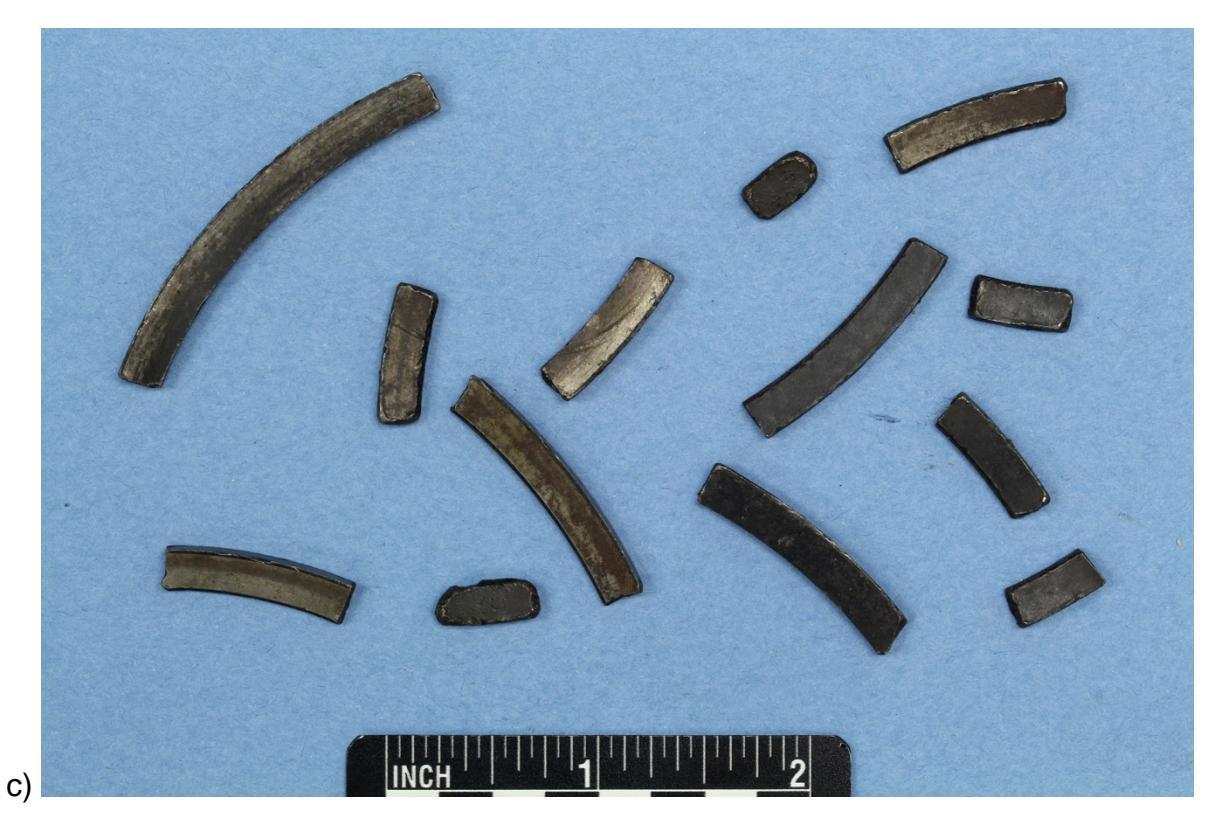
The piston pieces exhibited features consistent with extensive impact damage after separation, as seen in figure 6b, to the point where few discernable features remained (machining marks, fractures surfaces, etc.). The few fracture surfaces that were identifiable were either smeared, covered with debris, or exhibited features consistent with overstress fractures. The crown region was visible on one piece, shown in figure 7, and exhibited discernable machining lines on the surface up to the beveled edge. The insert and compression ring pieces were also fractured into multiple pieces, as seen in figures 6a and 6c, but did not exhibit the same extent of impact damage. The fracture surfaces of the insert and ring pieces were visually examined and all surfaces exhibited features consistent with overstress fractures.

Figure 6: a) Pieces of the top ring insert. An estimated 80% to 90% of the insert was recovered; b) pieces of the piston from the top land/crown region. An estimated 80% to 90% of the top land/crown material was recovered.

Figure 6 (cont.): c) Recovered pieces of the top compression ring. Approximately 70% of the ring was recovered.

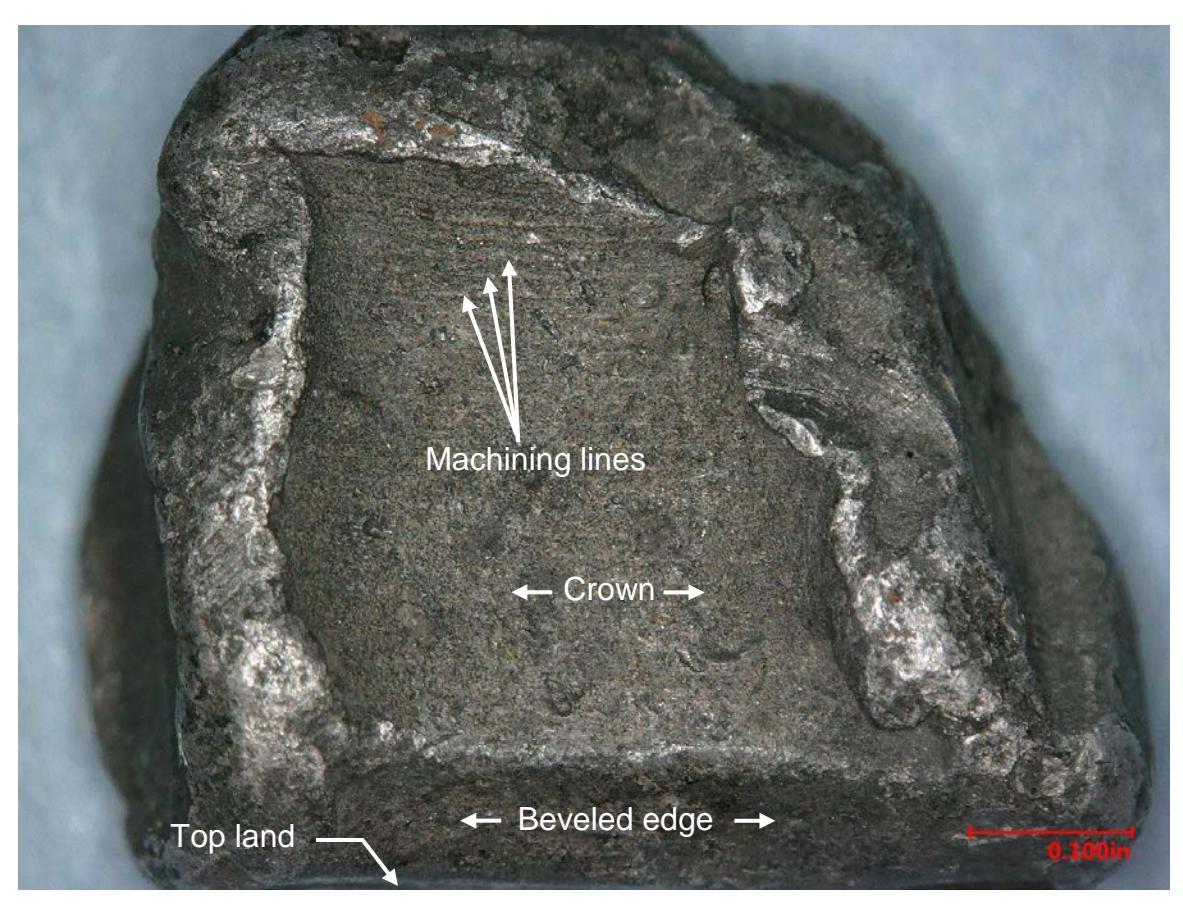
Figure 7: Fractured piece of number 4 piston from the crown/top land region. Machining lines were visible on the crown up to the beveled edge.

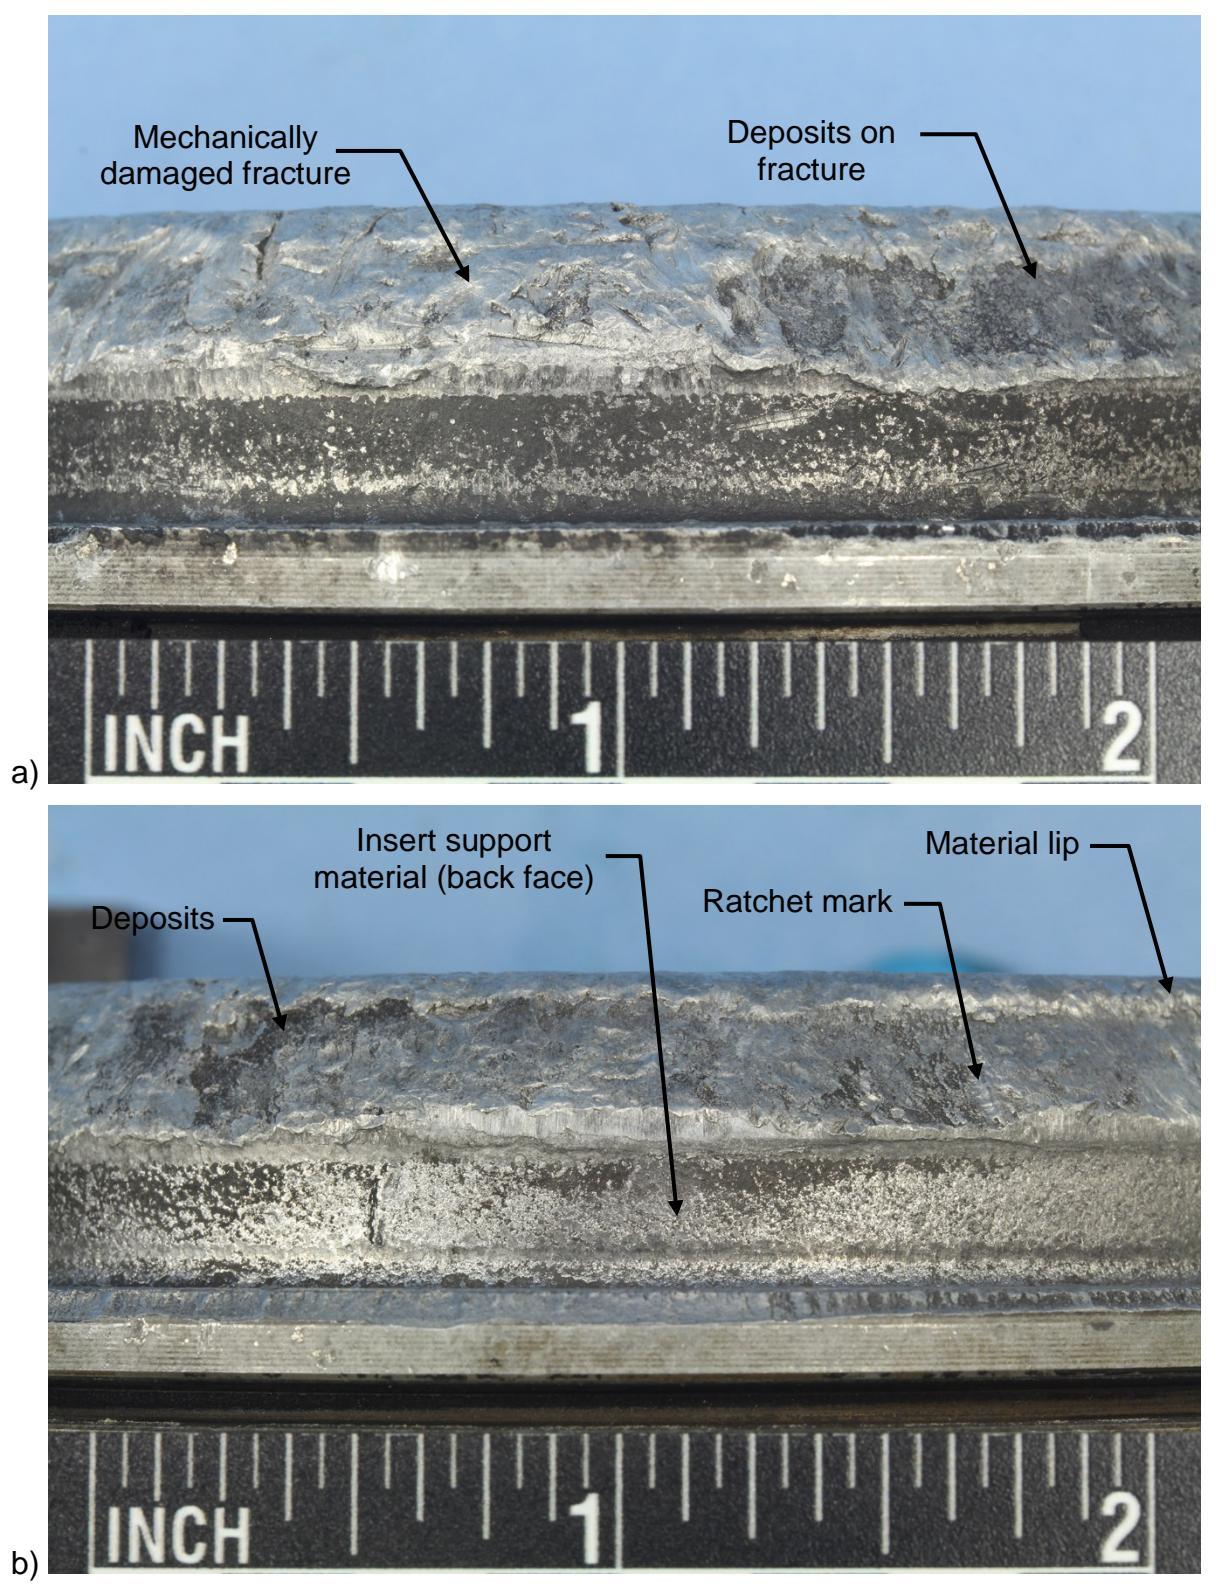
The inclined fracture surface around the top of the piston was examined visually. Much of the surface was mechanically damaged or covered with deposits as seen in figure 8a. Occasional ratchet marks were observed around the perimeter of the piston fracture adjacent to the insert support material (back face) and a material lip was observed along the intersection of the inclined fracture with the crown, as seen in figure 8b. The features were consistent with the fracture originating at the insert recess upper transition radius from multiple origins and progressing toward the crown.

The insert vertical segment support material was covered by lead deposits from approximately the 4:30 position proceeding clockwise to the 11:00 position. See figure 8a (6:00 position) and 8b (3:00 position) for regions with and without lead deposits on the vertical support material and the fractures along the lower support edge, respectively. The lead deposits had been rubbed away exposing discreet regions of the underlying support material. Those discreet regions exhibited a rubbed appearance, as seen in figure 16.

Figure 8: Side view of the piston showing the fracture and separated insert region: a) 6:00 orientation and b) 3:00 orientation.

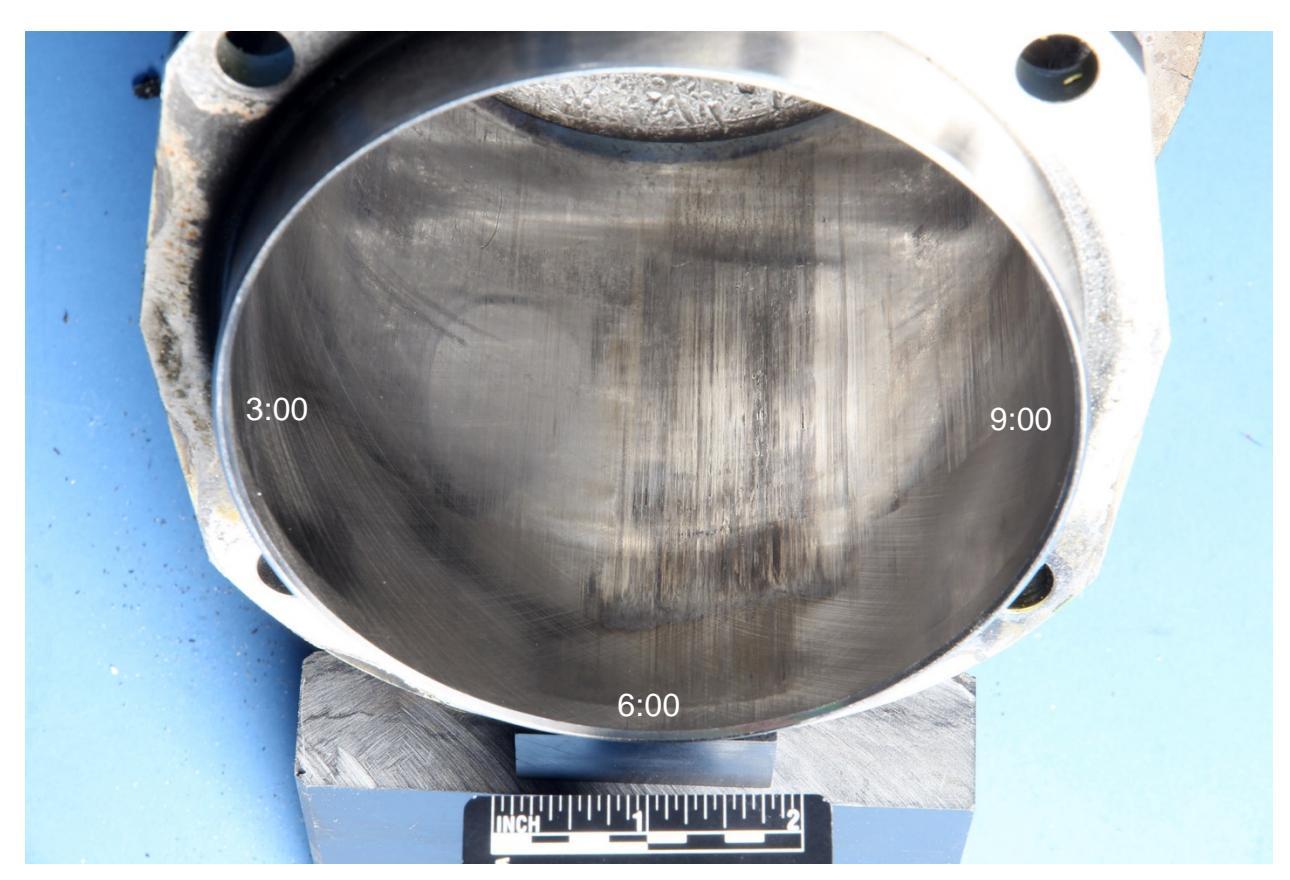
Figure 9: Image of the number 4 cylinder showing a scrape mark between the 6 o'clock and 7 o'clock positions. There was a corresponding scrape mark on the piston skirt.

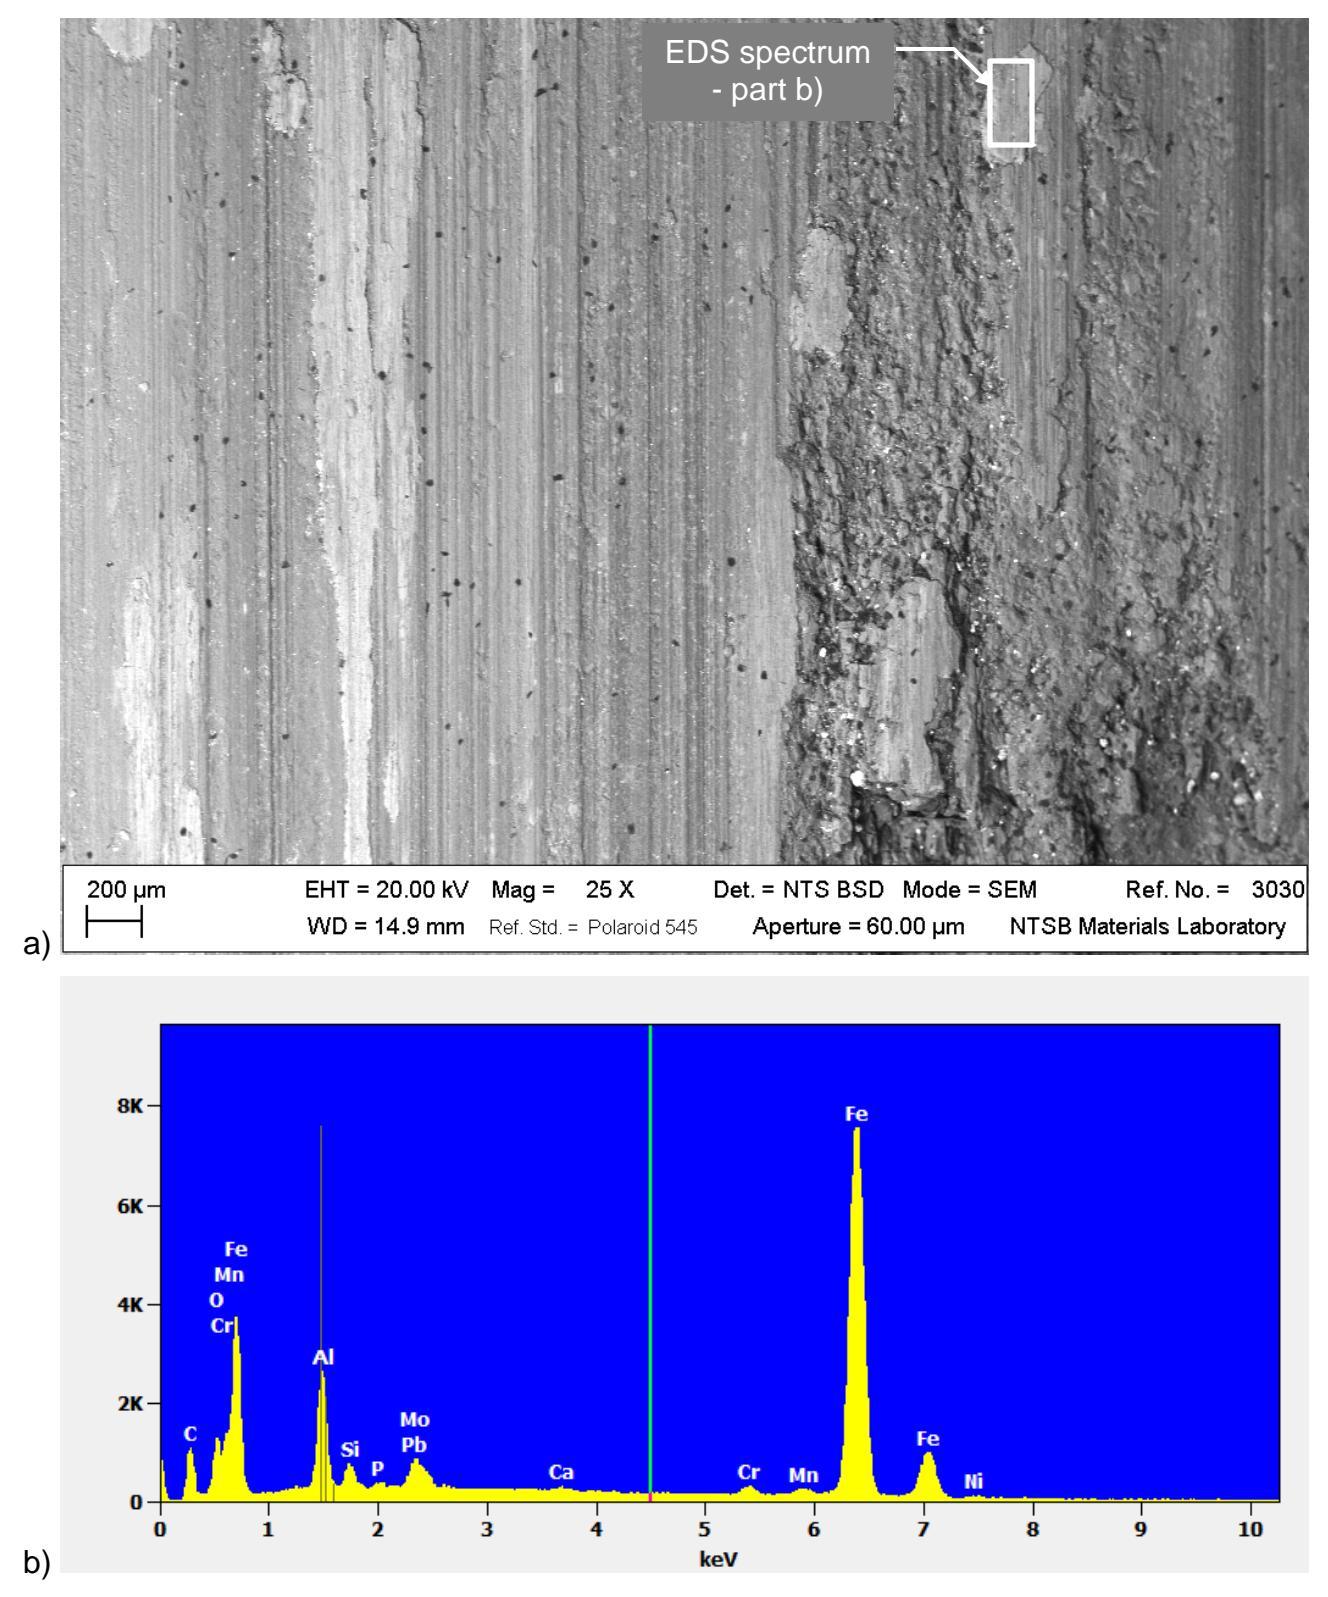
The region of the piston containing the scuff mark was sectioned from the rest of the piston and examined using a scanning electron microscope (SEM) equipped with an electron backscatter detector and an energy dispersive x-ray spectrometer (EDS). Images taken using the backscatter detector exhibit elemental contrast. Regions containing low atomic weight elements (such as aluminum) appear comparatively dark relative to regions containing high atomic weight elements (such as iron). A SEM backscatter image taken near the center of the scuff mark is shown in figure 10a. Light colored regions were observed that were smeared and elongated along the axial direction of the piston. One of the more discreet regions, indicated in the figure, was examined using EDS. The resulting spectrum is shown in figure 10b. The spectrum indicated the presence of an iron-based material transferred onto the surface of the piston.

Figure 10: a) SEM image near the center of the scuff mark on the number 4 piston skirt and b) EDS spectrum of transferred material at the location indicated in part a.

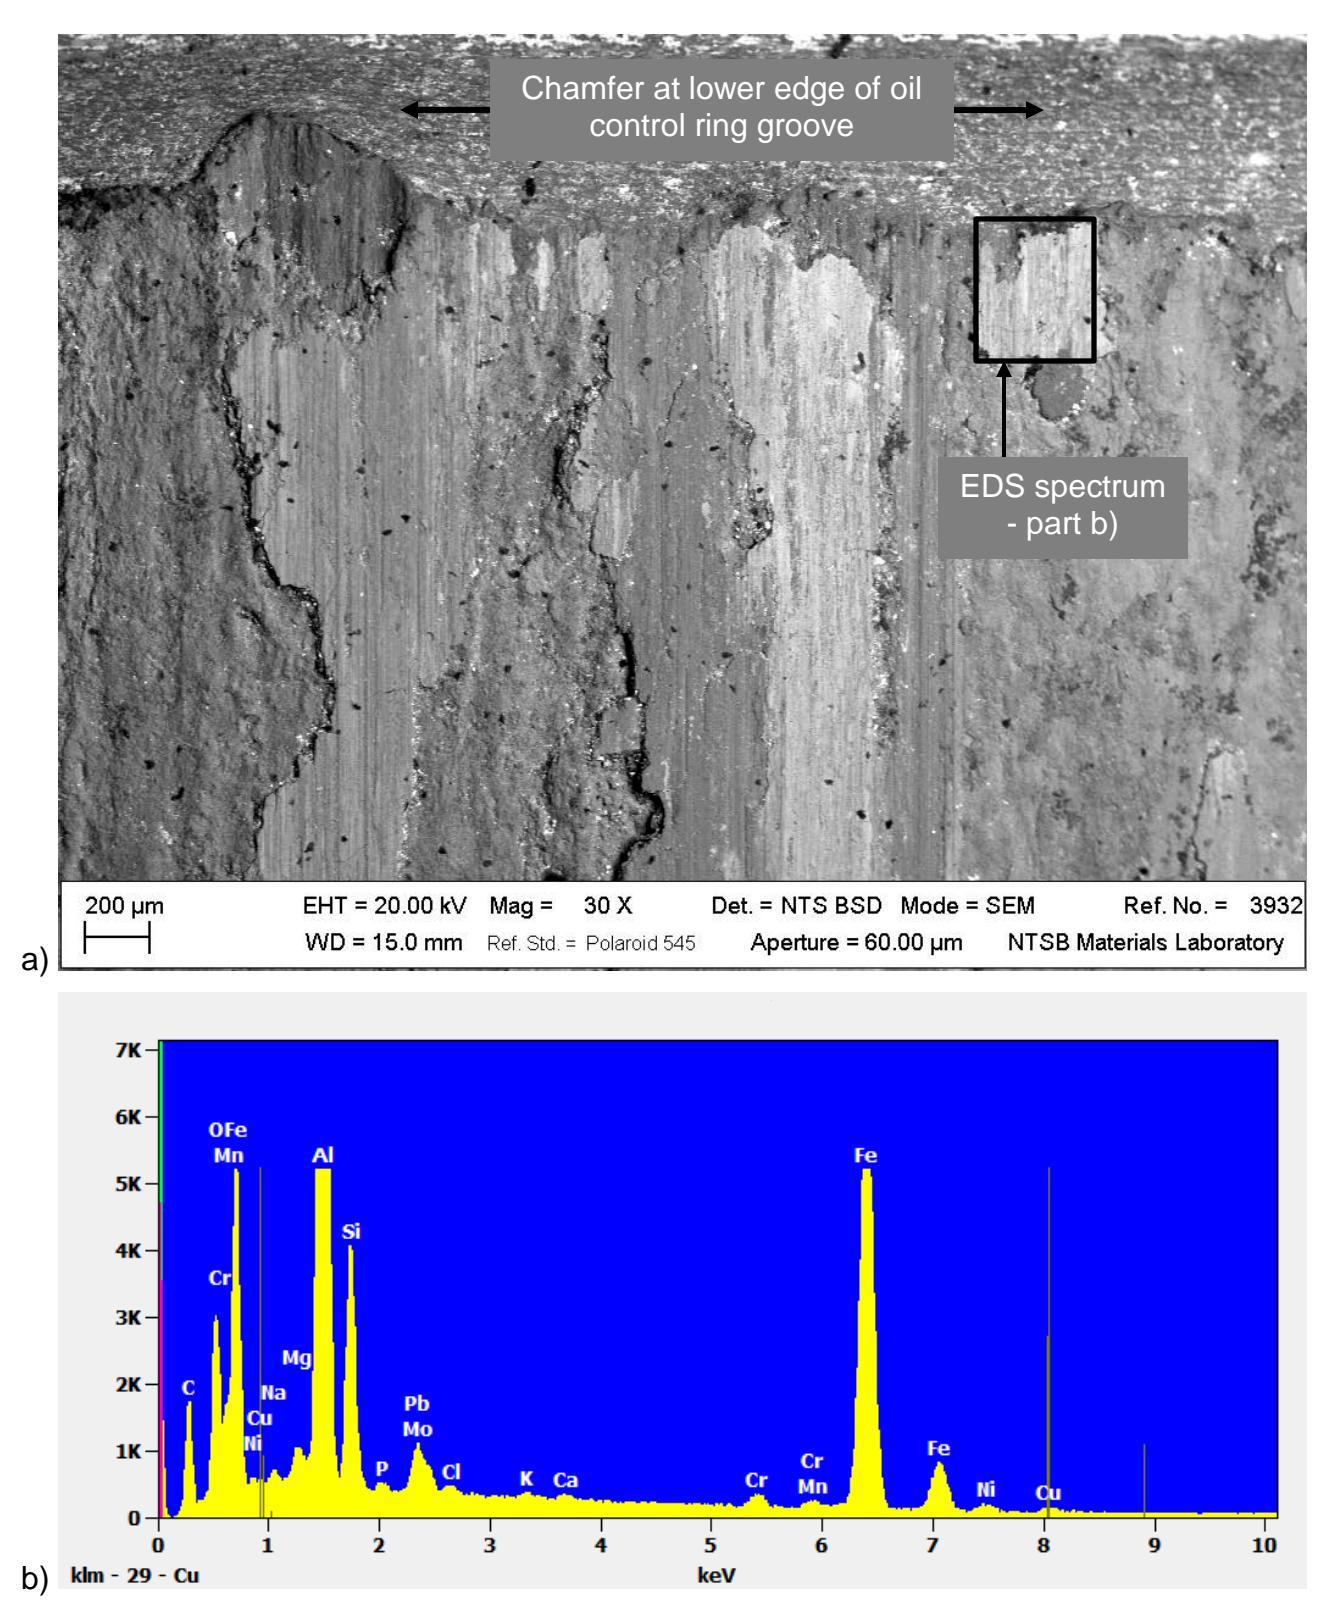
Additional regions were examined in a similar manner. Iron-based material transfer marks were seen throughout the scuff mark. However, toward the top of the scuff mark, an additional copper peak was observed in many of the EDS spectra. Figure 11a shows a SEM backscatter image taken just below the oil control ring groove. An EDS spectrum from the area indicated in the figure is shown in figure 11b. The spectrum contained similar elements as the spectrum shown in figure 10b with the addition of a copper (Cu) peak at an X-ray energy of 8.04 keV.

Figure 11: a) SEM image near the top of the scuff mark on the number 4 piston skirt near the oil control ring groove and b) EDS spectrum of transferred material at the location indicated in part a.

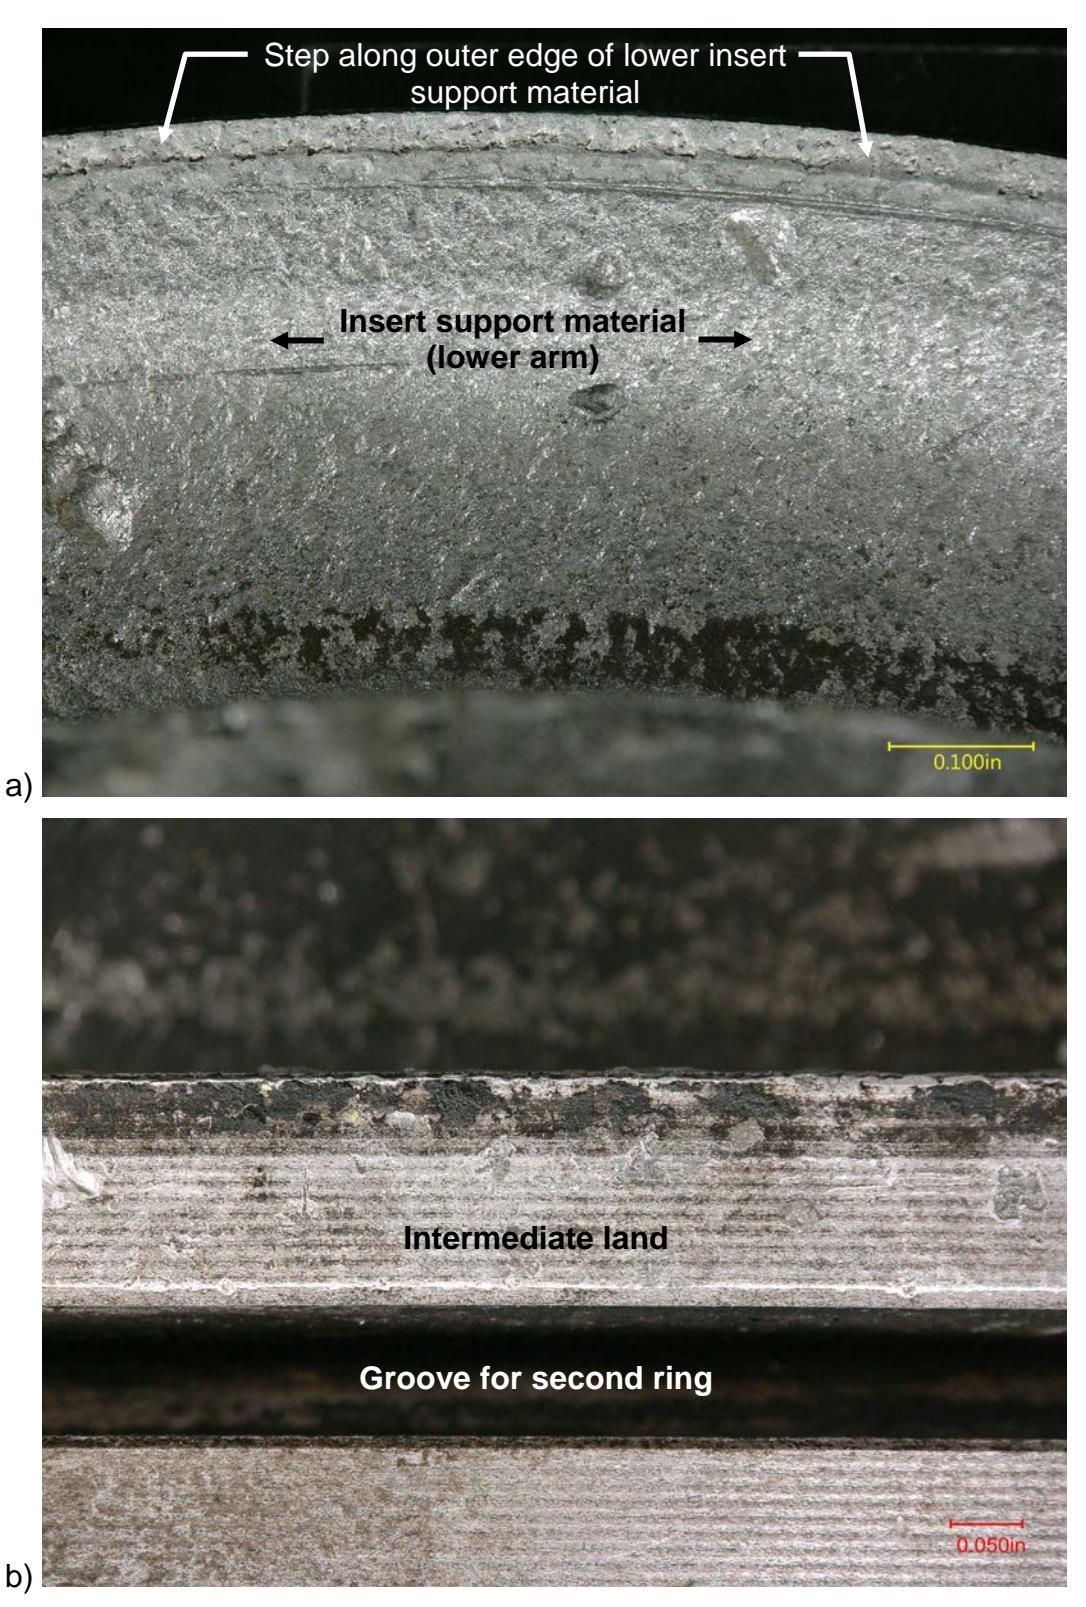
For reference purposes, the regions of the insert were referred to as the upper arm, vertical segment, and lower arm, as indicated in figure 3. The cast aluminum that was bonded to the insert was referred to as the support material. Along the perimeter of the piston, where the insert lower arm support material met the second (intermediate) land, the aluminum either exhibited a step along the edge or the outer edge was fractured, as shown in figures 13 and 14, respectively. The step was observed along two segments, one from approximately 11:00 to 1:00, and the other from approximately 6:00 to 7:00. The fractured edges were covered with lead deposits from approximately the 5:00 to 6:00 and 7:00 to 11:00 positions. Elsewhere, the fractures exhibited a rough appearance and multiple ratchet marks that were consistent with overstress fractures starting on the face of the lower support material, approximately 0.02 inch to 0.04 inch from the outer face of the piston and progressing radially outward and down (toward the piston skirt).

Figure 13: a) Image of the insert lower arm support material at the 12:00 position. A step was observed along the outer edge of the support material and b) side view showing the intact intermediate land.
