NATIONAL TRANSPORTATION SAFETY BOARD

MATERIALS LABORATORY FACTUAL REPORT

:	Oldenburg, Indiana
:	December 16, 2017
:	Cessna T210M, N761YZ
:	CEN18FA053
:	Timothy Sorensen, ASI-CEN
	::

Report No. 18-028

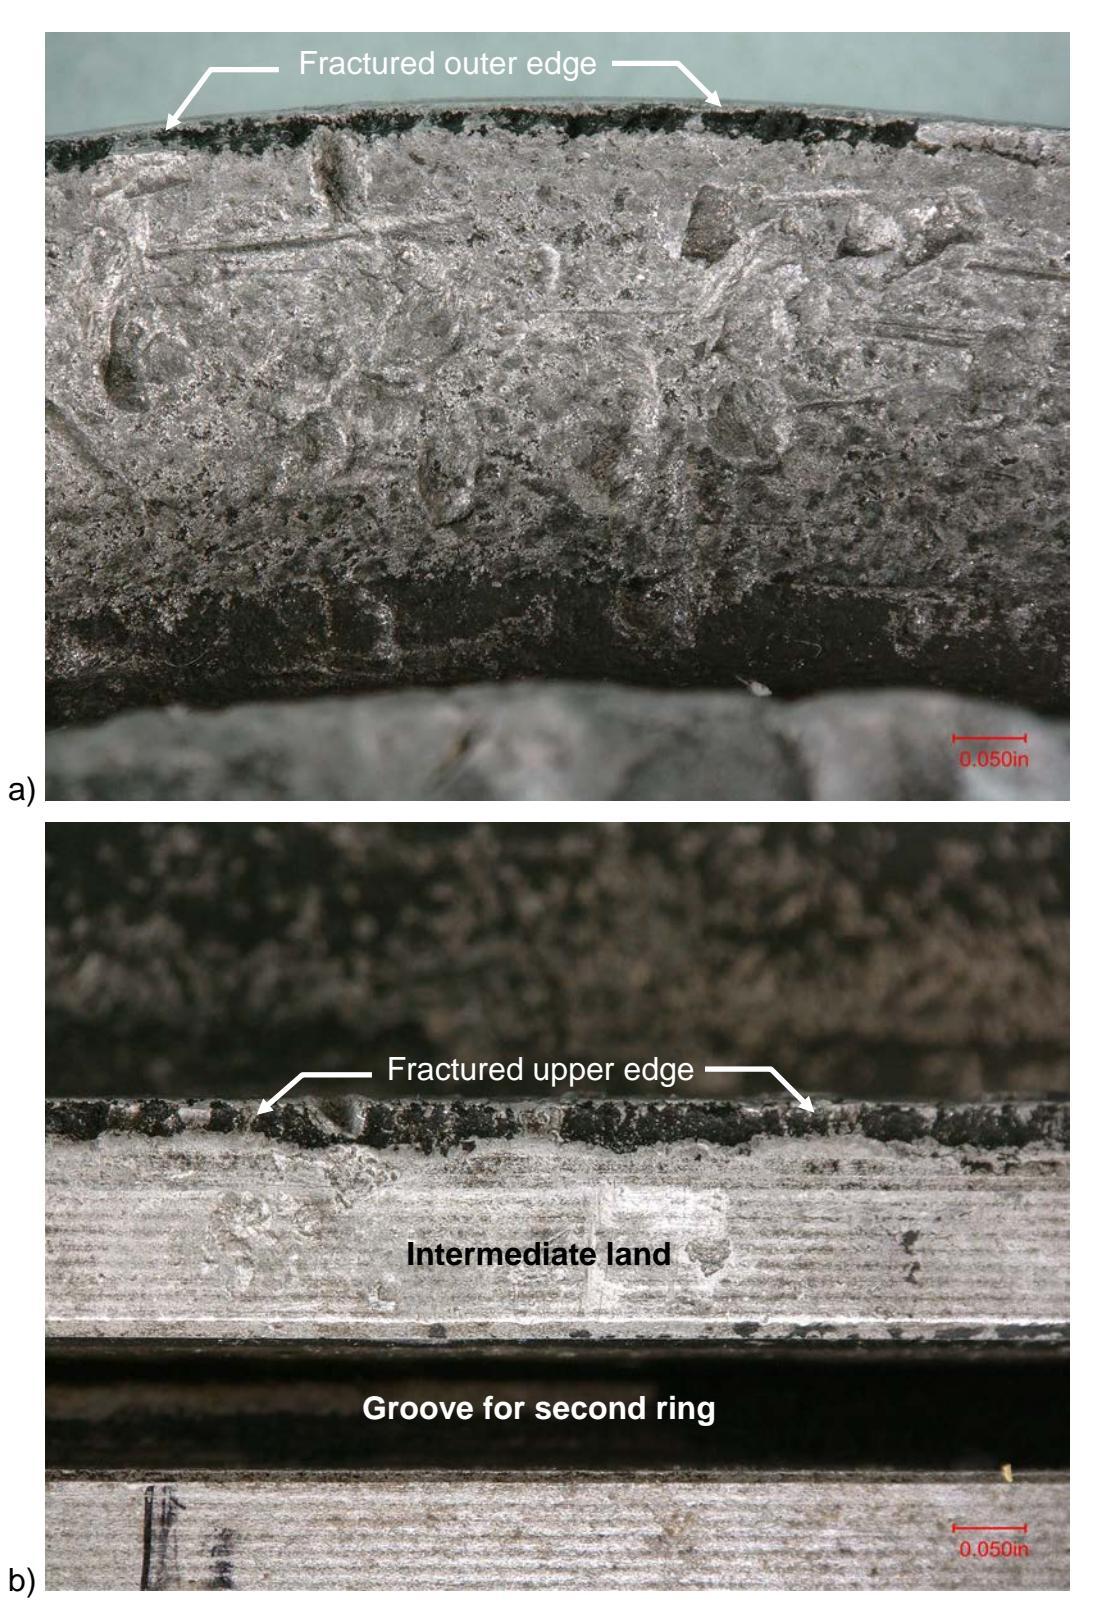
For reference purposes, the regions of the insert were referred to as the upper arm, vertical segment, and lower arm, as indicated in figure 3. The cast aluminum that was bonded to the insert was referred to as the support material. Along the perimeter of the piston, where the insert lower arm support material met the second (intermediate) land, the aluminum either exhibited a step along the edge or the outer edge was fractured, as shown in figures 13 and 14, respectively. The step was observed along two segments, one from approximately 11:00 to 1:00, and the other from approximately 6:00 to 7:00. The fractured edges were covered with lead deposits from approximately the 5:00 to 6:00 and 7:00 to 11:00 positions. Elsewhere, the fractures exhibited a rough appearance and multiple ratchet marks that were consistent with overstress fractures starting on the face of the lower support material, approximately 0.02 inch to 0.04 inch from the outer face of the piston and progressing radially outward and down (toward the piston skirt).

Figure 14: a) Image of the insert lower arm support material between the 5:00 and 6:00 positions. The outer edge of the lower arm support material was fractured and b) side view showing the fractured upper edge of the intermediate land.

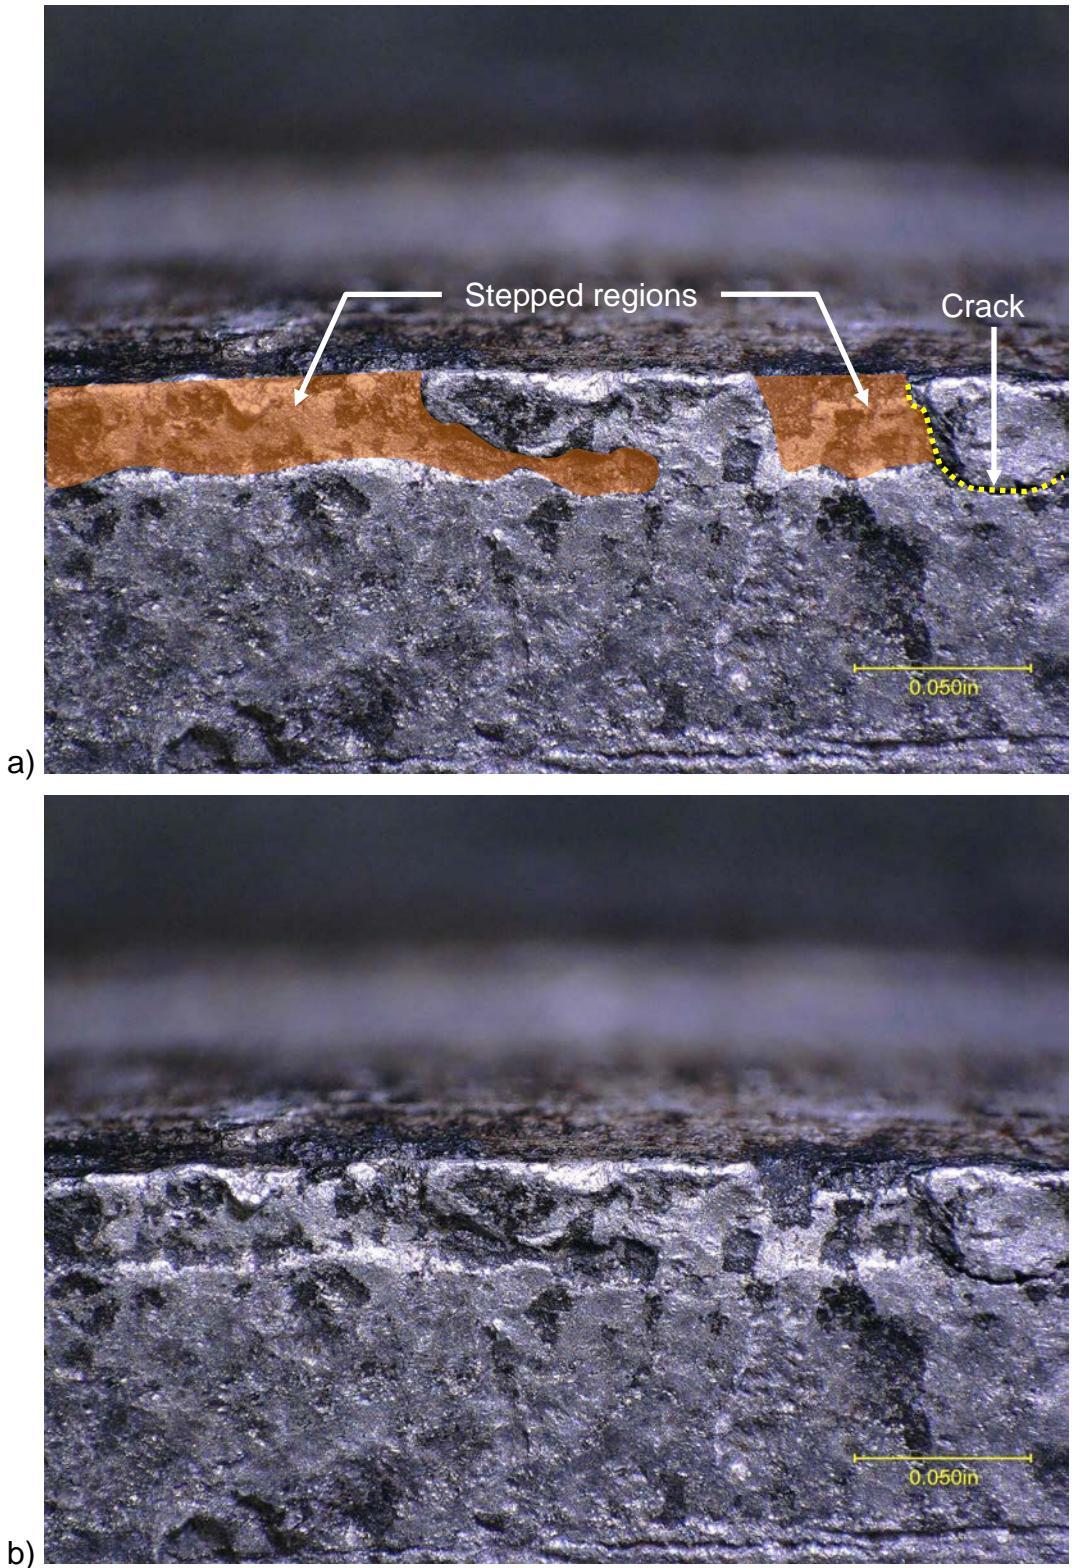
One area near the 7:00 position, near the transition from stepped to fractured edge, exhibited a region where the step became discontinuous as shown in figure 15. In the figure, the stepped regions are indicated by shading in the top photograph while the same image without the shading is shown in the bottom photograph. One region, at the edge of a stepped region exhibited a crack along the support material face as indicated in the top photograph.

Figure 15: Images near the 7:00 position at the transition from intact to fractured edge. At the location, the stepped edge was interrupted by a region without the step: a) Image with stepped regions shaded and a crack annotated and b) same image as part a) without annotations.

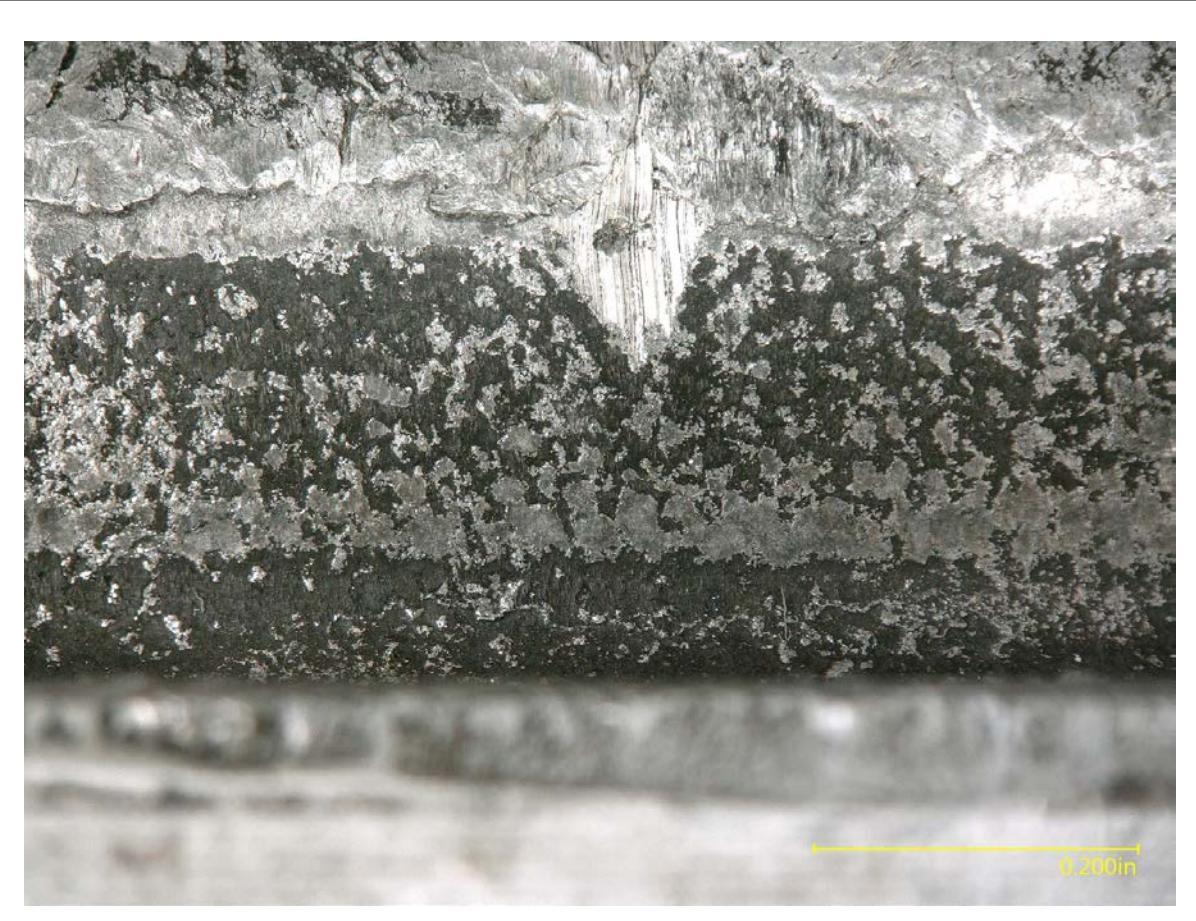
The insert vertical segment support material was covered by lead deposits from approximately the 4:30 position proceeding clockwise to the 11:00 position. See figure 8a (6:00 position) and 8b (3:00 position) for regions with and without lead deposits on the vertical support material and the fractures along the lower support edge, respectively. The lead deposits had been rubbed away exposing discreet regions of the underlying support material. Those discreet regions exhibited a rubbed appearance, as seen in figure 16.

Figure 16: Image of the insert back face support material near the 5:00 position showing the presence of engine exhaust deposits and discreet regions of aluminum material with a rubbed appearance.

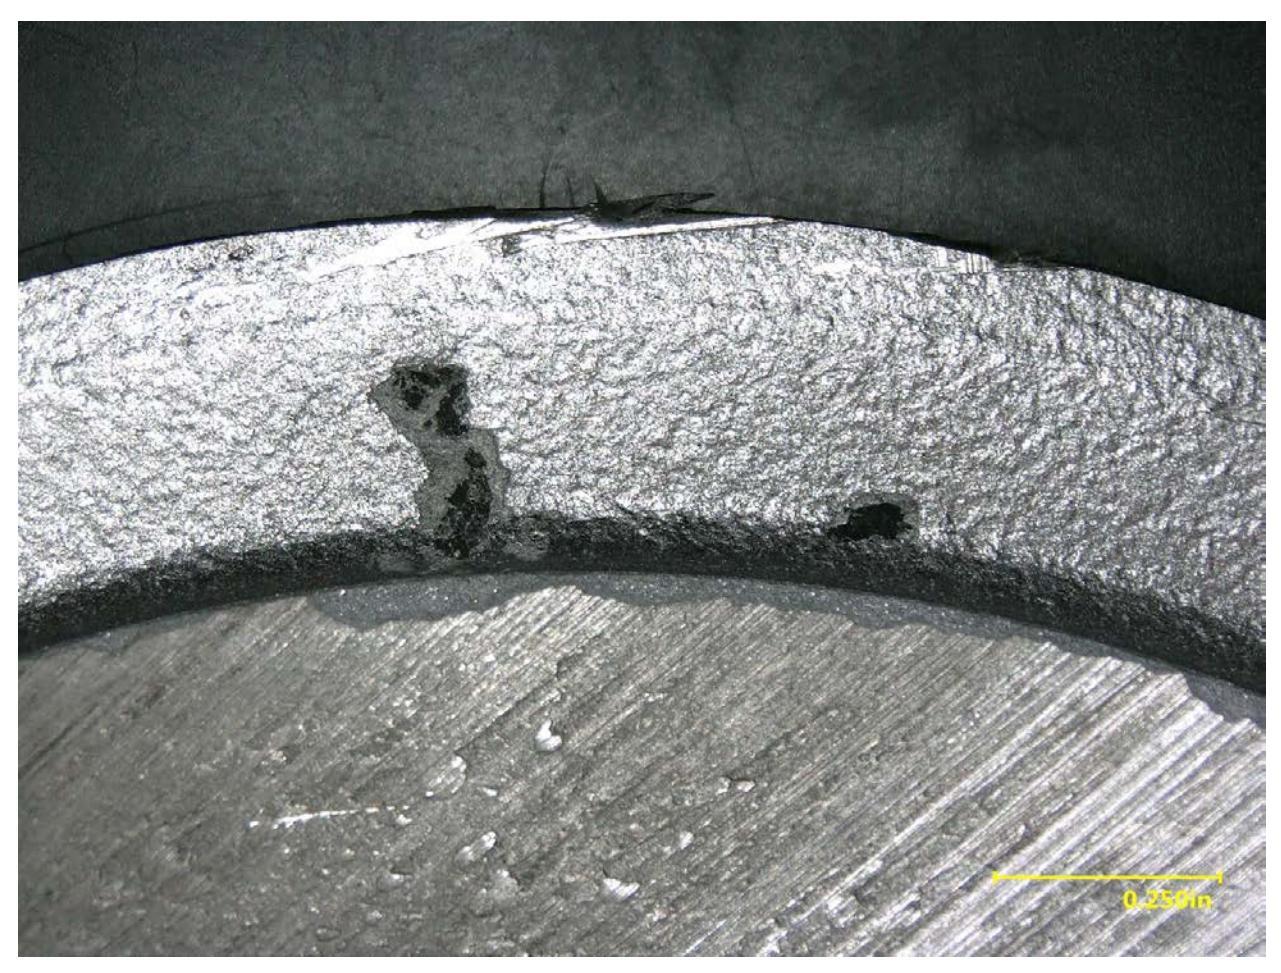
pistons exhibit any deposits on the support material. A notable feature was observed on the upper insert support material for piston 5 as shown in figure 20. Two regions were observed where aluminum had separated with the insert piece revealing regions of dark particles embedded in the aluminum. Scanning electron microscopy (SEM) and energy dispersive spectroscopy indicated the presence of molybdenum (Mo). However, none of the other pistons, including piston 4 exhibited any similar features.

Figure 20: Dark particulates exposed after separation of the insert upper arm from the piston support material for piston number 5.

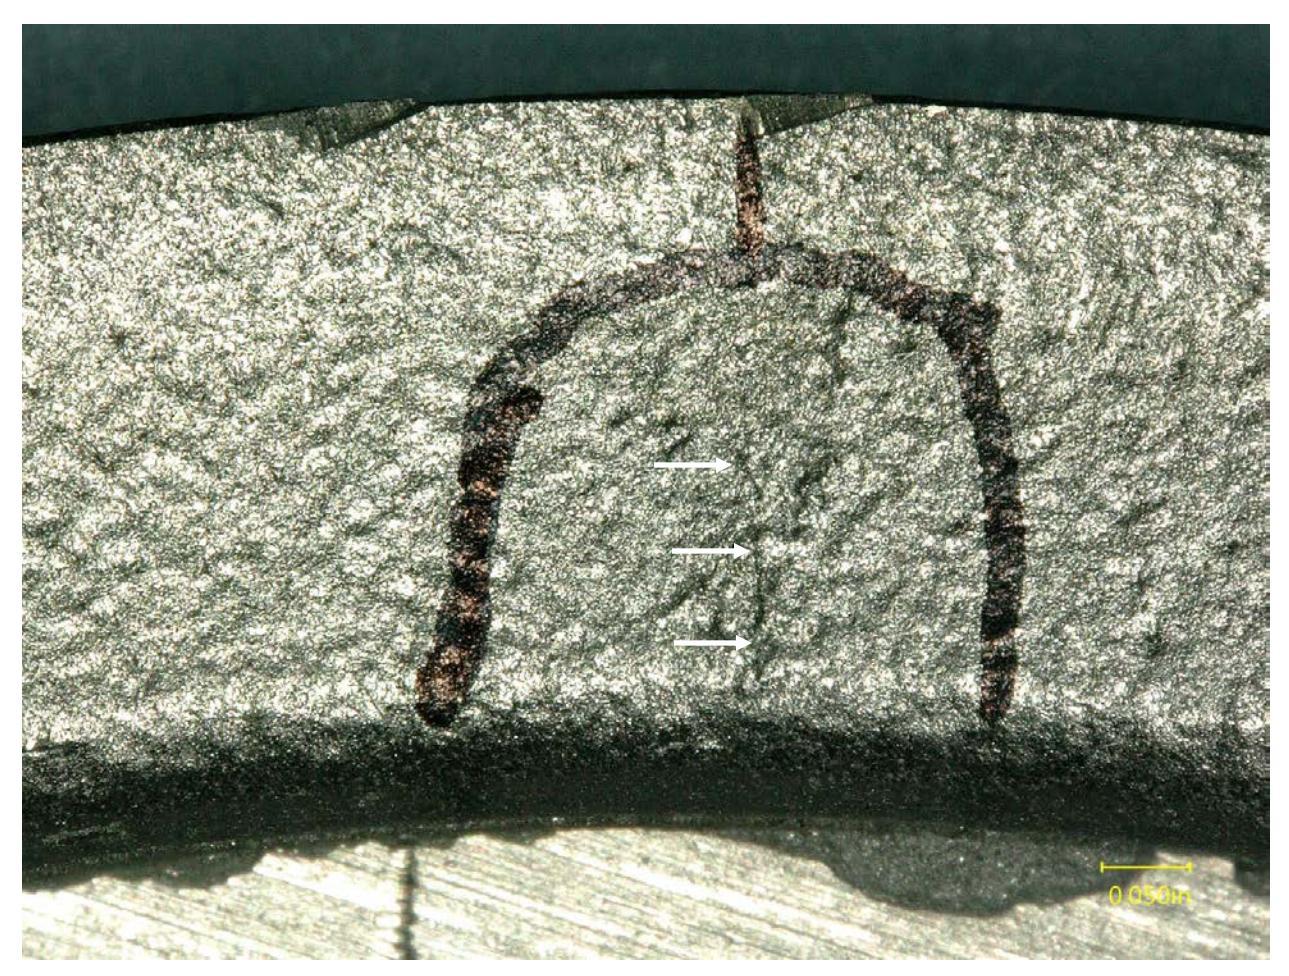
The exposed aluminum support material for pistons 1, 2, 3, 5, and 6 were cleaned and then examined for cracks using a fluorescent penetrant dye using standard laboratory procedures. One region on the piston 3 upper support material exhibited visible fluorescence along a radially aligned feature, which is shown in figure 21. The piston top was sent to an external laboratory and the feature examined using X-ray computed tomography but there were no sub-surface findings.

Figure 21: A linear feature detected by a fluorescent penetrant inspection of the number 3 piston insert upper arm support material. The edge of the feature is indicated by the white arrows.

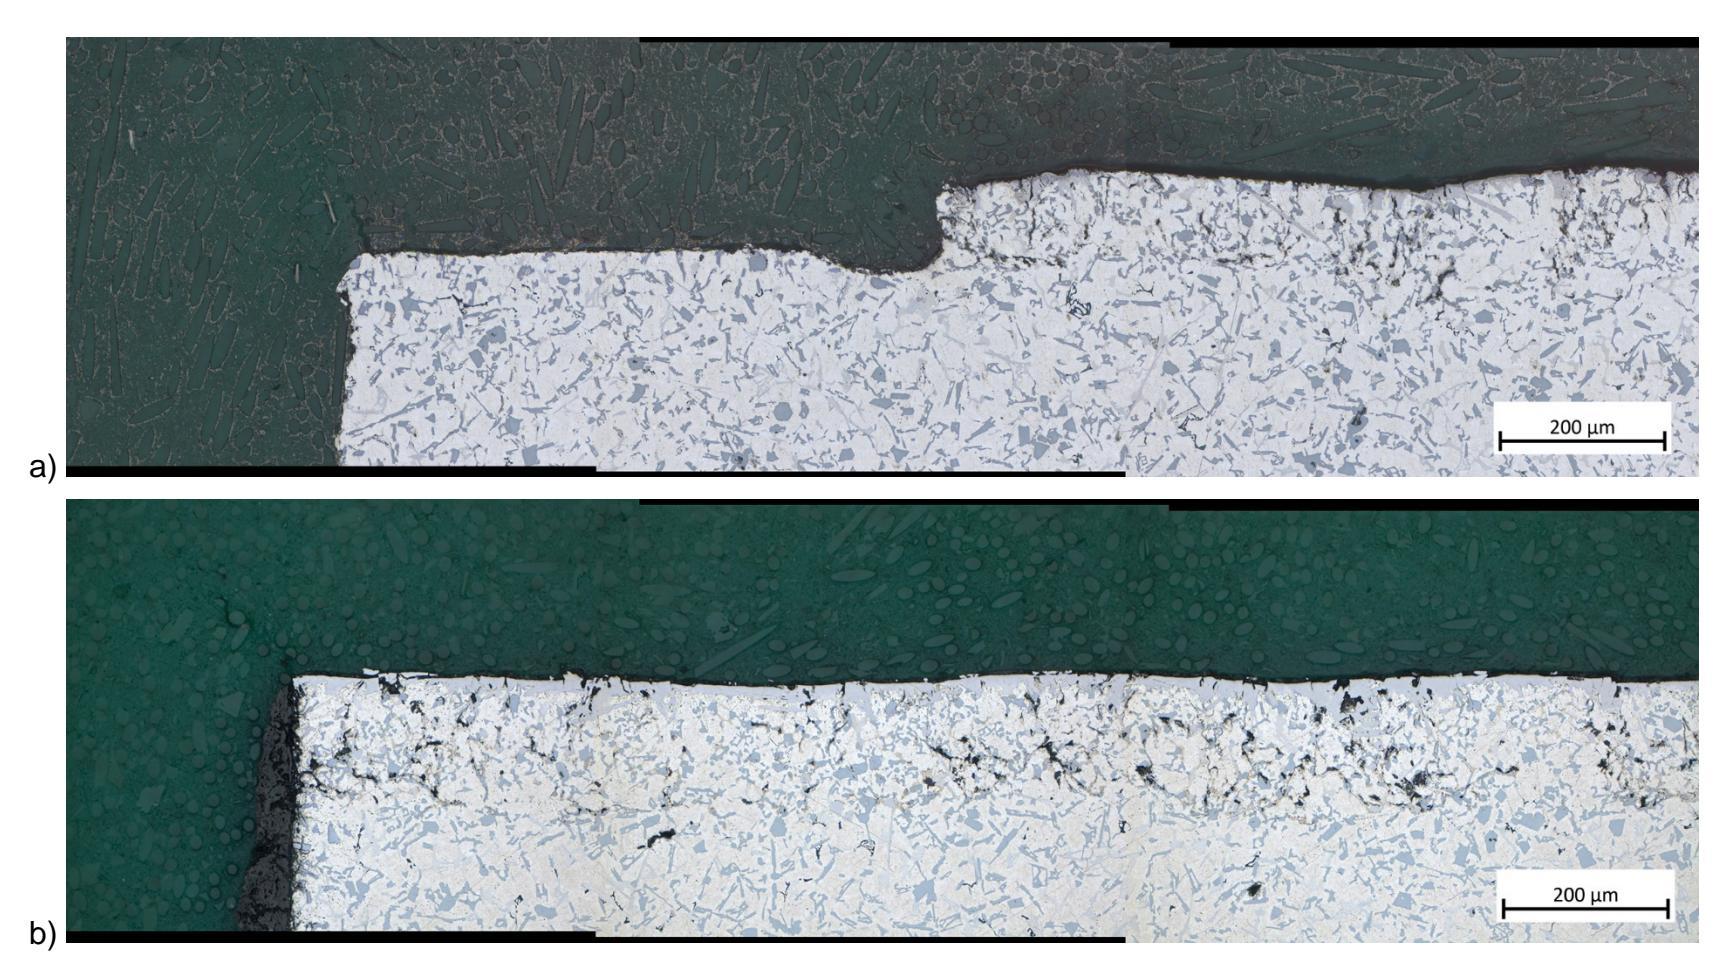
Figures 23a and b show the morphology and microstructure of the cast aluminum material at the edge where the lower support material met the outer face of the piston for the numbers 4 and 3 pistons respectively. The step near the edge for the number 4 piston is viewed in cross section in figure 23a. The step height was approximately 100 μ m (0.004 inch). Both pistons exhibited a typical cast microstructure with interspersed segregated aluminum and silicon regions. Near the aluminum/insert interface, the cast aluminum alloy exhibited multiple crack-like/porosity features on both cross sections. For the number 4 piston, this band extended approximately 150 μ m (0.008 inch) and for the number 3 piston, this band extended approximately 200 μ m (0.008 inch) from the interface.

Figure 23: Metallographic cross sections at the intersection of the lower support material with the outer face of the piston (intermediate land): a) number 4 piston showing the stepped edge in cross section and b) number 3 piston showing no stepped edge.

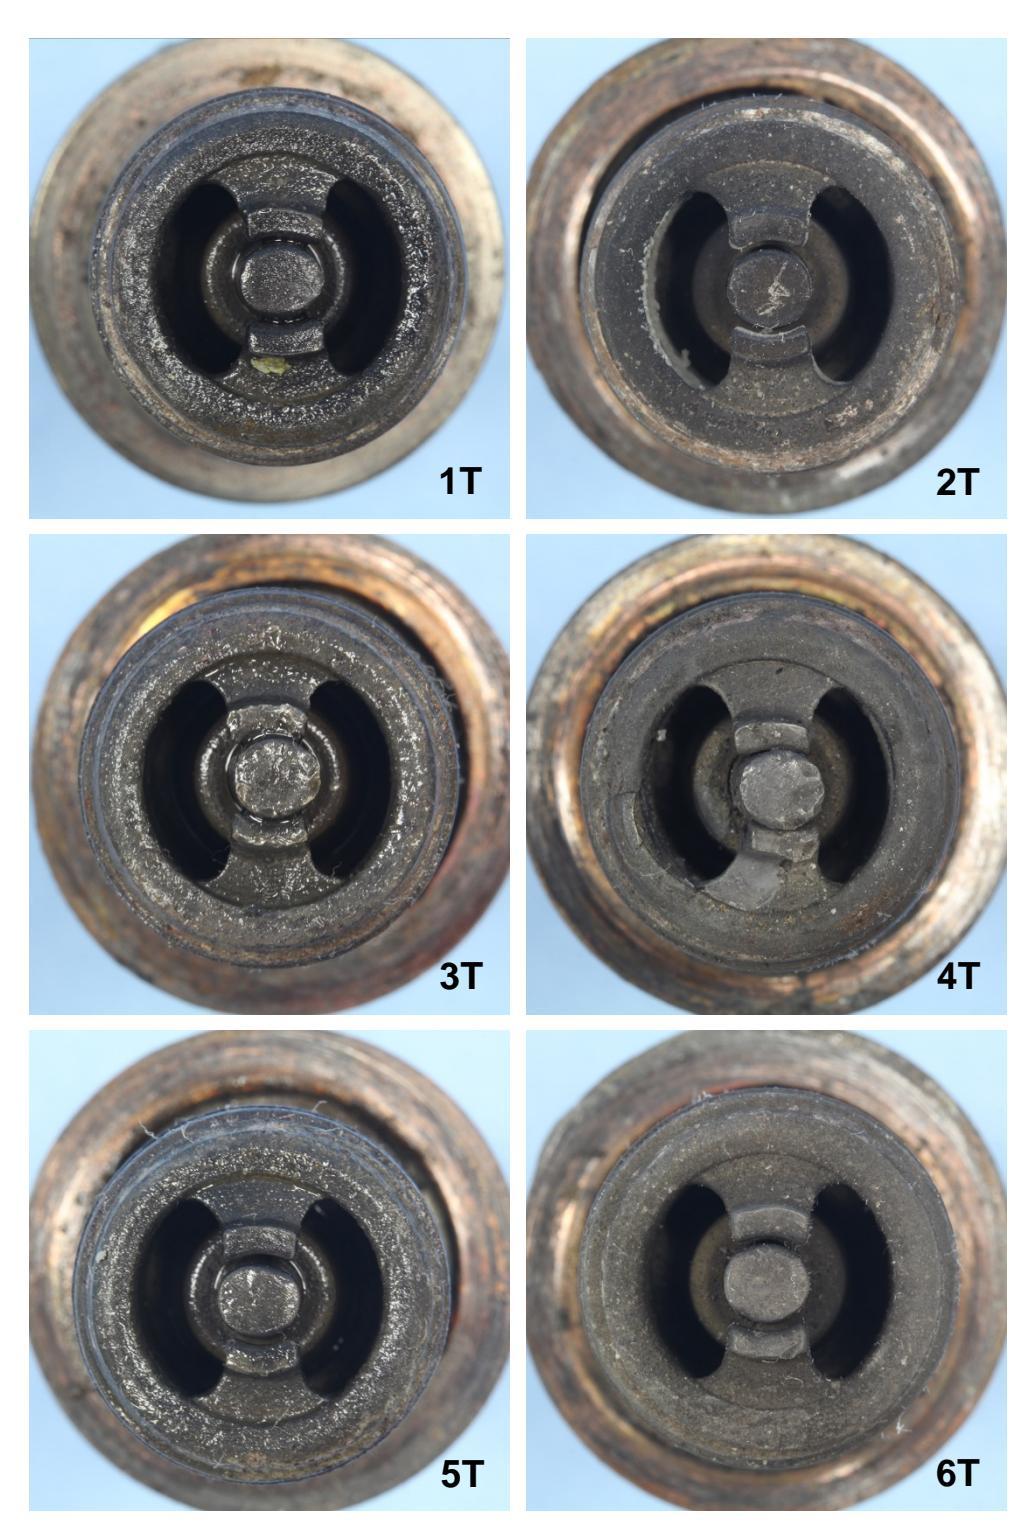
The spark plugs from the top position on the numbers 1 through 6 cylinders and the spark plug from the bottom position on the number 4 cylinder were examined visually and the continuity of the spark plug electrodes was examined with the assistance of an ohmmeter. The tips of the top spark plugs are shown in figure 24 and are labelled 1T through 6T for the numbers 1 through 6 cylinders, respectively. The bottom position spark plug from the number 4 cylinder is shown in figures 25a and b. None of the tips exhibited any pitting or erosion. None of the insulators exhibited cracking. However, the 4T and 4B spark plug ground and center electrodes were deformed.

Figure 24: Top spark plug tips for the numbers 1 through 6 cylinders, labelled 1T through 6T, respectively.

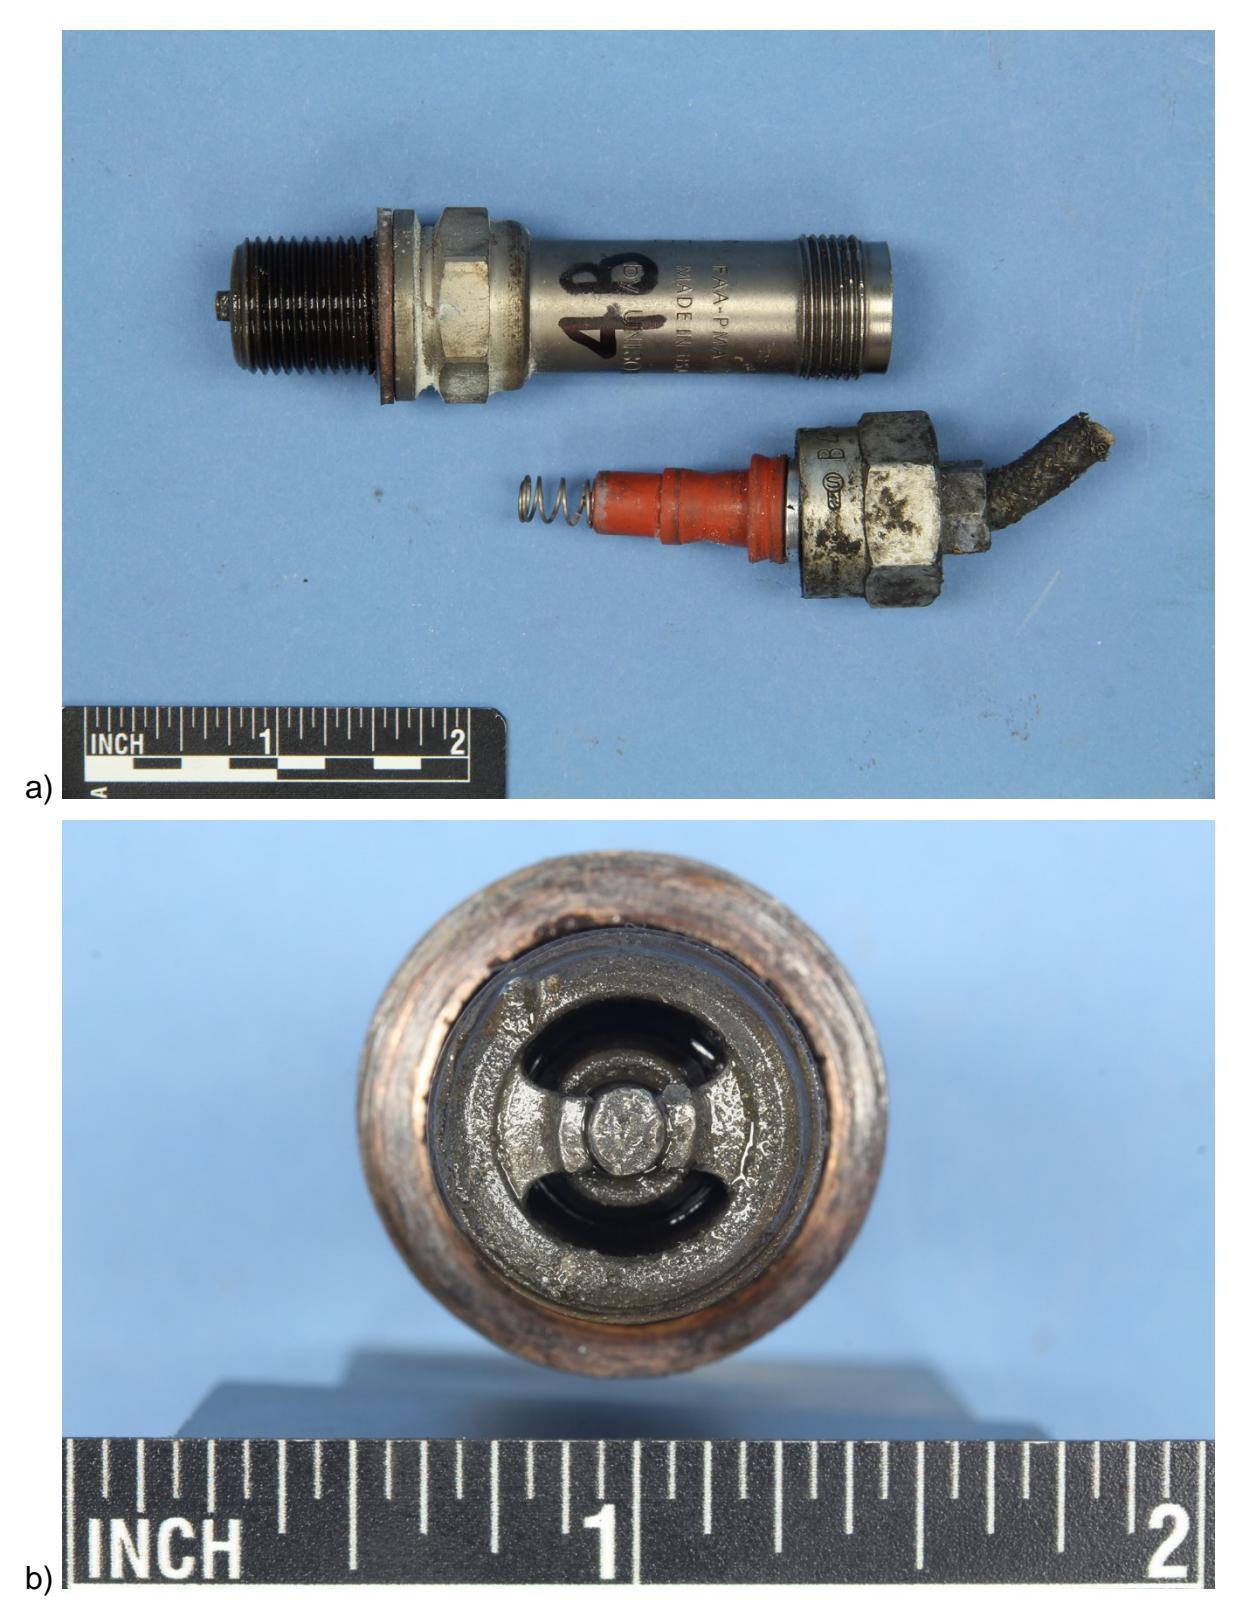
The electrical continuity of the electrodes was measured using an ohmmeter set to a range of 20 k Ω . One lead was placed in contact with the center electrode from the terminal end. The other lead was placed in contact with either the center electrode or ground electrode at the spark end. The resistance readings for all of the center electrodes ranged from 0.98 Ω to 1.07 Ω . The resistance reading for the 1T, 2T, 3T, 5T, and 6T ground electrodes was infinity (∞), while the resistance reading was 1.05 Ω the 4T ground electrode and 2.28 Ω for the 4B ground electrode, consistent with the mechanical damage to those electrodes.

Figure 25: Images of the number 4 cylinder bottom spark plug: a) overview image of the plug and the terminal connector and b) image of the spark plug tip.
