NATIONAL TRANSPORTATION SAFETY BOARD

Onboard Image Recorder

Specialist's Factual Report By Sean Payne

Location:	Atlanta, GA
Date:	May 23, 2013, 14:56 Eastern Daylight Time (EDT)
Aircraft:	Hawker Beechcraft A36, N8225T
Operator:	Private
NTSB Number:	ERA13LA252

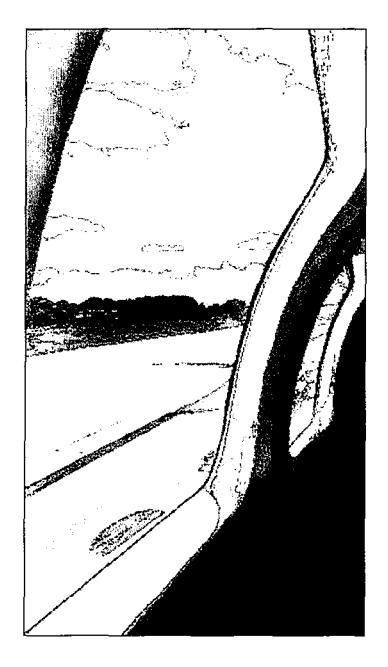
In agreement with the Investigator-In-Charge, a video group did not convene and a summary report was prepared. Figure 1 shows the field of view of the rearward facing passenger's cell phone during most of the recording.

Figure 1: An illustration of the field of view of rearward facing passenger's cell phone.
