Attachment 2 To Operations/Human Performance Group Factual Report

DCA11IA040

Flight Simulator Observation

Simulator Evaluations for United Airlines (UAL) A320 Flight 497 Incident Avionics Smoke Indication and Runway Excursion, New Orleans, Louisiana, April 4, 2011 (NTSB # DCA11IA040)

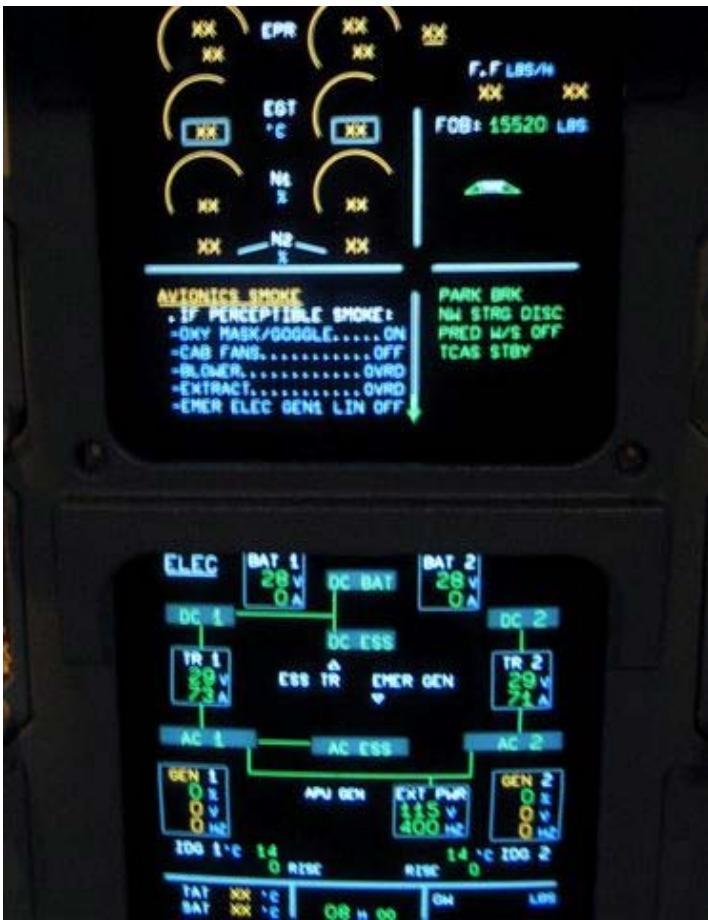
- 1. Avionics Smoke was activated from the instructor's panel.
- 2. Single chime heard and ECAM procedure appears on bottom left side of upper ECAM (see Figure 1).

- 3. White conditional statement is visible. Under the conditional statement is blue "to do" items. Green arrow on right side of procedure indicates there are more steps than are appearing on the screen (see Figure 1).

Figure 1: Upper and lower ECAM displays; Avionics Smoke procedure visible on lower left of upper ECAM.

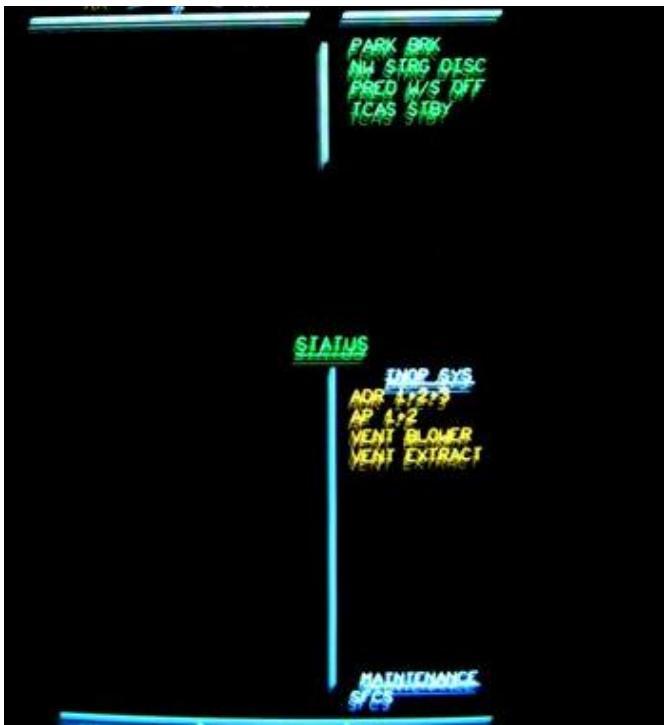
- 6. If the crew cleared the Avionics Smoke ECAM and then went to the "status" page, there was a "vent blower" and "vent extract" message under inoperative systems (see Figure 2). Blower and Extract "fault" lights were also illuminated on the overhead panel (see Figure 3). Pack 2 "fault" and Gen 1 Line "smoke" lights were illuminated (see Figures 3 and 4). (Note: Pack 2 fault was possibly a simulator glitch.)

Figure 2: STATUS page of ECAM indicating VENT BLOWER and VENT EXTRACT under inoperative systems (INOP SYS).

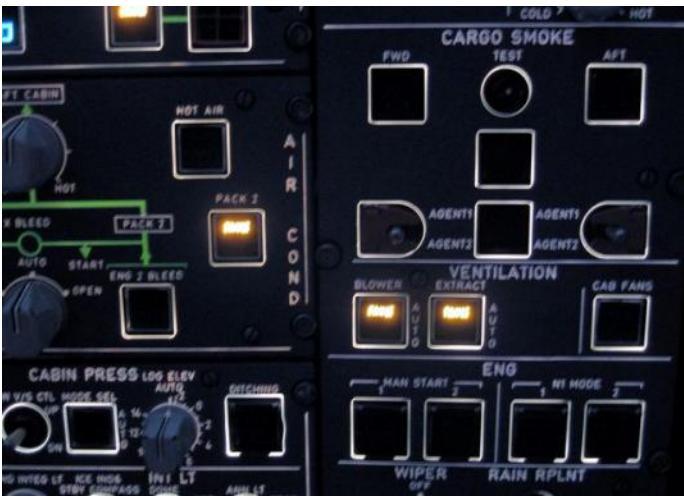
Figure 3: View of overhead panel; Ventilation blower and extract fault lights and Pack 2 fault light illuminated.

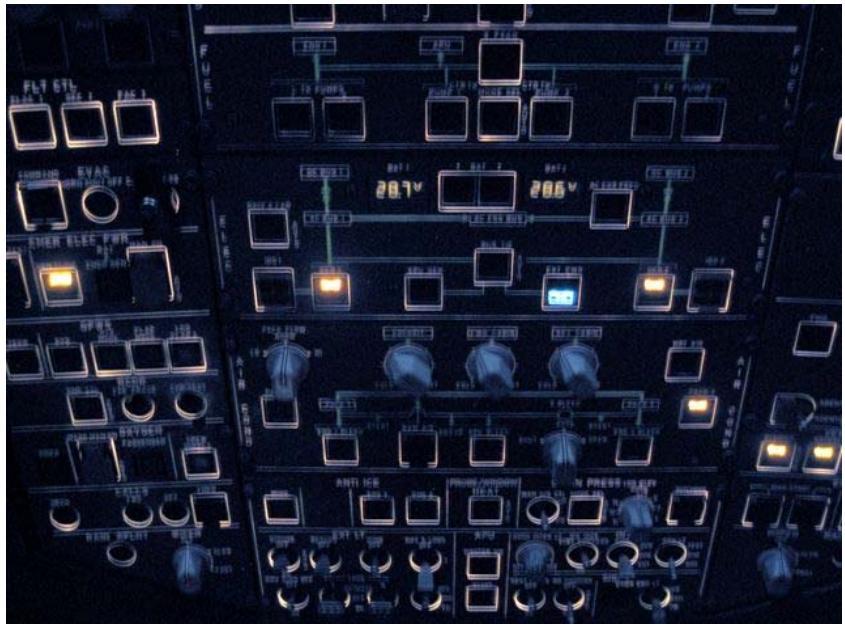
Figure 4: View of overhead panel; Gen 1 Line Smoke light illuminated on left side of picture; Ventilation blower and extract fault lights and Pack 2 fault light illuminated on right side of picture.

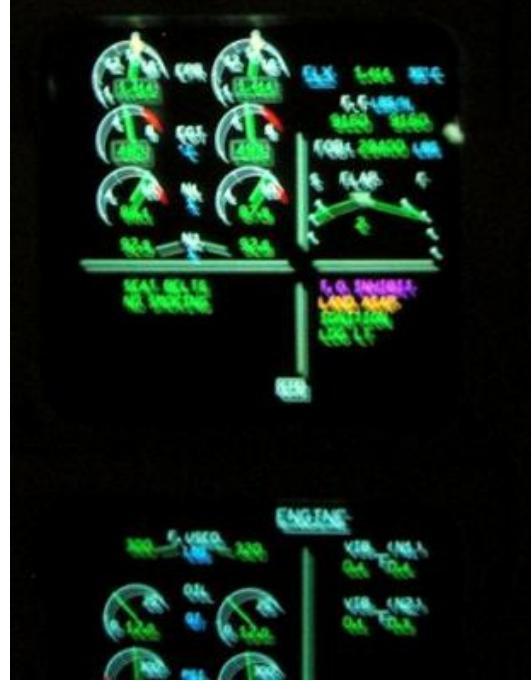
- 1. Avionics Smoke was activated from the instructor's panel.
- 2. "T.O. Inhibit" purple message and "Land ASAP" amber message appeared on the lower right of upper ECAM (see Figure 5).

Figure 5: View of upper ECAM with takeoff inhibit (T.O. INHIBIT) visible as purple message and Land ASAP visible as amber message.

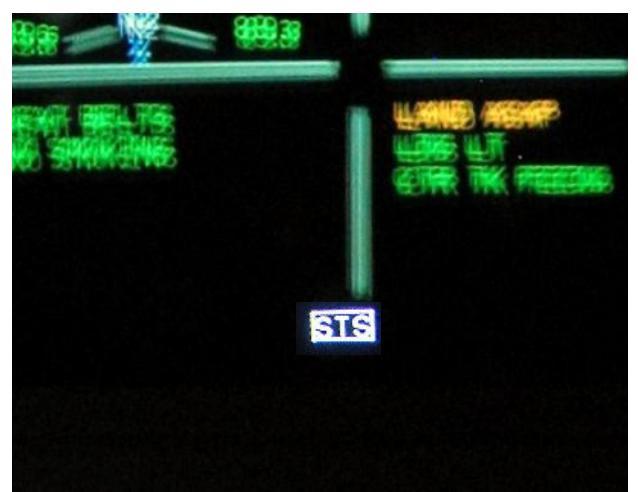
- 3. STS appeared on lower portion of upper ECAM (see Figure 6).
- 4. Blower and Extract "fault" lights and Gen 1 Line "smoke" light illuminated on overhead panel.

Figure 6: ECAM displaying STS (status) indicator message.

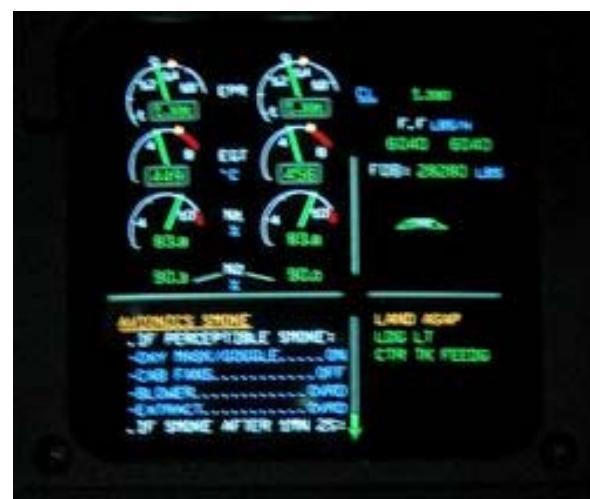
- 4. As blue "to do" items are cleared by the crew, a second white conditional statement became visible on the ECAM. (Figure 7 shows the two conditional statements as seen in flight.)

- 8. Crew hit "recall" and Avionics Smoke procedure appeared on the ECAM (see Figure 7).
- 9. The white conditional statement with the time had about 60 seconds remaining.

Figure 7: Avionics Smoke procedure displayed on the ECAM; two conditional statements visible.

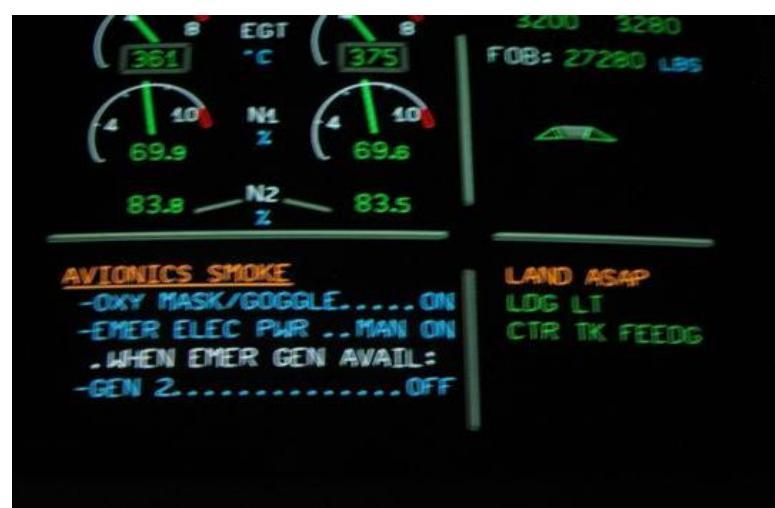
- 10. Crew ran through the procedure and before they got to the conditional statement with the timer, the timer went to zero and the message disappeared. It then seemed that the blue "to do" items pertaining to the timer conditional statement were a part of the previous conditional statement (see Figure 8).

Figure 8: Avionics Smoke ECAM procedure after conditional statement "If smoke after..." timer reaches zero.

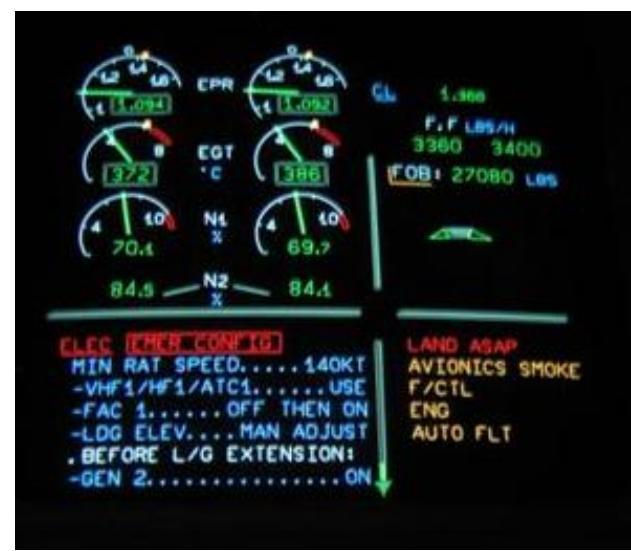
- 12. When crew selected Gen 2 off, all screens in the cockpit went black and after several seconds the captain's screens reappeared.
- 13. Chime heard and Emer Elec Conf appeared on the lower left of the upper ECAM. Red "Land ASAP" message appeared on lower right of upper ECAM. Lower ECAM was black (see Figure 9).

- 17. To tune/dial in the approach, crew had to use the "standby nav" or RNP.
- 18. An item on the Emer Elec ECAM procedure states as white conditional "before landing gear extension" then blue to do "gen 2…on" (see Figure 9).

Figure 9: Emergency electrical configuration procedure displayed on upper ECAM.

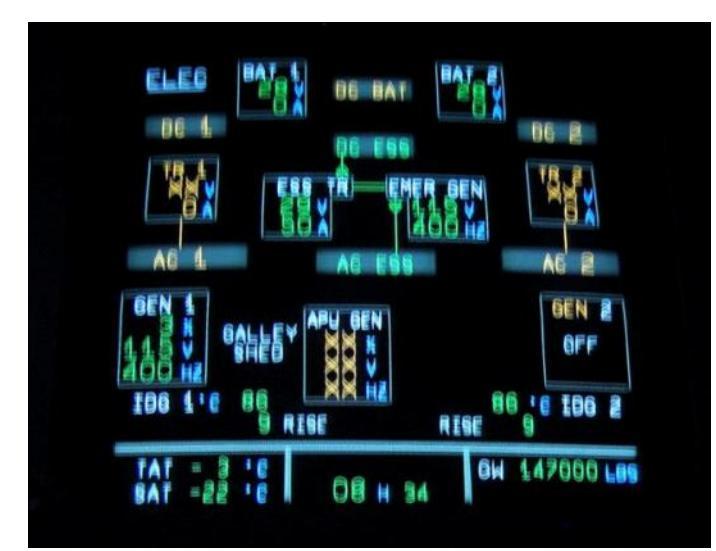
- 14. No visual indication that the RAT deployed.
- 15. On electrical page, crew could tell RAT deployed by seeing "Emer Gen" message (see Figure 10).
- 16. When selected, the "status" page appeared on the upper ECAM (see Figures 11 and 12).

Figure 10: Electrical page on ECAM with indications that the RAT has deployed.

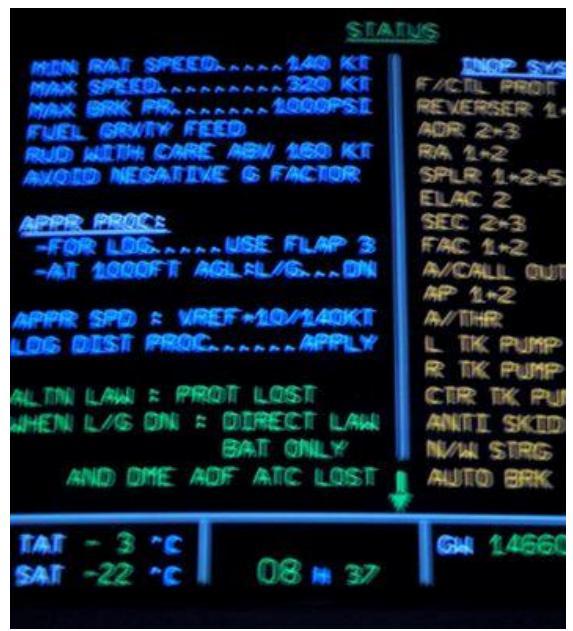
Figure 11: Status page 1 on upper ECAM when selected in emergency electrical configuration.

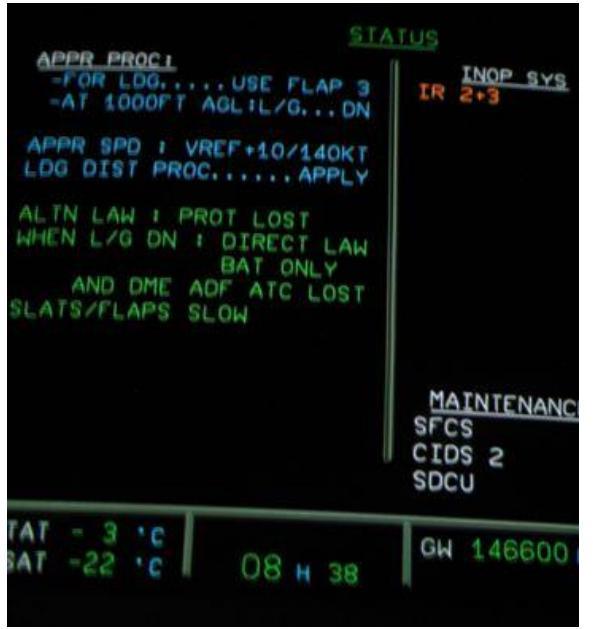
Figure 12: Status page 2 on upper ECAM when selected in emergency electrical configuration.
