TRAINING RECORD FOR LETTER OF AUTHORIZATION						
AIRCRAFT TYPE: Aero L-39	INITIAL RECUR	RENT				
NAME Michael Akbar C	howdry					
		:				
ADDRESS	STATE CO	ZTP 80401				
CITYGOIden	SIAIE					
PHONE NUMBER		<u>, , , , , , , , , , , , , , , , , , , </u>				
	TRAINING					
, T I	RAINER APPLICANT	DATE				
GROUND: SYSTEMS COCKPIT TAXI EMERGENCY FLIGHT PLANNING	Deltres Del	<u>3-21-98</u> <u>3-22-98/4-11-48</u> <u>3-22-98/4-11-48</u> <u>3-22-98/4-11-48</u> <u>4-11-98</u>				
TOTAL GROUND:	JI BHrs	4-11-98				
FLIGHT: INSTRUMENT INSTRUMENT INSTRUMENT AEROBATIC INSTRUMENT FORMATION INSTRUMENT SFO INSTRUMENT GO/AROUND INSTRUMENT	I.S.Hrs.	10-12-97 				
FLIGHT TIMEDATE 1.5 Hrs $10.10.97$ 1.5 Hrs $3.01-98$ 1.5 Hrs $4.1.98$ 1.5 Hrs $4.10.98$ 1.5 Hrs $1.0.0$ LIMITATIONS:For maticFAA FORM 8710-1 ATTACHEDMINIMUM HOURS REQUIRED AFGROUND INSTRUCTION-FLIGHT INSTRUCTION-	AIRCRAFT # N3977 Orie Nb00mc Junt Nb00mc Ail Nb00mc Ail Nb00mc Ail Nb00mc V Nb00mc V Nb0	REMARKS Listron glight - 20 menuars isl Training infront cox kp. + Monners. Ride

AERO VODOCHODY LTD. CZECH REPUBLIC L-39 ADVANCED FANJET TRAINER AIRCRAFT

- 3. How was the real condition of the airplane when the weight and balance was done in 1996

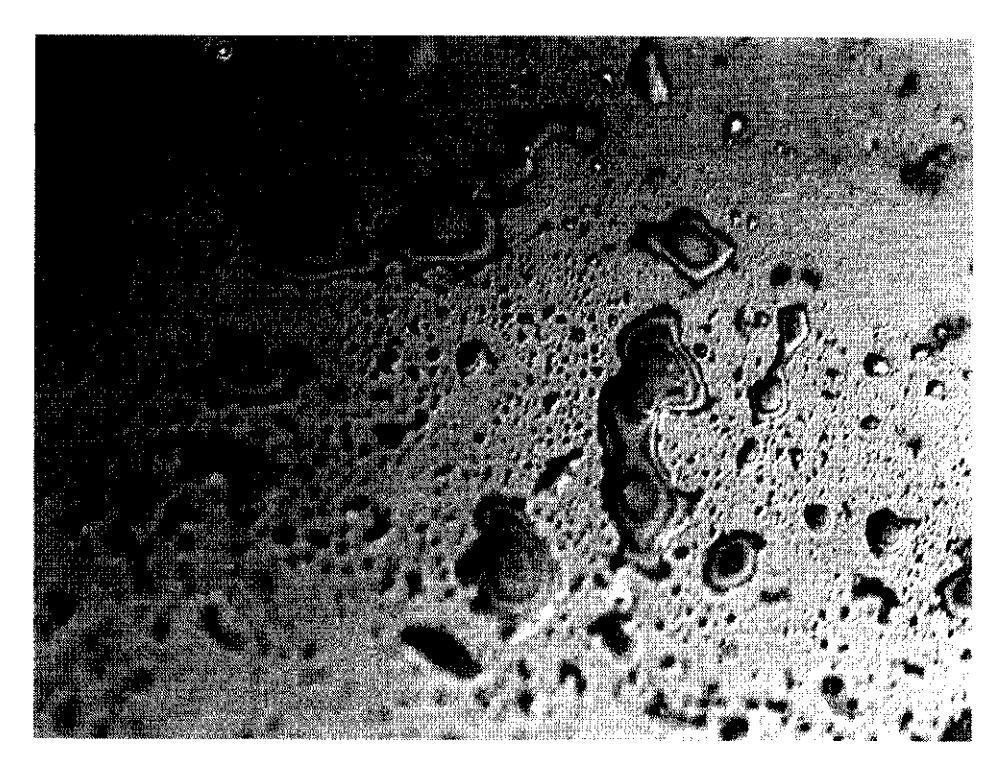
Figure 5: Left edge of the sample on the canopy sill edge at 500x magnification.

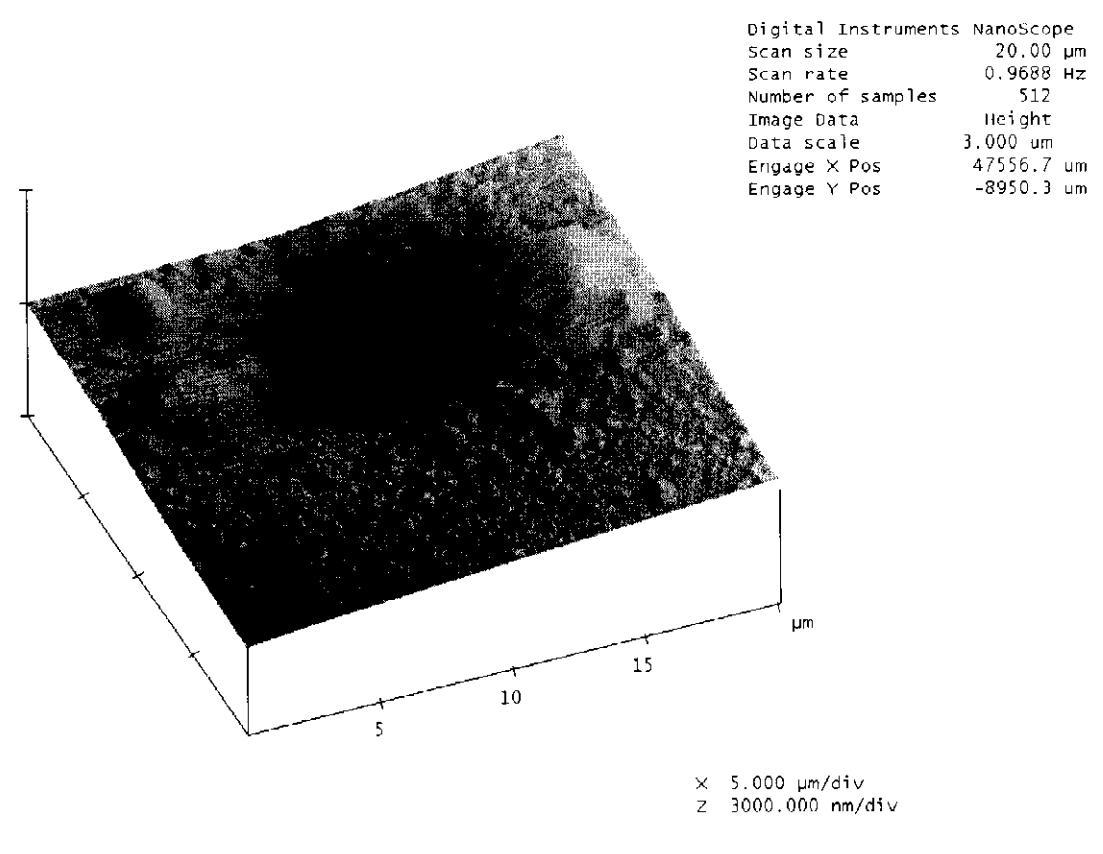
Figure 6: Image of scan over a pore in middle of sample on the canopy sill edge
