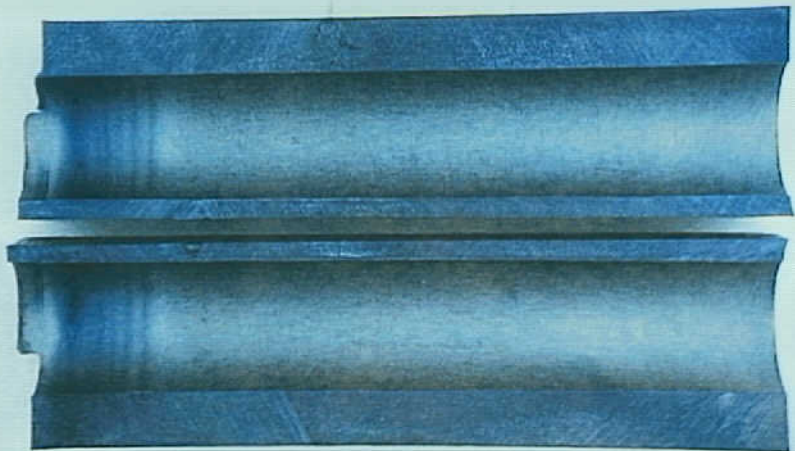
52.

Photo 27. Hole #52 drilled with increased cutting data with HSS to breakage. The hole has also been fine bored and honed. The hole was blue etched before and after being sectioned into two halves.
