NATIONAL TRANSPORTATION SAFETY BOARD Office of Aviation Safety Washington, D.C. 20594

POWERPLANT GROUP CHAIRMAN'S FACTUAL REPORT NTSB No: ENG17IA036

Aircraft: Boeing 757-232, N686DA, Delta Air Lines Flight 1057

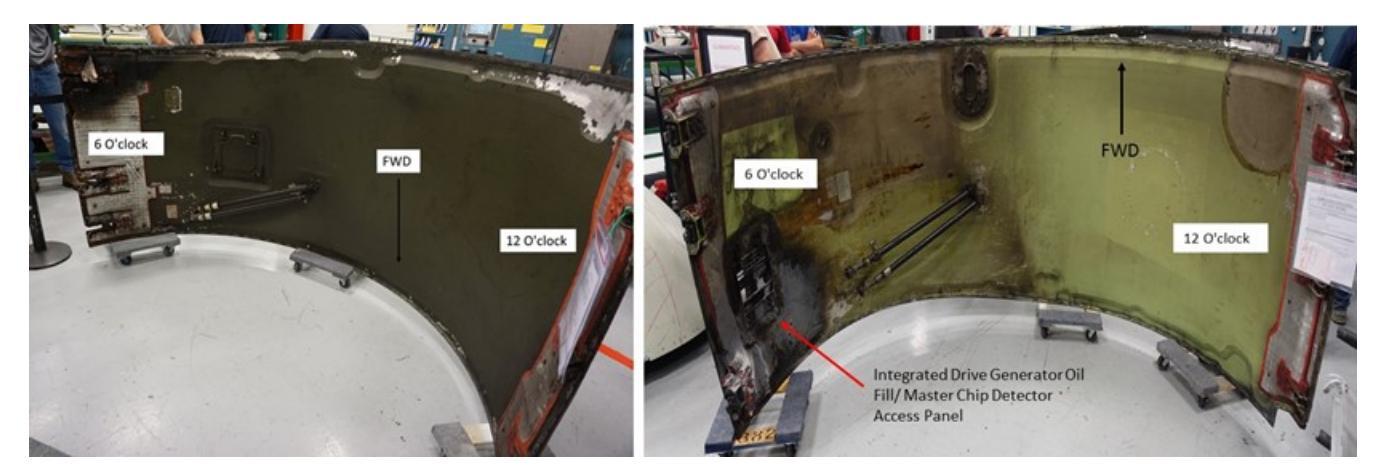
Both halves of the fan cowl were complete, and the three latch and hinge assemblies were intact and functional. According to the DAL maintenance crews, the fan cowl latches were secured when the airplane landed at LAS. Both fan cowl halves had discoloration, sooting, and thermal damage at the 6 o'clock position most concentrated near the aft edge (**Photo 2**).

Photo 2- (L) Left (Outboard) Fan Cowl, (R) Right (Inboard) Fan Cowl

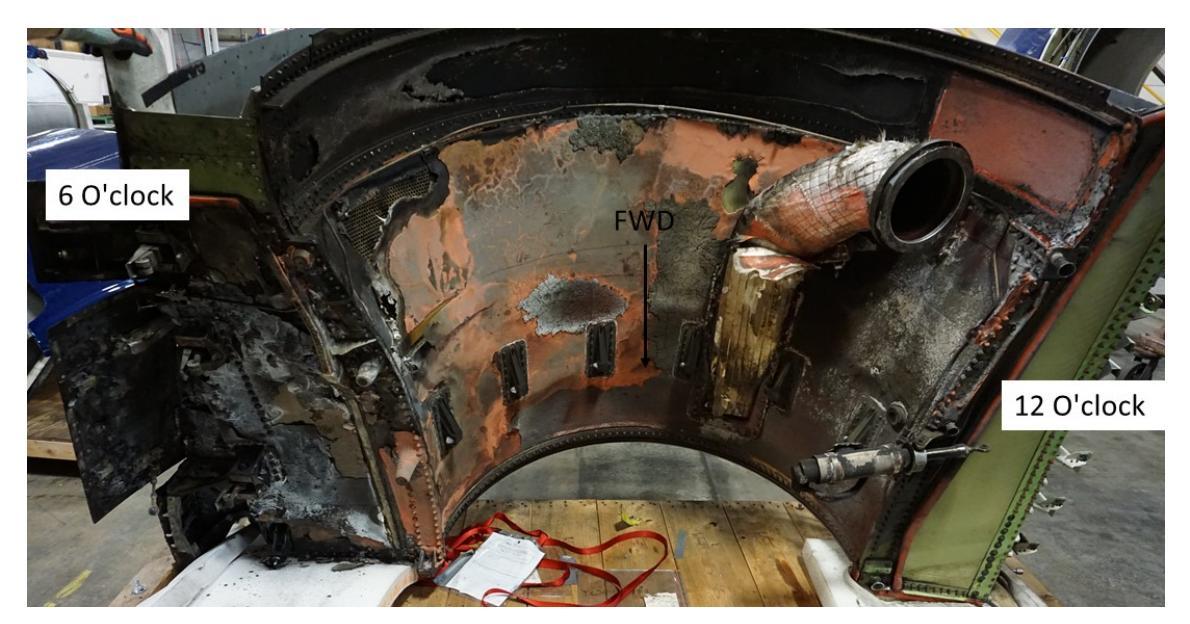
The TR translating sleeves were both in the stowed position. All hinges and latches were intact and there was no visible damage to thrust reverse actuation controls. The MA-25S insulation on the interior surface of the TR halves exhibited thermal distress, sooting and discoloration, except for a localized area on the right half from the 1 to 3 o'clock positions (**Photos 3 and 4**). The insulation in this area retained its reddish orange color and appeared wet/slick. The lower bifurcation wall located at the 6 o'clock position of each thrust reverser half showed evidence of dark discoloration and thermal distress.

Photo 3- Left (Outboard) Thrust Reverser

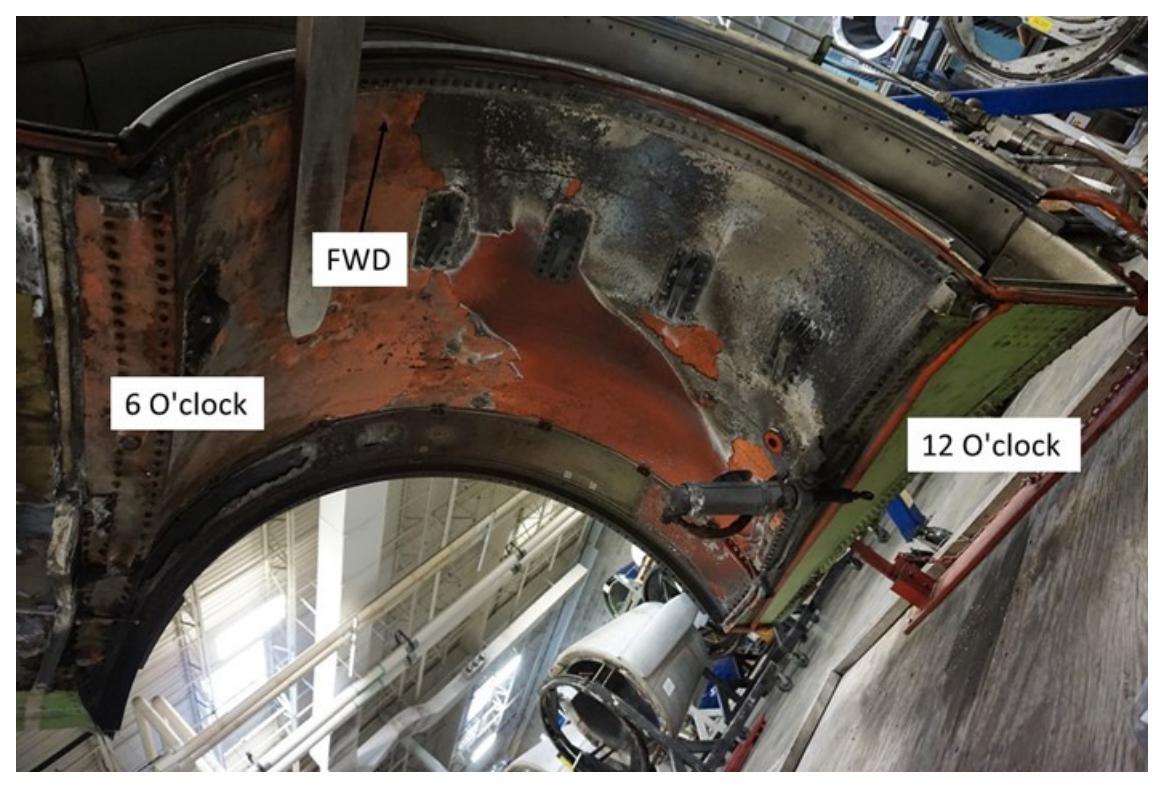
Photo 4- Right (Inboard) Thrust Reverser

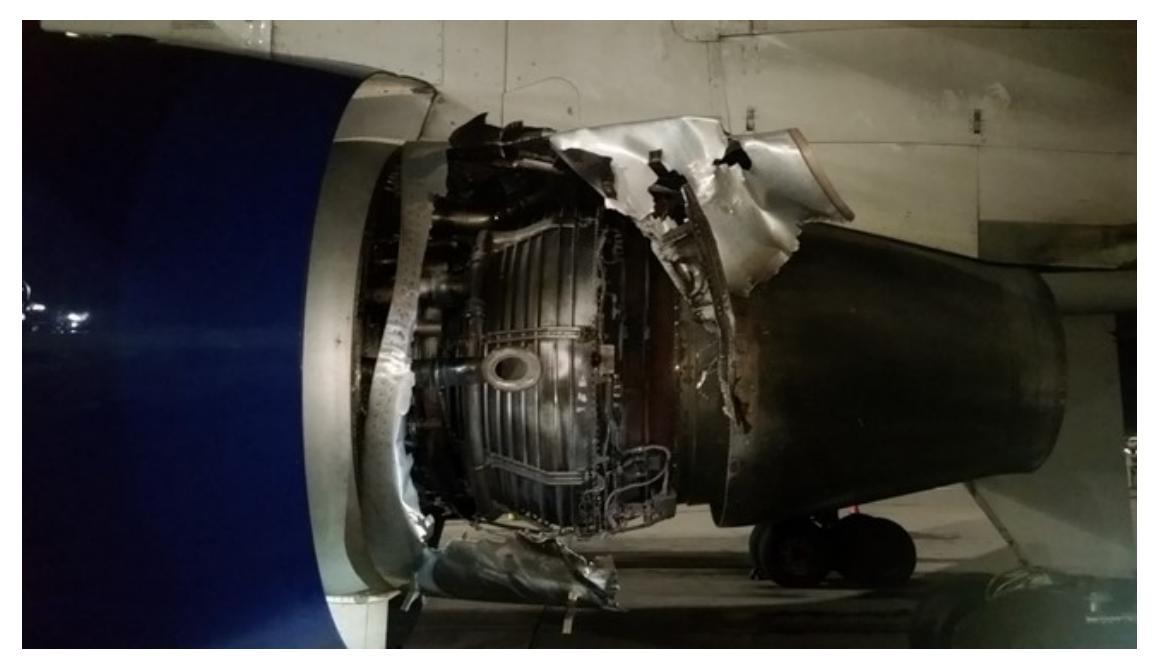
The left core cowl half exhibited thermal damage and deformation. A large section measuring about 48 inches circumferentially by 37 inches axially was separated and missing, and the remaining metal was deformed in the aft direction. The aft most of the three latches located at the bottom of the

engine was separated and missing. The three hinges located at the top of the engine were intact (**Photos 5** and 6).

Photo 5- Left (Outboard) Core Cowl Prior to Engine Removal

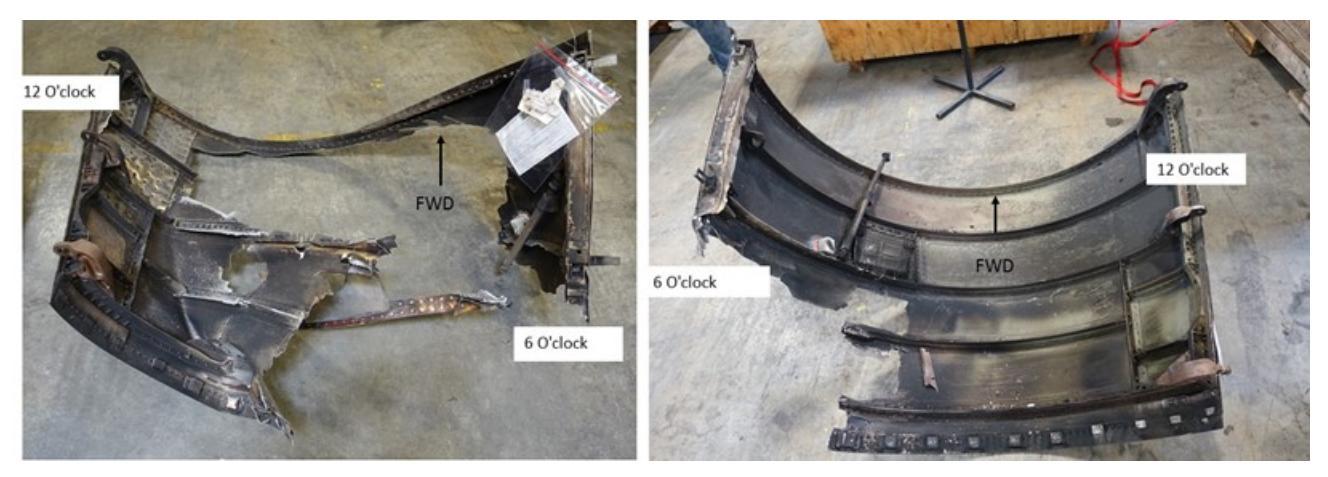
The right core cowl also had thermal damage, deformation, and missing material. A section measuring about 22 inches circumferentially by 17.25 inches axially was separated and missing. The aft most of the three latches the secure the core cowl was separated and missing. The three hinges located at the top of the engine were intact (**Photo 6**).

Photo 6- (L) Left (Outboard) Core Cowl, (R) Right (Inboard) Core Cowl

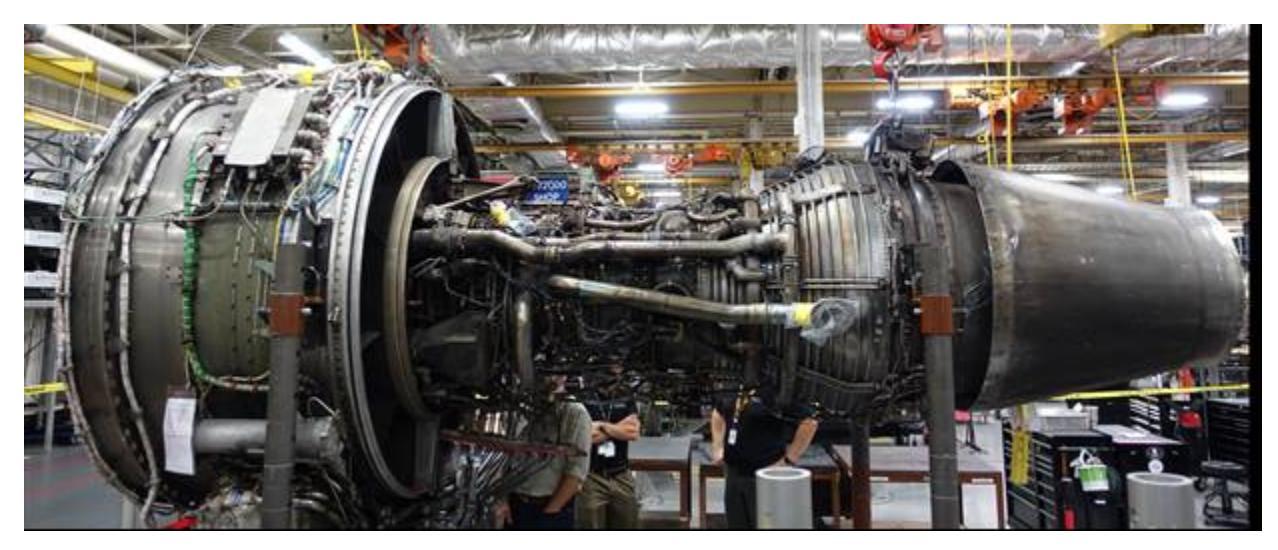
The engine was placed on work pedestals prior to the investigative team's arrival (**Photos 7, 8, and 9**). The engine fan blades were all intact and in good condition. Three consecutive blades (labeled 4, 5, and 6) at the 6 o'clock position were displaced about 1 inch in the aft direction but did not exhibit any impact damage on the blade surfaces. The midspan shrouds of the three consecutive blades at the 6 o'clock position were shingled, and the blade tips were dug into the fan case rub strip (**Photo 10**). The three blades had rub strip material accumulation on the blade tip convex side, consistent with counter clockwise rotation. The fan case rub strip was rubbed/gouged between the 4 and 8 o'clock positions in line with the fan blade trailing edge plane of rotation. The three displaced blades were forcefully released from the rub strip and following release they returned to their normal orientation and the fan/N1 spool could be spun freely by hand.

Photo 7- Left Side of Engine, As Received

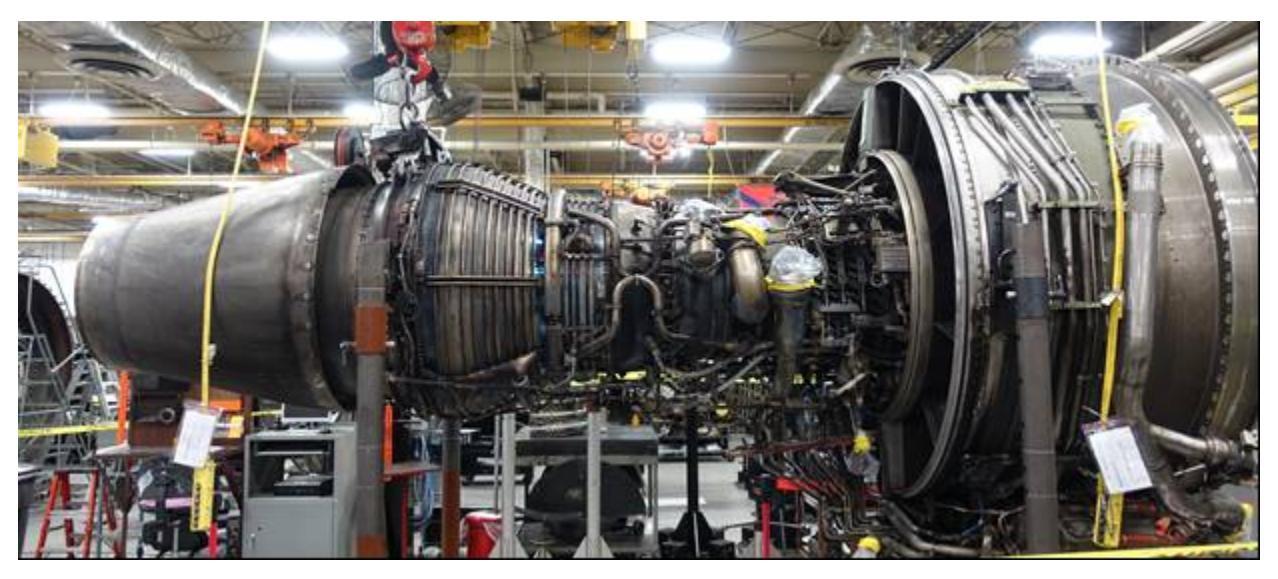
Photo 8- Right Side of Engine, As Received

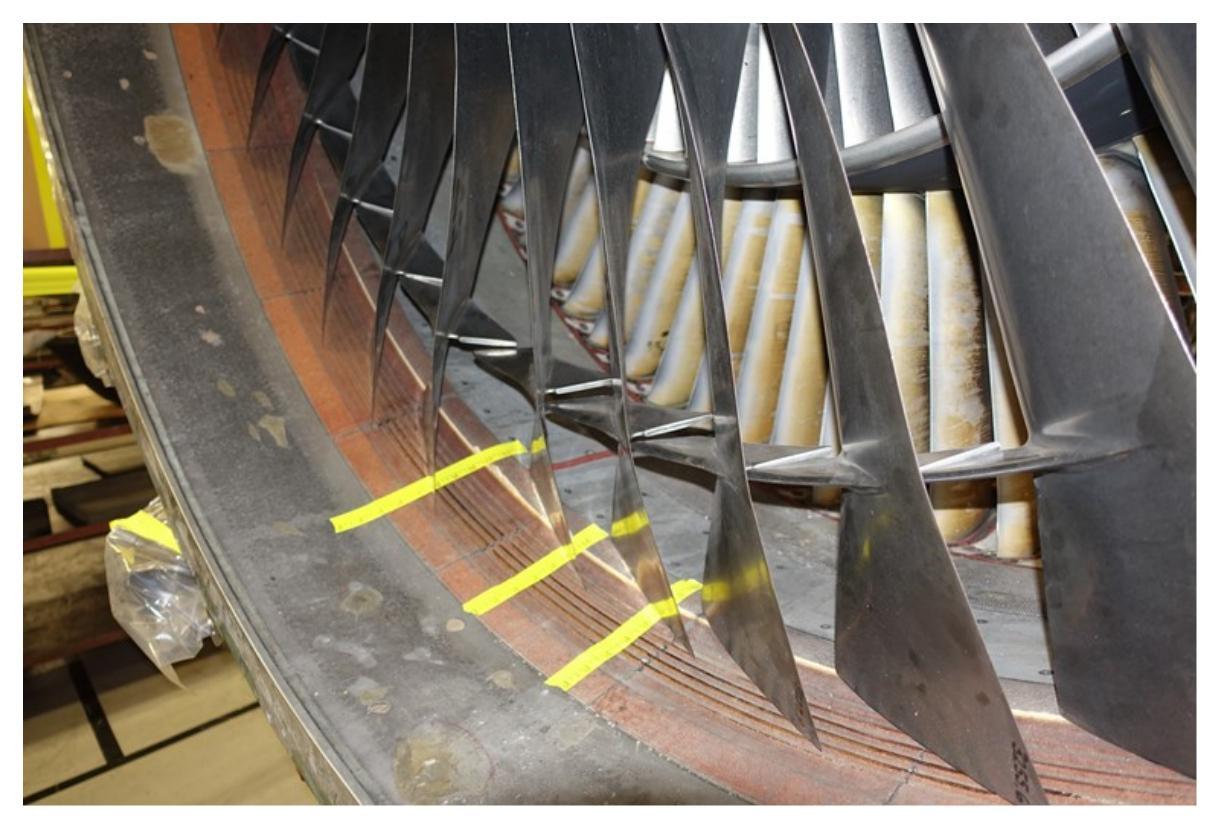
Photo 10- Fan Blade Displacement
