INVESTIGATION REPORT

Reference	WPR17LA133	Commercial File	N/A
Accident / Incident	RA-2017-152 / A-	Preliminary Information report A	Onsite Investigation
report	2017-008		Report A-2017-008

2.1 ENGINE EXAMINATION

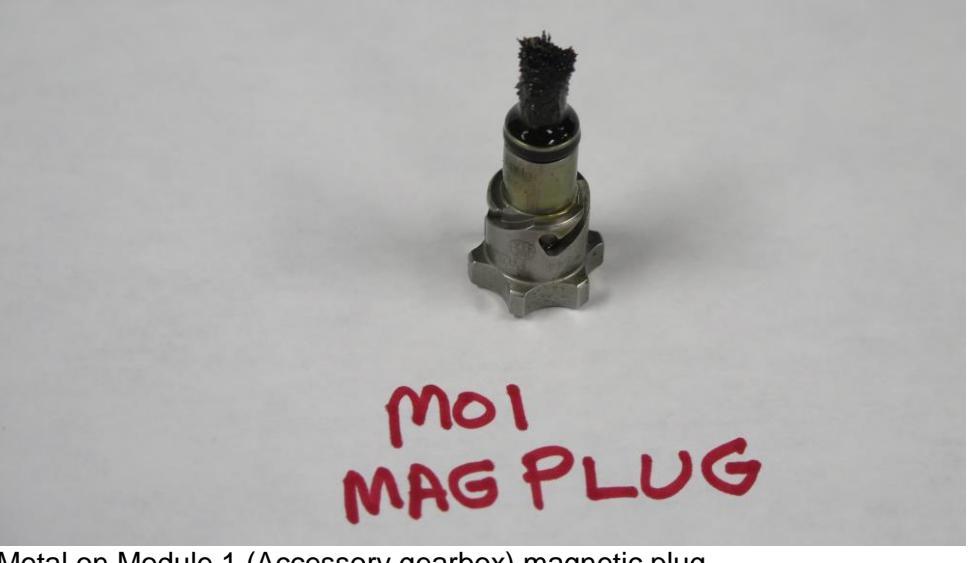
Before beginning the disassembly, all the magnetic sensors (N1A, N2A,B,C), the MO1,5 strainers and magnetic plugs and the main oil strainer were removed. All were clean except for the MO1 magnetic plug.

Metal on Module 1 (Accessory gearbox) magnetic plug (probably M50 material from failed MO2 bearing) Source of metal will be verified by lab analysis

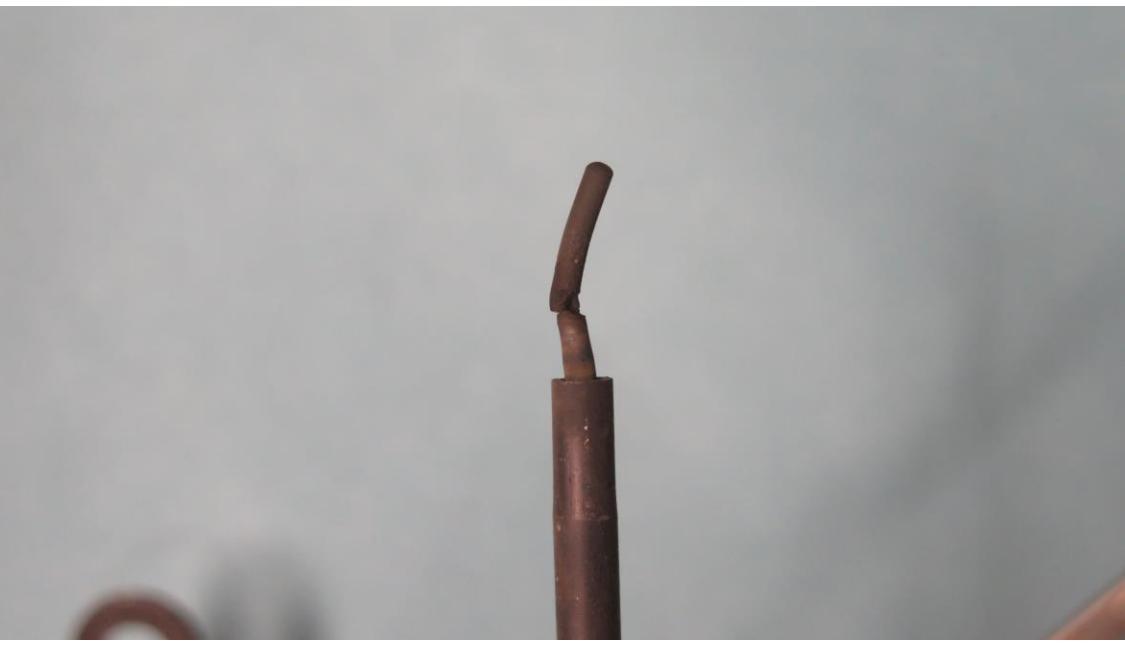
All engine accessories were removed from the engine. The thermocouple harness had sustained thermal damage.

Thermal damage on thermocouple probe

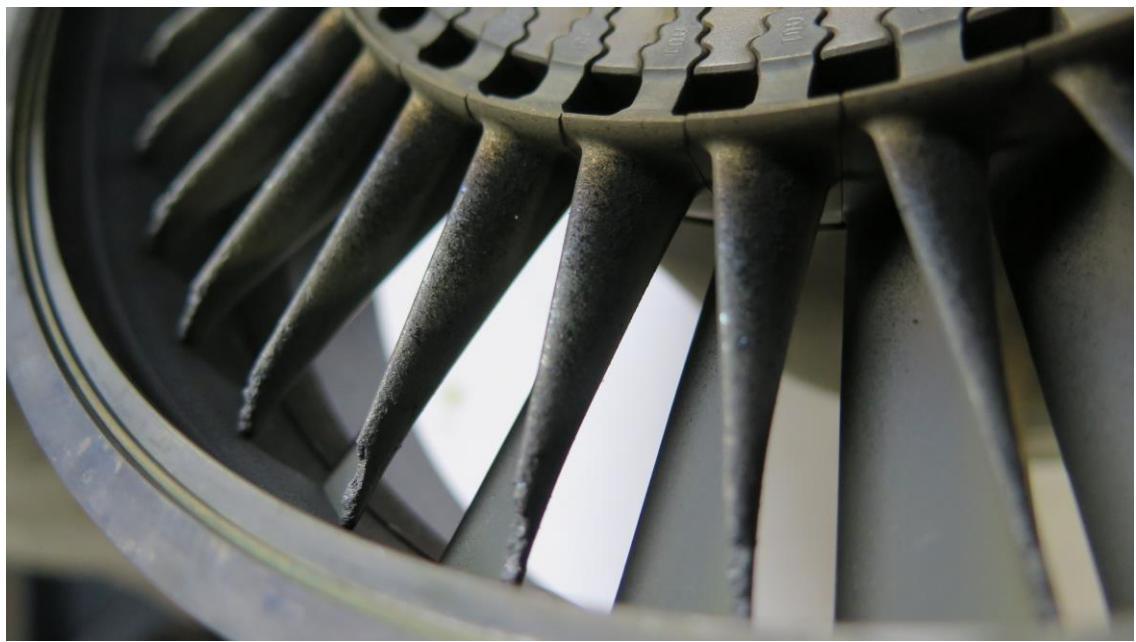
The MO4 (free turbine) was removed. After being separated from the gas generator it could be identified that the turbine was seized at the blade tip / shroud section and that the MO4 bearings spun freely by hand. There was evidence of thermal and impact damage on the leading edge of the free turbine blades.

Free turbine blade damage

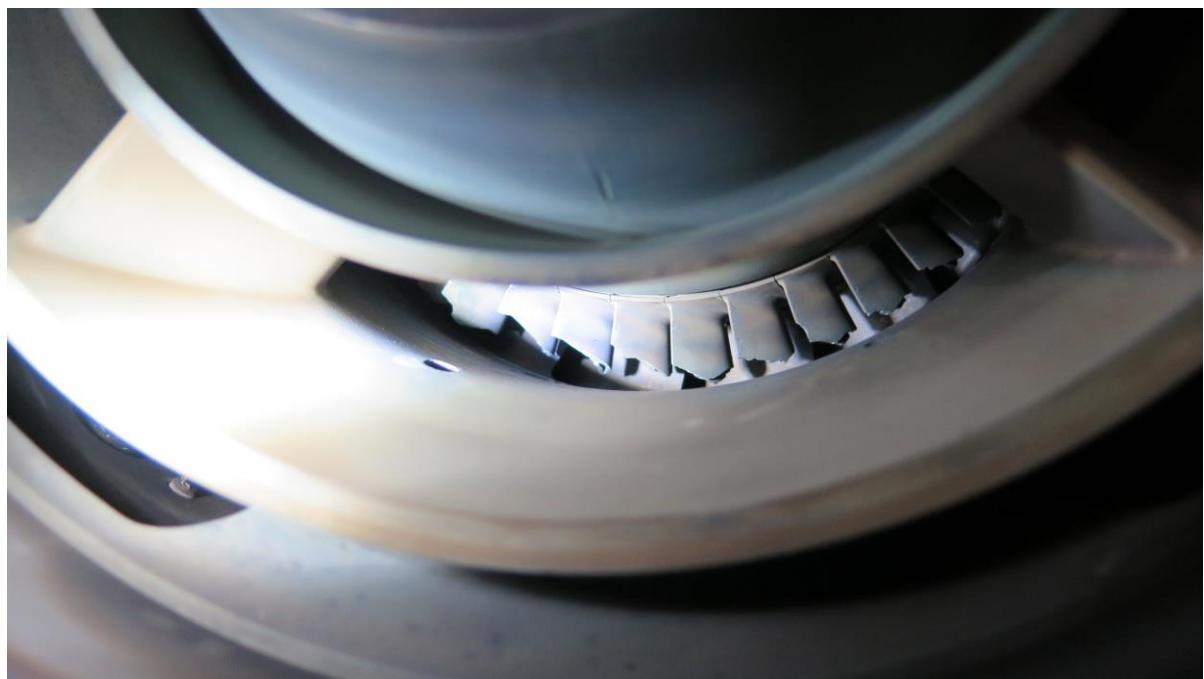
A boroscope inspection of hp turbine revealed a significant amount of heat damage to the turbine blades and thermocouples.

High pressure turbine with FTNGV removed

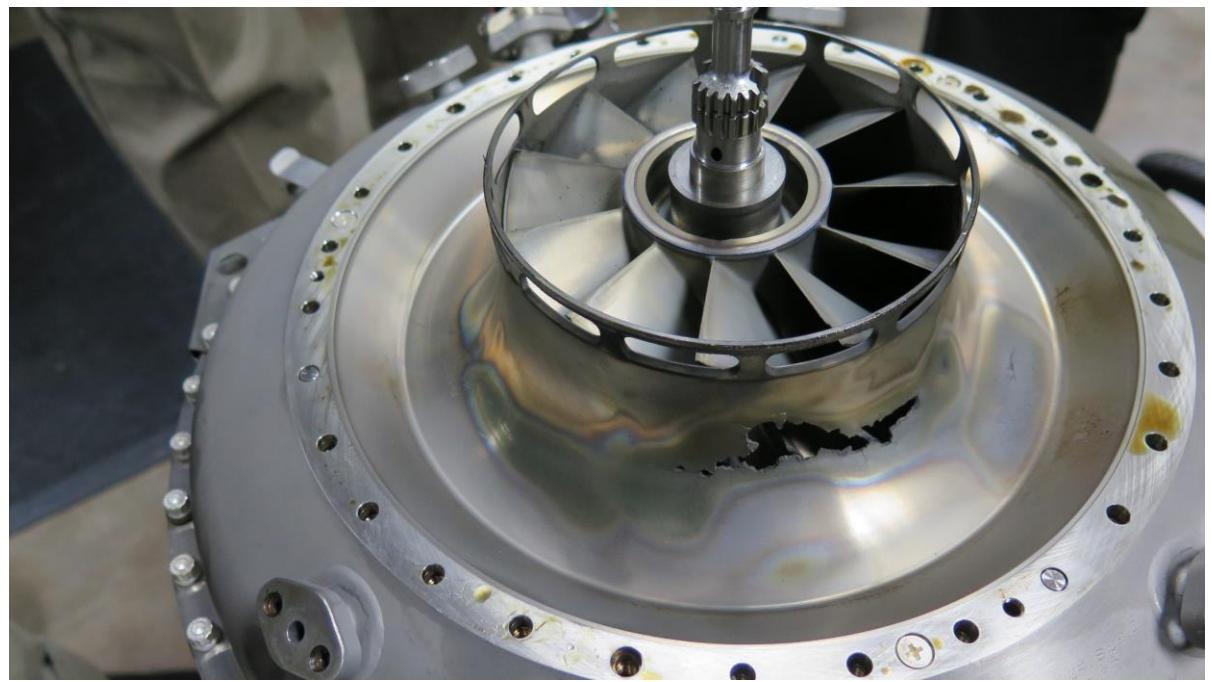
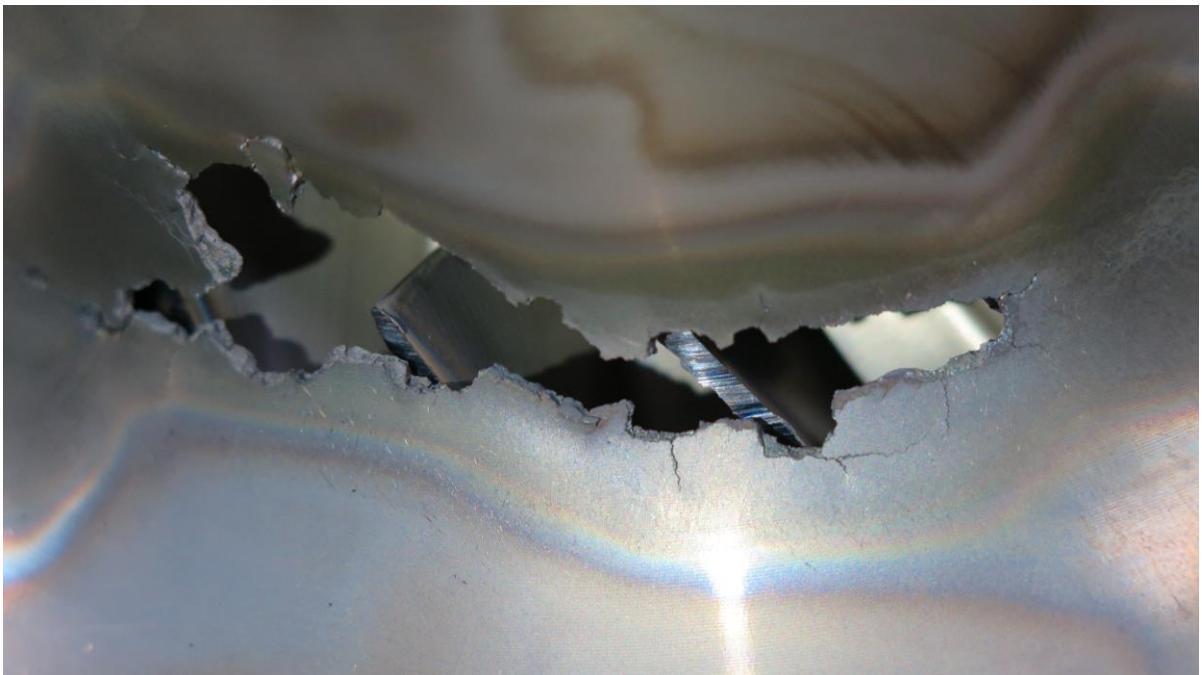
After removal of the MO2 the damage to the centrifugal compressor cover was exposed.

Hole in centrifugal compressor cover

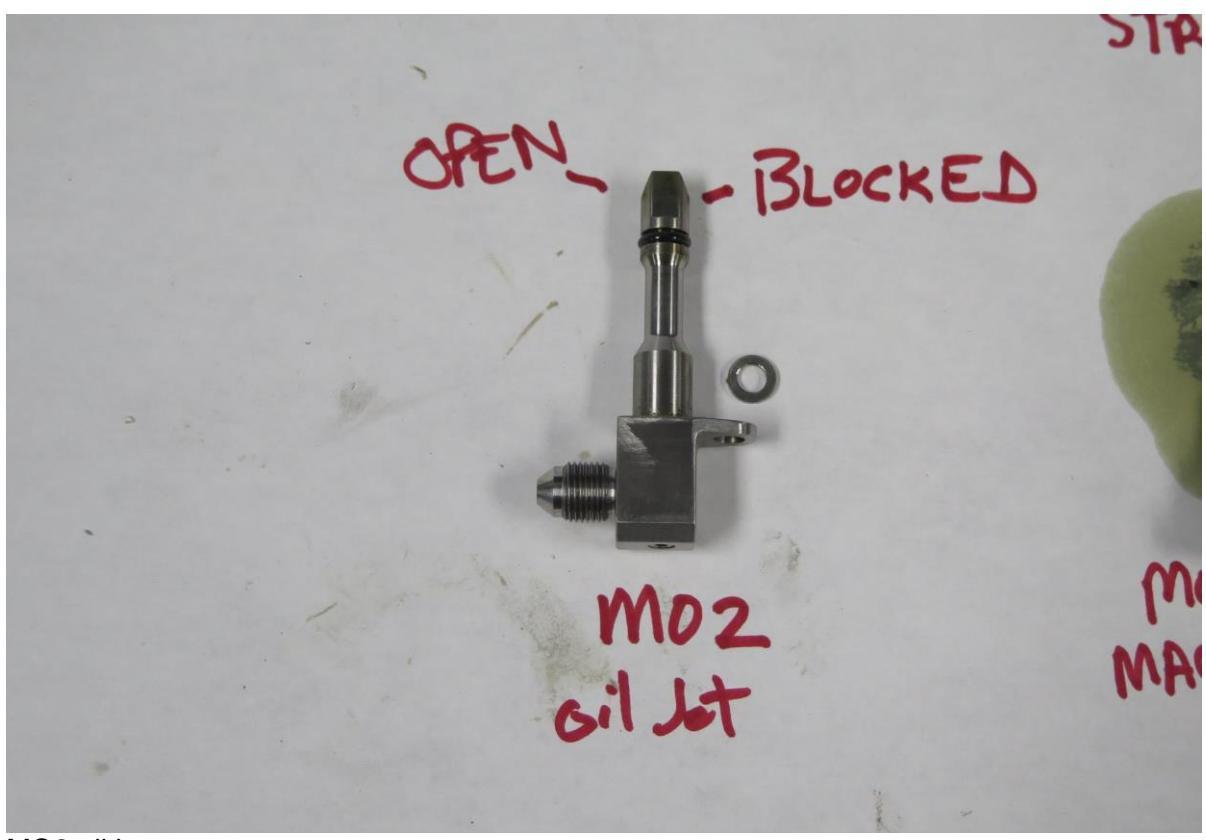
The MO2 was disassembled. The MO2 rear bearing had completely failed and was in pieces. The oil jet was checked by covering each hole and blowing through it. It was found that the jet for the rear MO2 bearing was obstructed. The jet was bagged for further investigation in France.

MO2 oil jet

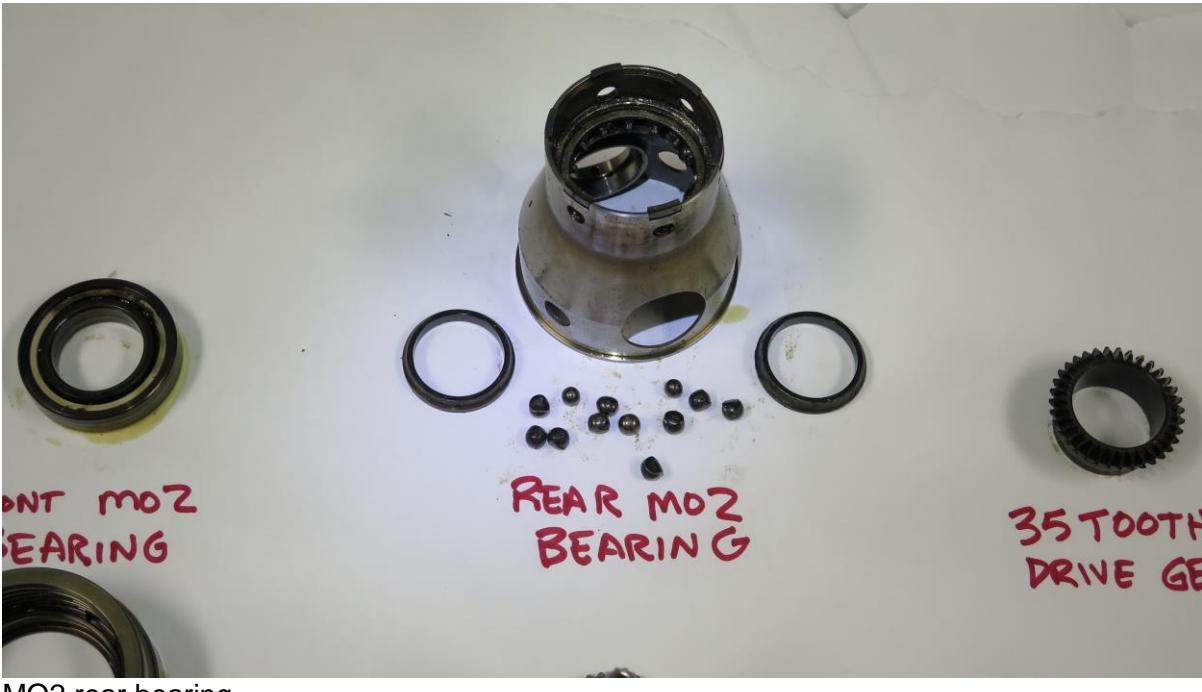
MO2 rear bearing

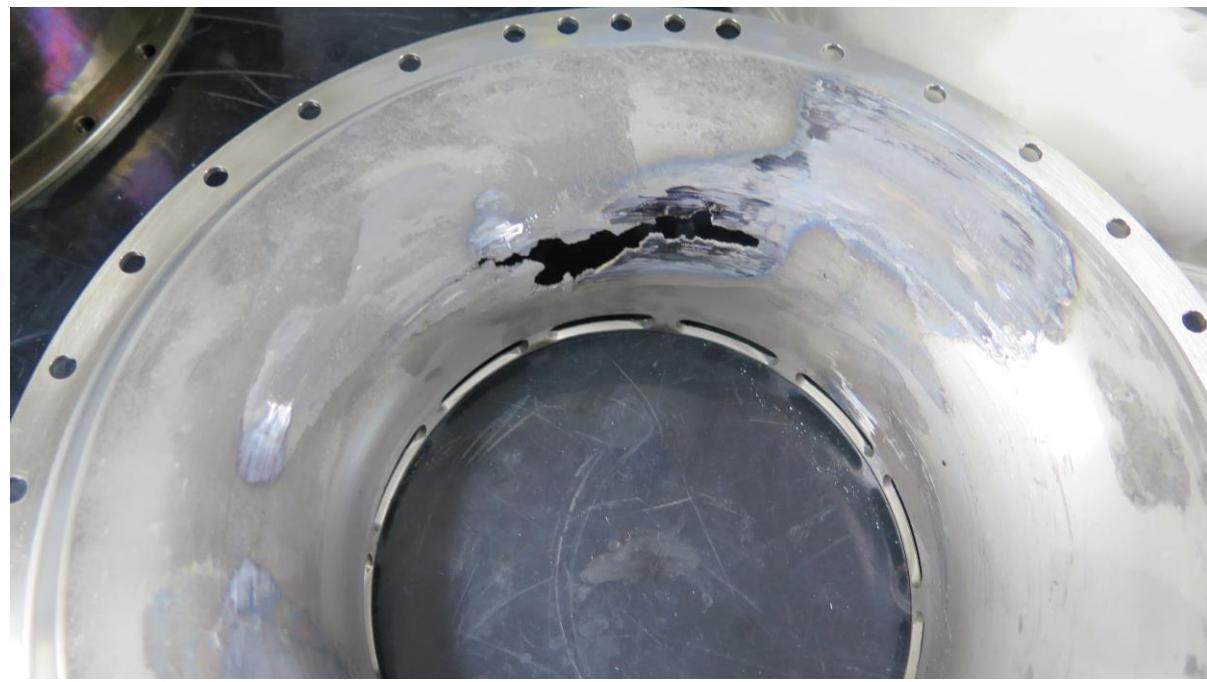
View of compressor cover from compressor side

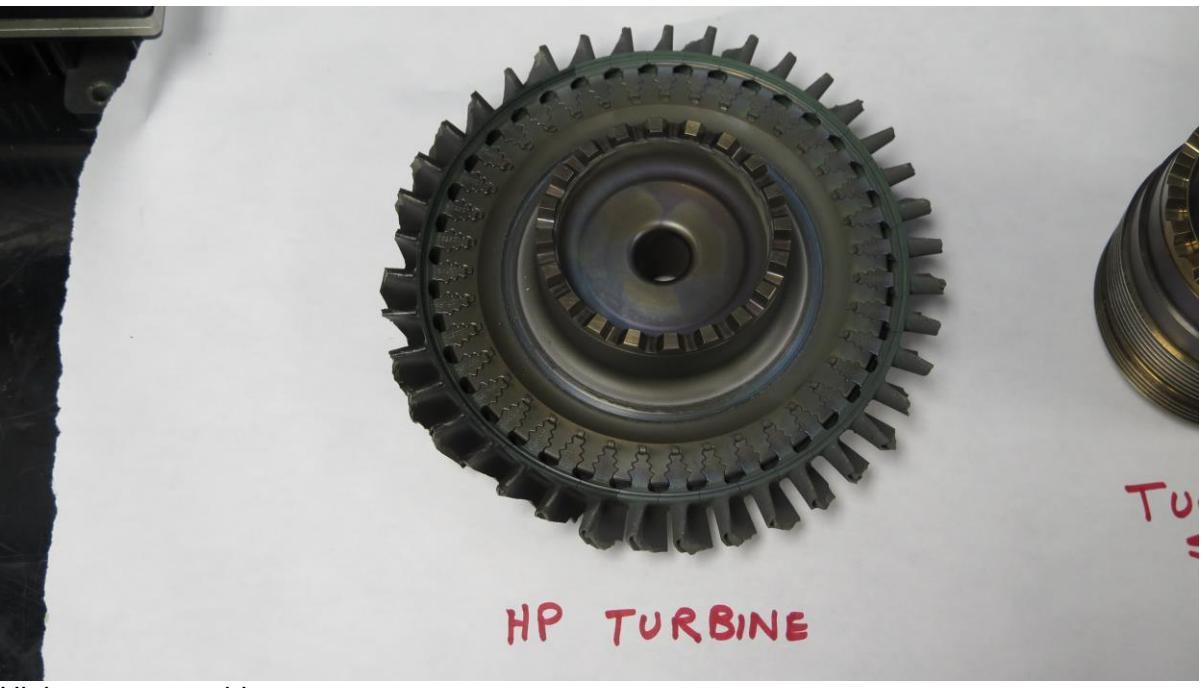
High pressure turbine
