NATIONAL TRANSPORTATION SAFETY BOARD Office of Aviation Safety Washington, D.C. 20594

ADDENDUM 1

SURVIVAL FACTORS GROUP FACTUAL REPORT OF INVESTIGATION

I. <u>ACCIDENT</u> : DCA11IA040

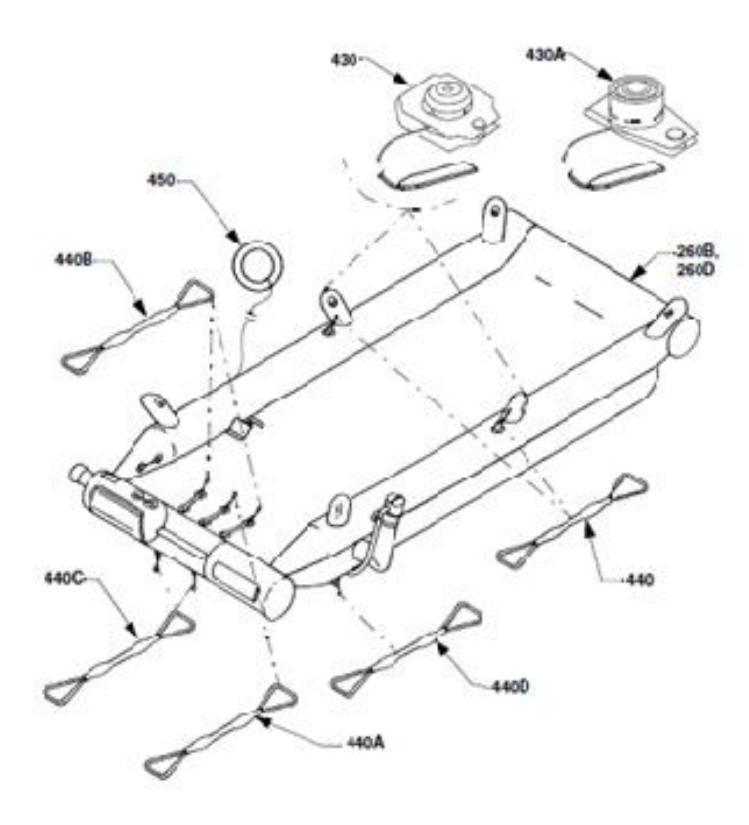
Figure 2. A320 Emergency Evacuation Slide/Raft Frangible Link Locations

The lacing cover cable was inspected and no damage was found. Remnants of safety wire were found at the slide release disk, as was designed to occur when the lacing cover releases from the packboard. The spacing between the lacing covers was in accordance with the OEM packing instruction. The mooring line, normally stored inside the girt was found completely out of the girt and the full length of the line was unraveled. All frangible links except for the frangible links at the toe end of the slide released.

The part numbers on the links that did not release were: C19347-102. The part numbers on the outboard links at the sill end of the slide that had released were both C19347-107, and the center frangible link at the sill end of the slide, which also released, was part number C19347-106. The cross link located at the sill end of the slide at each outboard end of the slide had released and contained part number: C19347-119. Figure 2 shows the locations of the frangible links on the A320 slide/raft.

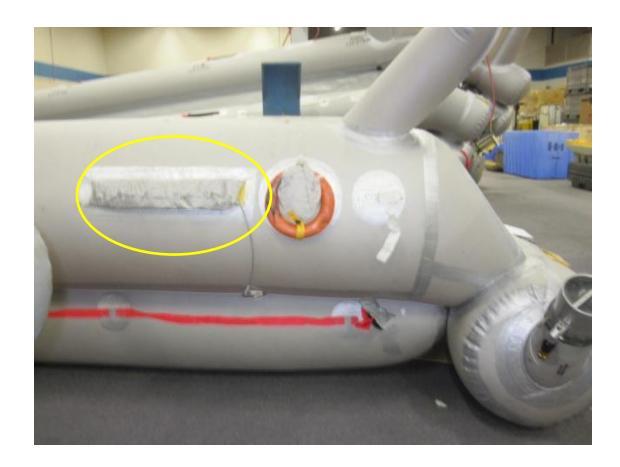
Photograph 1. Sea Anchor Pouch

The sea anchor pouch is mounted on the forward side of the 1R slide/raft and is attached to the slide with a plastic coated stainless steel cable mounted to a fabric loop attached about 12 inches below the sea anchor pouch. The 1R sea anchor cable measured 42.8 inches long. Photograph 1 shows the location of the sea anchor pouch.

Five of the 6 pouch snaps designed to secure the sea anchor were found unsnapped. The snap closest to the sill end of the slide was the only snap that remained snapped. The sea anchor stainless steel cable was found routed through the pouch at the sill end of the pouch and secured by the single snap that remained snapped. The sea anchor and sea anchor line had separated from its pouch and the sea anchor line (similar to the mooring line) ran beneath the slide/raft, wrapped around the inflation bottle gage lead and tube and across the bottom of the slide/raft to the aft aspirator. The sea anchor and remaining sea anchor line were ingested in the aft aspirator.

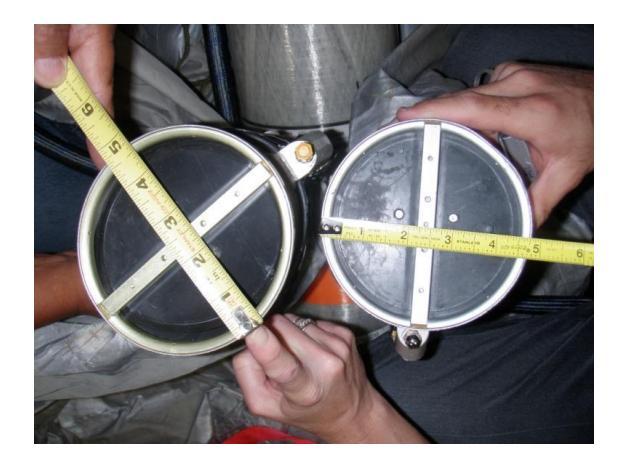
Photograph 2. Comparison of aspirator chamber diameters. Note: forward aspirator (on left) and aft aspirator (on right)

The forward aspirator was compressed such that its inlet was not concentric and the flappers would not fully close. One flapper closed to within 1/2 inch of the seated rim of the aspirator, and the other flapper closed to within 3/4 inches of the seated rim. Pressure was applied to the forward aspirator and the lower tube fully inflated, but quickly lost pressure through the unsealed aspirator flapper valve. The forward aspirator was disassembled, and the lower aspirator mixing tube was dented. The aspirator housing inlet diameter was measured at two different locations. 4.7 inches across the flapper valve hinge, and 4.93 inches parallel to the flapper valve hinge. Photograph 2 shows the difference between the 2L forward and aft aspirators inlets.

The aft aspirator was intact. Pressure was applied to the upper chamber of the slide through the aft aspirator. The upper chamber of the slide fully inflated and held pressure. The aft aspirator measured 4.8 perpendicular to the flapper valve hinge and 4.85 parallel to the flapper valve hinge.

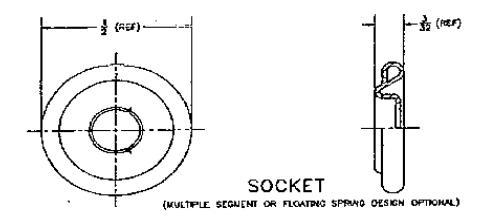
Figure 3. MS27982 Snap Socket Design Dimensions

The height of the socket lip is designed to be formed to 3/32 (.0937.) The 1R sea anchor pouch snap socket lip measured an average of .100 inch, and the 2L pouch snap socket lip measured an average of .0920 inch. Because the design of the MS27982 socket creates a flexible receptacle for the snap stud the formation of the 3/32 lip around the diameter of the socket can result in variable socket inside (ID) diameters. Therefore, each socket ID was measured on each snap on the 1R and 2L slide/raft sea anchor pouch. Table 1 below shows the dimensions recorded at each socket with snap position 1 corresponding to the toe end of the slide, and position 6 corresponding to the sill end (closest to the heaving ring) of the slide:

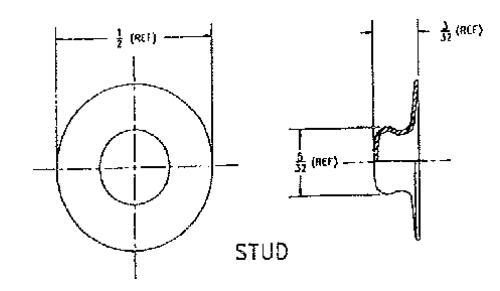
Figure 4. MS27982 Snap Stud Design Dimensions

Each snap stud was required to be 5/32 (.156) inch diameter and 3/32 (.094) inch long. The 1R slide/raft pouch snap stud measured an average of .156 long, and the 2L slide/raft pouch snap stud varied between .166- .191 inch long. Figure 4 shows the design dimensions for the MS27982 snap stud.
