Survival Factors Factual Report Attachment 1

Railroad:National Railroad Passenger Corporation (Amtrak)TrainTrain 89Location:Chester, PennsylvaniaDate:April 3, 2016Number:DCA16FR007

Car 82524 – Train 89 – Investigation

Car 82993 – Train 89 – Investigation

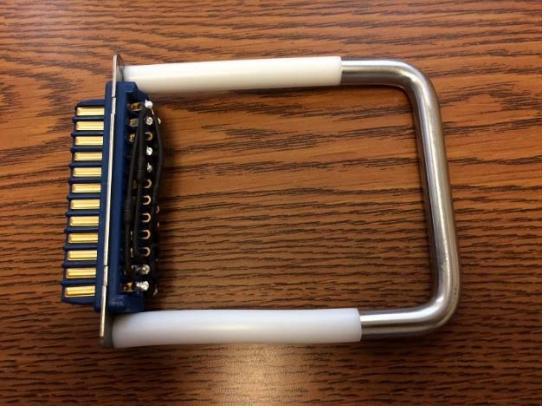
Photo – PA Trainline Tester

But, the combination of burned and disfigured pins at the PA shoe, did not allow the tester to work properly. To work around this problem, we performed a line-by-line continuity check from the trainline receptacle to the PA enclosure. This portion of the investigation revealed the issue of the incorrectly wired trainlines. The Voice output of the PA (T/L 3 & 4) was swapped with the Radio output of the PA (T/L 9 & 10). This is visually explained by examining marked-up schematic diagram D-04-414, Sheet 22 (attached).

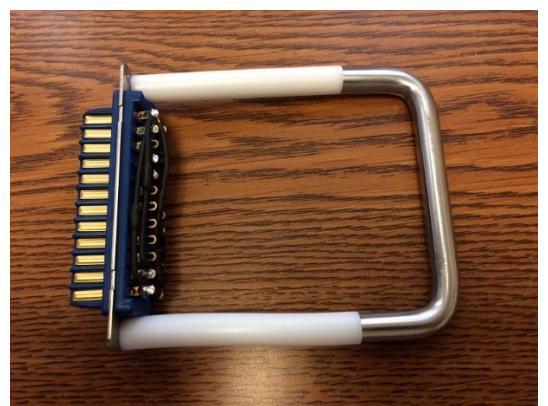
Photo – PA Trainline Tester

The MPT tester has been programmed to measure trainline continuity at 10 Ohms or less, and test report Lines 57 – 80 meet that criteria. After good continuity through the car was verified, the PA tester was inserted into the PA shoe. Resistance readings were then taken at the B-end, left and right side COMM receptacles. The numbers indicated that the trainlines running from the PA enclosure to the undercar junction box were intact, and wired correctly. Please reference drawings "PA Trainline Tester" and 020-XXXXX for more information.

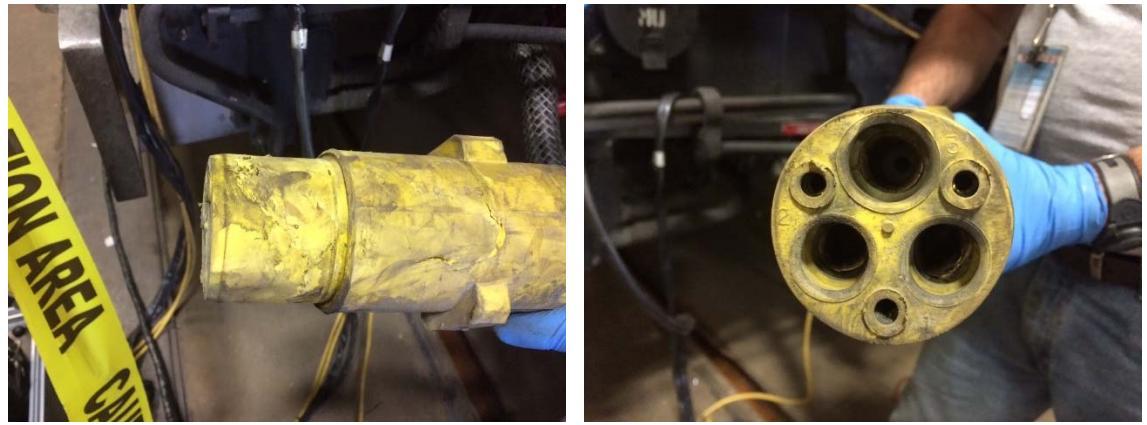
The 480 Volt trainlines could not be tested due to the damaged plugs on the A-end of the car. See photos below.

Photos – Damaged 480 Volt Trainline Plug on A-end of Car 82993
