### NATIONAL TRANSPORTATION SAFETY BOARD

### **UAS Aerial Imagery Factual Report**

### A. <u>ACCIDENT</u> CEN18FA078

Location:	Raton, New Mexico
Date:	January 17, 2018
Time:	1800 Local Time (MST)
Event:	Bell UH-1H N658H CFIT

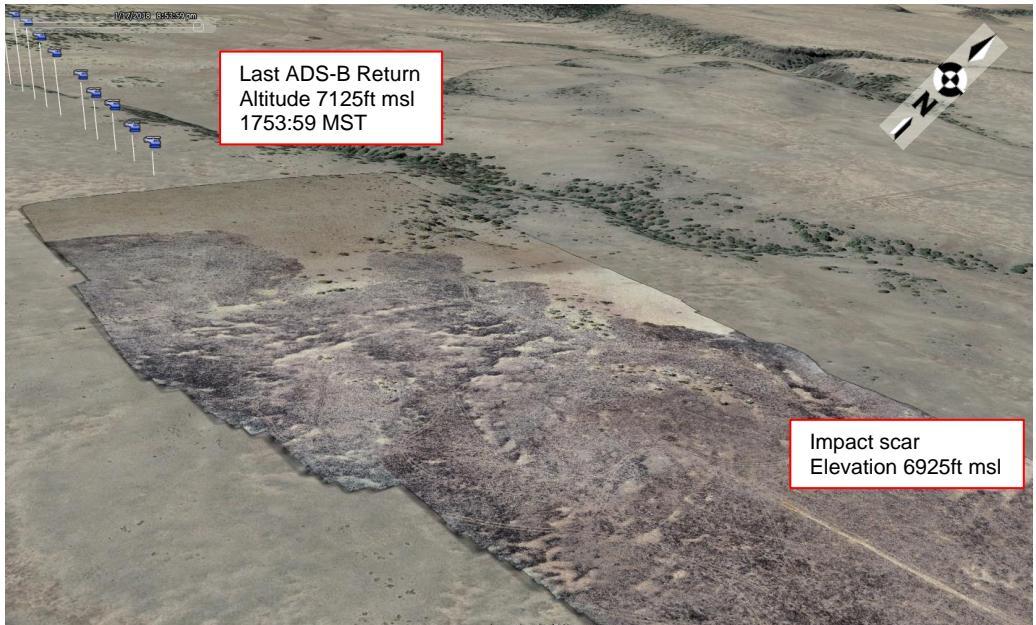
Figure 1 – Flight Path of Helicopter, source: ADS-B

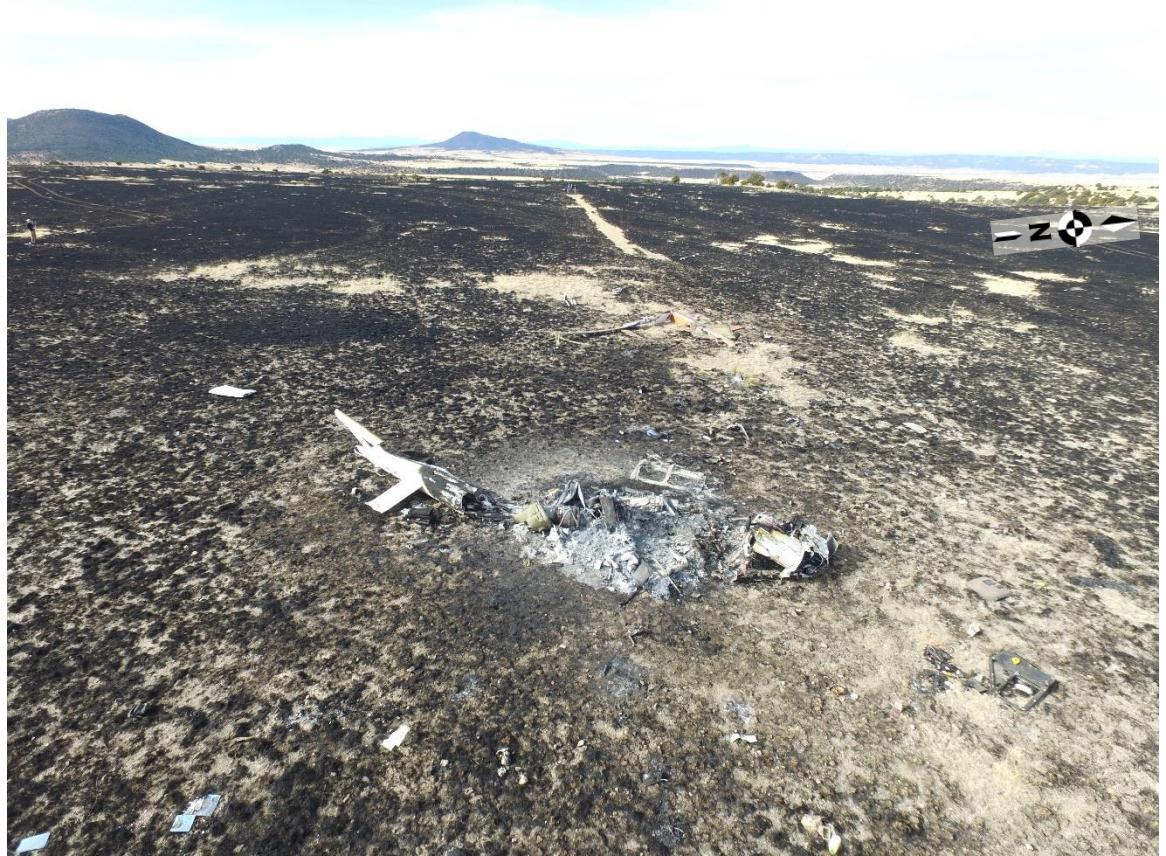
Figure 2 – Wreckage looking back toward impact scar

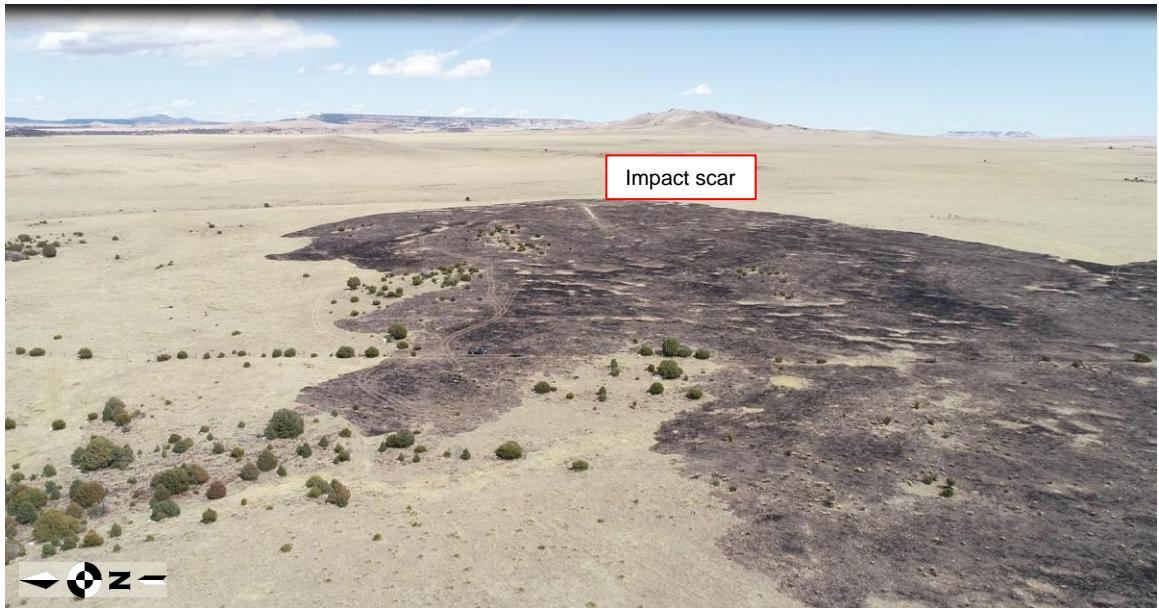
Figure 3 – View along route of flight toward impact during daylight

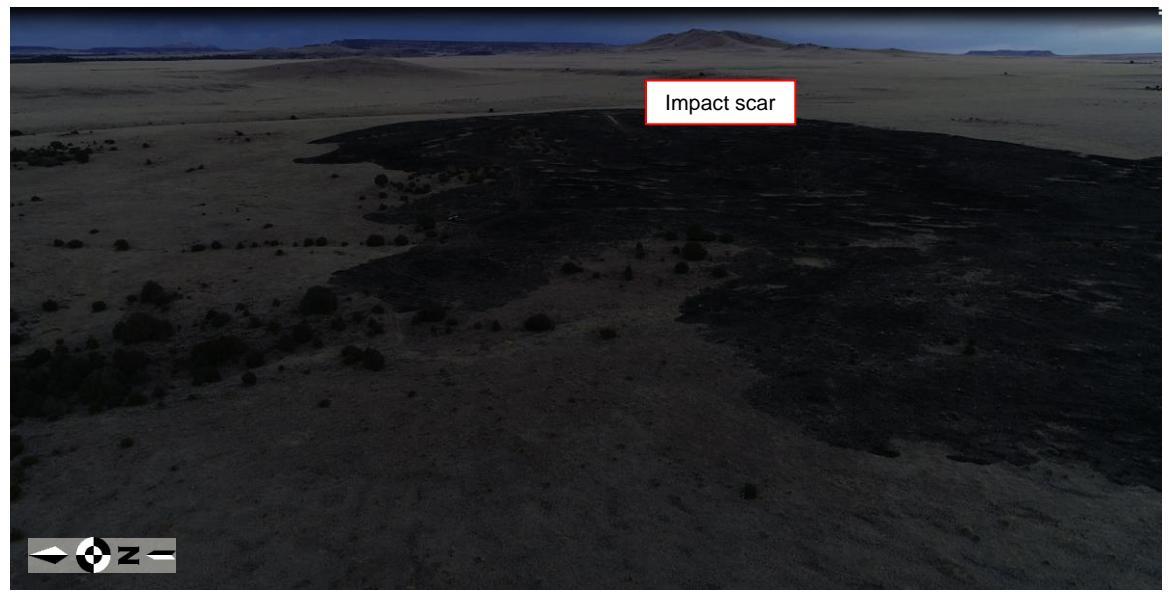
Figure 4 – View along route of flight toward impact at sunset

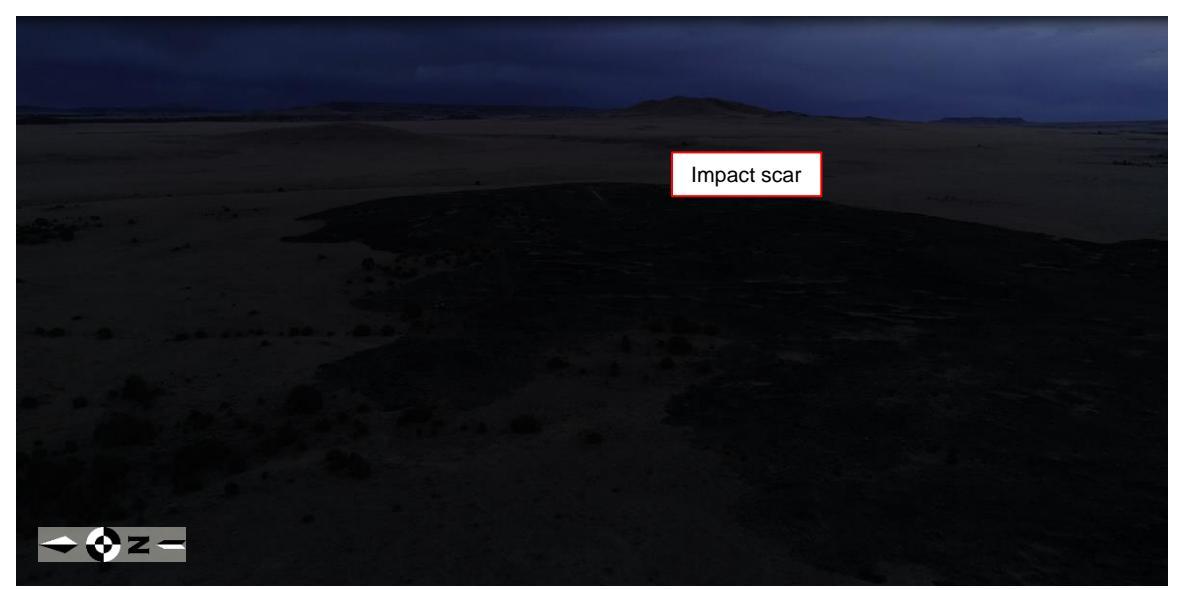
Figure 5 – View along route of flight toward impact during twilight
