NATIONAL TRANSPORTATION SAFETY BOARD

UAS Aerial Imagery Report

A. ACCIDENT CEN18FA132A/B

Location: Marion, Indiana
Date: April 2, 2018
Time: 1725 Local Time (EDT)
Event: Collision N5614E C150/N511AC C525

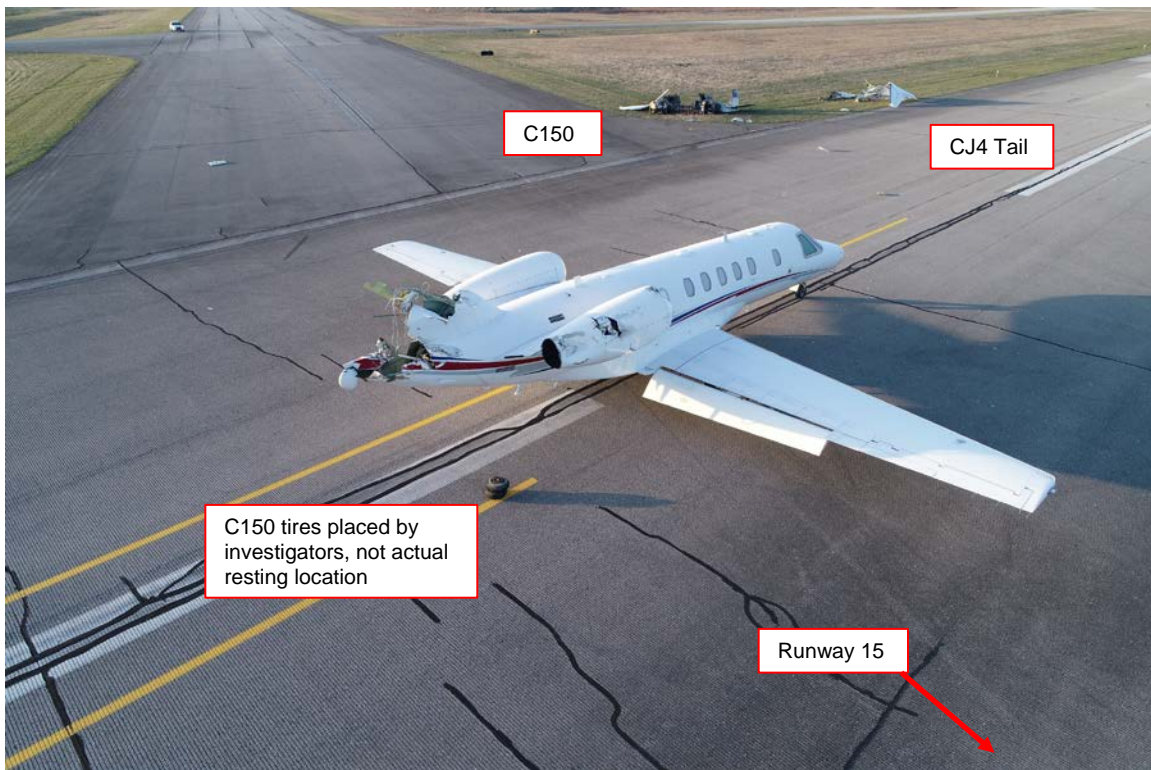
Figure 1 – CJ4 moved by investigators to the approximate location of collision, C150 and CJ4 tail in background

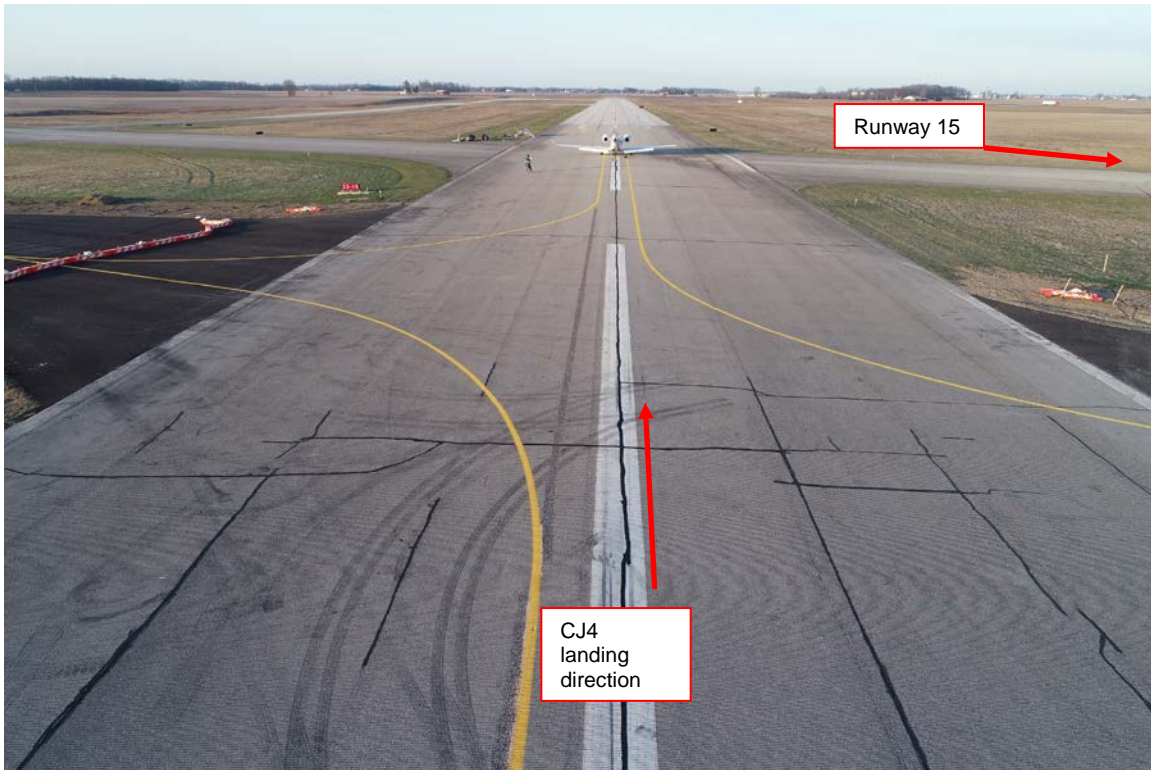
Figure 2 – View along Runway 22 toward collision point

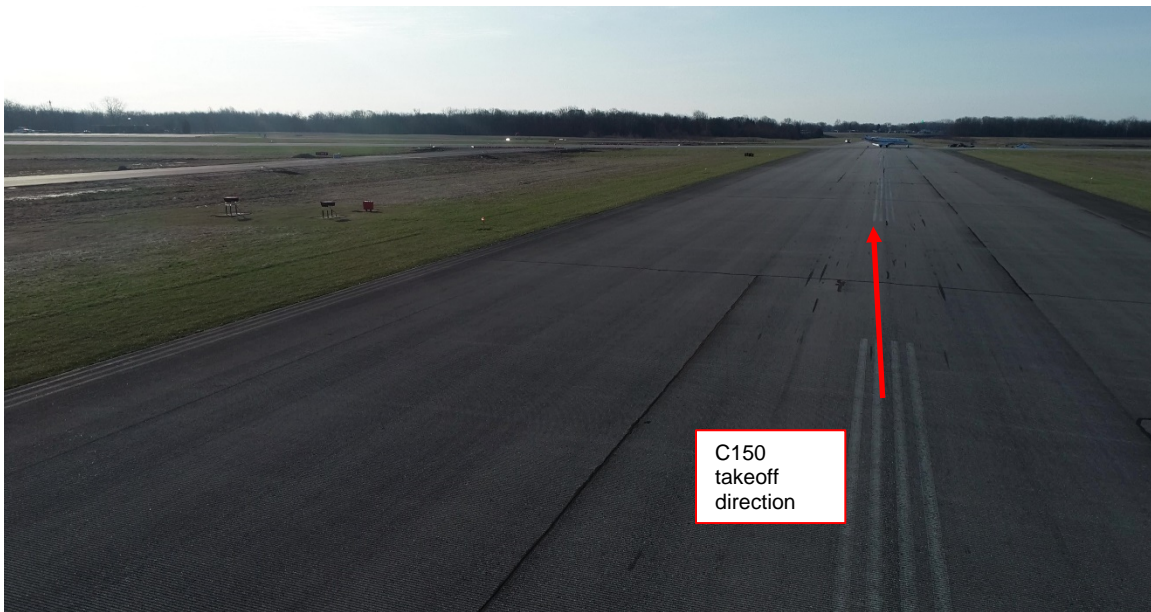
Figure 3 – View along Runway 15 toward impact (note: sun angle not the same as accident time)

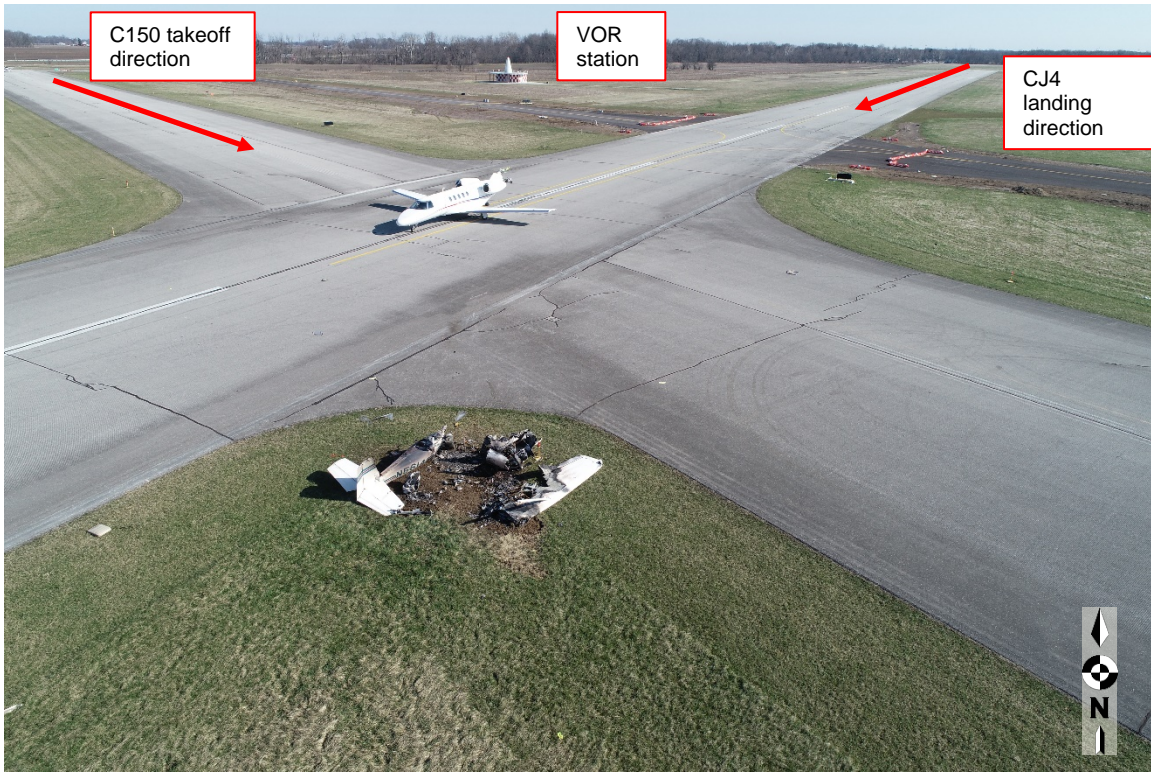
Figure 4 – View of wreckage looking towards VOR station

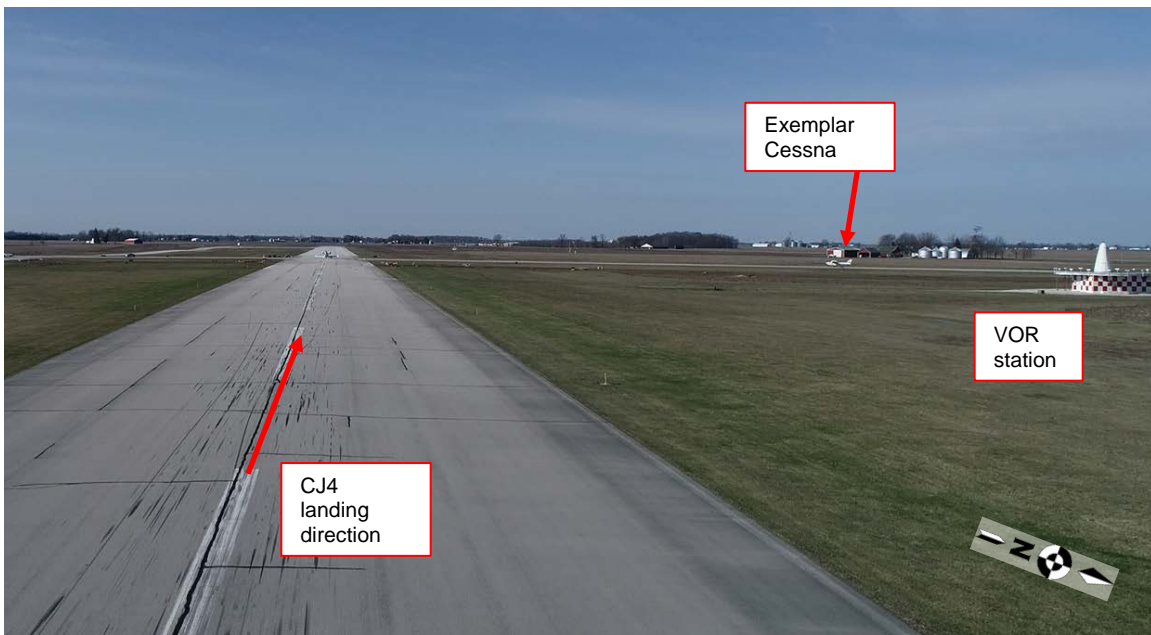
Figure 5 – Frame from video of runway 22 viewpoint from over 1000-foot fixed distance marker, with exemplar Cessna on runway 15

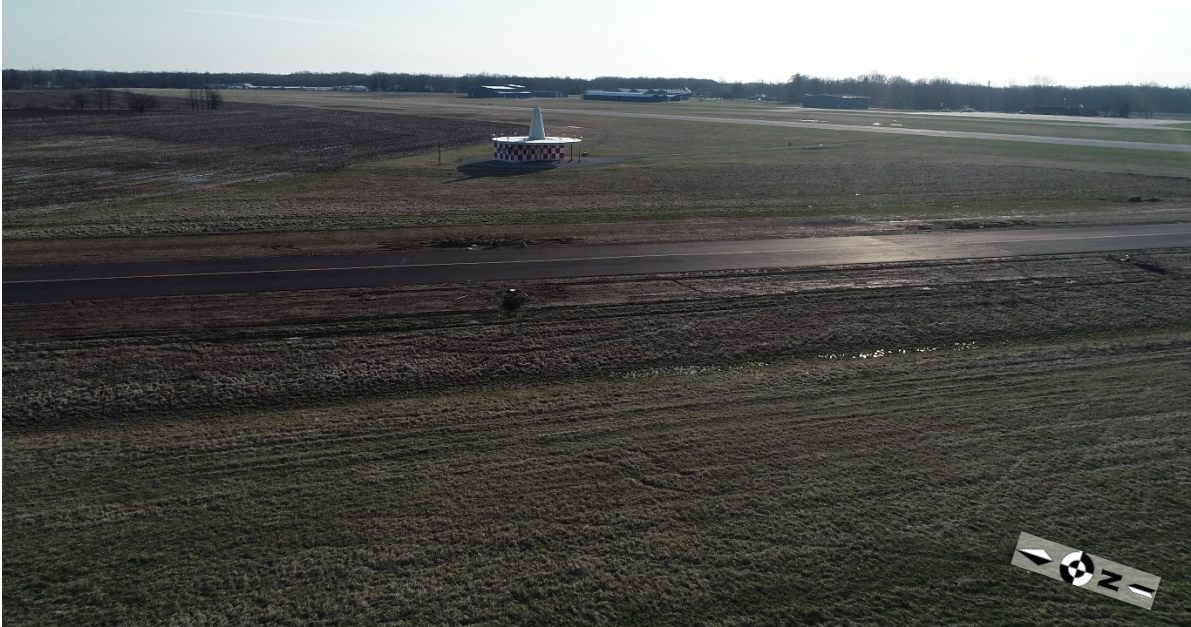
Figure 6 – Frame from video above runway 15 (higher than C150) toward runway 22 showing VOR

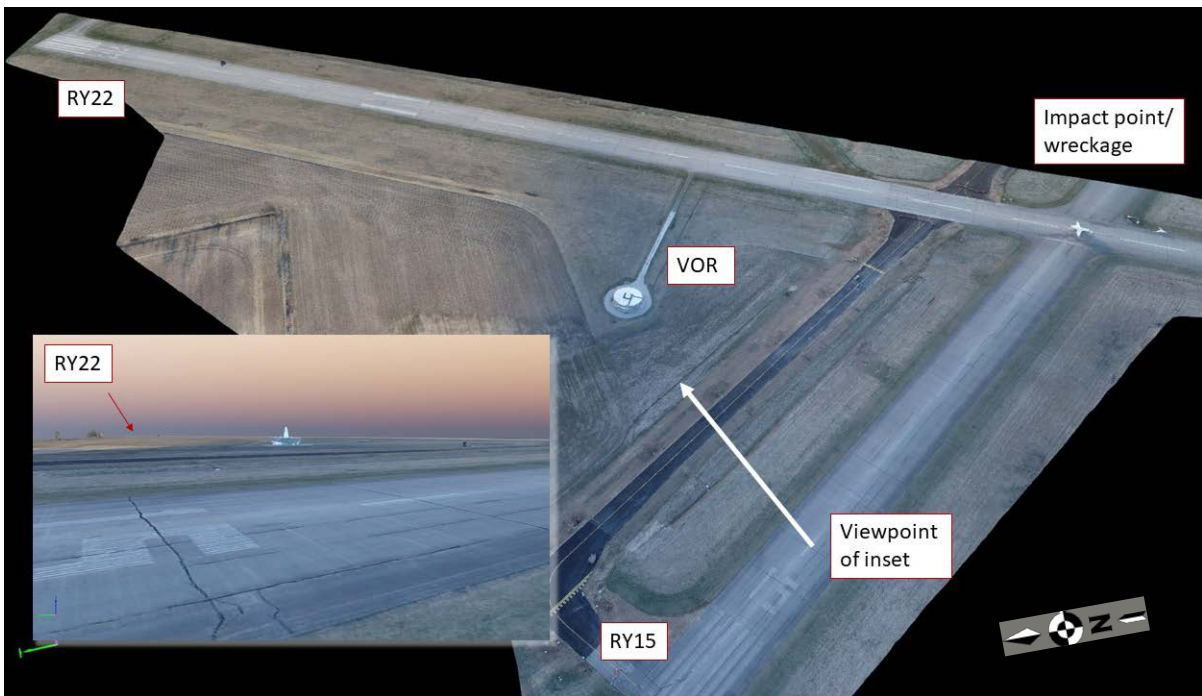
Figure 7 – Excerpt of 3D point cloud with sample viewpoint from vicinity of runway 15

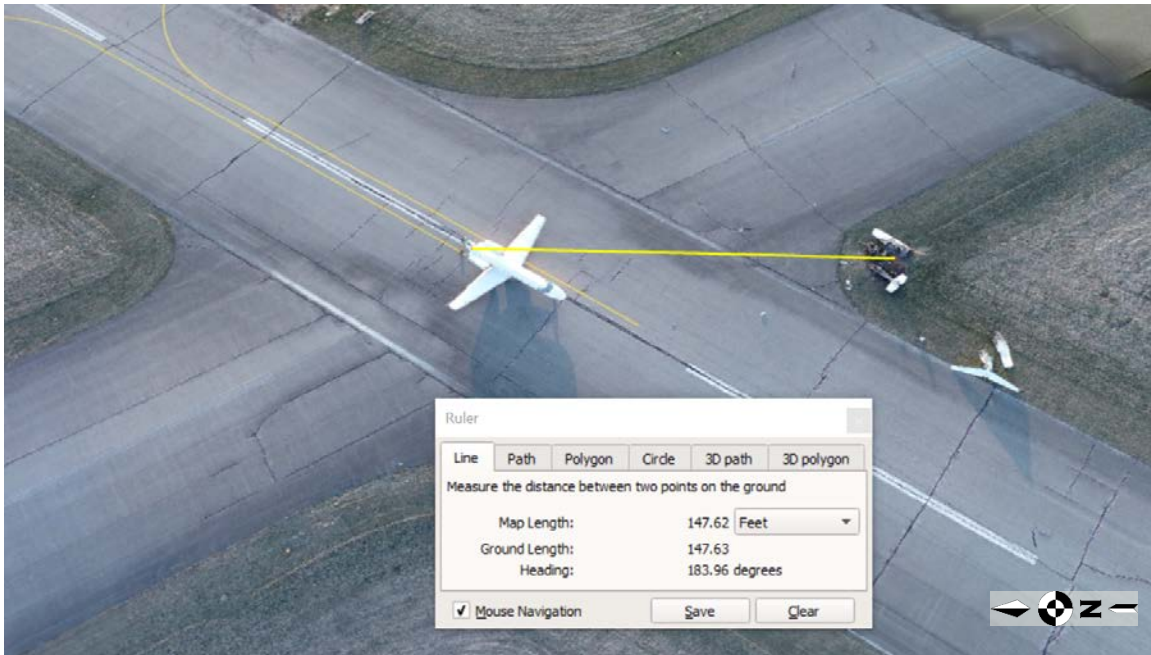
Figure 8 – Snip of orthomosaic overlaid on Google Earth showing measurement between CJ4 tail and C150

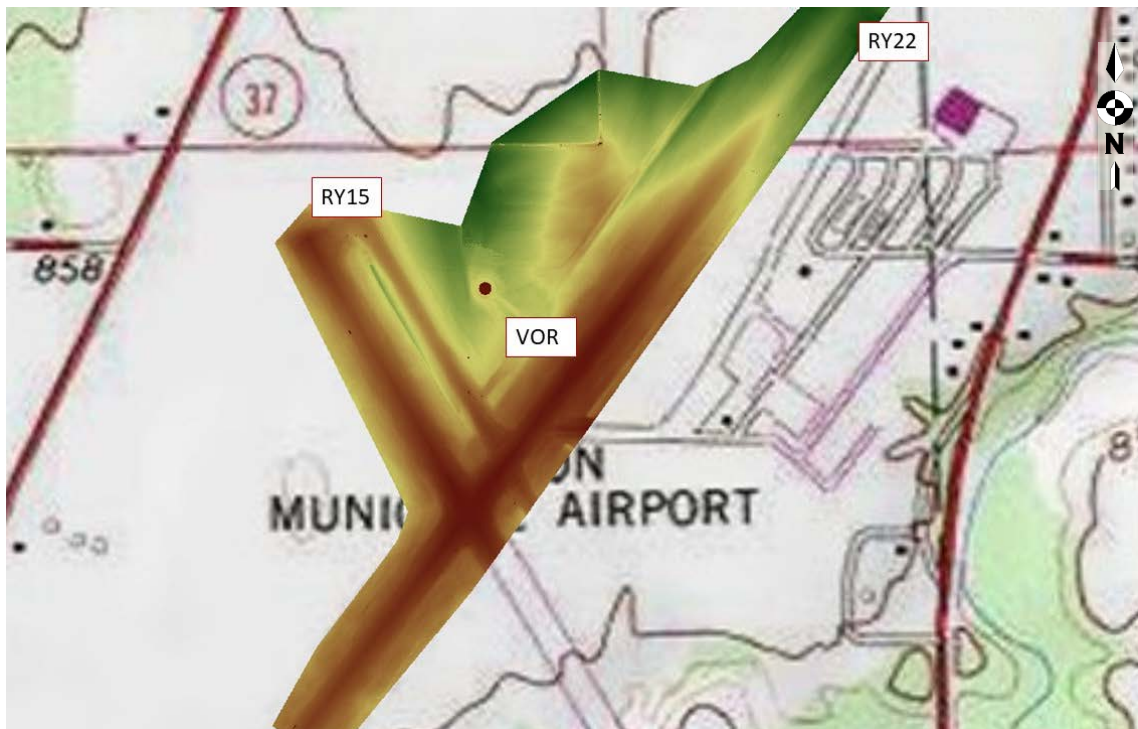
Figure 9 – Digital surface model overlaid on topographic chart, red indicates higher elevations, green lower. Note the elevation difference between the runway thresholds.

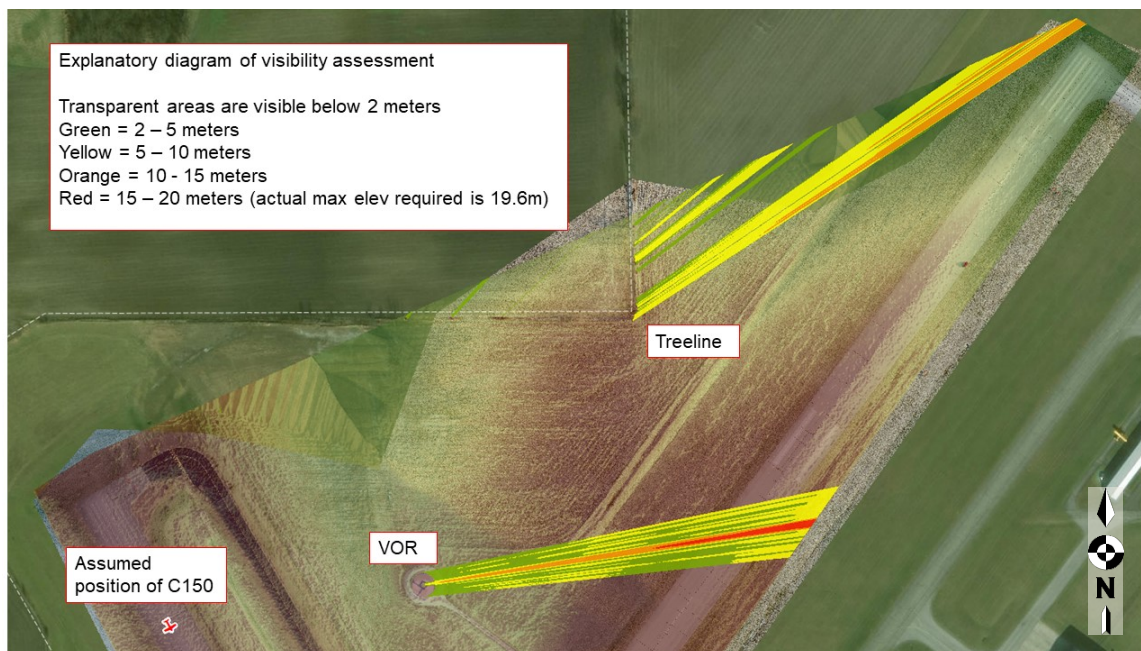
The below diagram (Fig 10) explains the visibility assessment. Map layers include:

For example, for an object in the orange colored area to the northwest of the runway 22 threshold to be visible to the C150 assumed position, it would need to be at least 10-15 meters above the underlying terrain.

Figure 10 – Explanatory diagram of visibility assessment.

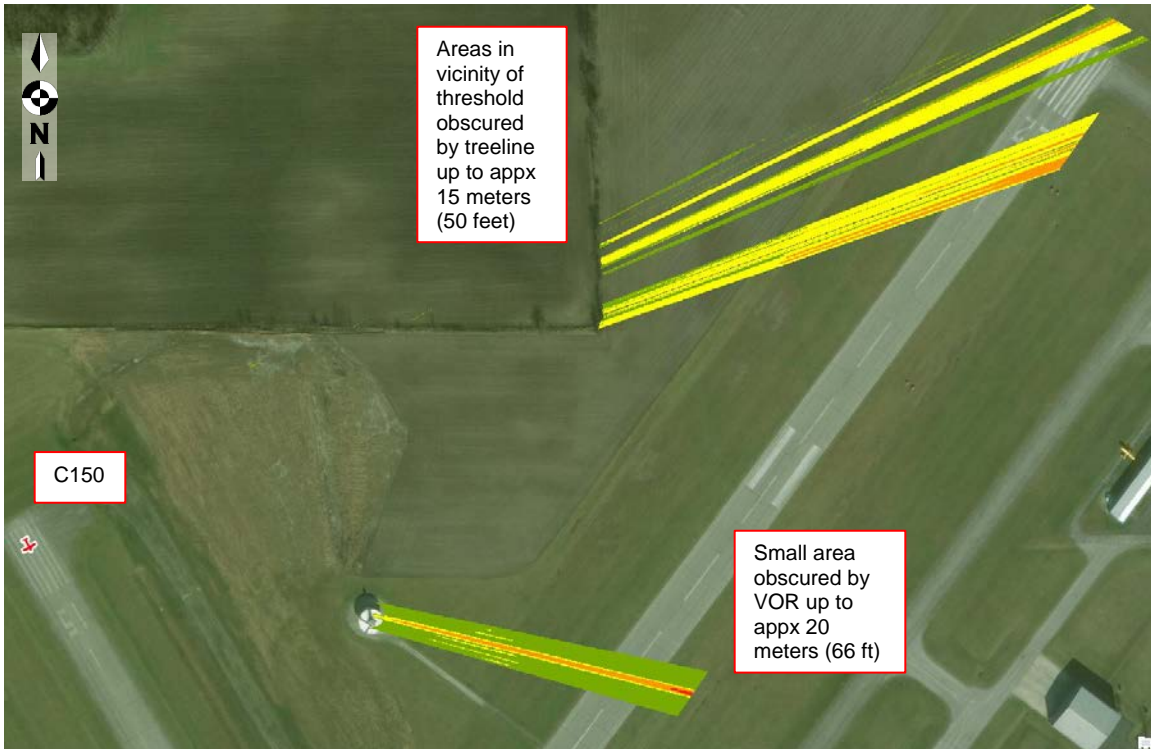
Figure 11 – Visibility assessment with C150 at runway 15 threshold.

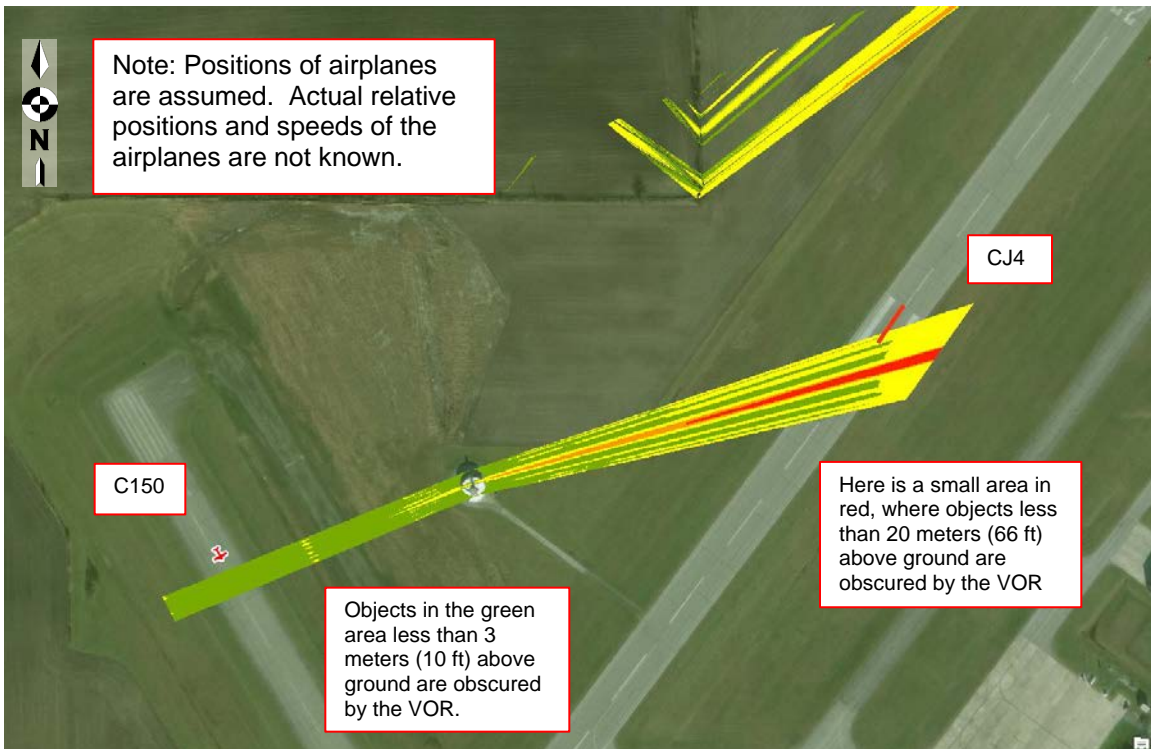
In the below assessment, the mutual viewpoints between the C150 and an assumed CJ4 position were calculated. The CJ4 was processed as a line of observer points to account for the higher speed compared to the C150.

Figure 12 – Mutual visibility assessment.
