VEHICLE DATA RECORDERS SPECIALIST'S FACTUAL REPORT

Flushing-Queens, New York

HWY17MH015

NATIONAL TRANSPORTATION SAFETY BOARD

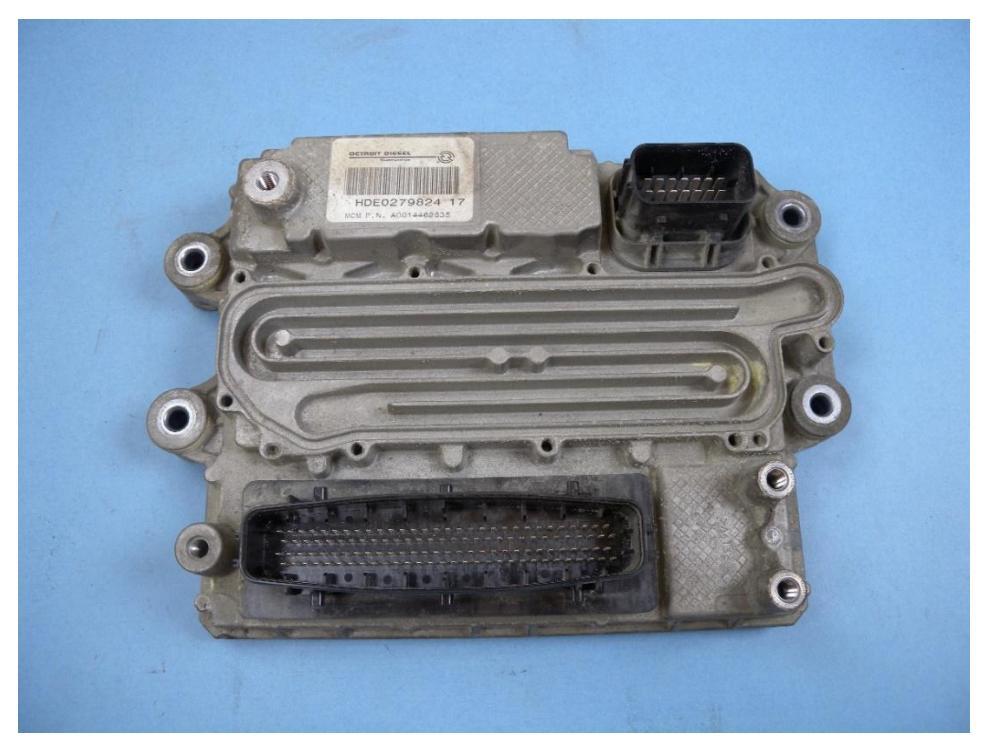
Vehicle Recorder Lab for evaluation. An exterior inspection of both modules revealed the devices had sustained no overt mechanical damage. To prevent the over-writing of any existing fault code records, the CPC module was downloaded using a vehicle forensic adapter which simulated the vehicle network. Using this forensic adapter, the manufacturer's standard software was used to obtain the hard brake, last stop record, and diagnostic fault code records. Recovery and download of any error message data that may be resident in the MCM but not reported to the CPC module will be the subject of a follow-on report. Figures 1 and 2 show the modules as-received.

Figure 1. DDEC 10 MCM2.1 as removed from the MCI motorcoach.

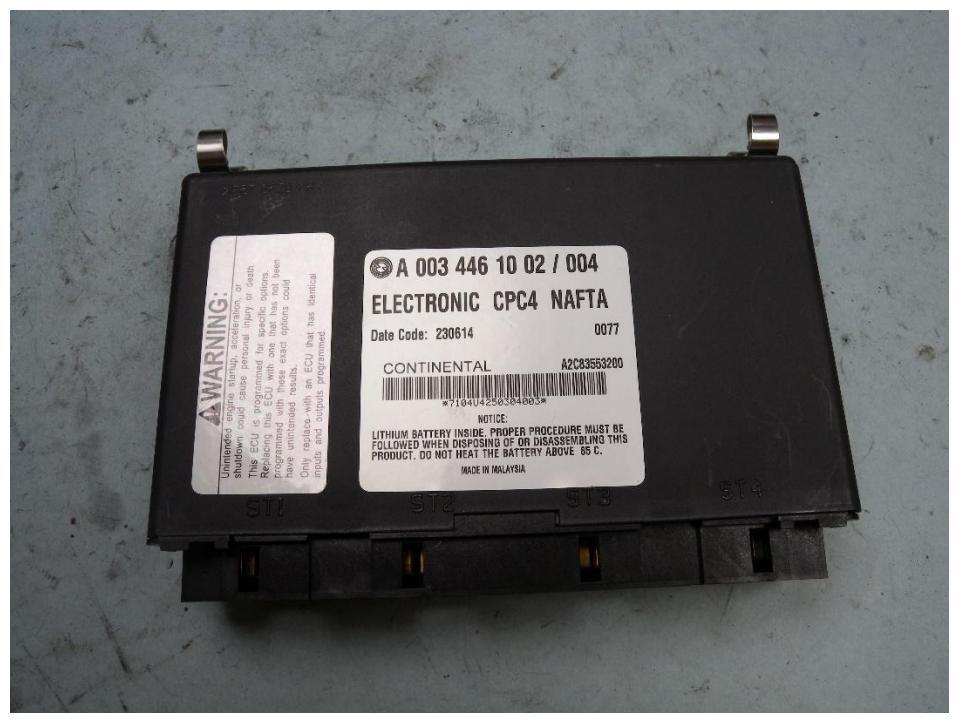
Figure 2. Continental CPC4 as removed from the MCI motorcoach.

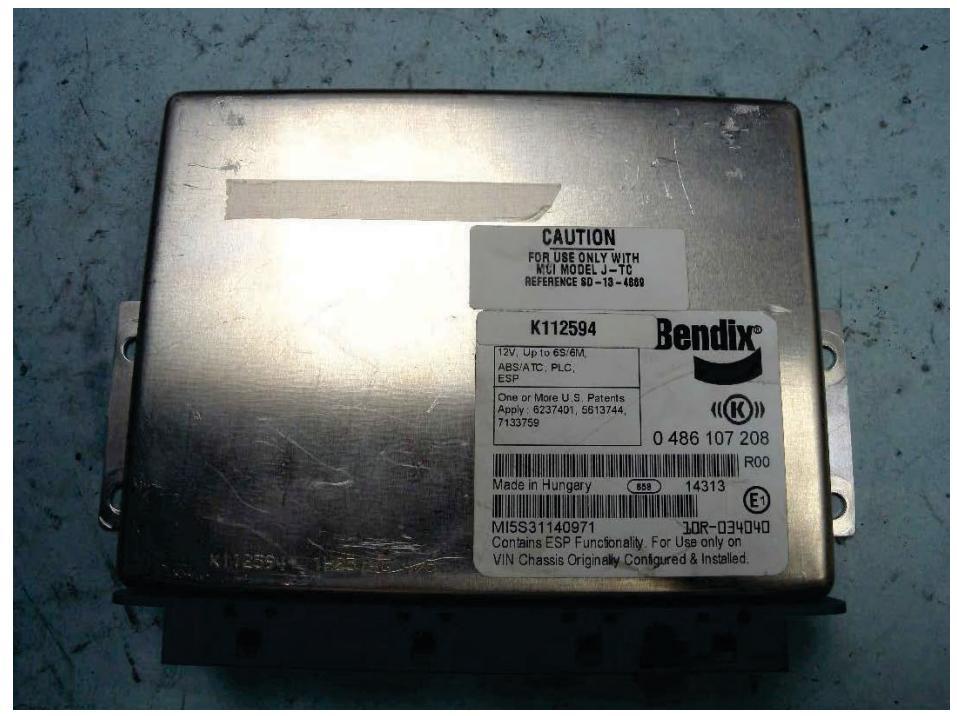
Figure 4. Bendix EC60 ABS as removed from the MCI motorcoach.

The EC60 was removed and sent to the Vehicle Recorder Lab for evaluation. An exterior inspection revealed the device had sustained no overt mechanical damage. The manufacturer's standard software⁵ was used to obtain the EC60 Event report including active and inactive diagnostic trouble codes (DTC), ESP counters related to levels of electronic stability system engagement; and a basic Wingman[™] report including active cruise with braking (ACB) status information.

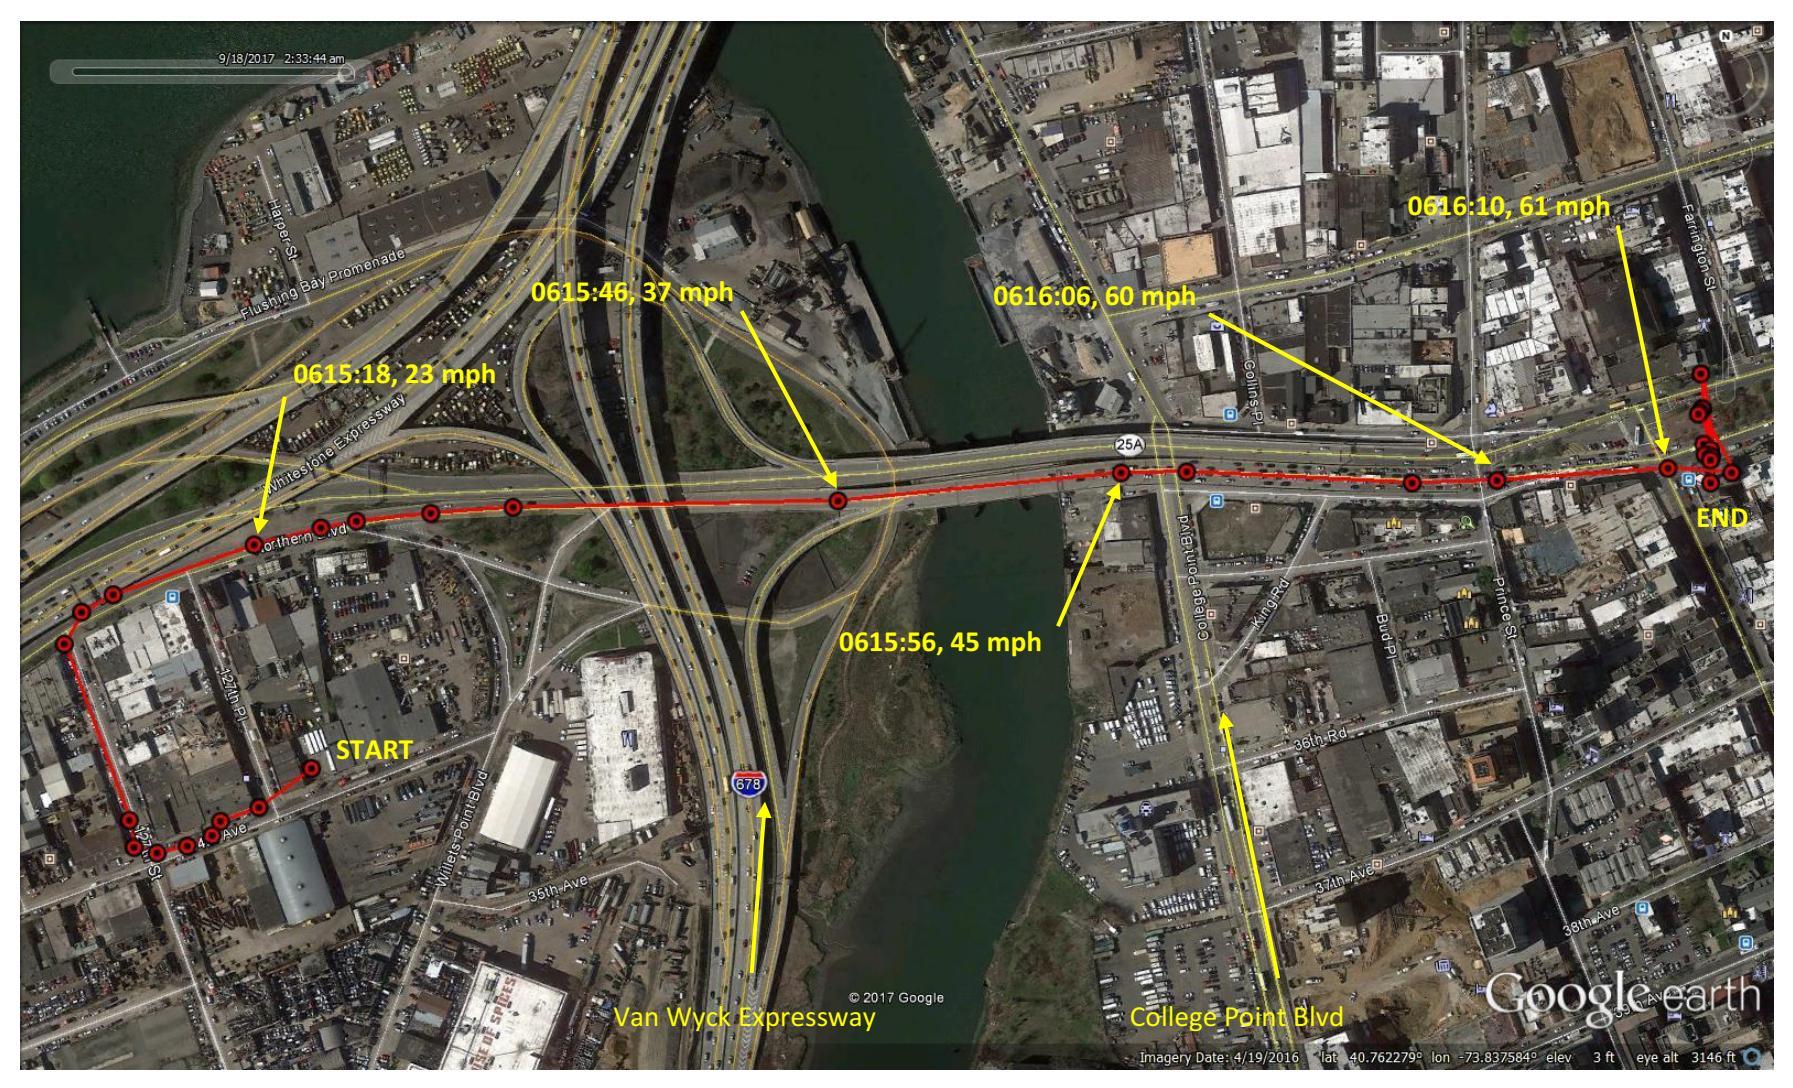
Track log data was downloaded from the TracManager servers using Dhalia's standard login. A Google Earth plot of this data is given as figure 5. The track log started at 0611:19 EDT with the MCI motor-coach in the Dahlia yard. Thirty-five points were recorded over the course of the 22 minute, 25 second long track log. The update rate of the GPS track data varied from 1 point per second, to 1 point per 164 seconds. Speeds during the drive were below 30 mph until the vehicle crossed the bridge under the Van Wyck Expressway. Starting at 0615:46 EDT, as the vehicle crossed under the expressway and approached College Point Blvd, it began to accelerate to a recorded maximum of 61 mph just prior to the crash; which occurred at approximately 0616:10 EDT. The vehicle was travelling at an average of 60 mph for approximately 10 seconds prior to the crash. The system continued to send and record GPS data for about 17 ½ minutes after the crash with a spread of latitude / longitude positions consistent with standard GPS measurement accuracy. The last GPS position was recorded at 06:33:44 EDT.

Figure 5 shows the TracManager data related to the 2015 MCI J4500 motorcoach described in section 3.1.1 above. The recorded track is shown in red. The weather and lighting conditions depicted in this figure do not necessarily correspond with the weather and lighting conditions present at the time of the crash.

Figure 5. Google Earth overlay showing MCI motor-coach drive from Dhalia yard to crash site. Time is expressed in EDT

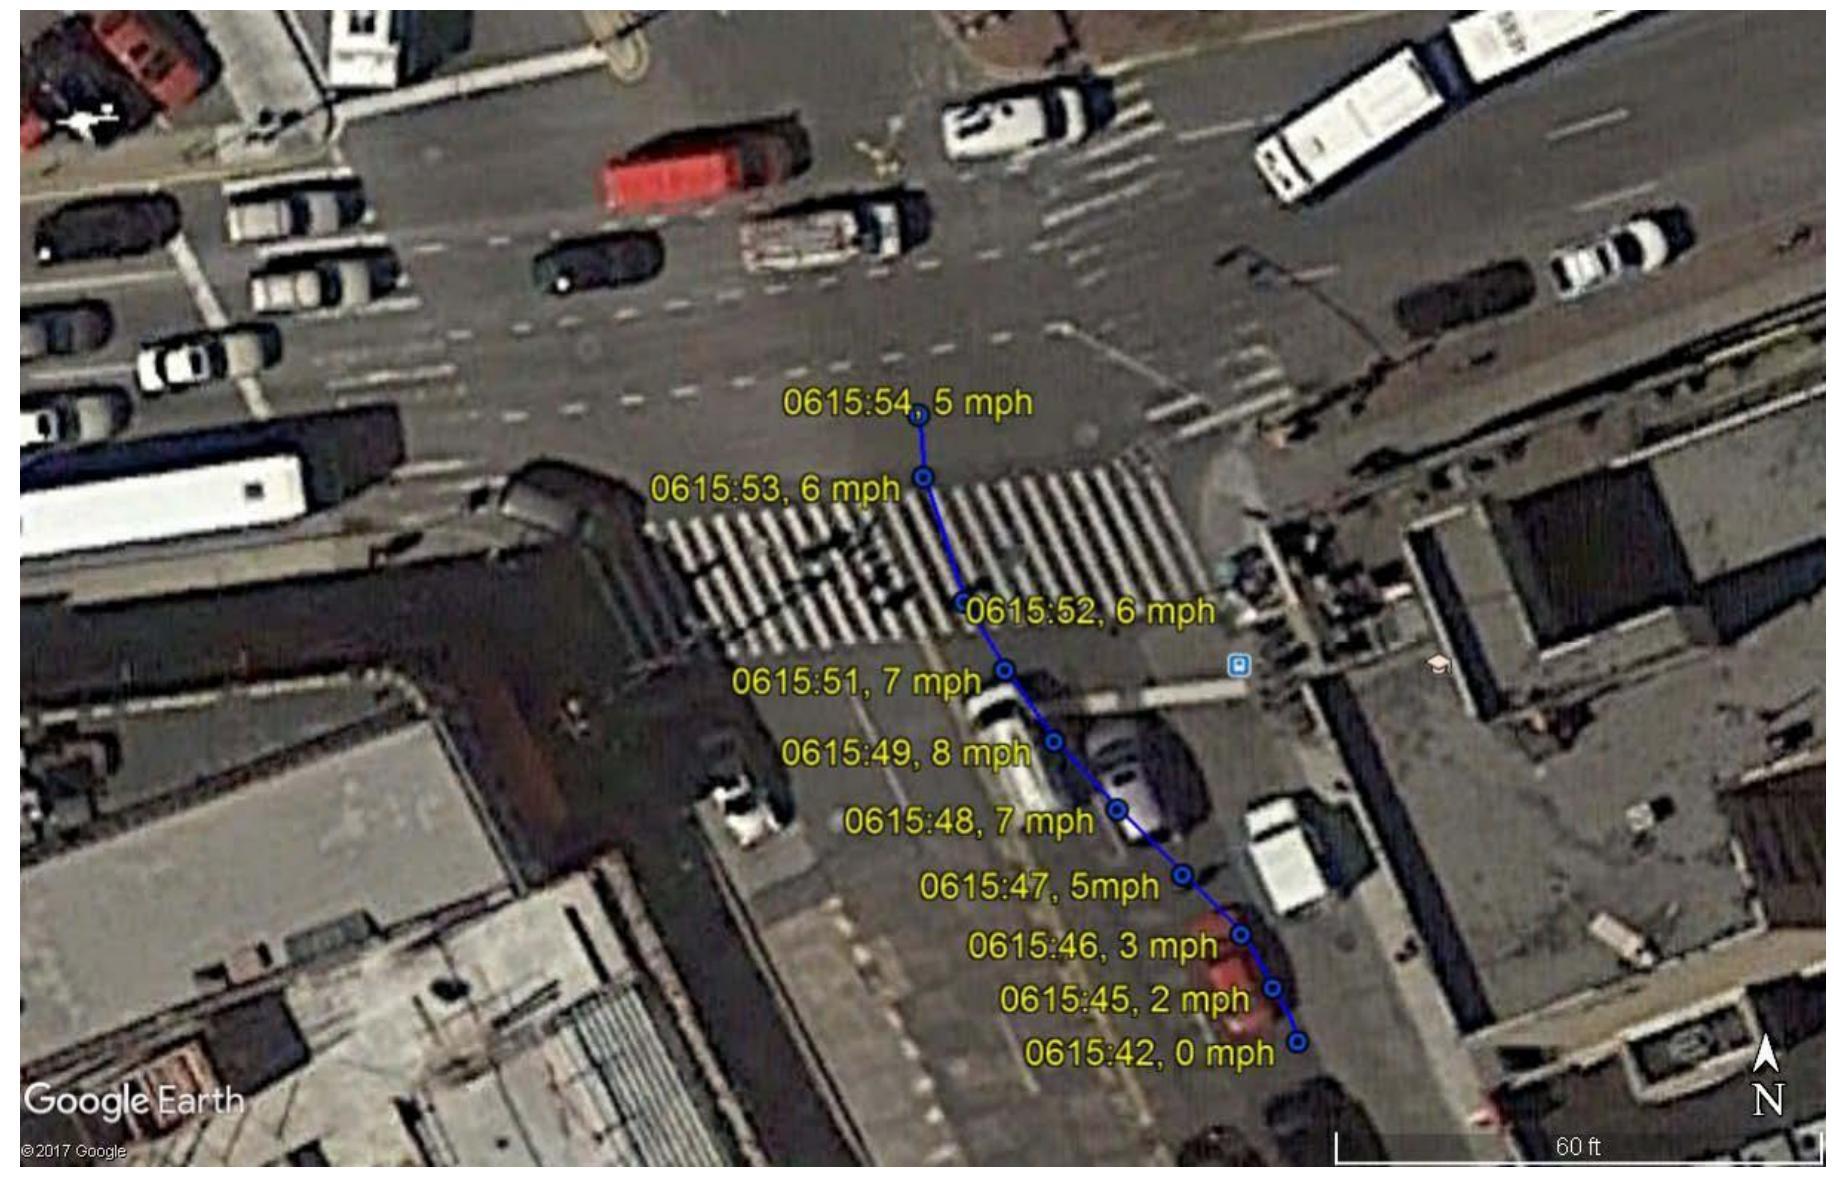
Clever Devices engineers in conjunction with the NYMTA recovered additional data recorded after the downloaded last stop reports. This data included 44 system messages that included timestamps and latitude / longitude information. GPS latitude / longitude information is plotted in figure 6 showing MTA transit bus position during the last 14 seconds of recovered data. The source of the timestamp information is being researched and timing correlation for this data will be the subject of a follow-on report.

Figure 6 shows the Clever Devices data related to the 38-passenger MTA transit bus described in section 3.4.1 above. The recorded track is shown in blue. The weather and lighting conditions depicted in this figure do not necessarily correspond with the weather and lighting conditions present at the time of the crash.

Figure 6. Google Earth overlay showing position of the MTA transit bus during the last seconds prior to the crash. Time is expressed in EDT.
