From:	Eick Donald
To:	Boggs Daniel
Cc:	Helson David
Subject:	Williston, FL Weather
Date:	Tuesday, April 18, 2017 9:08:56 AM
Attachments:	image001.png
	image011.png

Weather Conditions on April 15, 2017 surrounding Williston, Florida

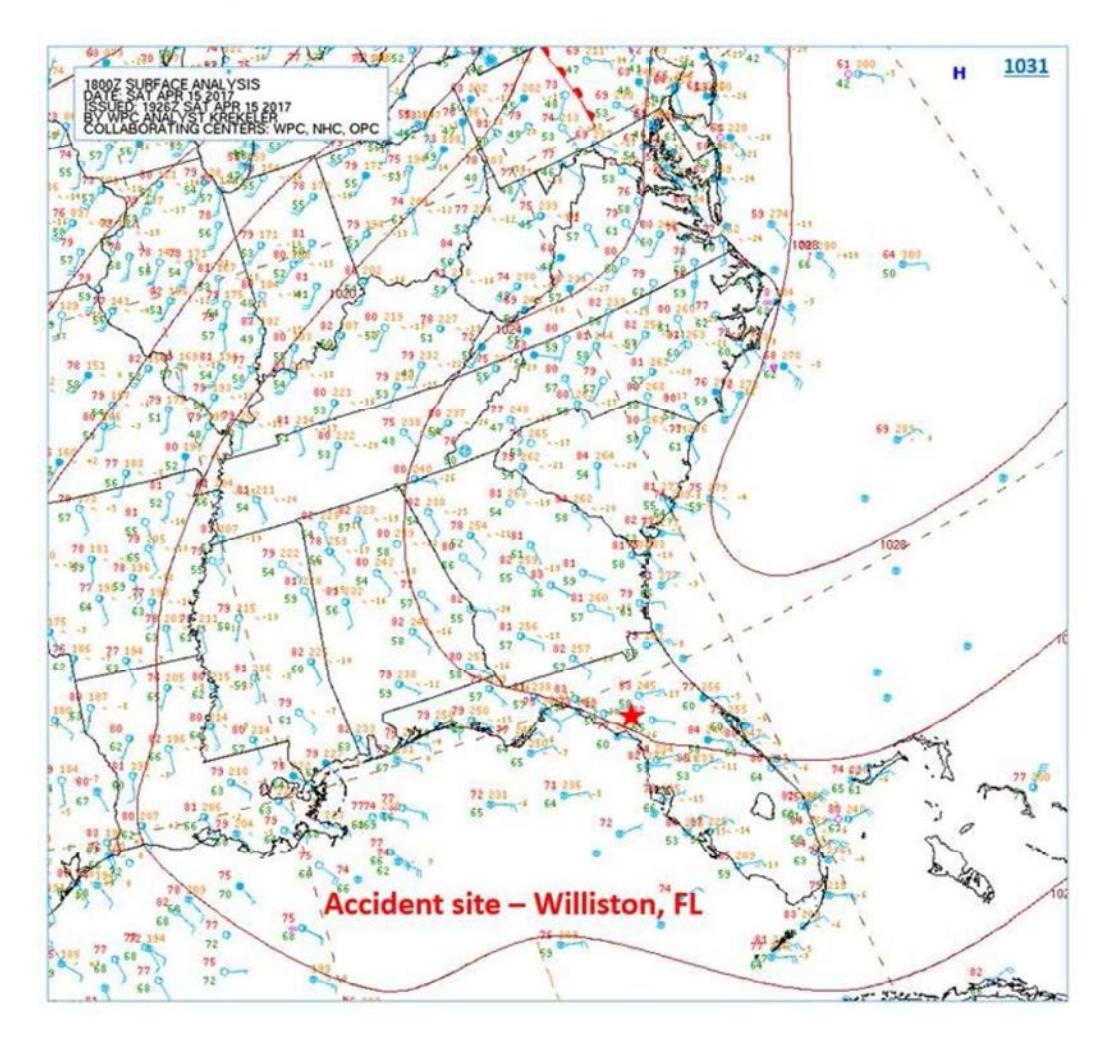
Synoptic conditions – The NWS Surface Analysis Chart for 1400 EDT (1800Z) on April 15, 2017 is included. The chart depicted a high pressure system at 1031-hectopascals off the east coast with a ridge of high pressure extending southwestward into northern Florida. The station models depicted generally easterly winds at 10 to 20 knots across the region with partly cloudy skies, temperatures in the 80's (°F), with dew point temperatures in the 50's.

A review of the National radar mosaic indicated no weather echoes over the region immediately surrounding the period of the accident. A review of the NWS Storm Prediction Center (SPC) Convective Outlook indicated no thunderstorms were forecast over the region, so thunderstorms were rules out. The absence of any weather echoes also ruled out any microburst threat over the area.

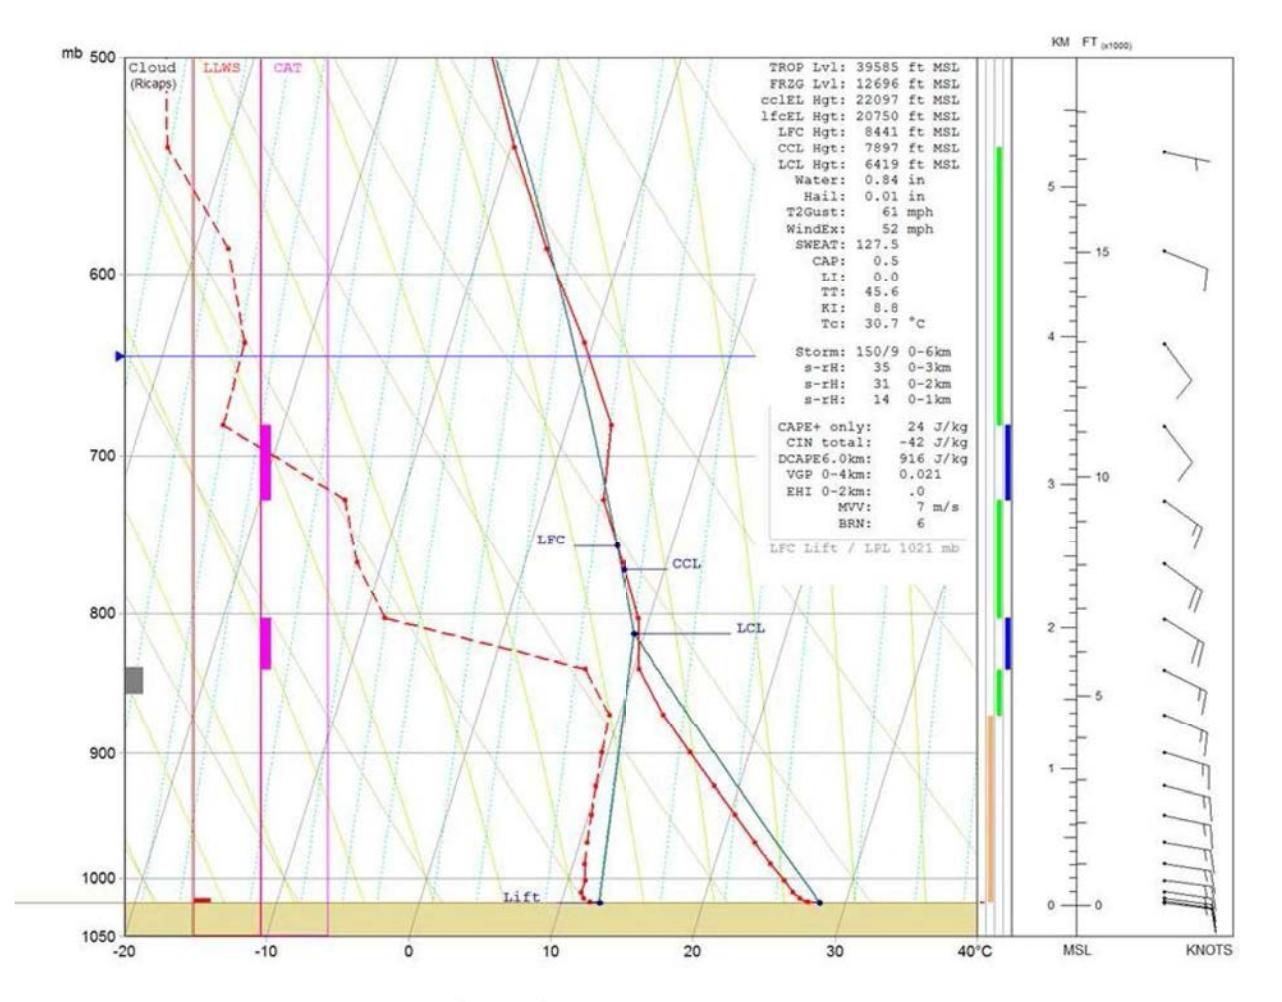
Sounding – A High-Resolution Rapid Refresh (HRRR) numerical model was run over the accident site and at the approximate hour of the event, and was plotted on a standard Skew T log P diagram. The image below is the 1400 EDT diagram of forecast conditions at the time of the accident. The model indicated a potential lifted condensation level (LCL) at 6,367 feet agl and a con (CCL) at 7,845 feet agl, and a level of free convection at 8,389 feet agl, supporting high based fair weather cumulus type clouds. With a lifted index of 0.0 and a K-index of 8.8 a low or weak support for convection was expected, and the low relative humidity of 38%. The wind profile indicated little variation in wind direction with height with increasing wind speeds to 20 knots by 6,000 feet. The mean 0 to 6 kilometer or 18,000 feet wind was from 120° at 12 knots, and the freezing level was identified at 12,600 feet. Only a light low-level wind shear condition was identified and no significant turbulence or icing conditions were identified. The relatively clear skies, warm temperatures did result in strong thermals to approximately 6,000 feet.

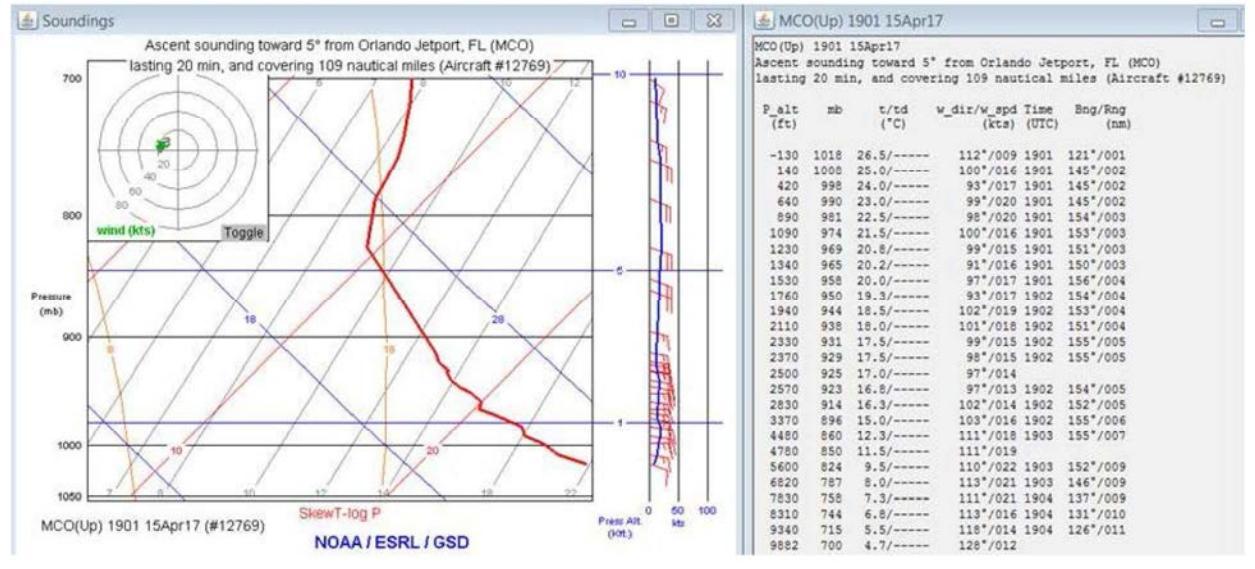
An Aircraft Meteorological And Data Report (AMDAR) from an aircraft identified as #12769 that departed from Orlando International Airport at 1501 EDT (1901Z) approximately 80 miles southeast of the accident site provided another vertical sounding and is provided below. No significant inversions were noted below 5,000 feet. The wind was from the east or from 112° at 9 knots and increased to 100° at 20 knots at 640 feet.

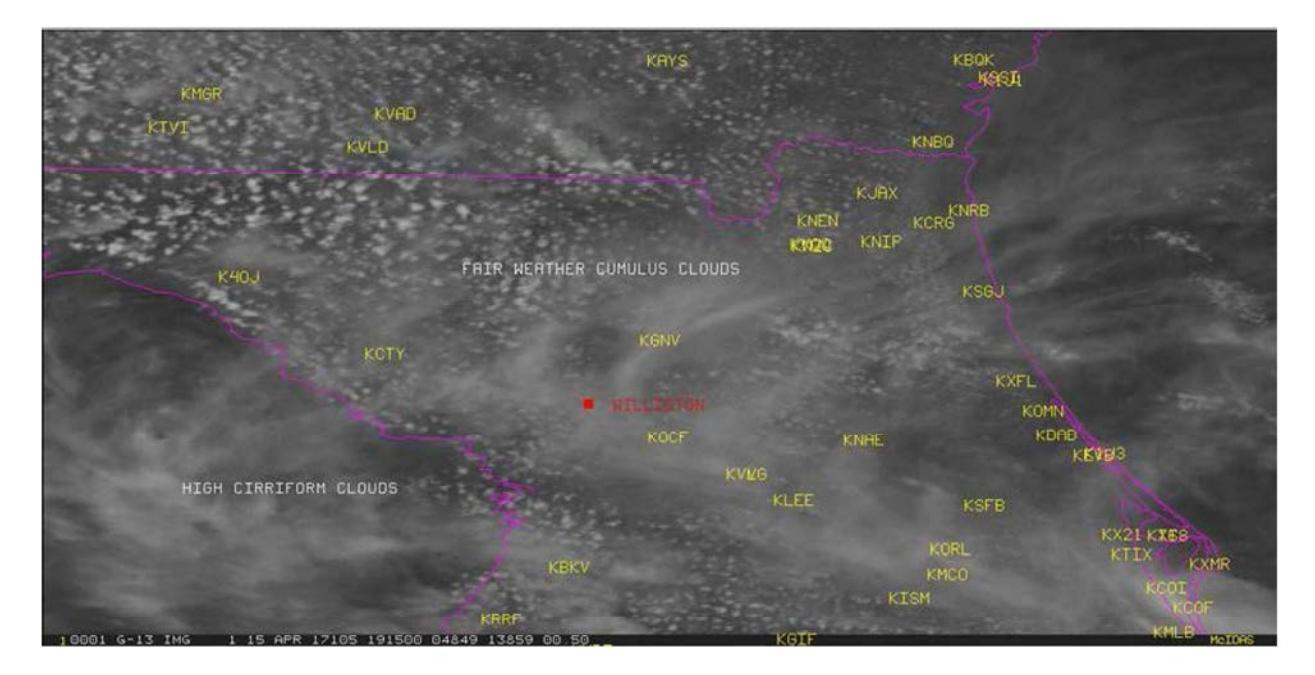
Satellite imagery – the GOES-13 visible and infrared imagery were also reviewed. The visible image at 1515 EDT (1915Z) at 2X magnification is included. The image depicts fair weather cumulus clouds scattered over the area with some high cirriform clouds above, indicative of normal diurnal heating and cellular convection. The east coast sea breeze front can be seen pushed further inland with the prevailing easterly winds, with no defined sea breeze front on the west coast of

Florida. No cumulonimbus (CB) or cumulus congestus (TCU) type clouds are observed over the region and no outflow boundaries identified in the cloud features.
