NATIONAL TRANSPORTATION SAFETY BOARD

Weather Study

ANC17FA009

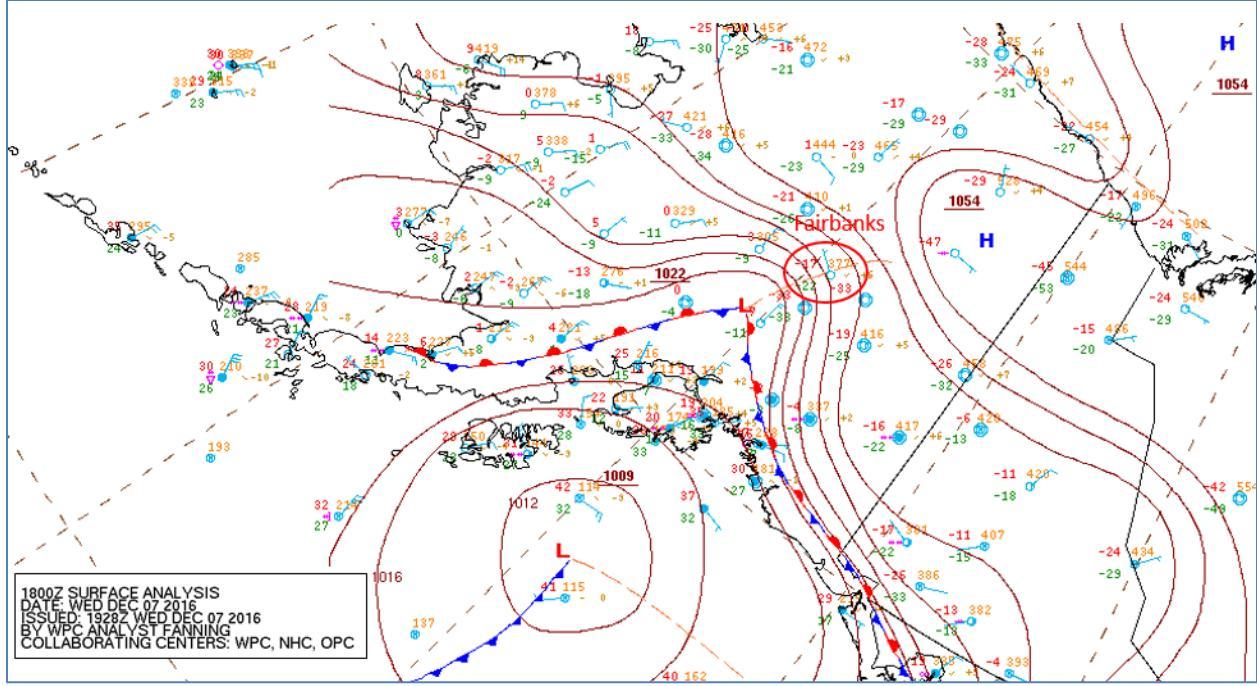
Figure 1 - Alaska Surface Analysis Chart for 0900 AKST

The NWS Alaska Surface Analysis Chart for 0900 AKST (1800Z) on December 7, 2016 is included as figure 1 with the approximate accident site marked by a red star. The chart depicted a cold-core high pressure system over northeastern Alaska at 1054-hectopascals (hPa)¹ with a ridge of high pressure dominating over northern Alaska. To the south of the accident site over the Anchorage area the chart depicted a low pressure system at 1022-hPa along a stationary front which stretched southwestward and southeastward across the coastal sections of Alaska and the Alaska Range and Chugach Mountain ranges. A trough of low pressure also extended north and then northeastward from the low pressure system into the Fairbanks area, which is noted in the red circle. Further south in the Gulf of Alaska was another closed low pressure system at 1009-hPa with a cold front stretching southward with a defined cyclonic or counterclockwise wind flow in the northern hemisphere. The accident site was located under the cold air mass north of the front and near the trough of low pressure with a ridge of high pressure to the north producing an extensive area of clear and stable conditions.

The station model for Fairbanks depicted wind as calm, clear skies, with a temperature of -17° Fahrenheit (F), dew point of -22° F, with a sea level pressure of 1039.3-hPa. No significant weather or clouds were depicted in the immediate area surrounding the accident site, even with the trough extending over the area. Further south along and north of the stationary front to the southeast of the area several stations reported light snow and overcast clouds.

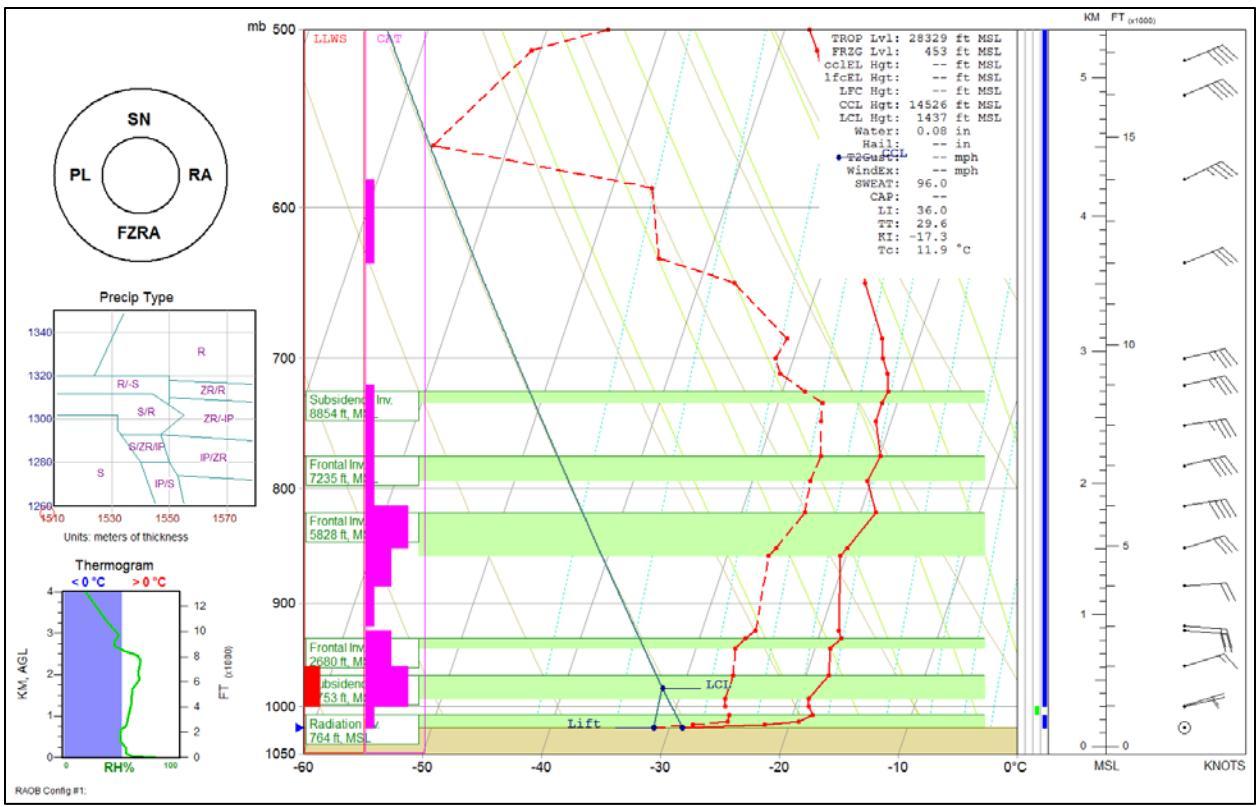
Figure 2 - NWS Fairbanks 1500 AKST sounding

The Fairbanks 1500 AKST sounding depicted a surface based temperature inversion with several other inversions or layers where there was an increase in temperature with altitude below 9,000 feet (shown in green shading on the diagram). The inversions resulted in a Lifted Index (LI)⁴ value of 36.0, which indicated an absolutely stable atmosphere. The lifted condensation level (LCL)⁵ was identified at 984 feet agl, and the convective condensation level (CCL)⁶ at 14,073 feet. No layers were identified with a relative humidity greater than 80% to support clouds, and thus no structural icing conditions were identified.

The sounding wind profile indicated calm surface wind, with winds from the east increasing with height over 20 knots above 2,000 feet with a low-level wind maximum was identified near 6,000 feet with wind from 080° at 38 knots. The mean 0 to 6 kilometer or 18,000 feet wind was from 069° at 31 knots, with the maximum wind was identified at 060° at 52 knots at 24,000 feet with the tropopause height at approximately 28,300 feet.

The sounding thermal and wind profiles depicted several layers of strong vertical wind shear between 1,700 and 3,000 feet and near the low-level wind maximum between 4,500 and 6,000 feet and indicated a high probability of 80% and greater for moderate and greater turbulence in these layers (indicted in pink bars on the left side of the diagram). In addition, due to the calm surface wind and increase in wind immediately above the surface based inversion, a slight low-level wind shear (LLWS) environment also existed (shown in red on left of the chart). The turbulence potential was not verified by any pilot reports surrounding the period (see section 4.0 below). The observed wind at 983 feet or approximately 1,000 feet was from 075° at 5 knots.

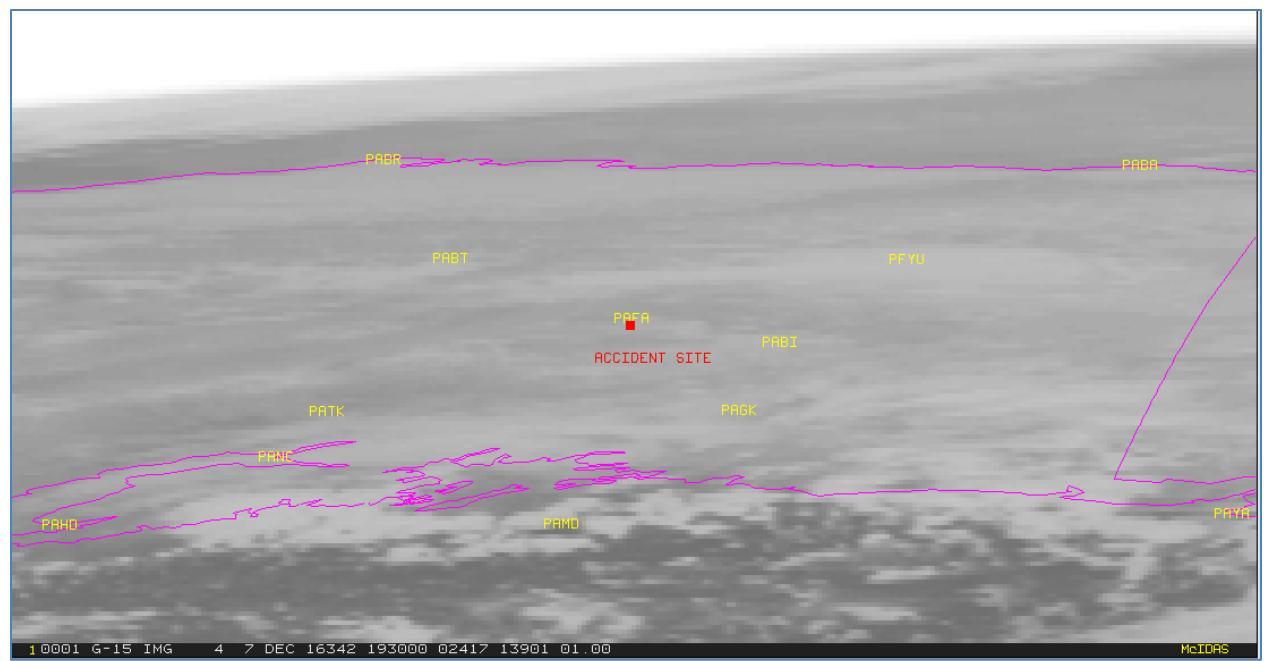
Figure 4 - GOES-15 infrared image at 1030 AKST

Figure 4 is the GOES-15 infrared image at 1030 AKST at 4X magnification with the accident site in red, with a resolution of 4 kilometers. The thermal image depicted clear skies over a snow covered terrain in the vicinity of the accident site, which is marked by the red square. Low to mid-level clouds were identified along and north of the stationary front along the coastal sections of Alaska with little clouds over central and northern Alaska.

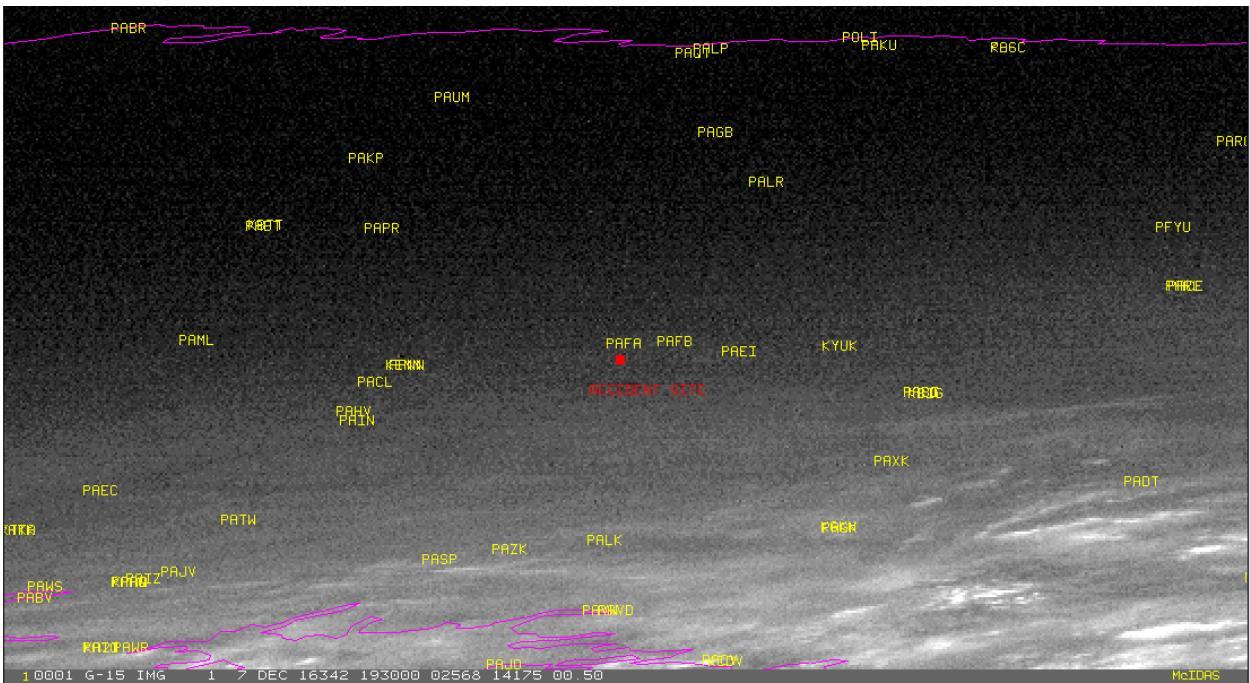
Figure 5 - GOES-15 visible image at 1030 AKST

Figure 5 is the GOES-15 visible image at 2X magnification at 1030 AKST with a resolution of 1 kilometer and with the accident site noted. The image depicted clear skies over the accident site with snow covered terrain. The extreme north latitude and diminishing light conditions limited a more complete satellite analysis over the region during the period.

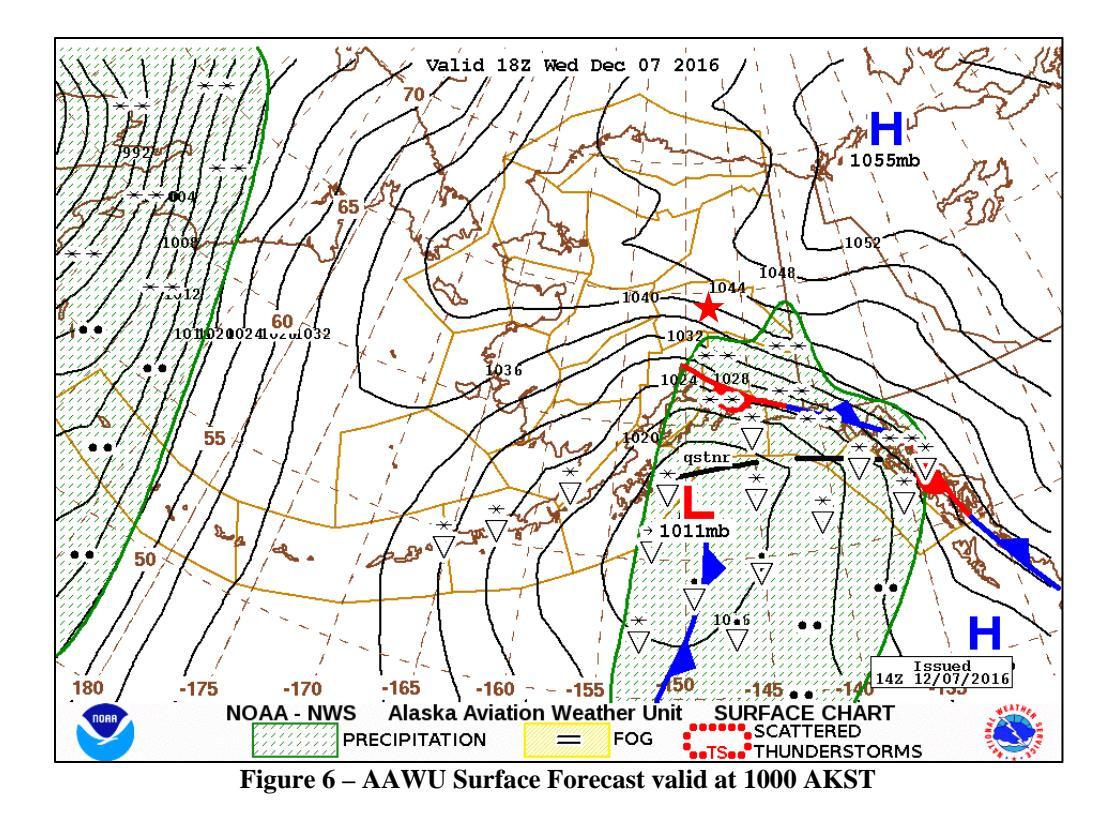
The NWS Alaska Aviation Weather Unit (AAWU) graphic version of the area forecast are included below. Figure 6 is the AAWU Surface Forecast issued at 0500 AKST and valid for 0900 AKST (1800Z) with the approximate accident site marked by the red star. The chart depicted a high pressure ridge extending over the region with no significant weather over the Fairbanks area; however, an area of precipitation in the form of snow was expected to the south and southeast of the area associated with the trough of low pressure extending from the low pressure system in the Anchorage area northward and the stationary front along the coastal region.

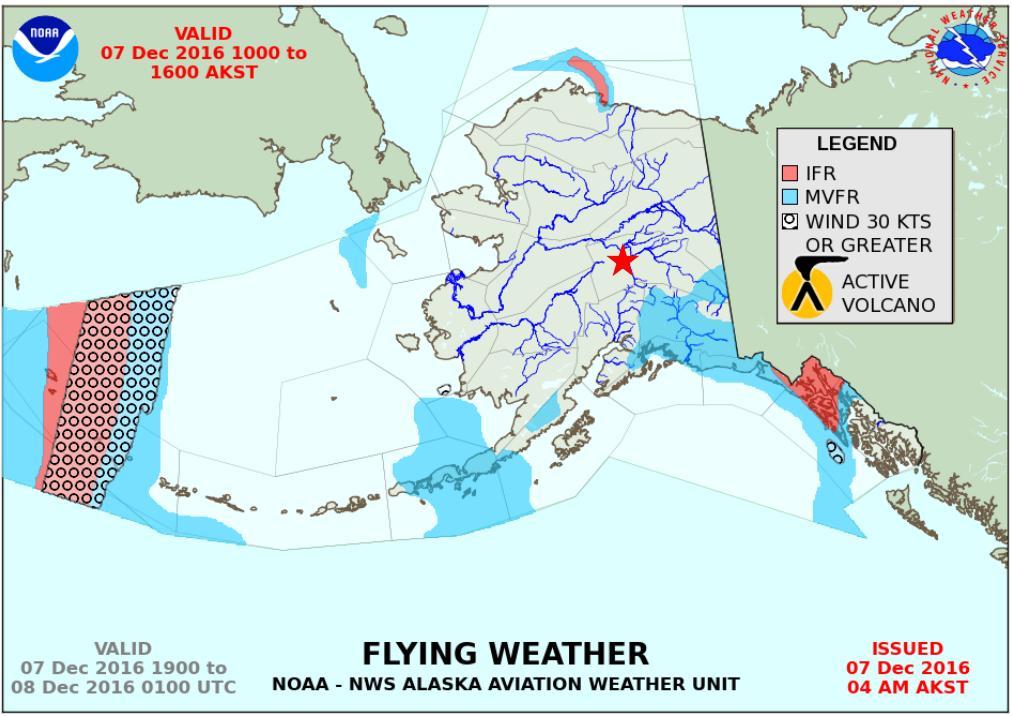
Figure 7 - AAWU Flying Weather forecast

Figure 7 is the AAWU Flying Weather Forecast providing the general flight category⁷ and where strong surface winds of 30 knots or more are expected for the period from 1000 through 1600 AKST, which was issued at 0400 AKST. The chart depicted VFR conditions expected to prevail over the Fairbanks area with MVFR conditions to the south-southeast and extending along the southeast Alaska coastal region.

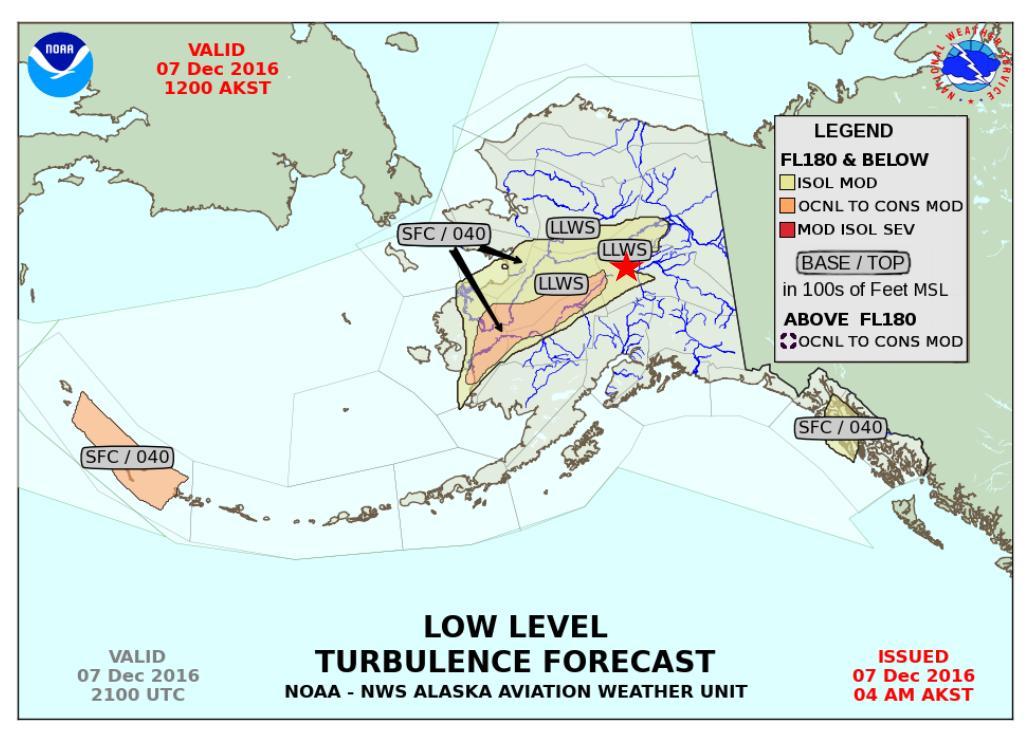
Figure 8 - Low-Level Turbulence Forecast valid for the period

The low-level turbulence forecast issued at 0400 AKST and valid for the period is included in figure 8. The morning forecast included a risk of low-level wind shear over the region and isolated moderate turbulence below 4,000 feet.

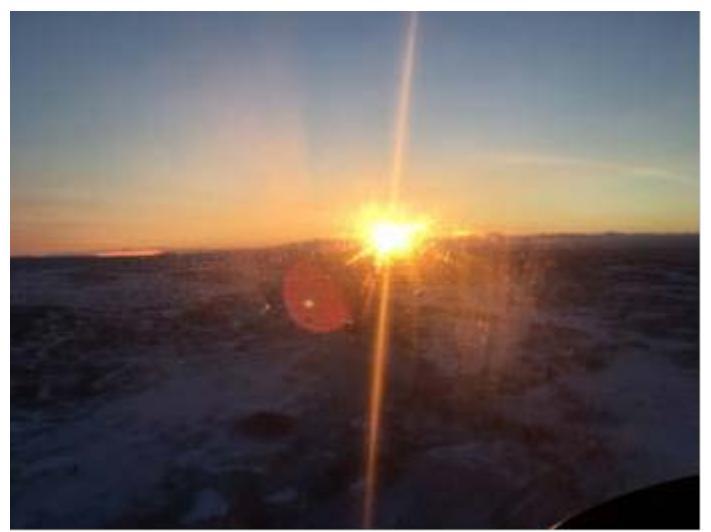
Figure 9 - Approximate Sun location at the time of the accident

At the approximate time of the accident the sun was 0.1° above the horizon at an azimuth of 153° .
