## NATIONAL TRANSPORTATION SAFETY BOARD

MATERIALS LABORATORY FACTUAL REPORT

Place: Coral Gables, FloridaDate: 09/13/2021Vehicle: 2021 Tesla Model 3NTSB No.: HWY21FH011Investigator: Thomas Barth

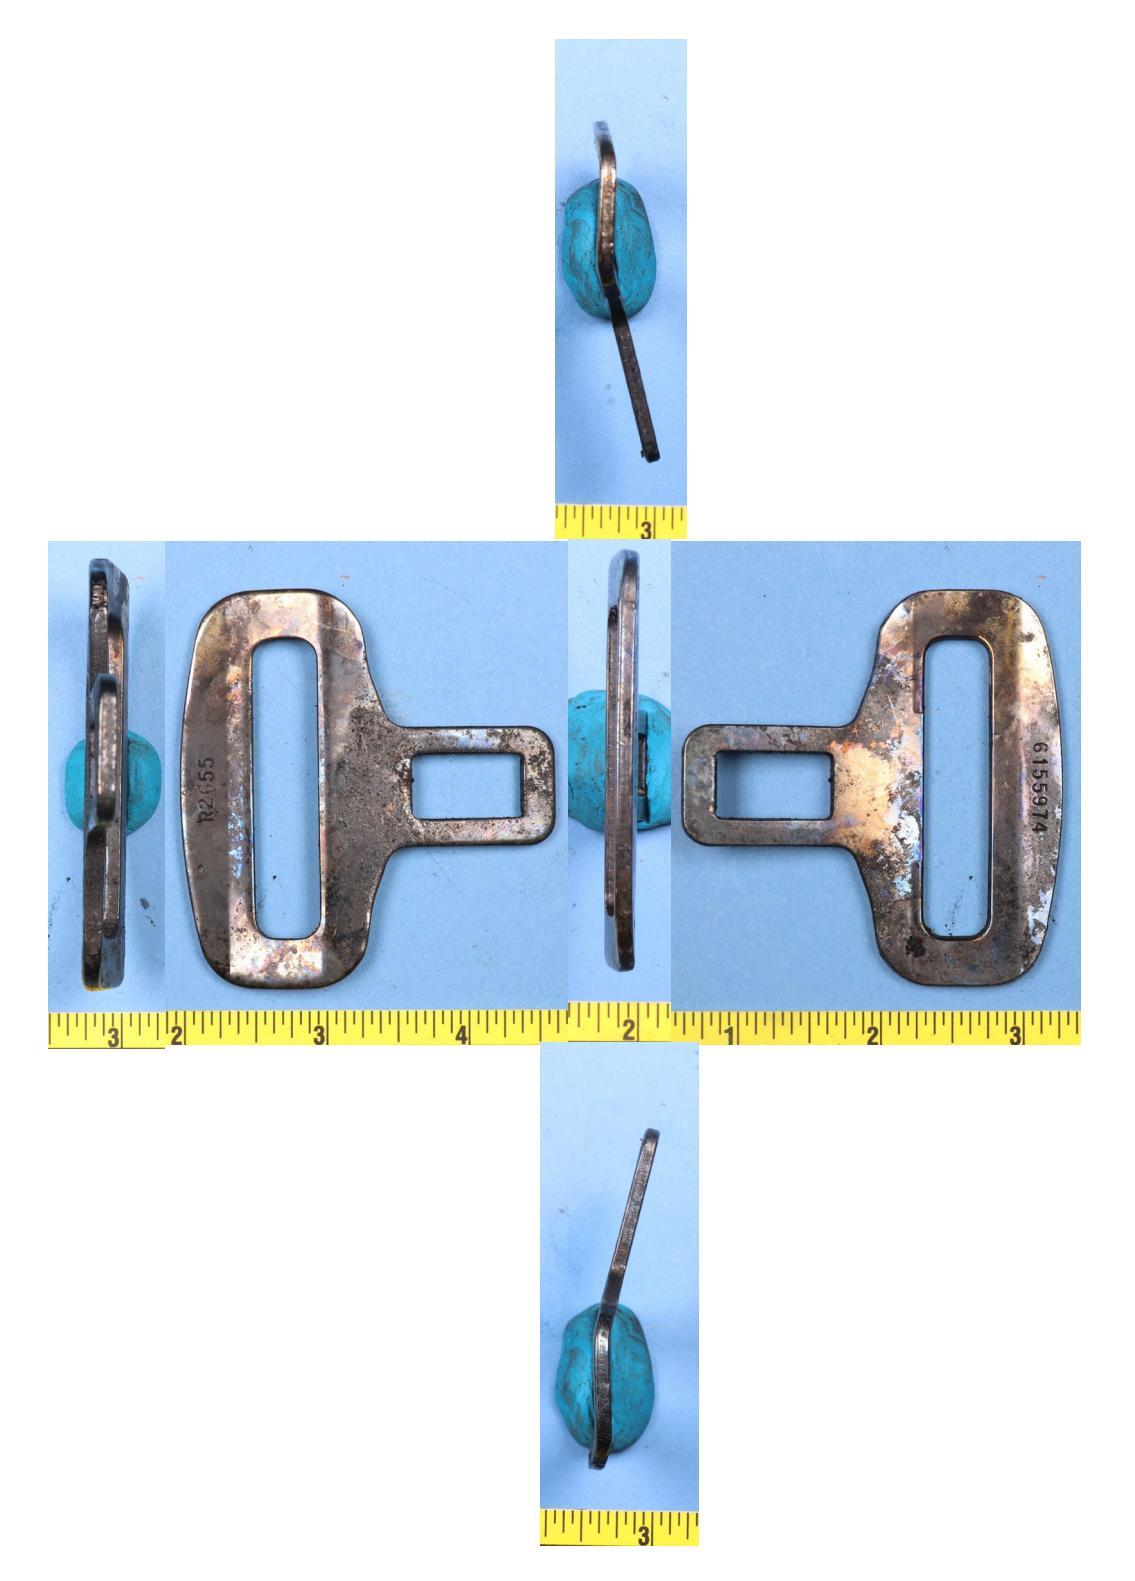
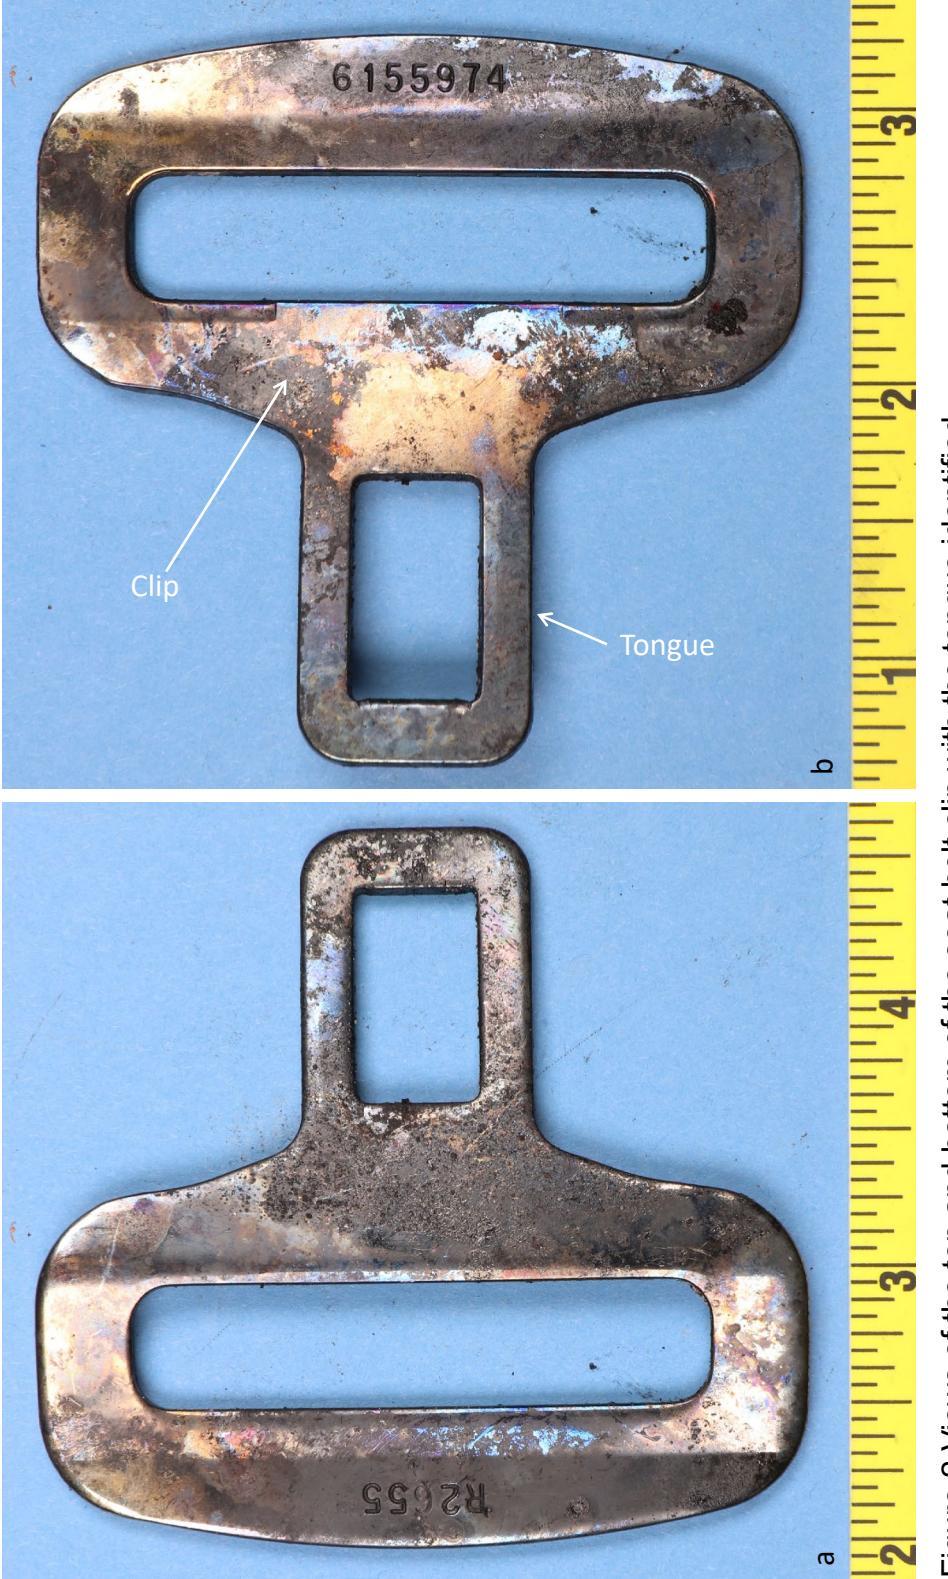
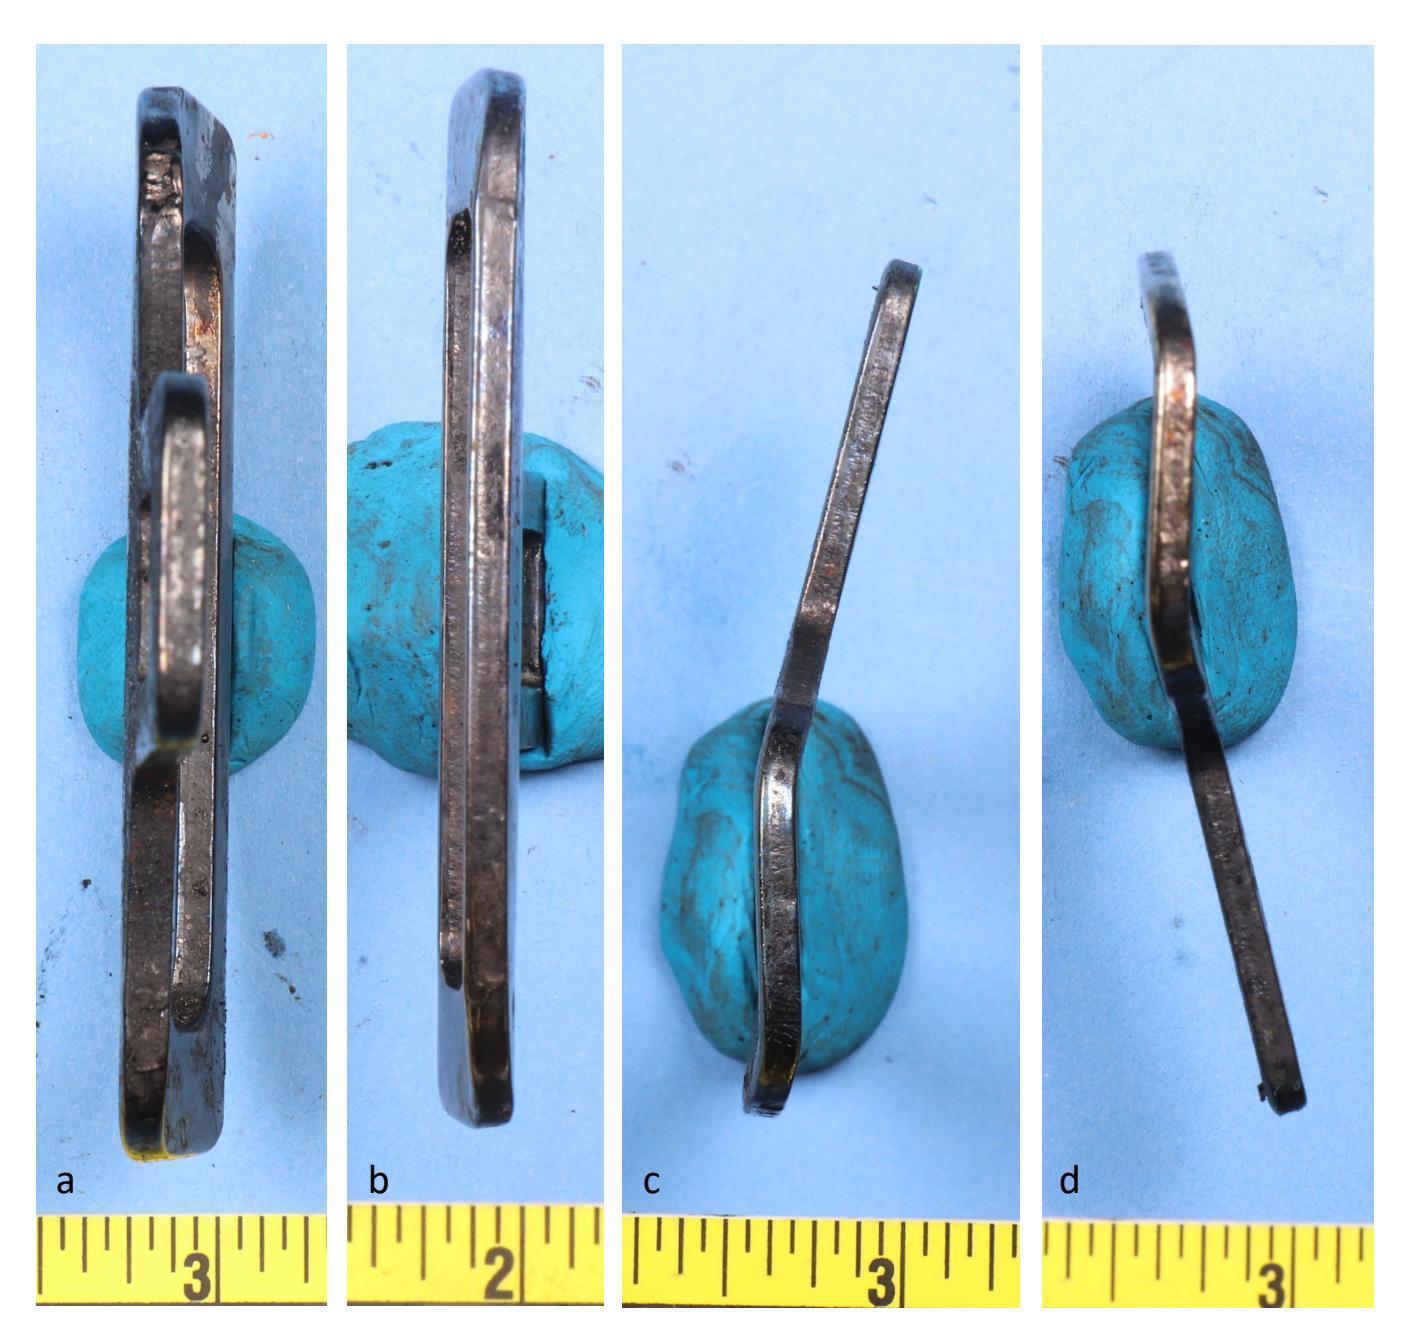
Multiple views of the as-received seatbelt clip are shown in Figures 1-3. No deformation or mechanical damage to the clip or tongue was noted.

Figure 1 Orthogonal arrangement of the seat belt clip images shown in Figures 2 and 3.

Figure 2 Views of the top and bottom of the seat belt clip with the tongue identified.

Figure 3 Views of the sides or edges of the seat belt clip.

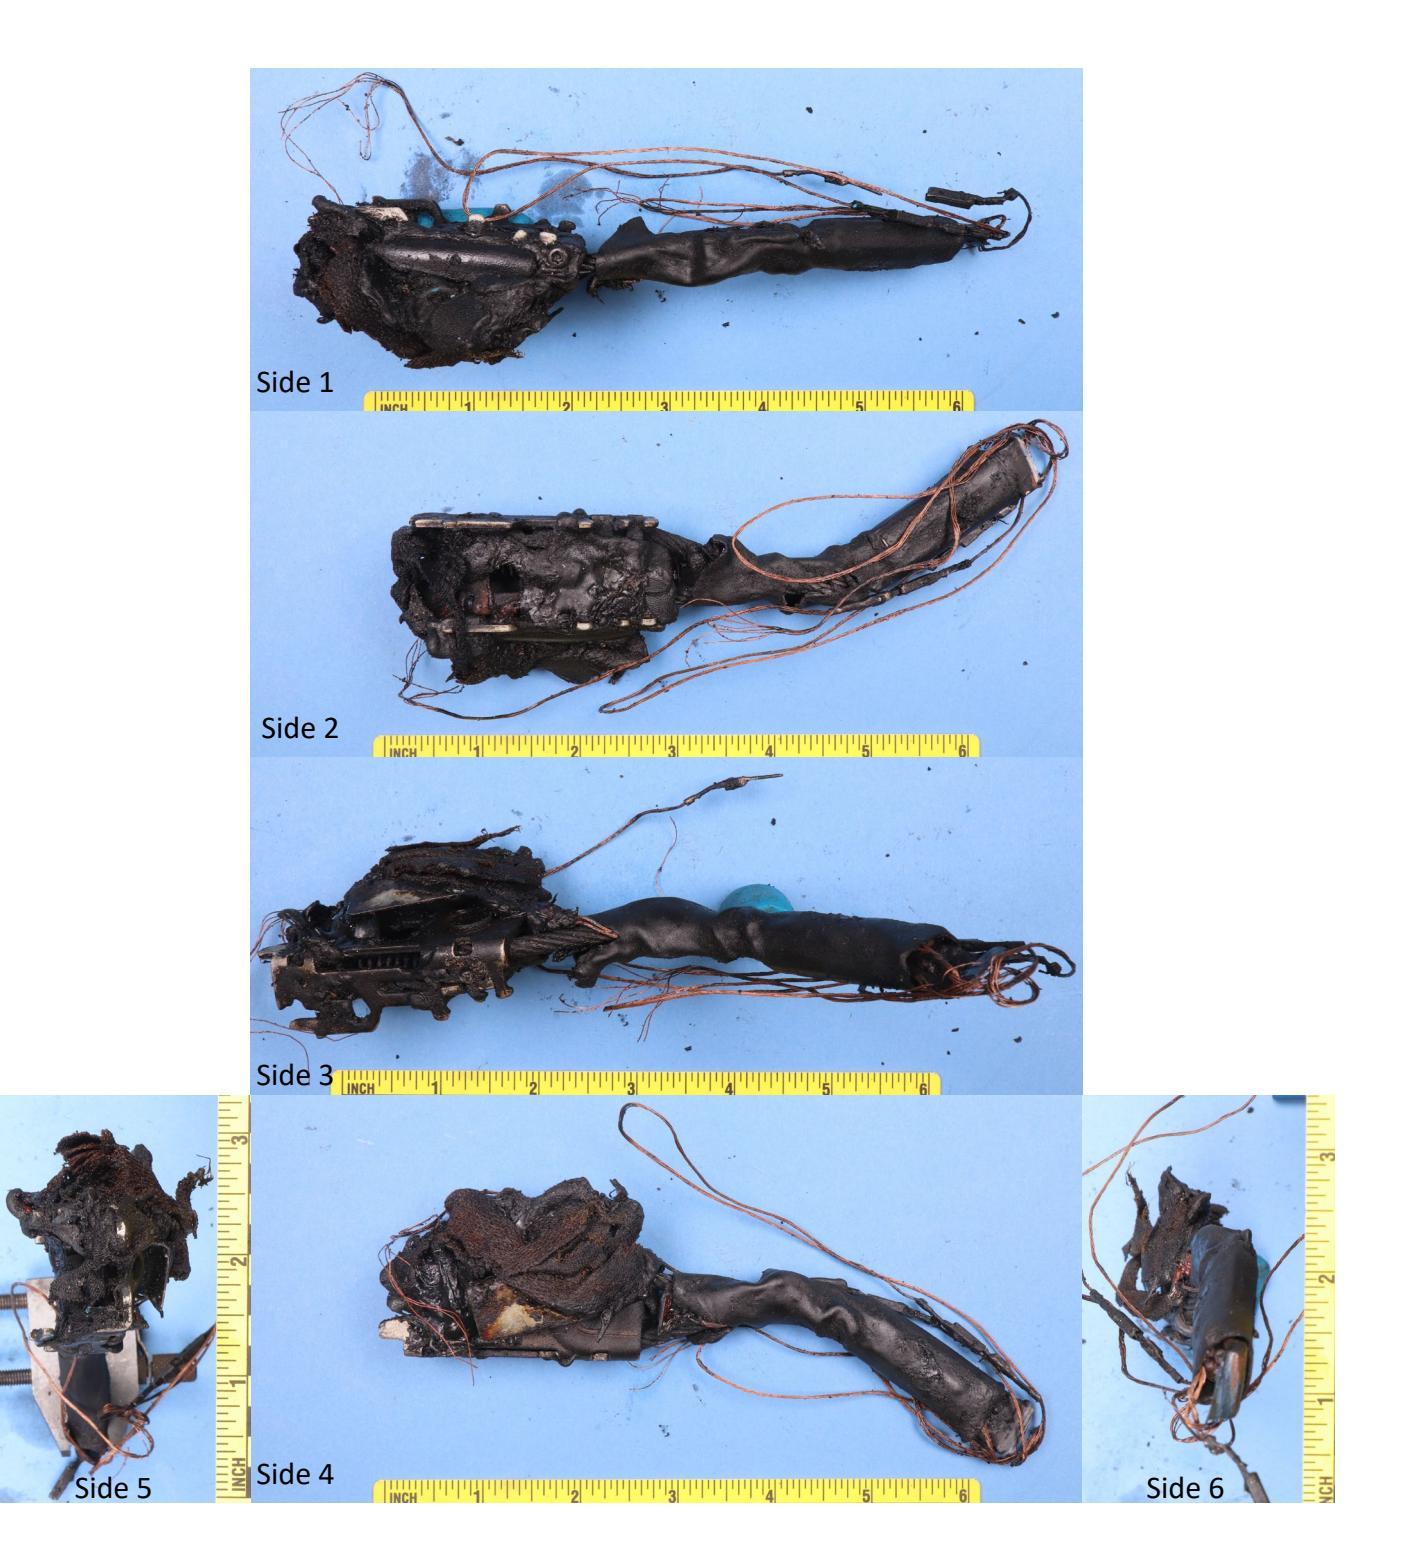
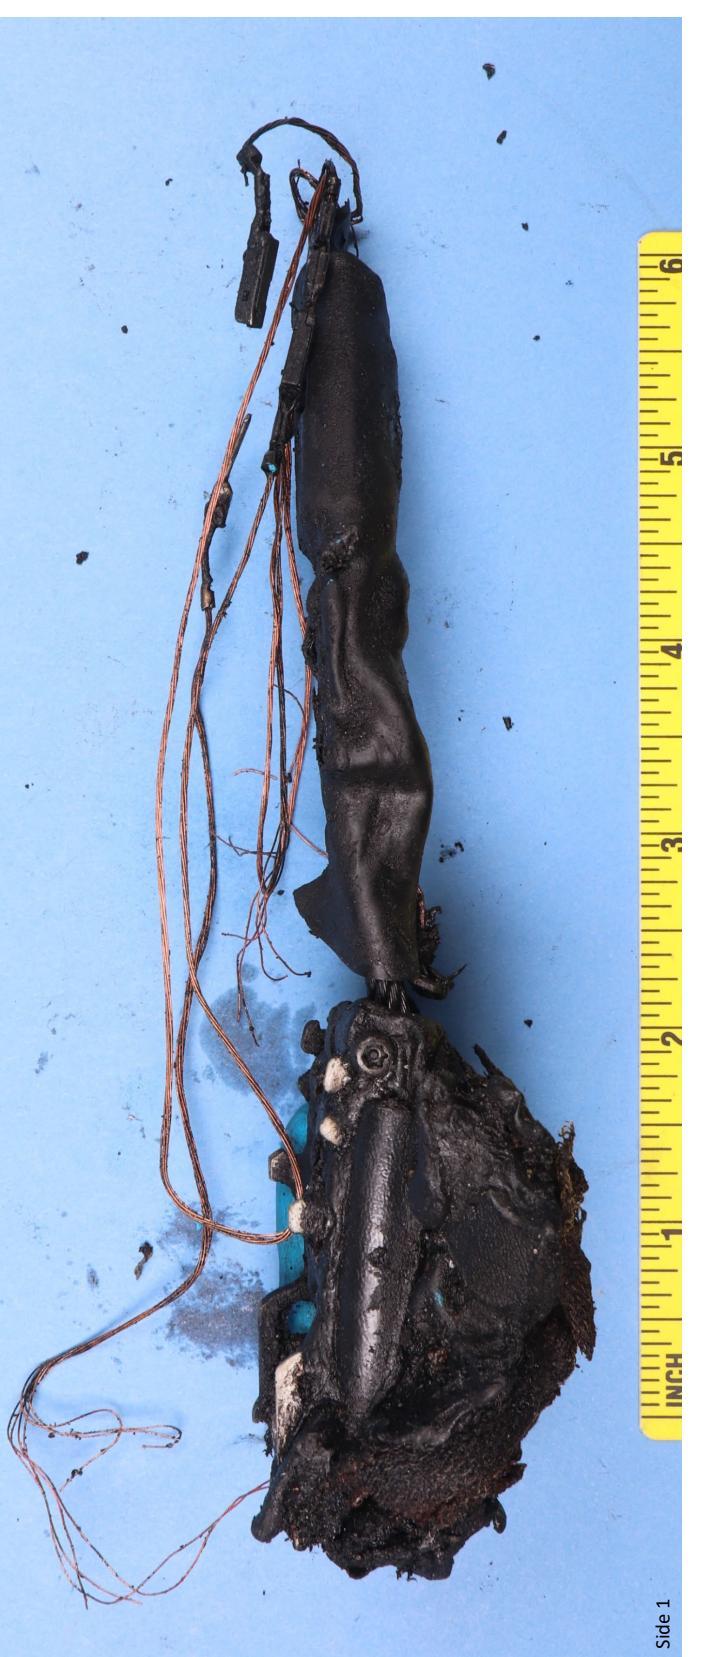
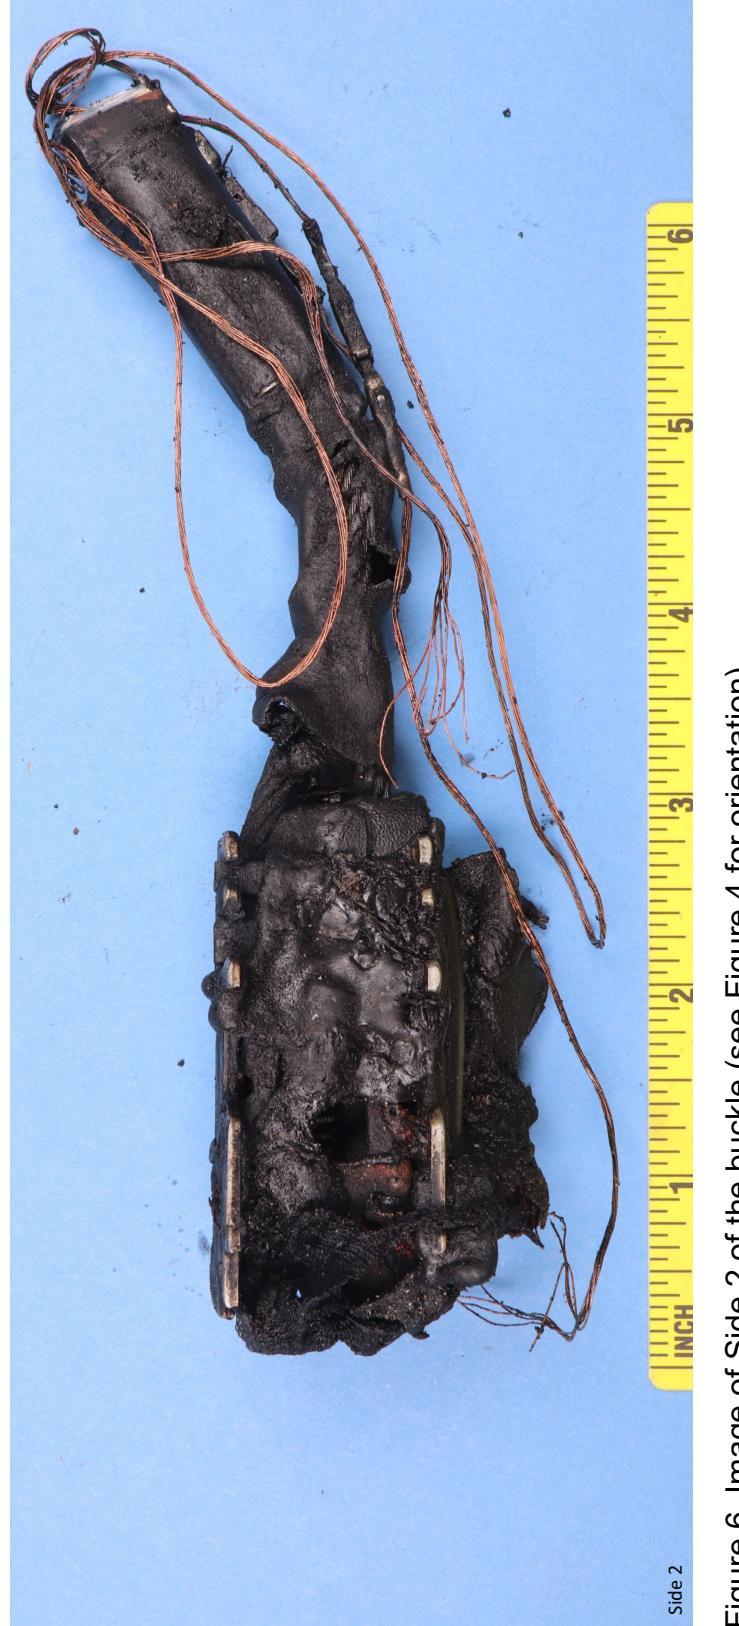
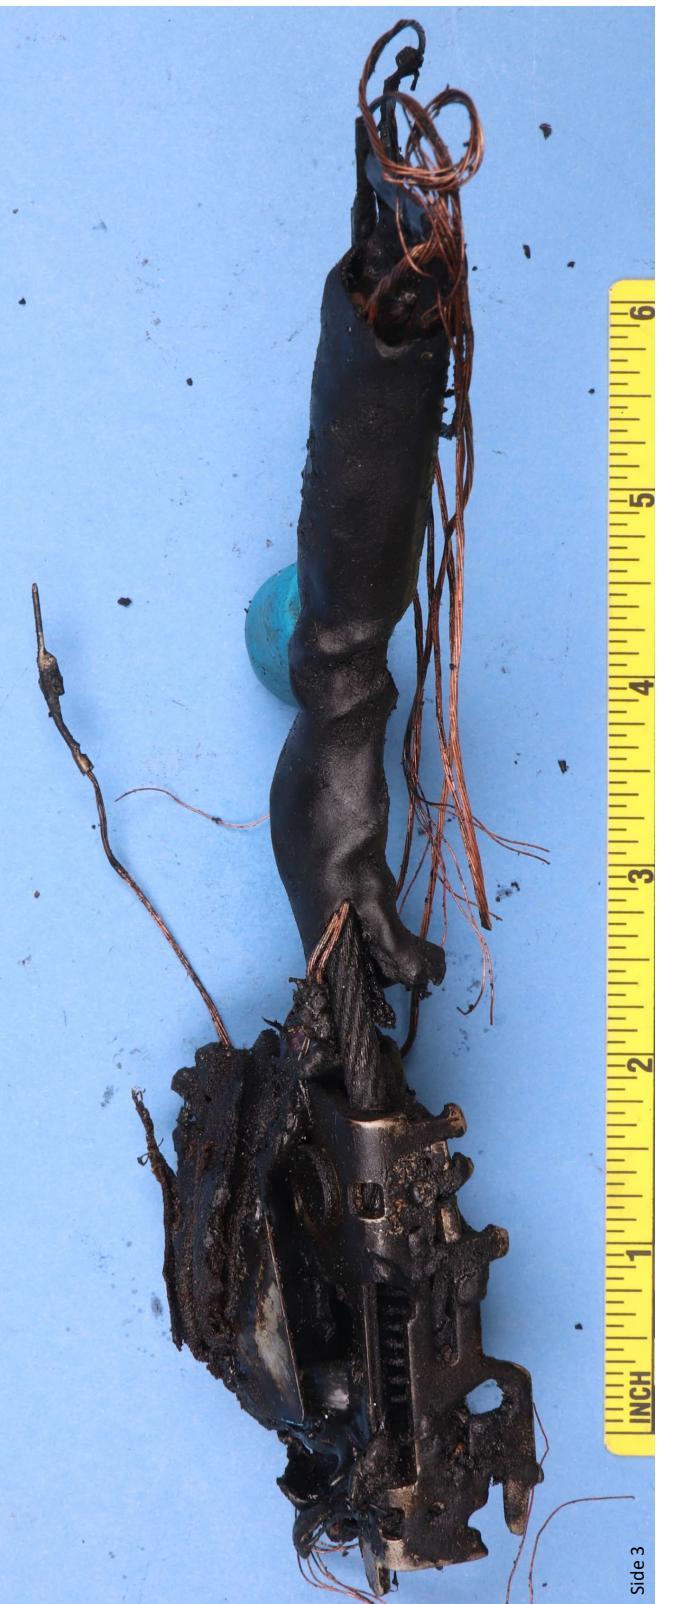
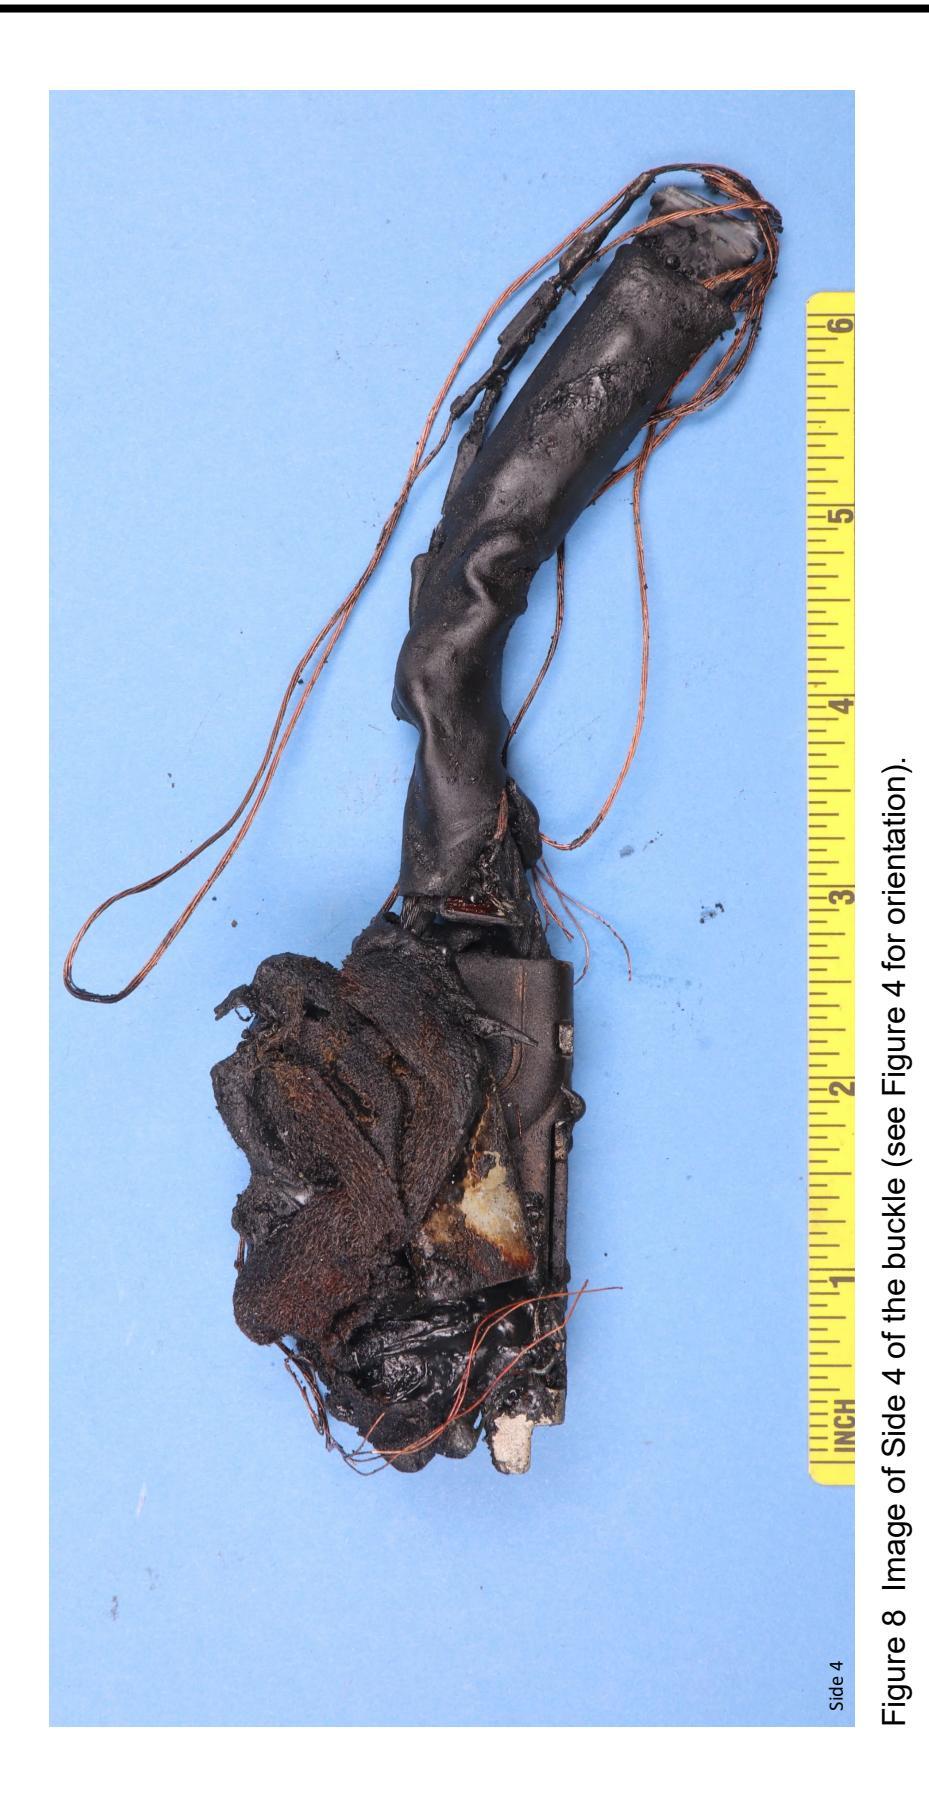
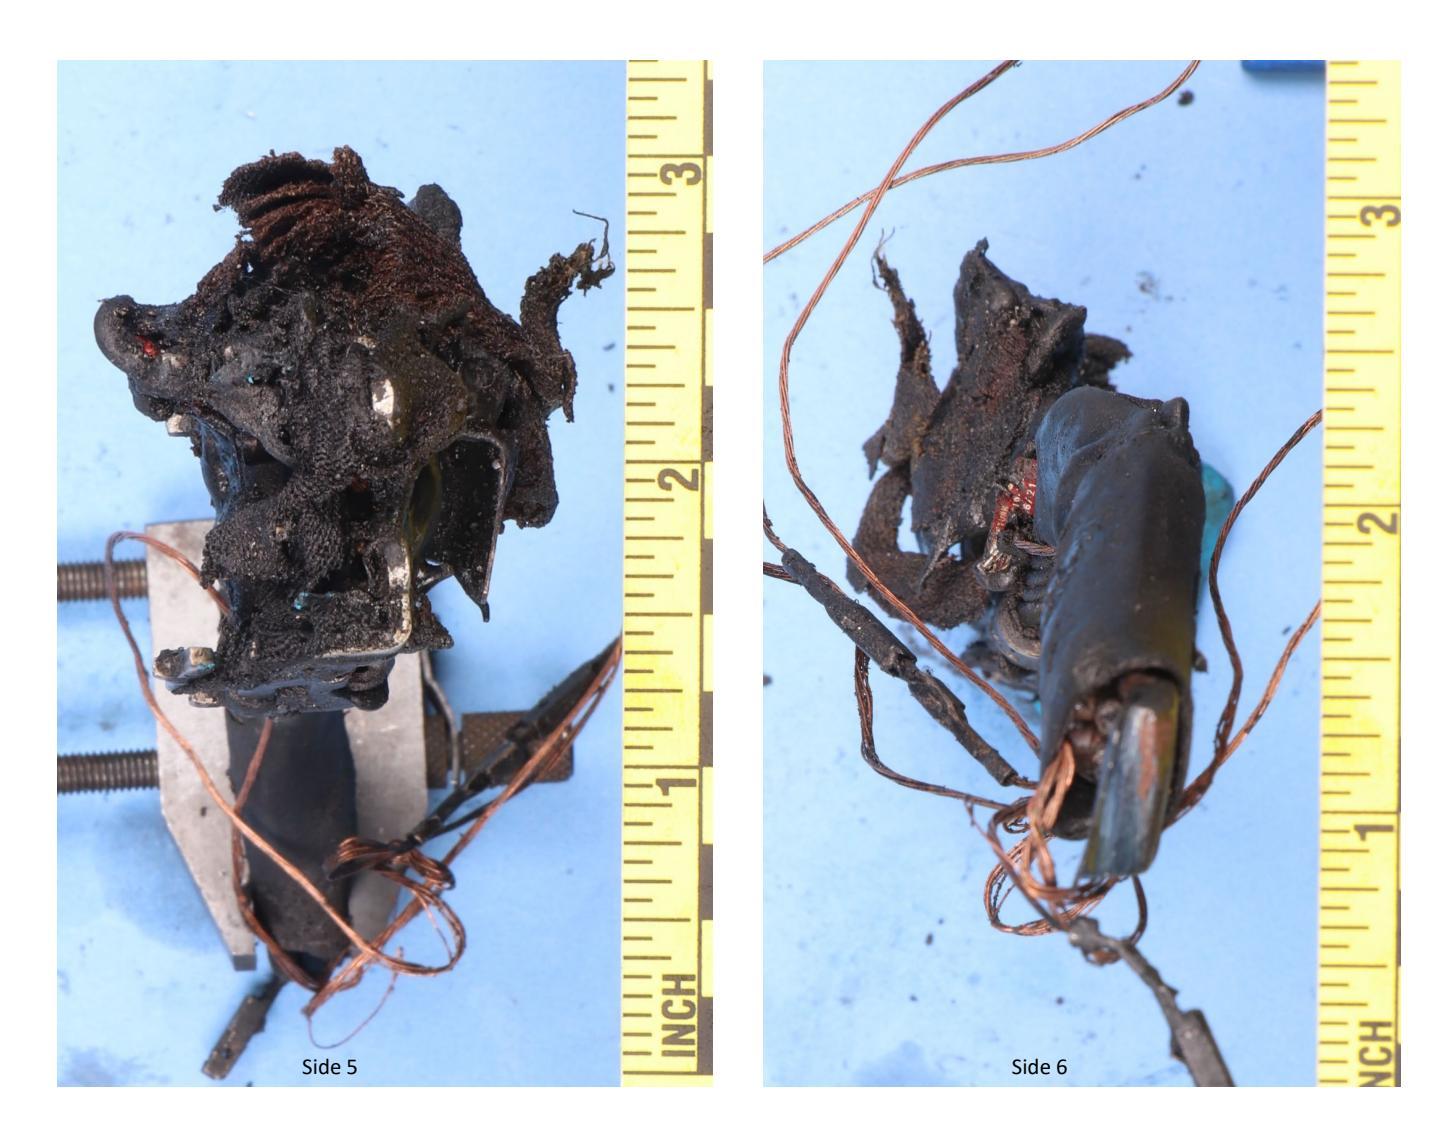
Figure 4 Orthogonal arrangement of the seatbelt buckle images are shown in Figures 5-9.

Figure 5 Image of Side 1 of the buckle (see Figure 4 for orientation).

Figure 6 Image of Side 2 of the buckle (see Figure 4 for orientation).

Figure 7 Image of Side 3 of the buckle (see Figure 4 for orientation).

Figure 9 Images of Sides 5 and 6 of the buckle (see Figure 4 for orientation).

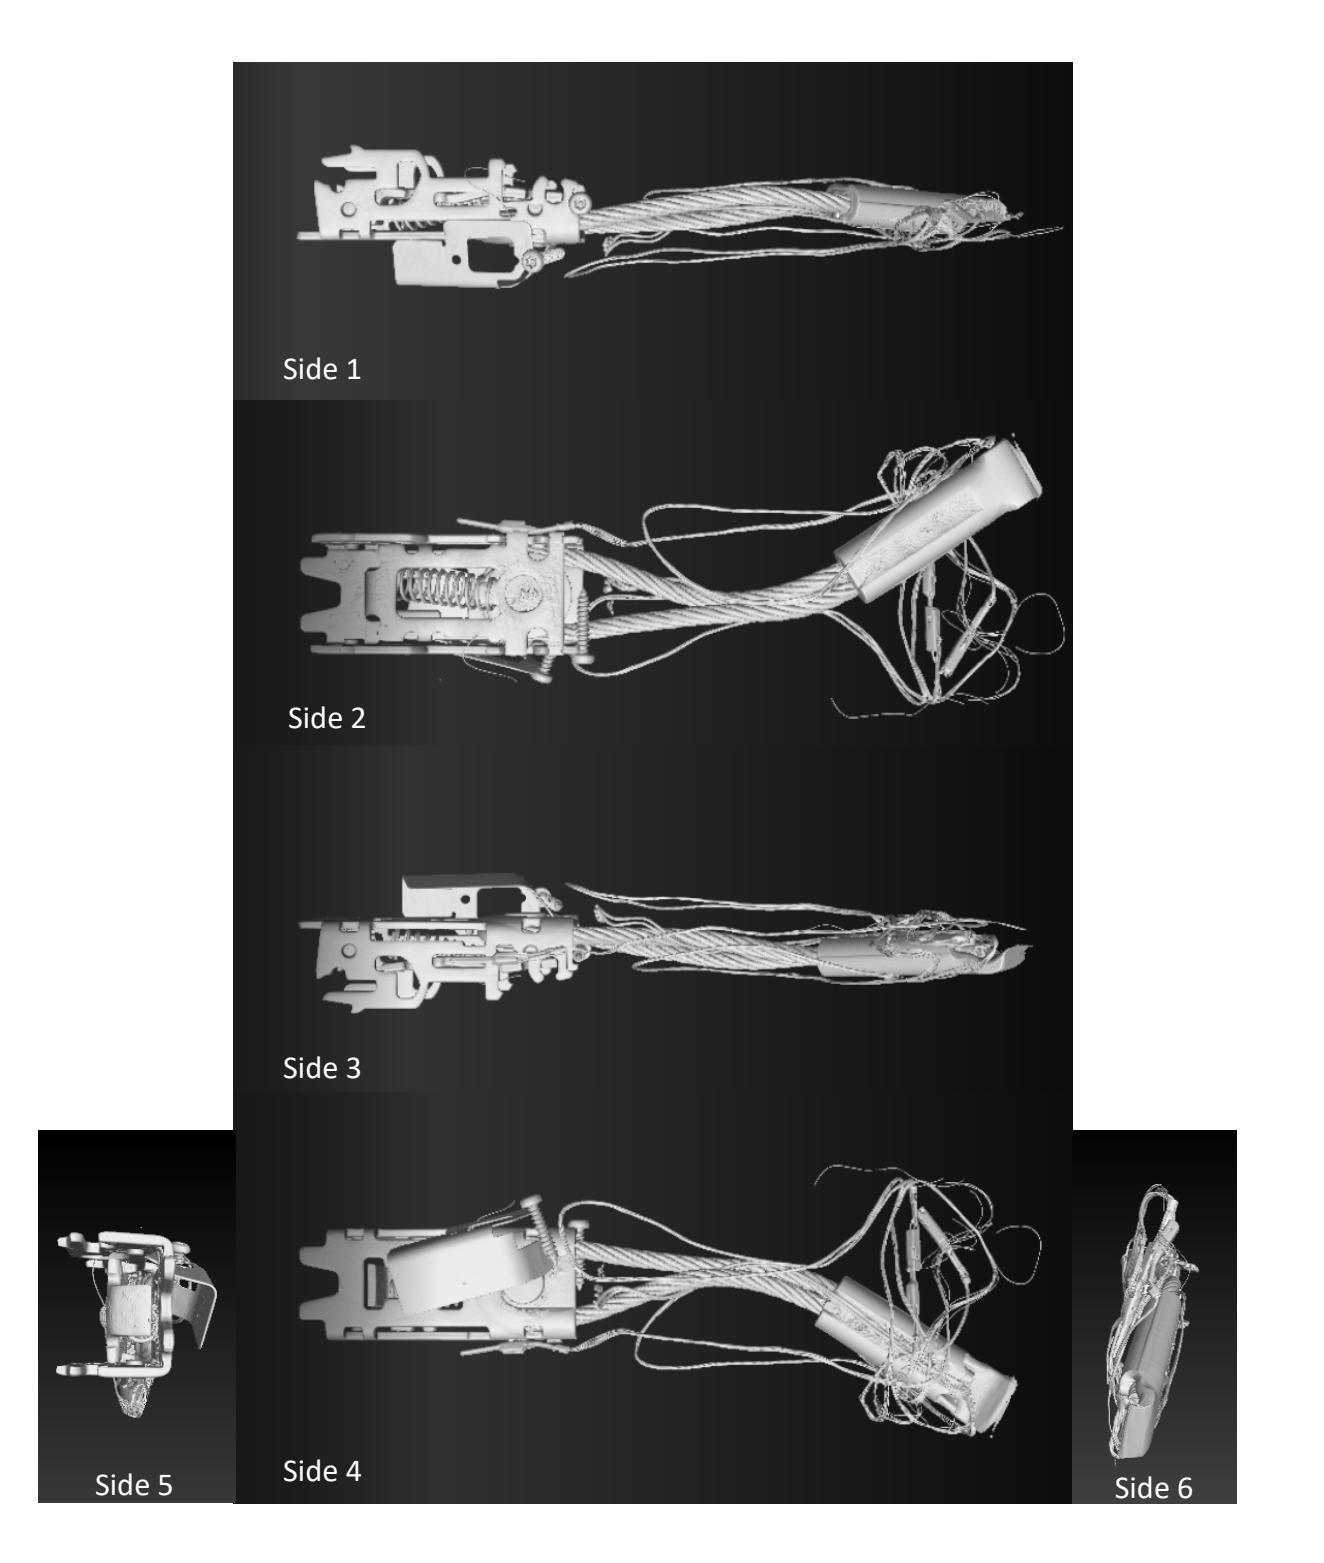
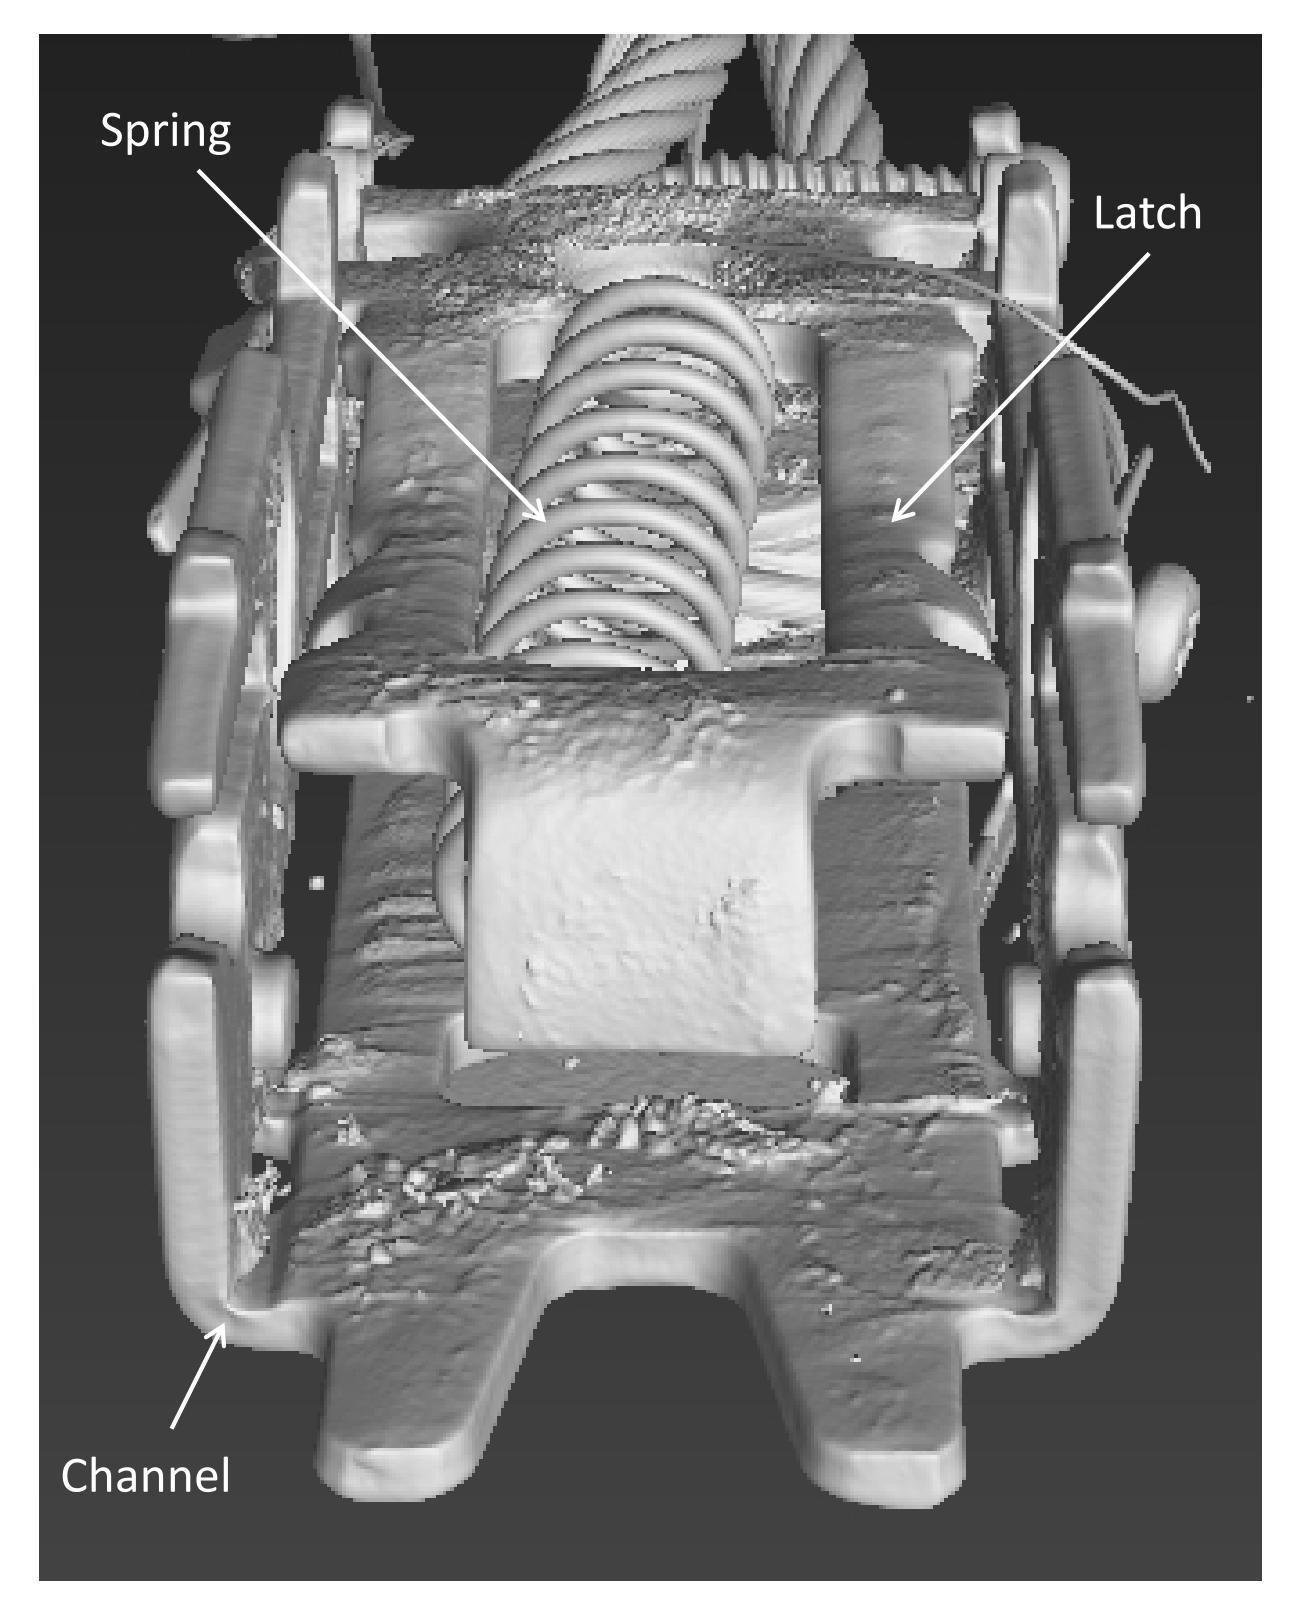
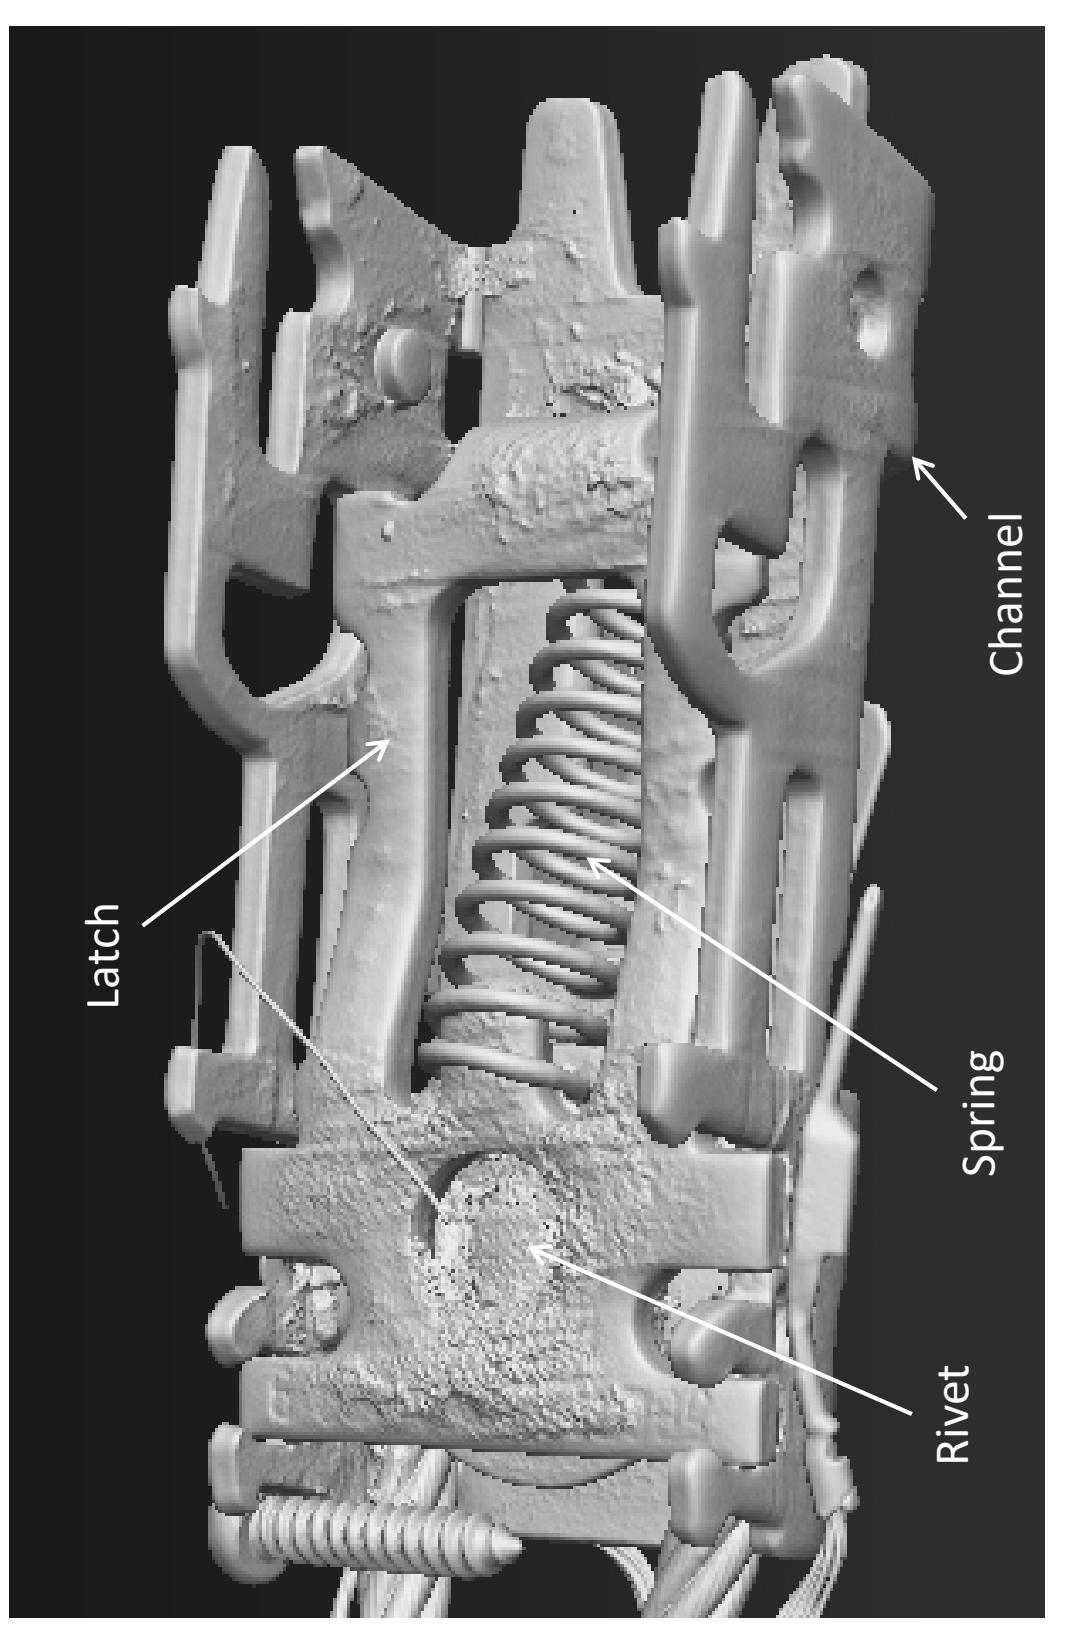
Multiple views of the as-received seatbelt buckle are shown in Figures 4-9. The seatbelt buckle assembly was imaged by x-ray CT using a 450 kV micro-focus x-ray CT imager at NTS Chesapeake Labs, Belcamp, MD. X-ray CT radiographs of the high radioopaque (e.g., steel) components within the buckle are shown in Figures 10-12. Based on the radiographs, the buckle is an end-release, tongue-eject design. The spring is out of place due to the post-crash fire damage to the organic and polymeric components. No deformation or mechanical damage was noted for the channel or latch.

Figure 10 Orthogonal arrangement of x-ray CT radiographs of the seat belt buckle images shown in Figure 4.

Figure 11 X-ray CT radiograph image of the internal ferrous buckle components—oblique view from the insertion end.

Figure 12 X-ray CT radiograph image of the internal ferrous buckle components—oblique side view.
