NATIONAL TRANSPORTATION SAFETY BOARD

AIRFRAME AND ENGINE EXAMINATION

WPR19LA063

Accident Date: January 13, 2019 Exam Date: September 24, 2019

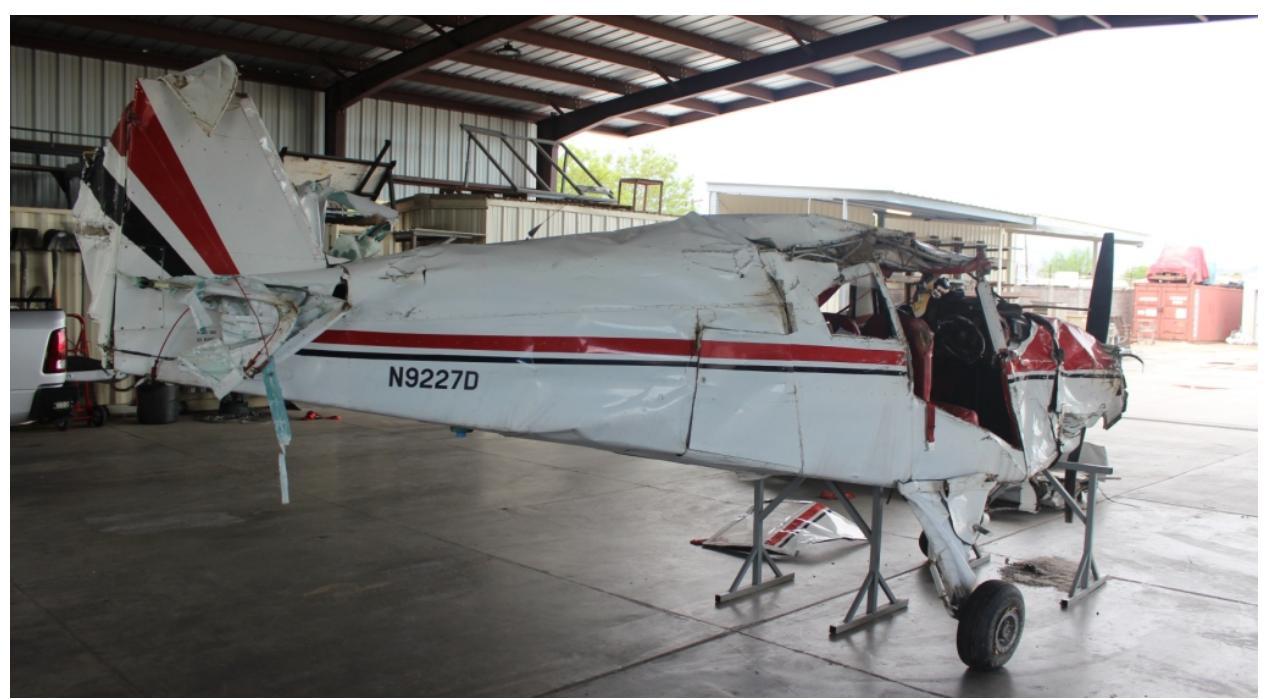
Figure 1 - Aft Right View

The fuselage was generally intact but displayed crushing and deformation throughout its structure. The cabin roof was crushed and deformed downward, and the window frames were buckled. Some aft crushing deformation was noted adjacent to the firewall and door frame. The forward cabin door was impact-separated; it was buckled and deformed, and the window was shattered. The windscreens and windows were fractured and separated from their frames. The baggage door remained in its frame, and was jammed closed.

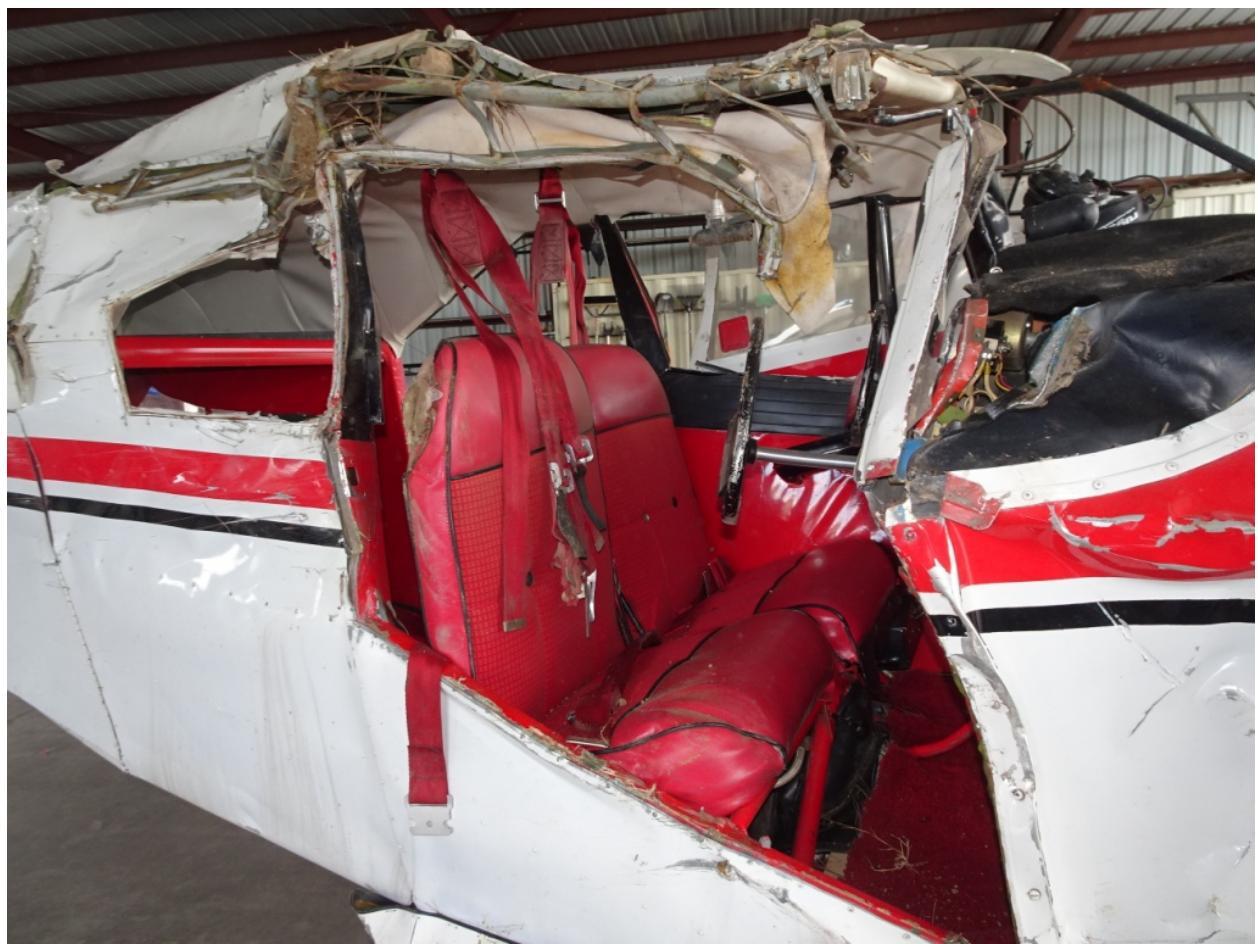
Figure 3 - Passenger Door and Front Seats

The two forward seats remained mounted to the cabin floor; each displayed some frame deformation. The lap belts for each forward seating position remained anchored to the cabin floor and were unbuckled. Two sets (1 set per seat) of 4-point style shoulder harnesses remained attached to the cabin ceiling. Neither set was latched to its respective lap belt. There were no aft seats installed at the time of examination, however two sets of seat belts remained attached to the cabin floor.

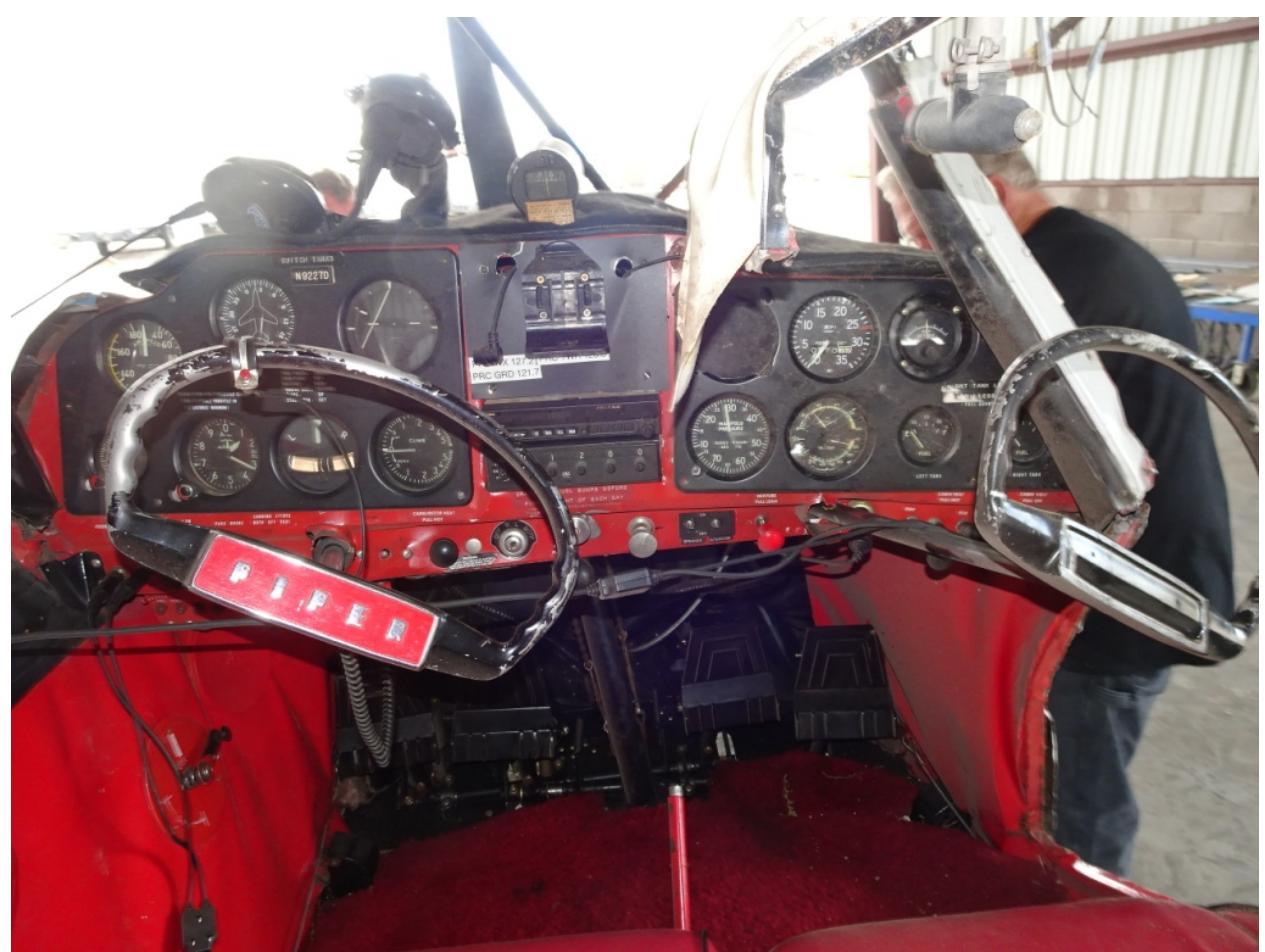
Figure 9 - Instrument Panel

Some deformation was noted to the instrument panel. Radios and instruments remained mounted in the panel. The cockpit throttle control was set to idle, the mixture set to full rich Both the throttle and mixture knobs were jammed and could not be moved. The primer knob was in and locked. The carburetor heat knob was set to off. The magneto switch was set to both; however, the key was absent and not located.

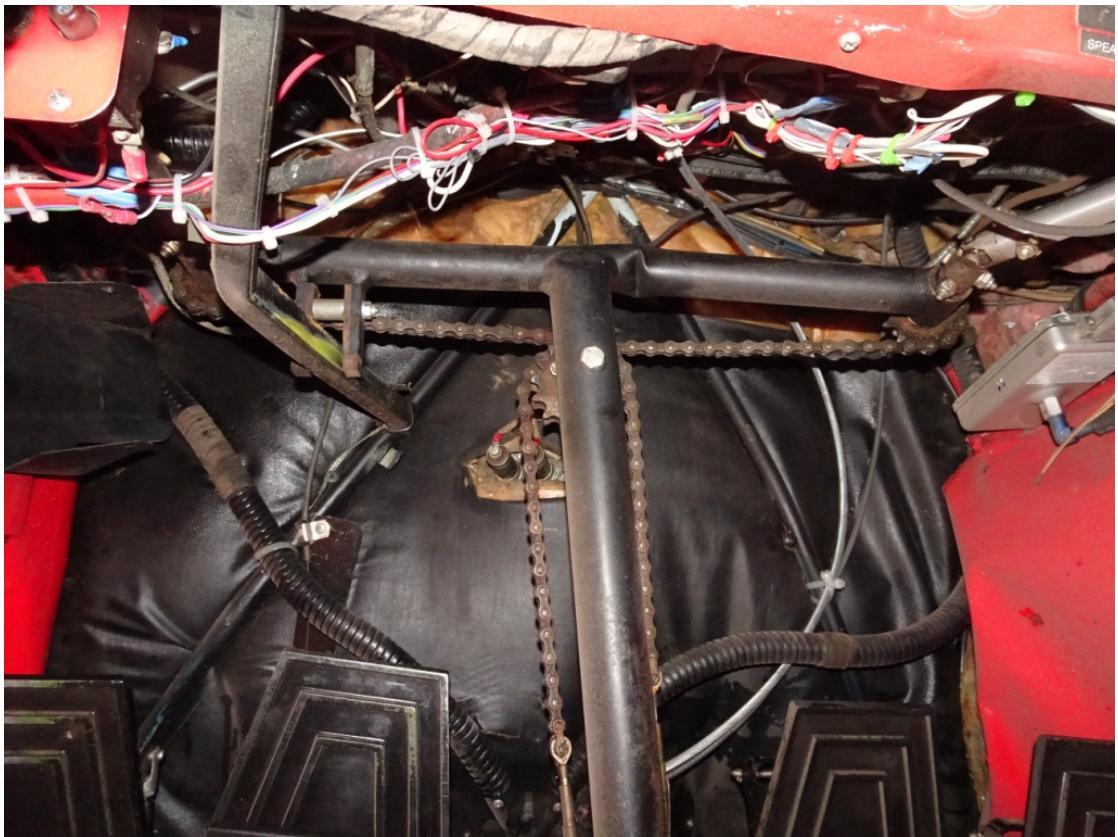
Figure 12 - Under-Panel Flight Control Linkages

Both control yokes remained attached to the control tee bar, and the aileron control chains were routed normally over the sprockets. The aileron control cables could be traced through to recovery cuts in the overhead cabin structure near the wing roots. The flap handle remained in place in the cabin floor and was positioned to flaps up. The flap control cables terminated in recovery cuts in the overhead cabin structure near the wing roots.

The elevator control cables remained attached to the control bellcrank; the control cables could be traced through the fuselage to their respective attachments on the elevator. The rudder pedal bar remained mounted to the cabin floor, and the rudder cables remained connected to the pedal bar ends. Rudder cable continuity could be traced through the fuselage to the rudder control horns.

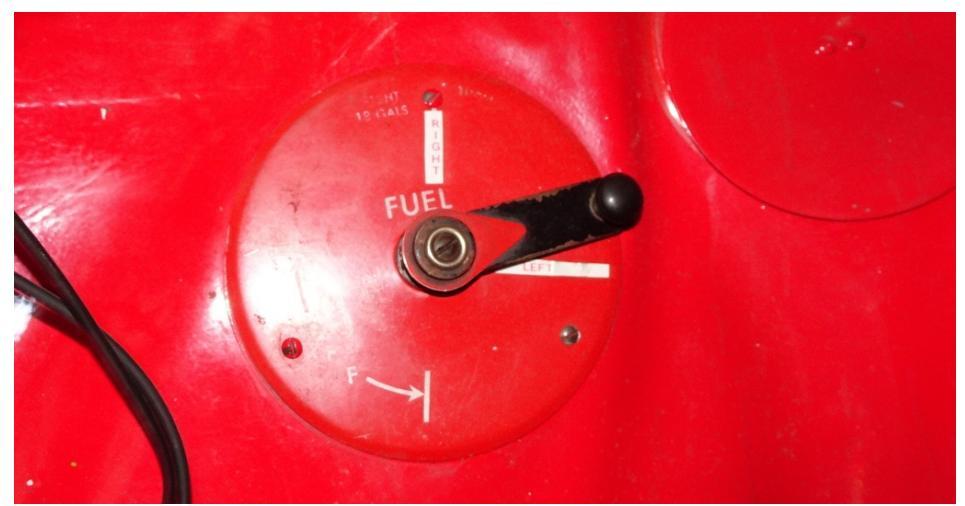
Figure 13 - Fuel Selector Valve Handle

The fuel selector remained undisturbed in its normal location in the left lower forward cabin wall. The handle was found positioned near the detent for the left tank. The fuel selector was removed and tested for blockage using light air pressure. No blockage was noted in either the left or right tank detent. Some impedance was noted when the selector was positioned to the setting

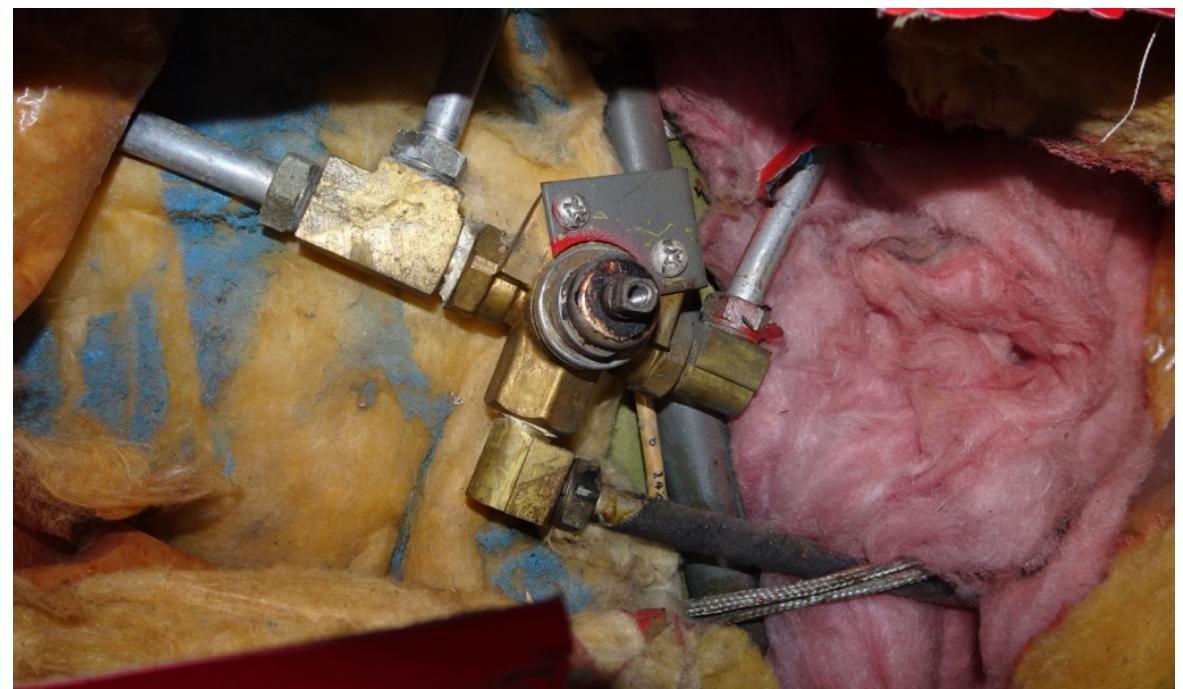
Figure 14 - Fuel Selector Valve (in situ)

noted during initial examination, and a visual inspection of the valve port revealed that the port was about 40% occluded by this setting. The valve handle was difficult to move. The fuel lines were found to be securely attached to the valve. No fuel was noted in the fuel selector or adjacent lines, and no evidence of any fuel leaks was observed.

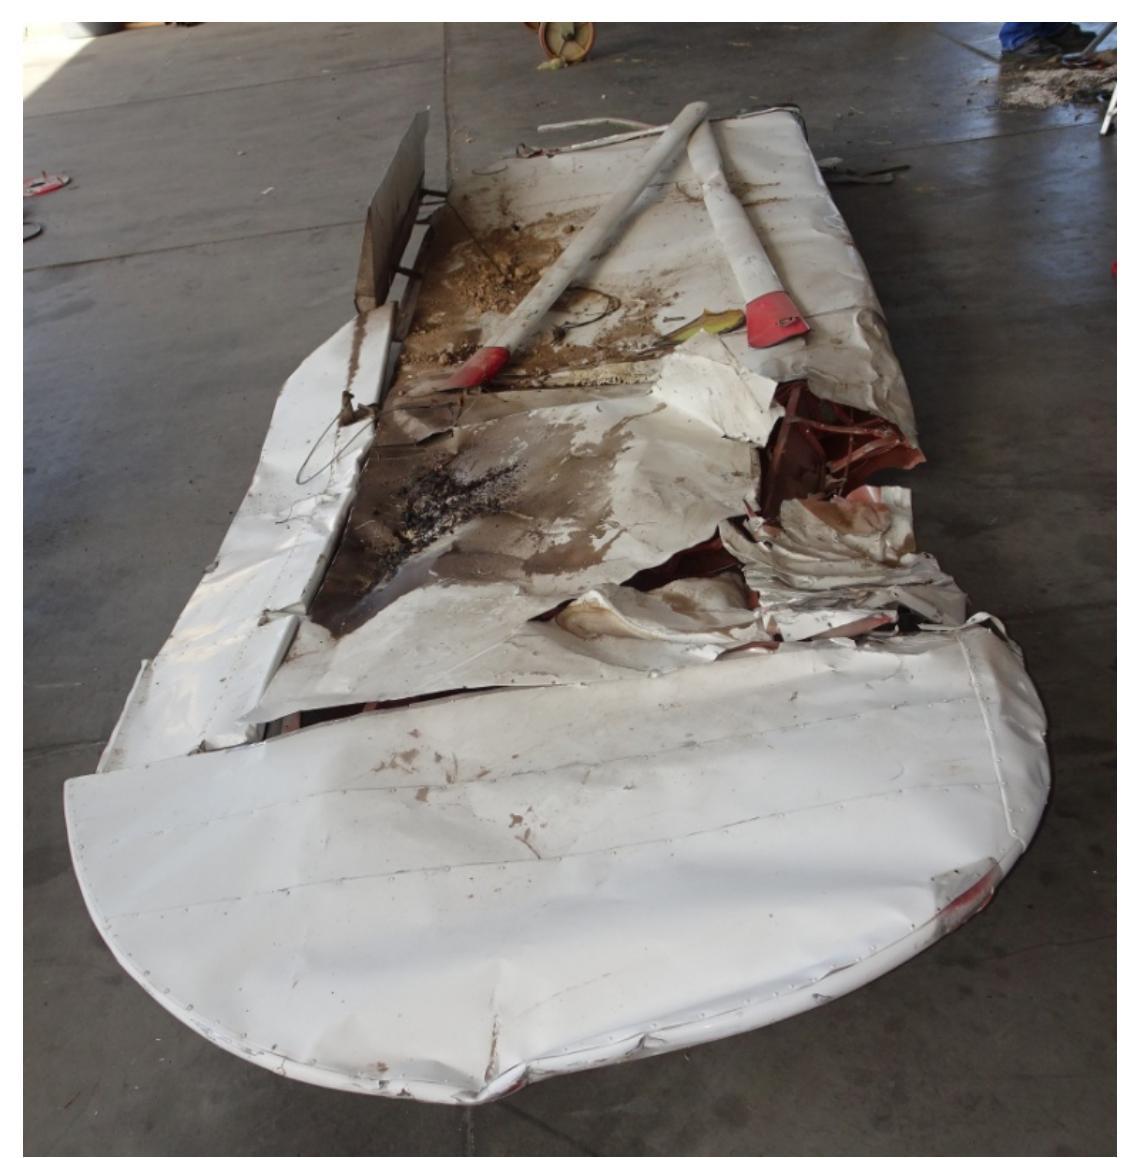
Figure 17 - Left Wing

The left wing was cut from the fuselage at the wing root during recovery. Some deformation and buckling were noted throughout the wing skins and structure. An area of aft crushing and tearing was noted about 5 ft from the wing root, extending to the tip. The lift struts remained attached to the wing and displayed recovery cuts ≈ 12 inches from the fuselage attachment clevises.

The aileron remained attached to the wing at the hinges. The aileron cables remained attached to the aileron control horn and were routed through the wing to recovery cuts at the wing root. No damage was apparent to the aileron stops.

The flap remained attached to the wing and was extended beyond its normal range and lay roughly perpendicular to the wing's chord. Some buckling and distortion were noted along its inboard end. The flap control cable remained attached to the flap control bracket and terminated in a recovery cut near the wing root.

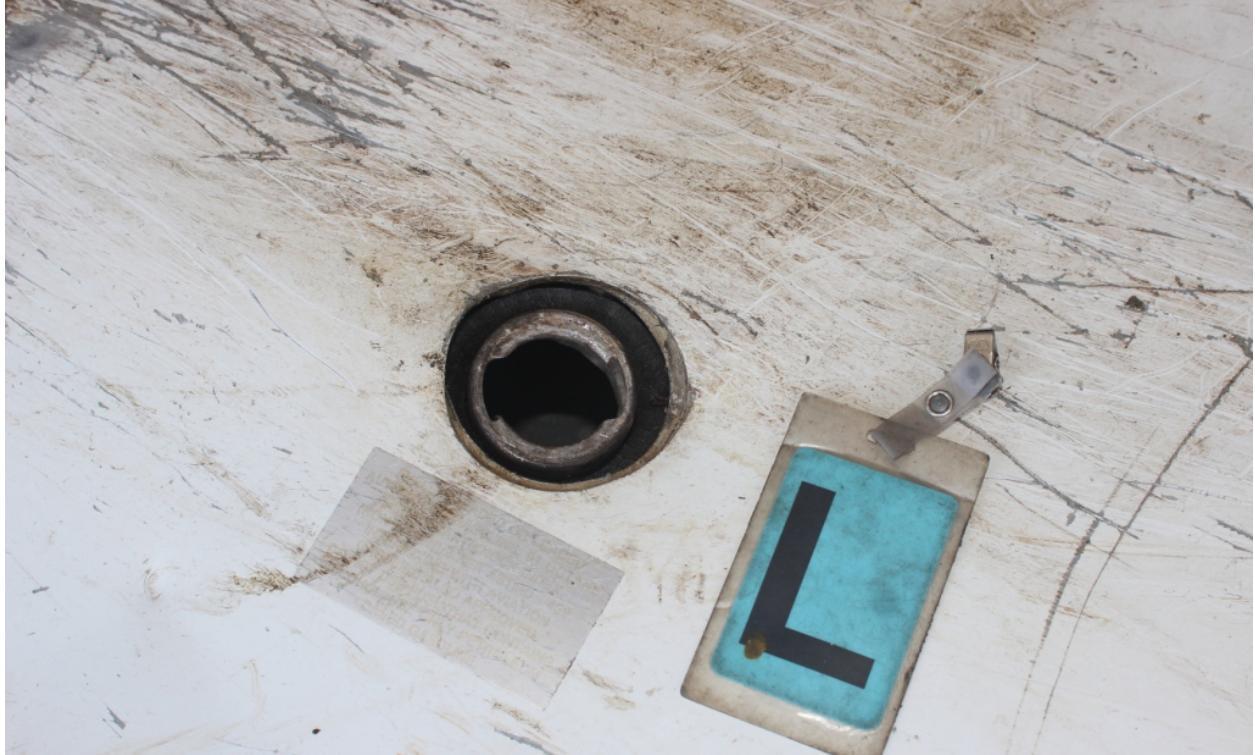
Figure 18 - Left Wing Skin and Fuel Port

The fuel tank remained in place in the inboard wing section. The tank displayed some buckling and denting. The fuel filler cap was absent, the filler neck showed no obvious damage, and the wing skin covering the tank showed no marks consistent with contact with a fuel cap. When a donor fuel cap was installed, it locked into place within the filler neck. No fuel was observed within the tank.

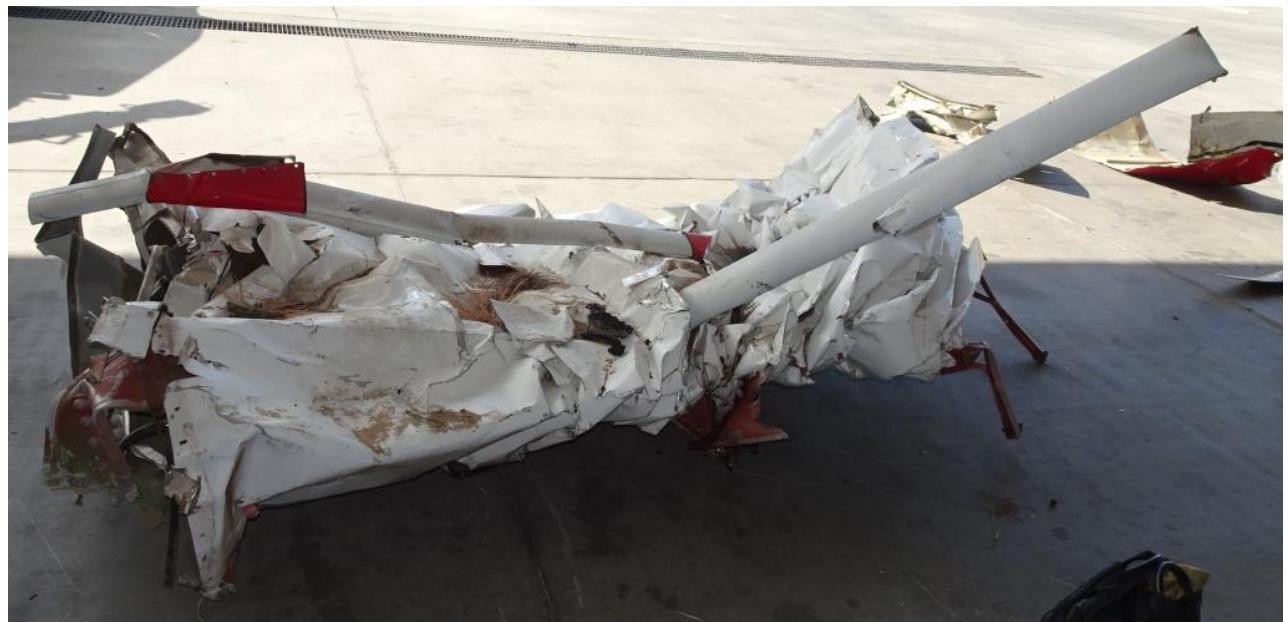
Figure 19 - Right Wing

The right wing was cut from the fuselage at the wing root during recovery. The wing was accordion-crushed spanwise from the tip inboard, reducing it to about half of its original span. The lift struts remained attached to the wing; the forward lift strut was impact separated at the fuselage attachment clevis, and the aft displayed a recovery cut ≈ 12 inches from the fuselage attachment clevis.

The aileron remained attached to the wing at the hinges. It was accordion-crushed along its span. The aileron cables remained attached to the aileron control horn and were routed through the wing to recovery cuts at the wing root. No damage was apparent to the aileron stops.

The flap remained attached to the wing and was in the retracted position. Some buckling was noted adjacent to its inboard attach bracket. The flap control cable remained attached to the flap control bracket and terminated in a recovery cut near the wing root.

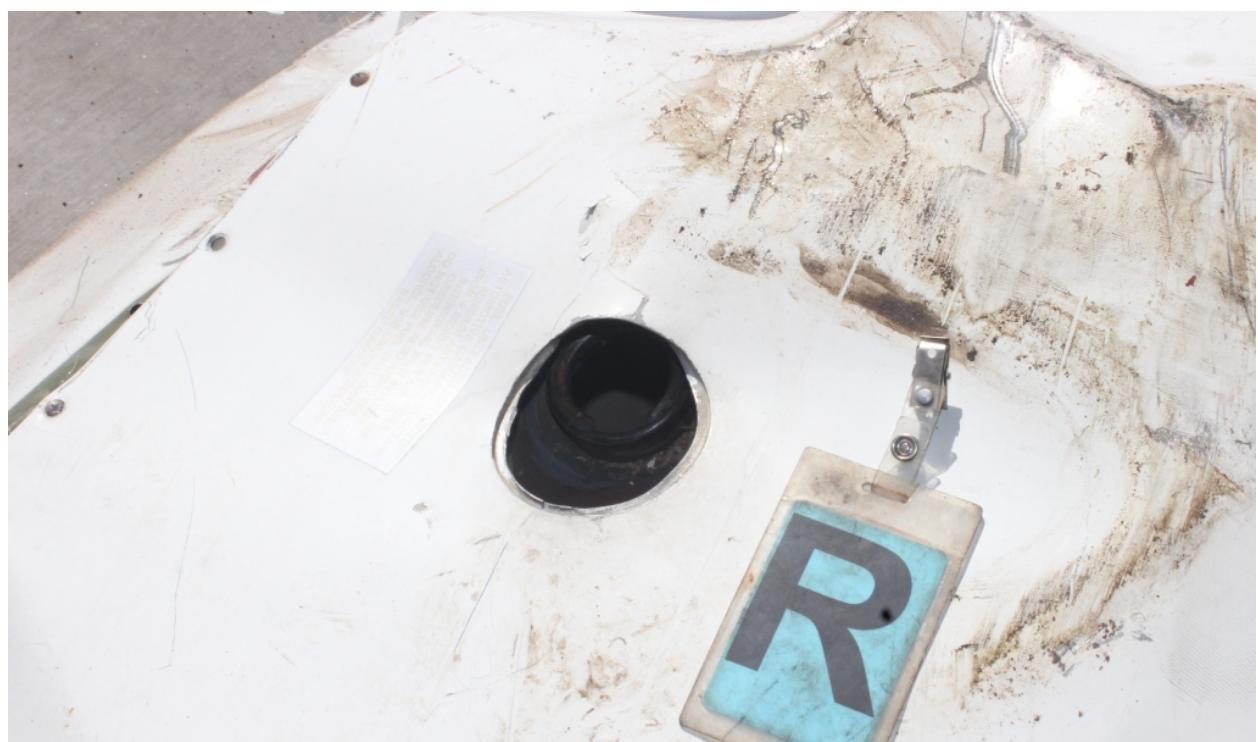
Figure 20 - Right Wing Skin and Fuel Port Cutout

The fuel tank remained in place in inboard wing section; it was crushed and deformed. The fuel filler cap was absent and the filler neck showed no obvious damage. The wing skin covering the tank partially overrode the filler neck but showed no marks consistent with contact with a fuel cap. When a donor fuel cap was installed, it locked into place within the filler neck. No fuel was observed within the tank.

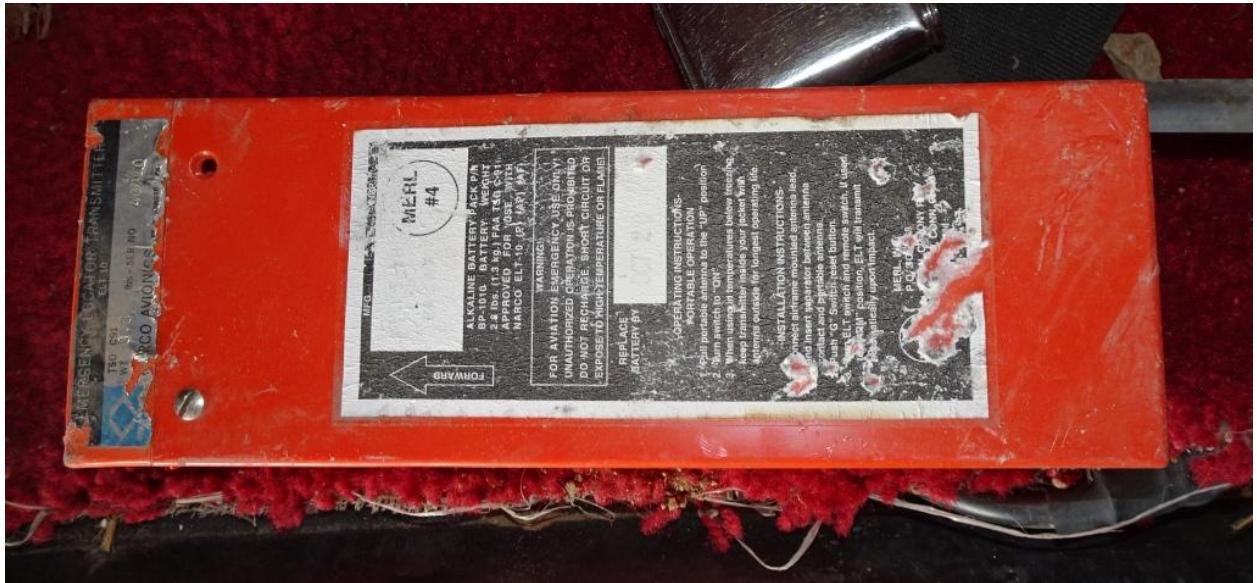
Figure 24 - ELT

The aft fuselage/tailcone section remained attached to the cabin section and displayed some wrinkling and deformation. The underside appeared clean and was free of oil. The TSO C91 ELT (121.5 MHz) had been removed from its tray and disconnected from its antenna during the recovery of the aircraft; it was found switched to OFF during this examination. When or by whom the ELT was switched OFF was not able to be determined.

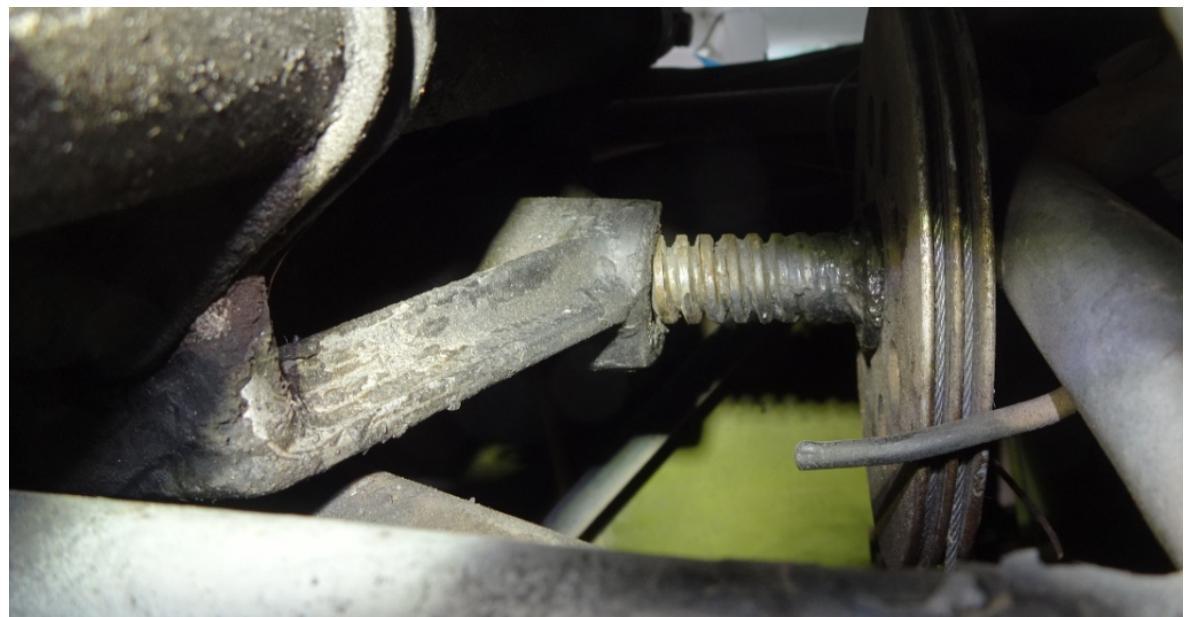
Figure 27 - Pitch Trim Pulley and Barrel

The left horizontal stabilizer and left elevator were twisted and crushed forward. The right horizontal stabilizer was crushed inboard to the empennage. The right elevator was impact separated and crushed. The elevator control cables remained attached to the elevator control horn and continuity could be traced to the forward control bellcrank. The pitch trim barrel appeared undamaged; 8 threads were exposed on the top of the trim screw, correlating to neutral pitch trim.

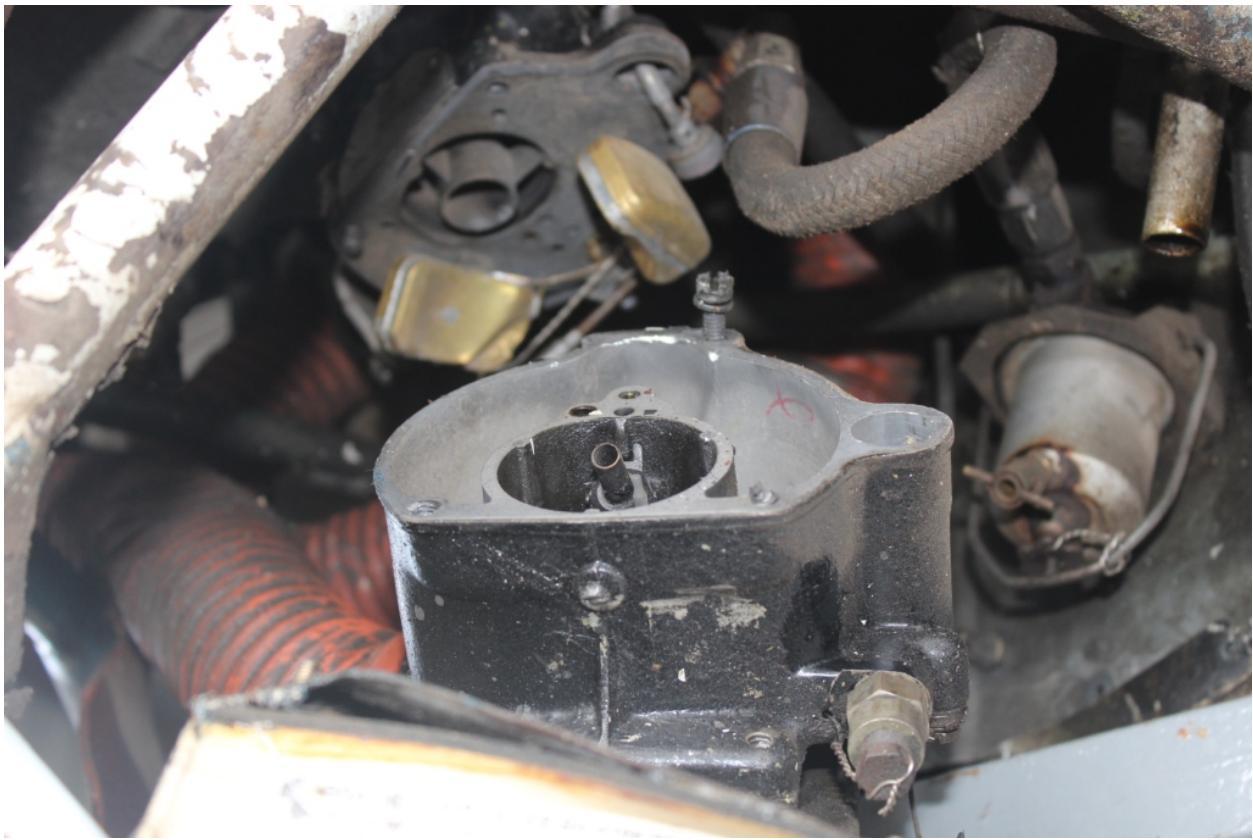
Figure 36 - Displaced Carburetor Bowl and Airbox

The carburetor bowl was fracture-separated from the carburetor base, and the portion that remained attached at the mounting pad was secure. The fracture surface signatures were consistent with overload. The throttle/mixture controls were found securely attached at their respective control arms of the carburetor. The castellated nut and cotter pin remained secure and the serrated interface at the throttle arm remained securely mated. Control continuity to the cockpit was established. All engine compartment fuel lines were found to be secure at their respective fittings.

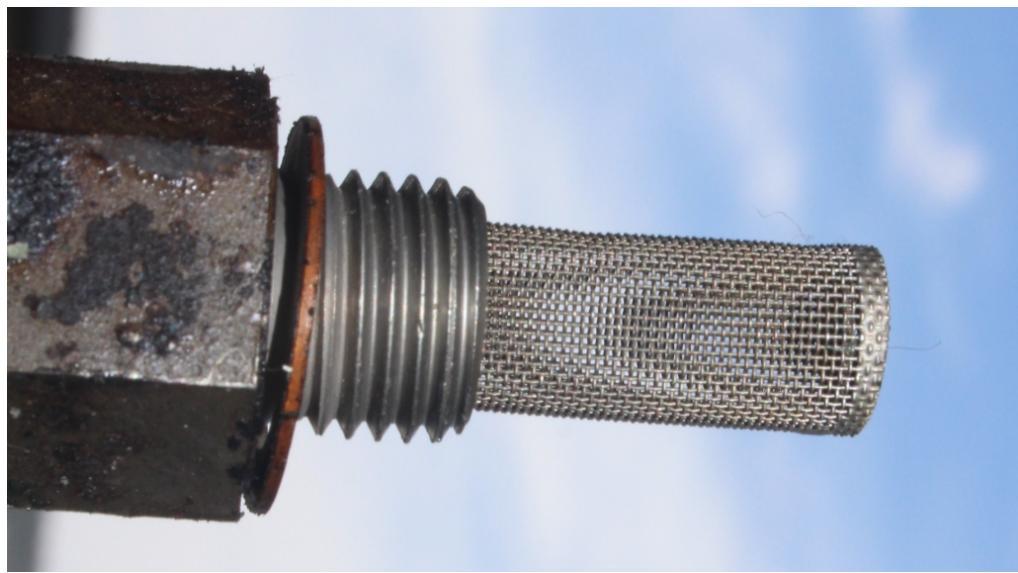
Figure 38 - Carburetor Fuel Inlet Screen

The impact-damaged float assembly remained secure at the mounting. The float pontoons exhibited no evidence of rubbing against the wall of the bowl. All internal locking tabs and safety devices of the carburetor were in place and properly secured. The fuel inlet screen was found properly installed and free of contamination. No external fuel staining was observed.

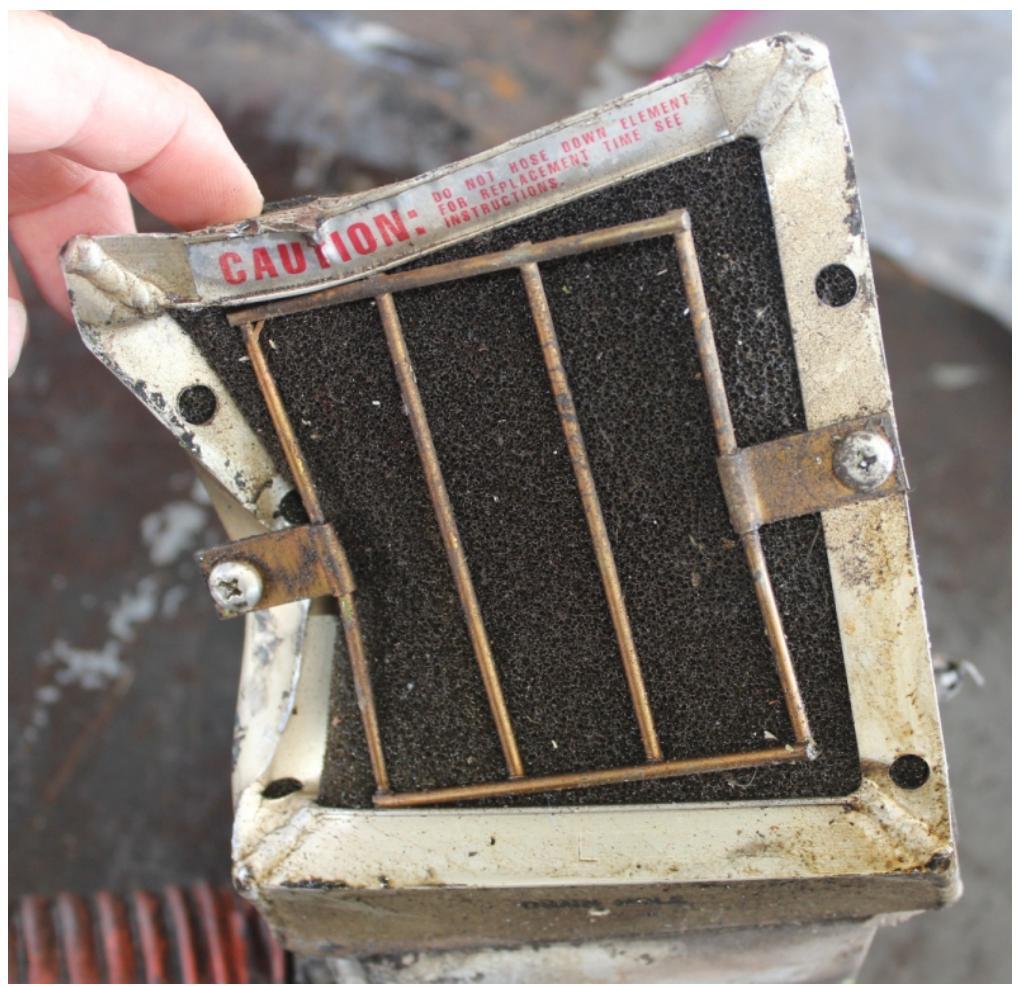
Figure 41 - Engine Air Intake Filter

The carburetor and induction system were examined and observed to be free of obstruction. The foam filter element remained securely attached to the airbox bracket. The filter element remained intact and exhibited no evidence of pre-impact obstruction to airflow.

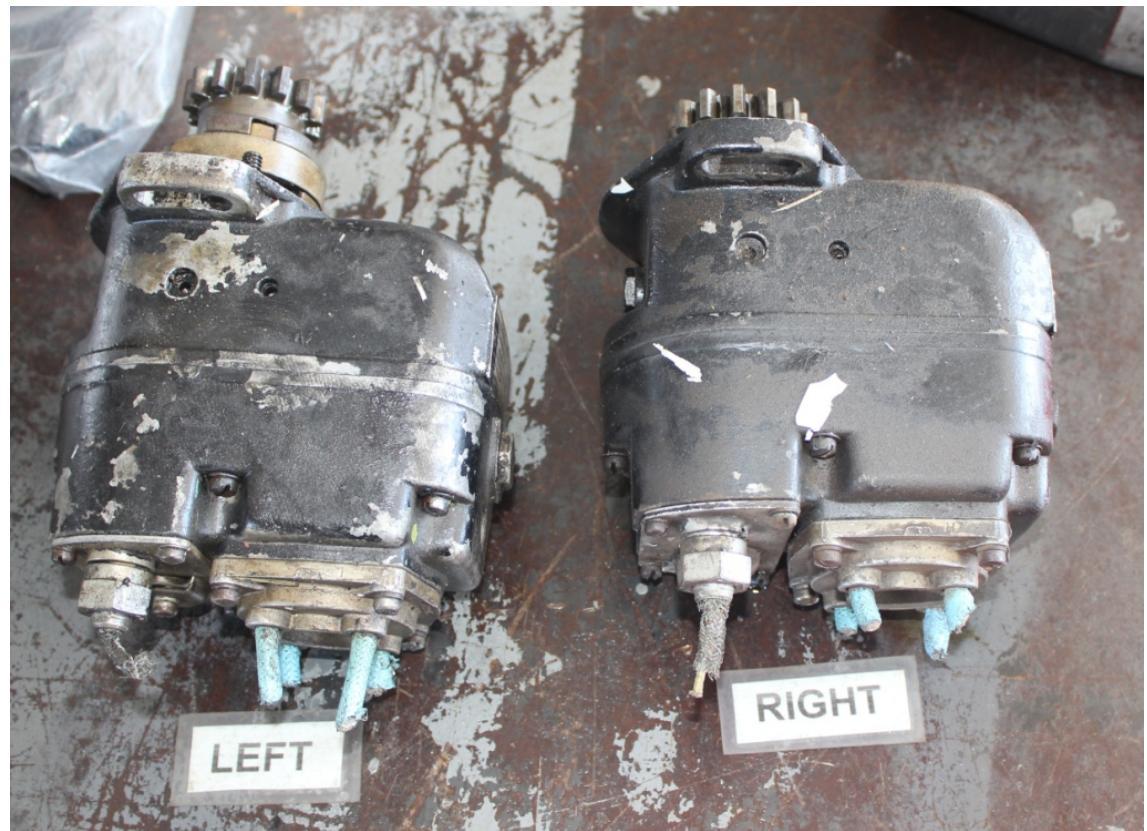
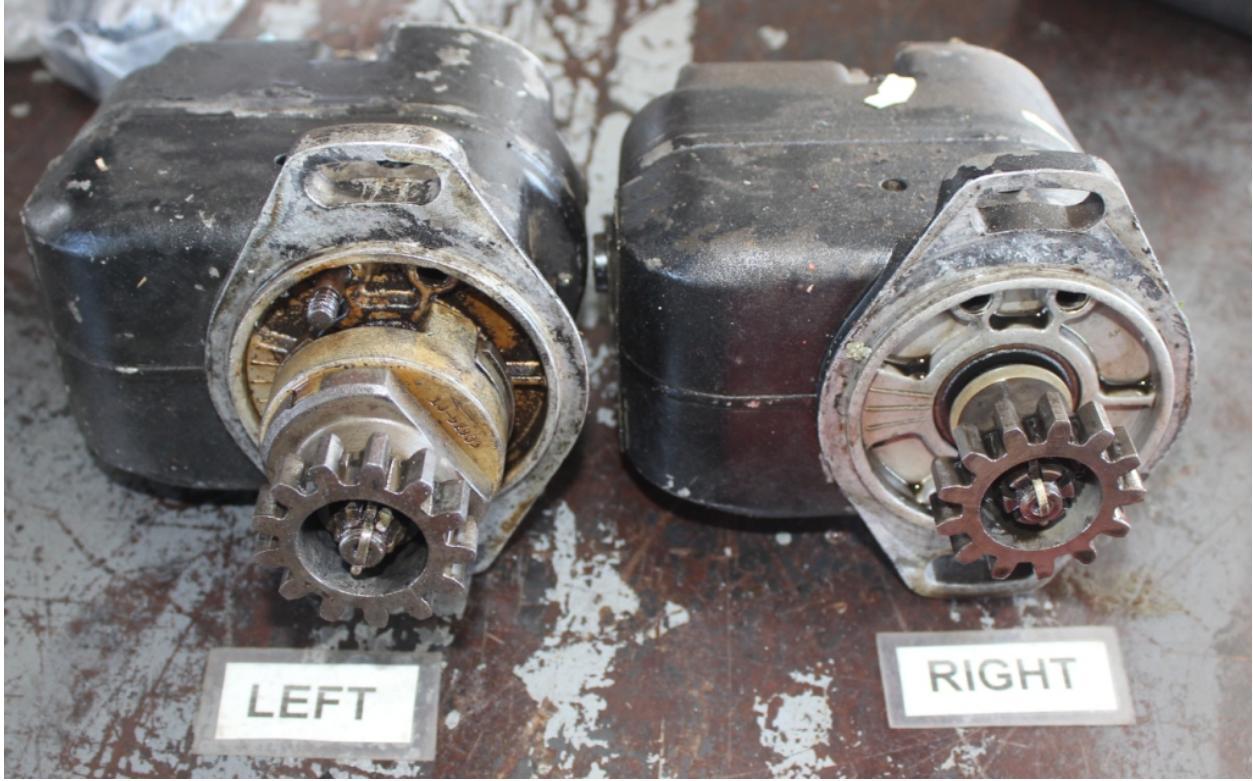
The left and right magnetos remained securely clamped at their respective mounting pads. The ignition harness was secure at each magneto terminal and each respective spark plug. Magneto to engine timing could not be ascertained, due to the destruction of the flywheel. The magnetos were removed for examination. Each magneto produced spark at the end of the respective spark plug lead, during hand rotation of the drive. The drives of each magneto remained intact and undamaged.

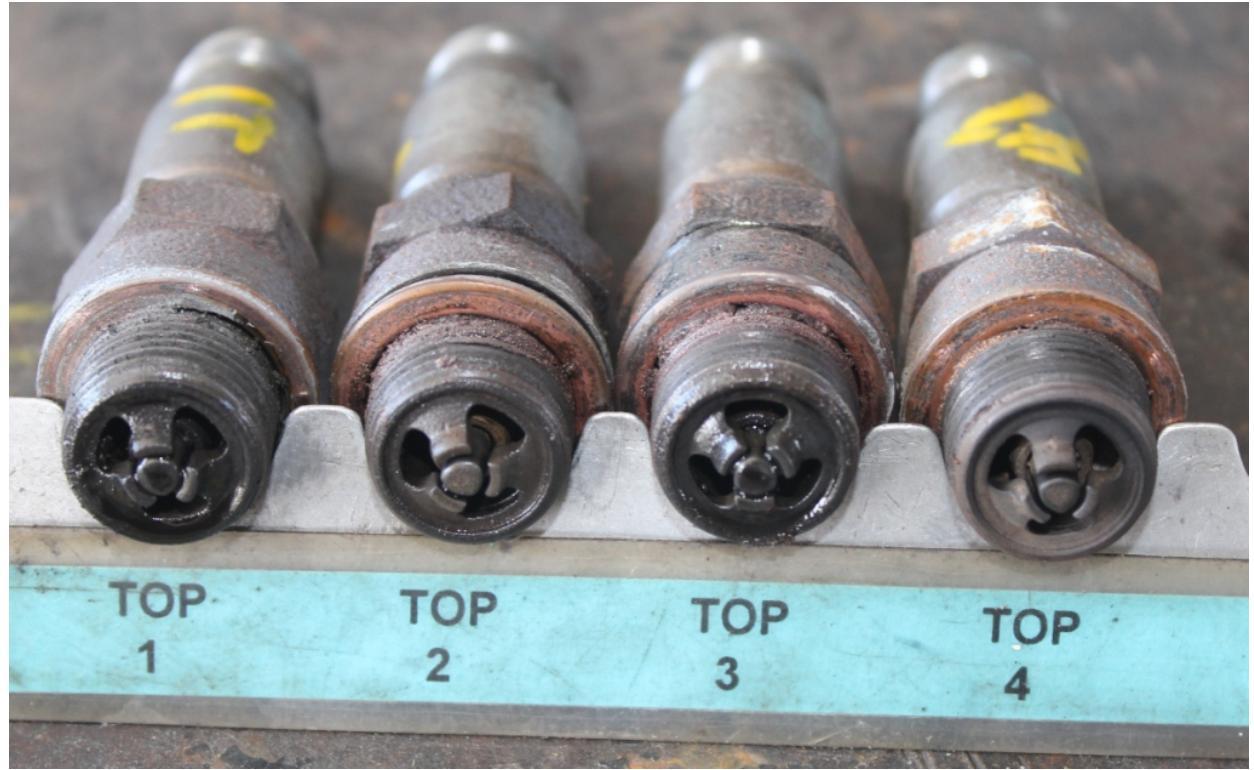
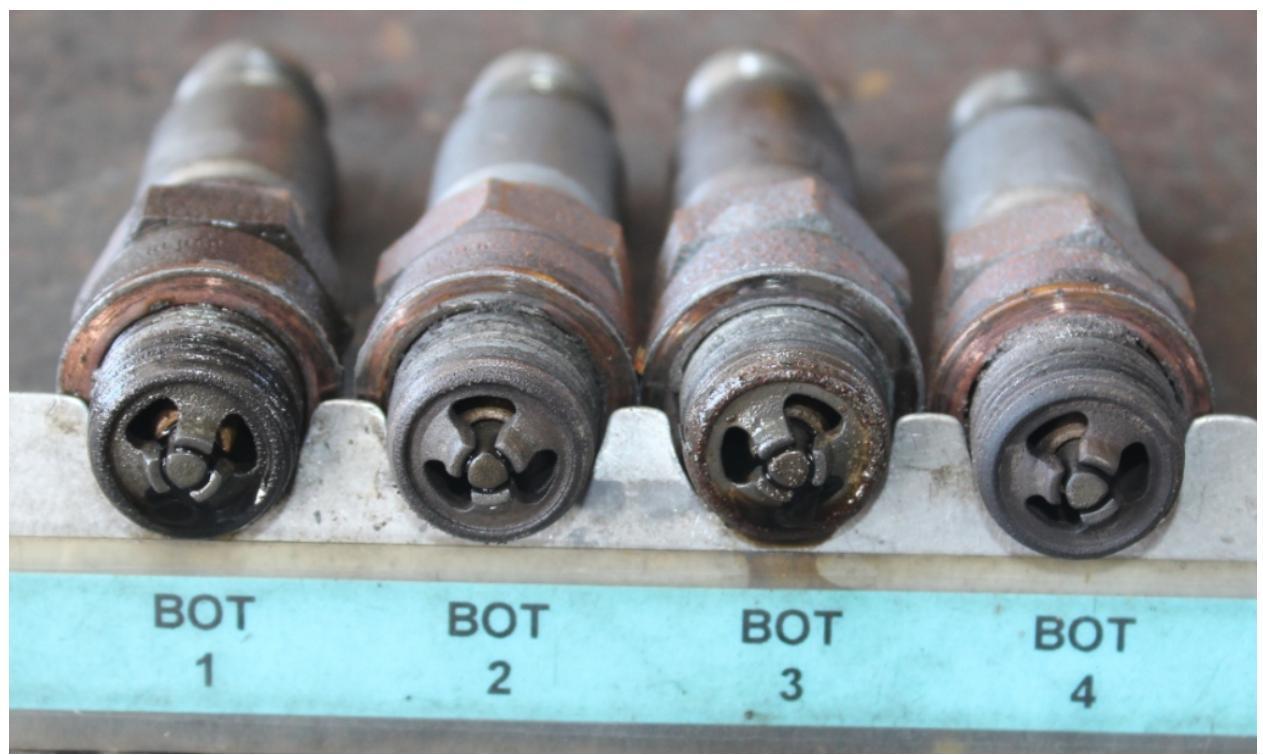
The Auburn brand spark plugs were secure at each position with their respective spark plug lead attached. The spark plugs were removed, examined and photographed. The spark plugs electrodes remained mechanically undamaged and according to the Champion Spark Plugs "Check-A-Plug" chart AV-27, the spark plug electrodes displayed coloration consistent with normal operation. The static oil soaking of the spark plugs (as noted) was attributed to the engine positioning at the mishap site and post recovery.

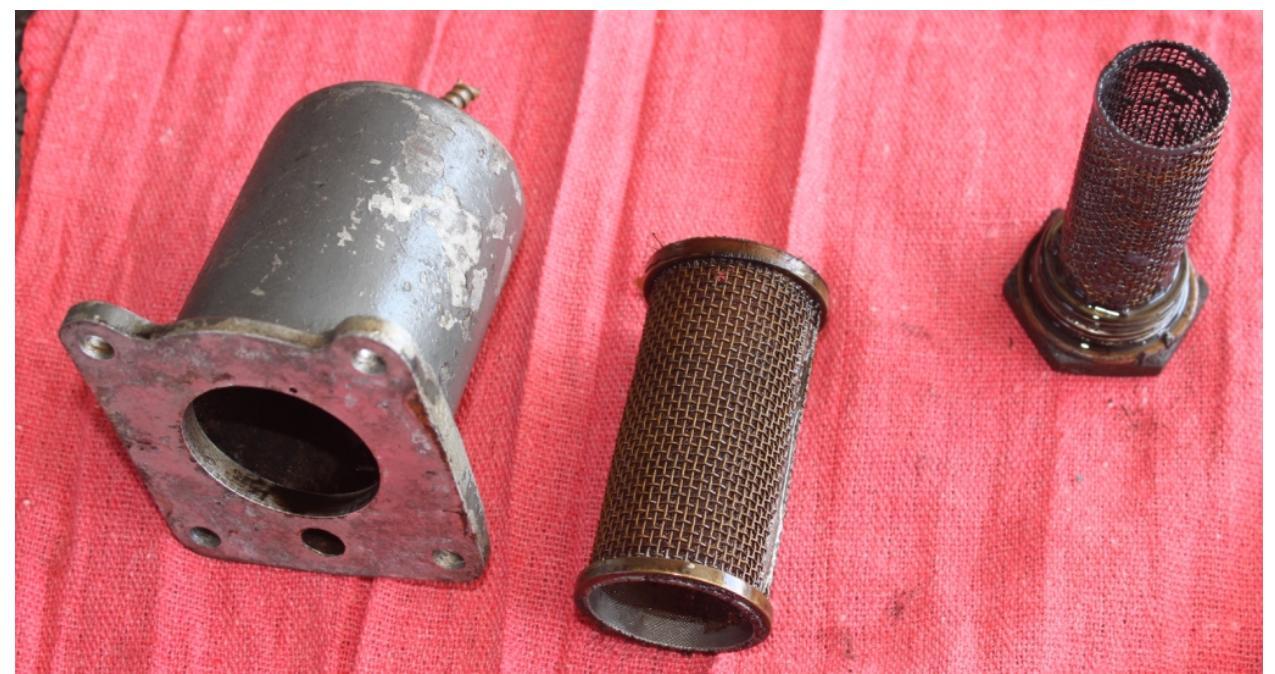
Figure 46 - Oil Pressure Screen Housing, Oil Pressure Screen, Oil Pickup Screen (left to right)

The oil suction and pressure screen were found secure and uncontaminated by any pre-impact debris.
