NATIONAL TRANSPORTATION SAFETY BOARD

AIRFRAME AND ENGINE EXAMINATION

WPR19LA063

Accident Date: January 13, 2019 Exam Date: September 24, 2019

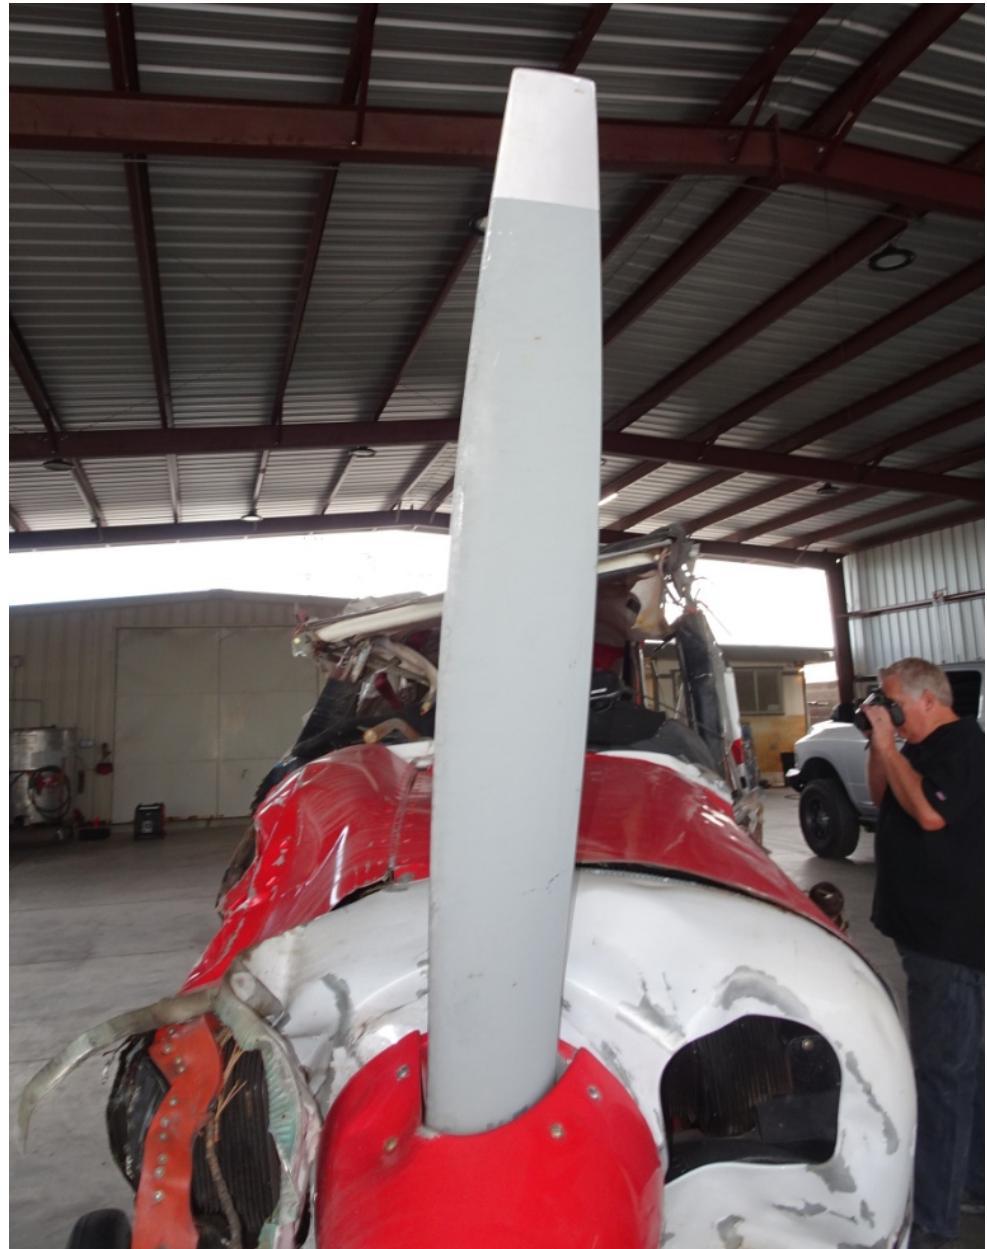
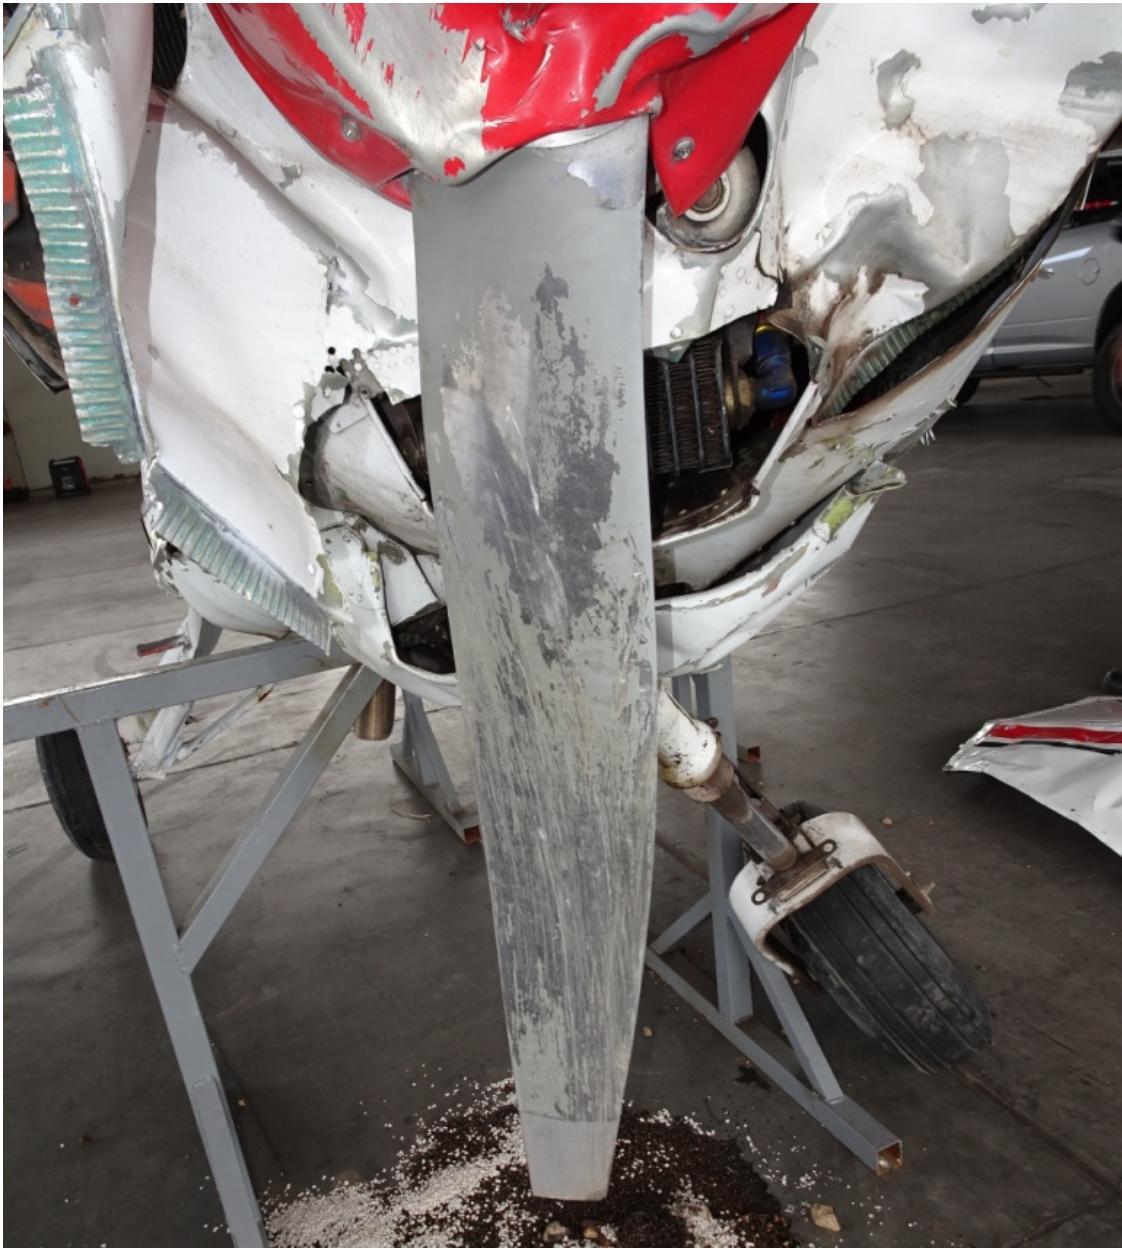
The propeller remained mounted to the crankshaft. The spinner remained attached to the propeller backing plate and was crushed aft, with no circumferential scoring noted. The backing plate/engine mounting flange was fractured. One propeller blade was straight, with no chordwise scraping or leading edge damage noted. The other propeller blade was bent slightly aft, displayed no obvious leading edge damage, and showed a series of spanwise scrapes.
