Strain Investigation Feature No. 25 WPAT 22-inch ROW 15

Strain Investigation Study

Strain Investigation Feature No. 25 Pipeline System: Woodpat 22" Crude Pipeline Segment: Roxana - Patoka Woodpat 22" ROW 15

Date of Field Inspection 06/15/2021 Marathon Project ID No. 141302

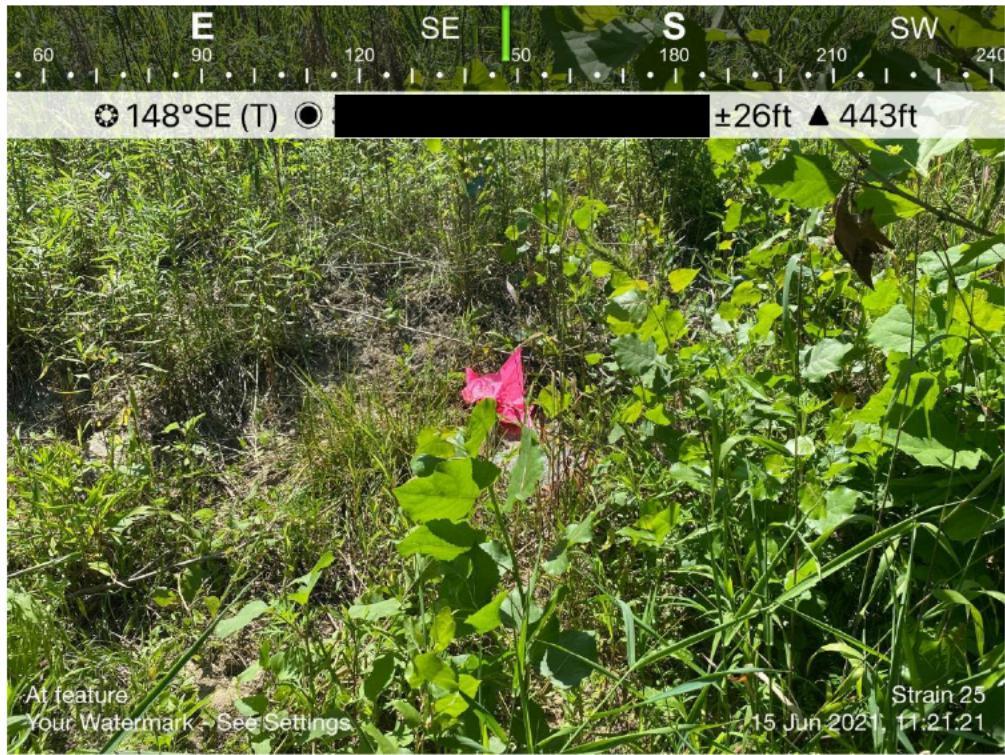
Photo 1. At strain point looking southeast.

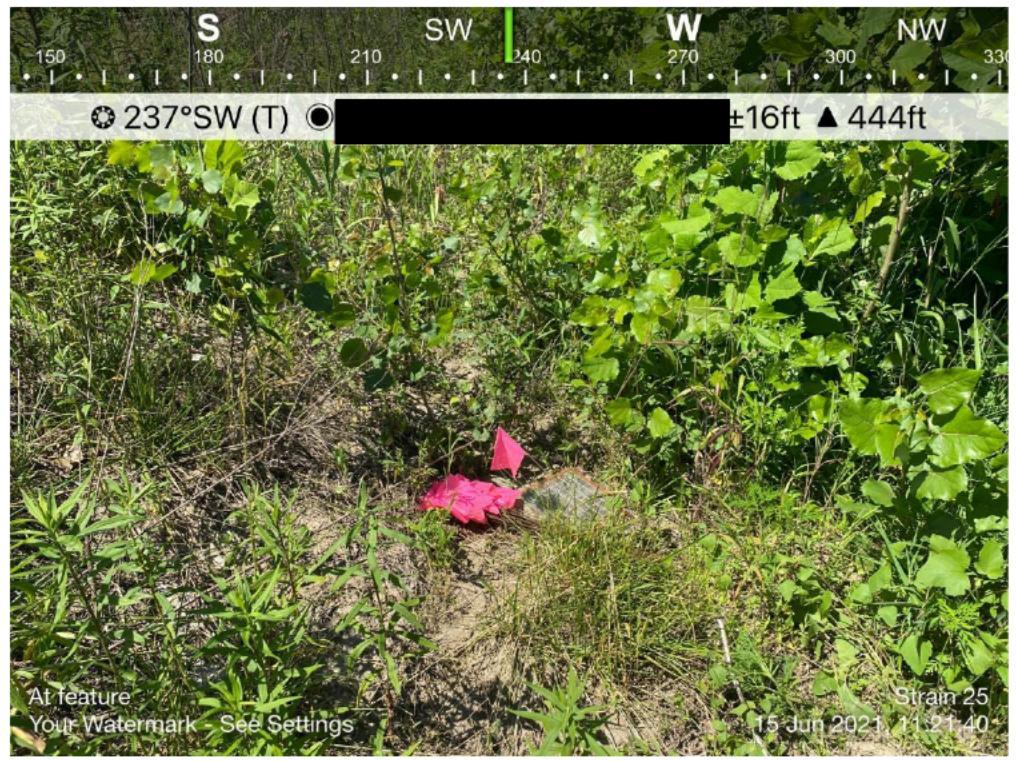
Photo 2. At strain point looking southwest.

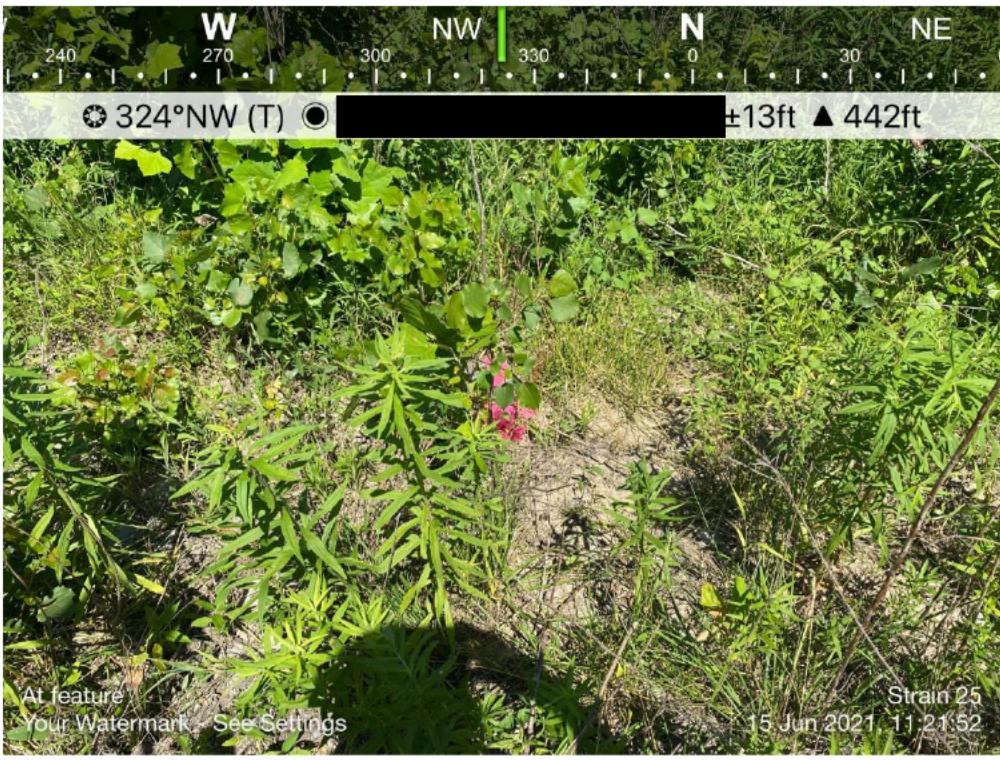
Photo 3. At strain point looking northwest.

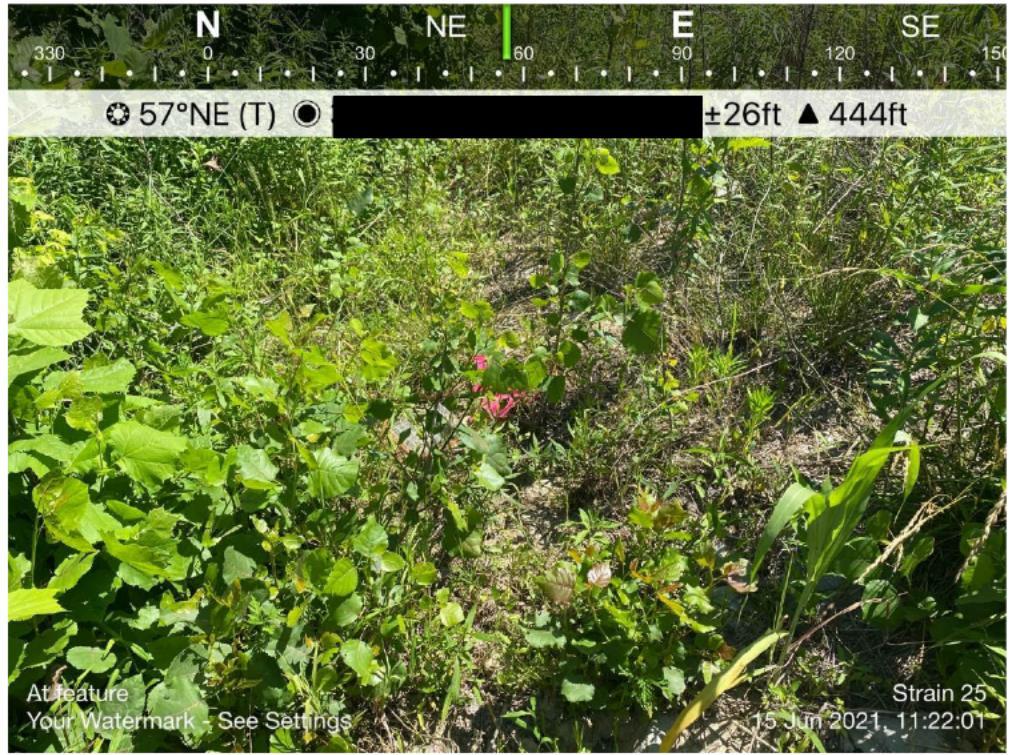
Photo 4. At strain point looking northeast.

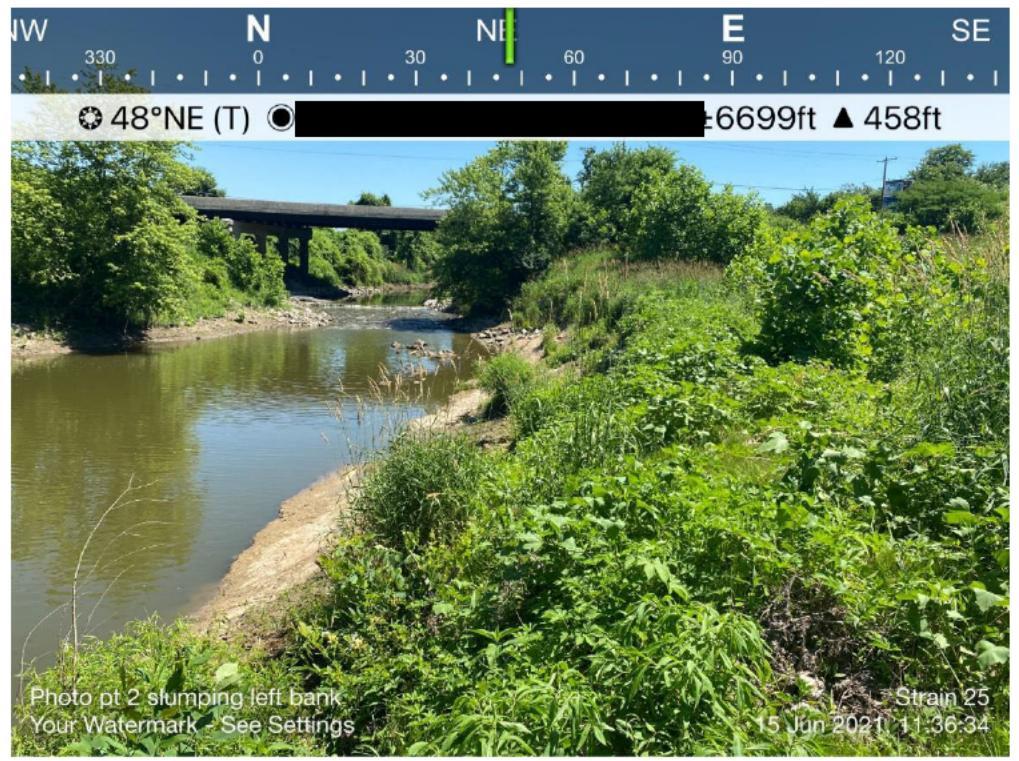
| Geohazard Type: | Unstable bank of Cahokia Creek | | | |
|---|--|--|--|--|
| Additional Comments and Recommendations: | Concrete matting armors a portion of the left bank here but below the matting the bank is badly eroded with ongoing instability noted in aerial imagery and during the site visit. The data collected suggests that the pipeline is bending both horizontally and vertically in the direction of the bank failures here. This bank stability could be resulting in the observed pipeline bending. Recommend increased monitoring of bank stability and repeat depth of cover surveys. Consider additional armoring of left bank to decrease ongoing bank instability. | | | |

Photo 8. Photo location 2 looking upstream and at slumping on left bank.

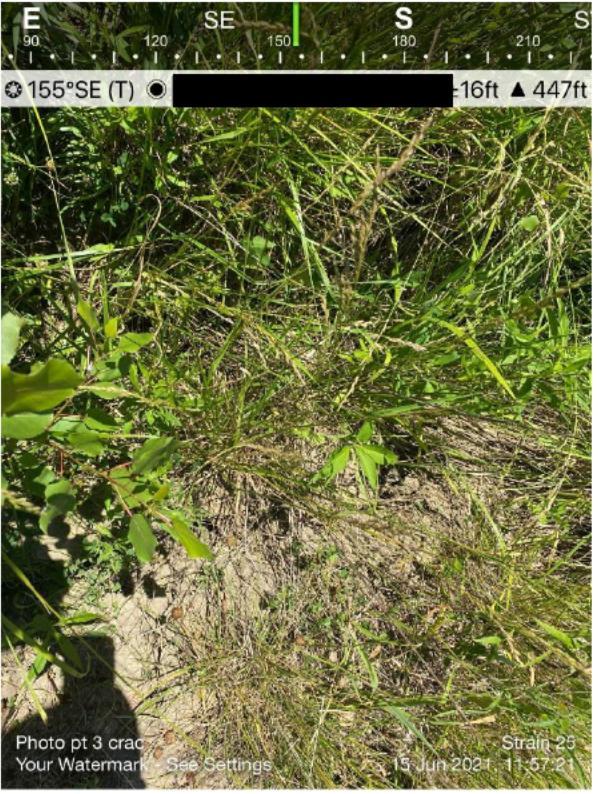
Photo 11. Photo location 3 looking at cracking in bank.

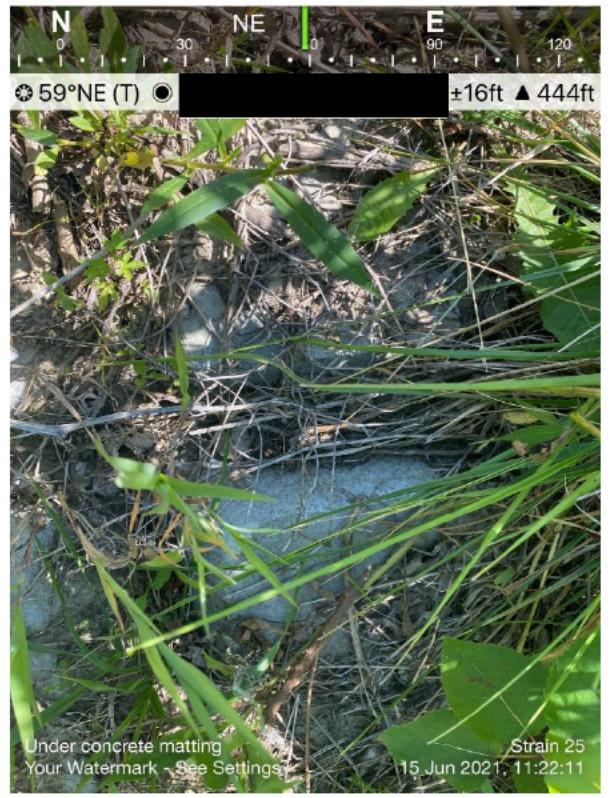
If Yes, Provide Details: Concrete matting on portion of left bank

Photo 12. Concrete matting over pipeline.

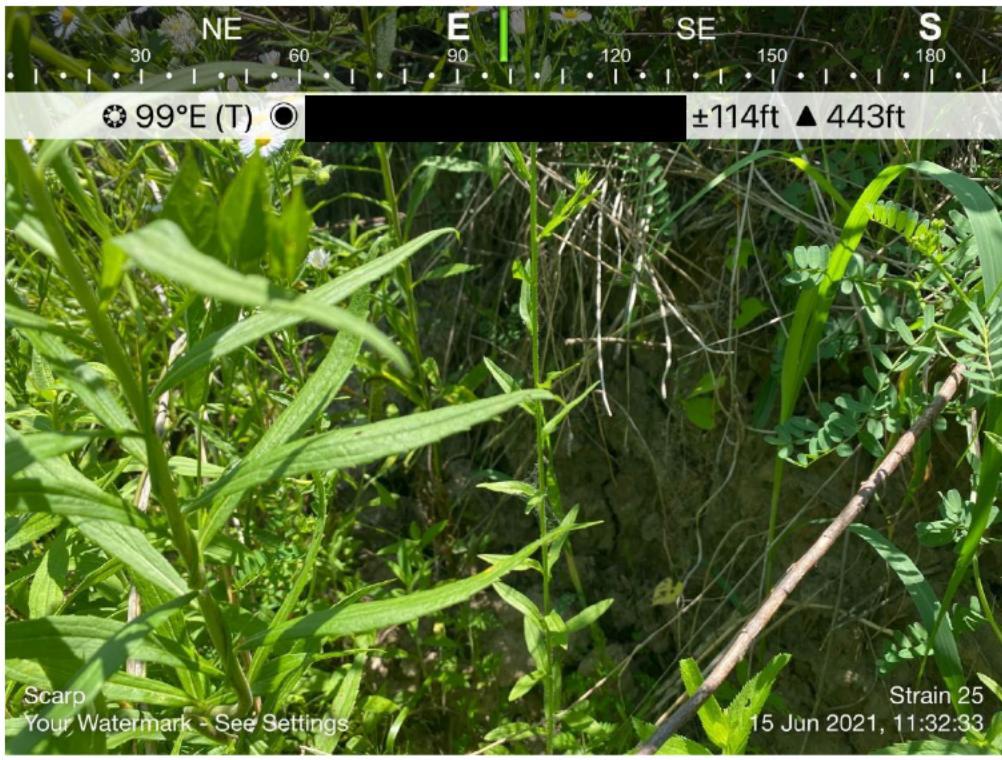
| Geohazard Type: | Unstable bank of Cahokia Creek | | | |
|---|--|--|--|--|
| Severity Index 1-10 (10 Being Most Severe): | 7; proximity ongoing bank instability | | | |

Photo 13. Scarp on left bank of Cahokia Creek.

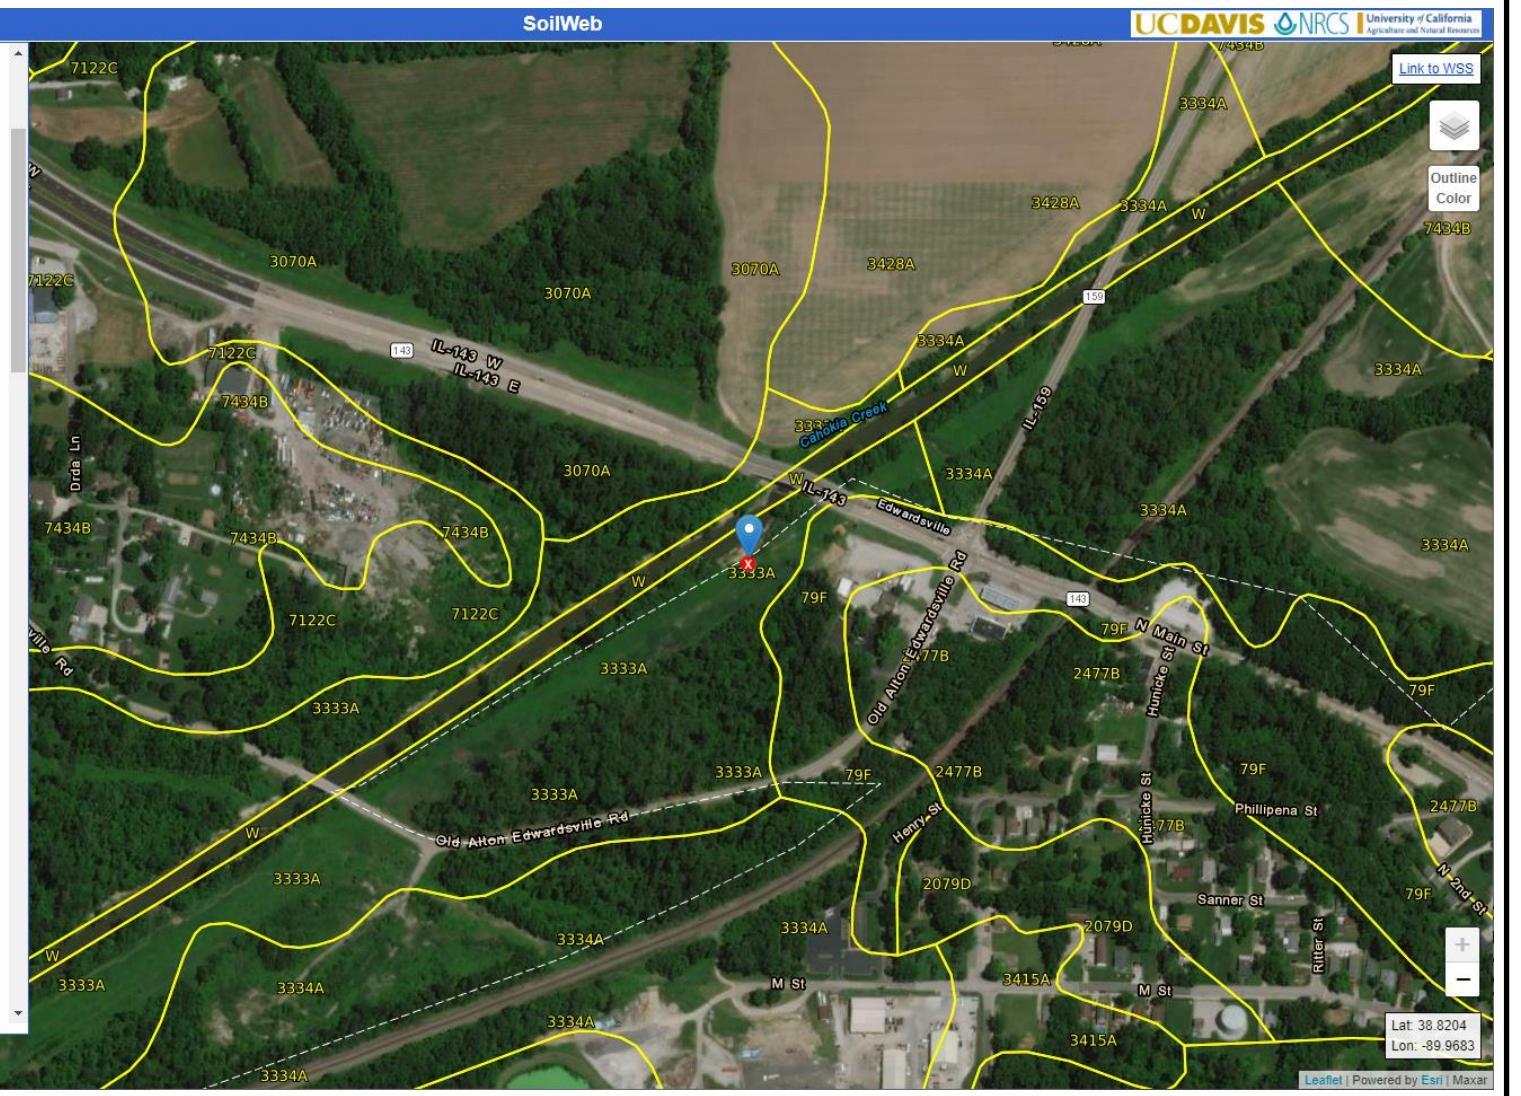
Overview Map of Soil Web Data in the Vicinity of the Strain Investigation Feature No. 25; Soil Data from NRCS Soil Web

| Geohazard Type: | Unstable bank of Cahokia Creek | | | |
|---|--|--|--|--|
| Area Soil Type: | Silt loam, somewhat poorly drained | | | |
