NATIONAL TRANSPORTATION SAFETY BOARD

ACCIDENT SITE EXAMINATION SUMMARY

WPR18FA201

Location:Burnet, TexasDate:July 21, 2018Aircraft:Douglas DC-3, N47HLNTSB Investigator-in-Charge:Joshua Cawthra

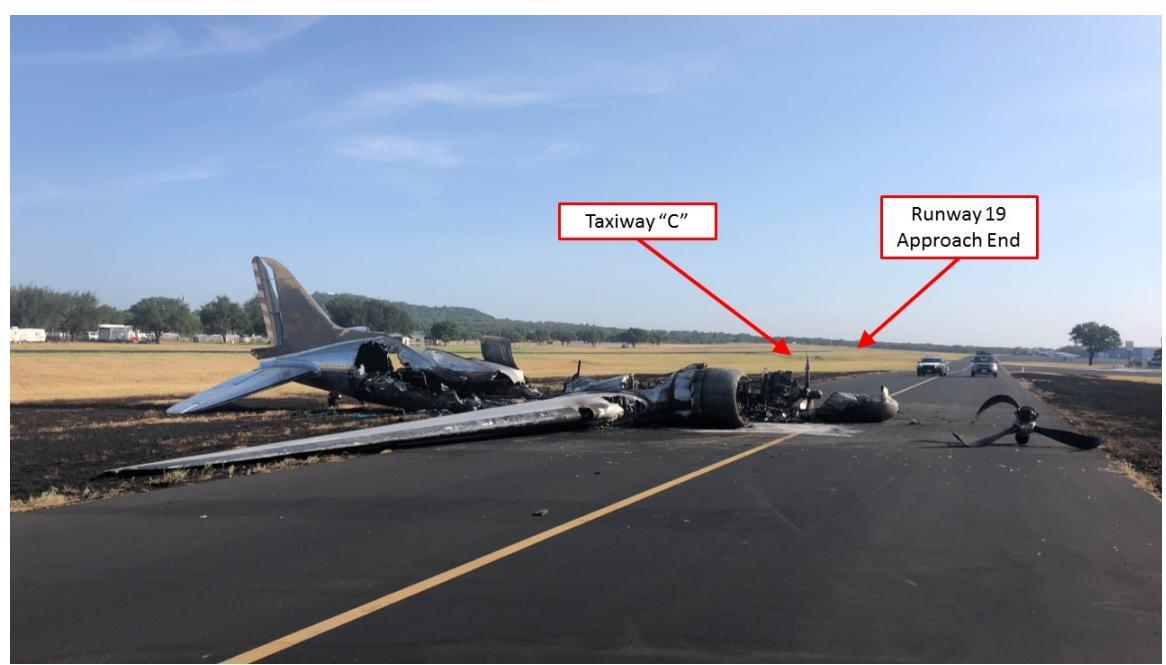
Examination of the accident site revealed that the airplane came to rest upright on a heading of about 113° magnetic, about 145 feet east of the left side of runway 19.

Figure 1: View of the main wreckage in relation to runway 19 and taxiway C.

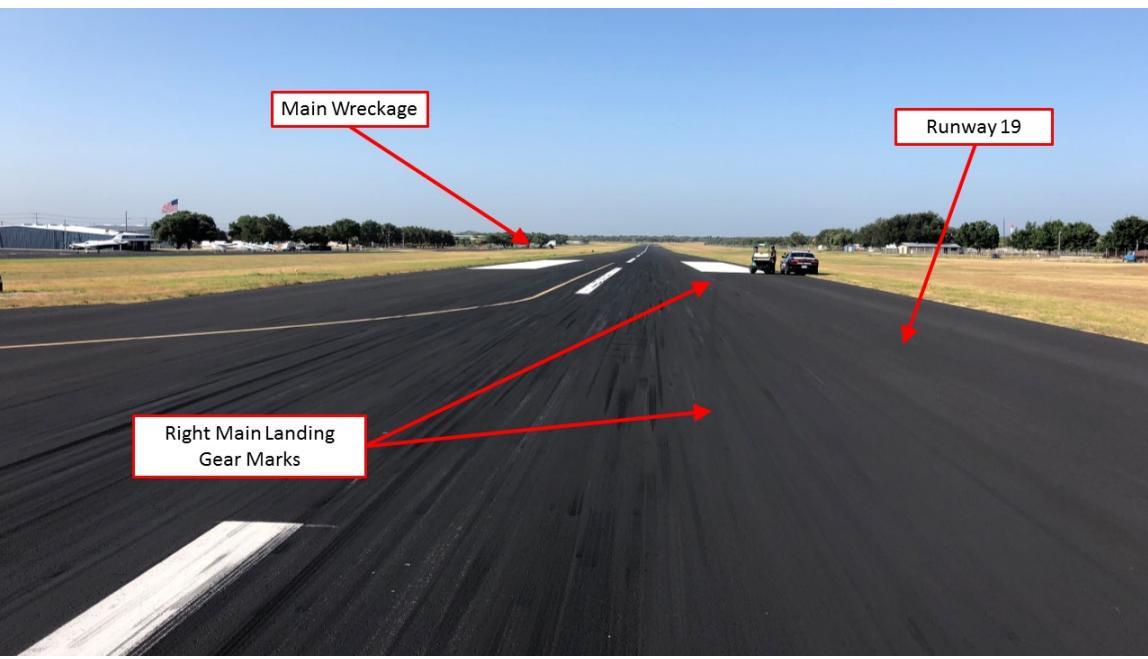
Examination of runway revealed that about 843 feet from the approach end of runway 19 was a skid mark, consistent with the right main wheel, that extended from slightly right of runway center line toward the 1,000-foot markers, progressively moving toward the right side of the runway as seen in figure 2. About 1,106 feet from the approach end of the runway, the skid mark began to progressively move left, increasing in angle toward the left side of the runway about 1,170 feet from the approach end of the runway.

Figure 2: View of tire marks on runway 19.

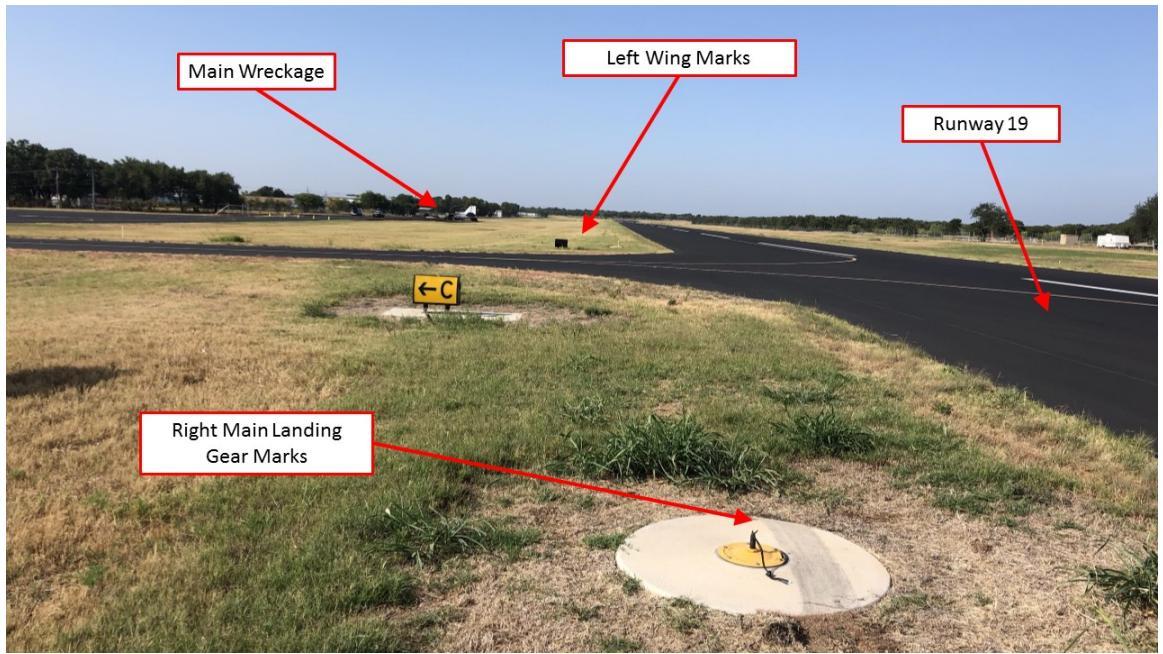
At 1,566 feet from the approach end of the runway, the right main exited the left side of the runway and continued in an almost parallel manner until it struck a runway light just prior to taxiway Charlie, or about 1,730 feet from the approach end of the runway. Shortly after the runway light, the wheel impression from the right main landing gear stopped, as seen in figure 3. The next identifiable ground impression was located to the left of the runway, about 2,111 feet from the approach end of the runway and was consistent with an impact by the left wing. The ground scar, consisting of freshly displaced dirt extended for about 200 feet, paralleling the runway.

Figure 3: View of tire marks next to runway 19 near taxiway C.

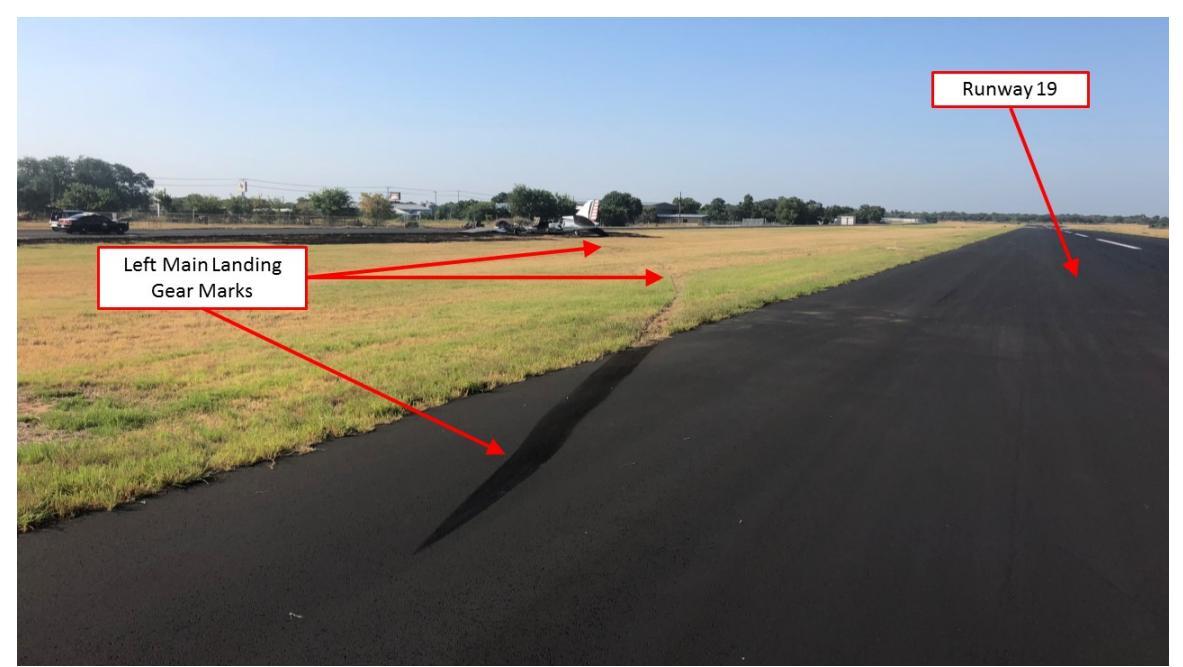
A skid mark, consistent with the left main landing gear was observed about 2,377 feet from the approach end of the runway, on the left edge of the runway. Extending from the skid mark, was an area of displaced dirt, which extended toward the main wreckage, as seen in figure 4.

Figure 4: View of tire marks next to and on runway 19 near taxiway C.

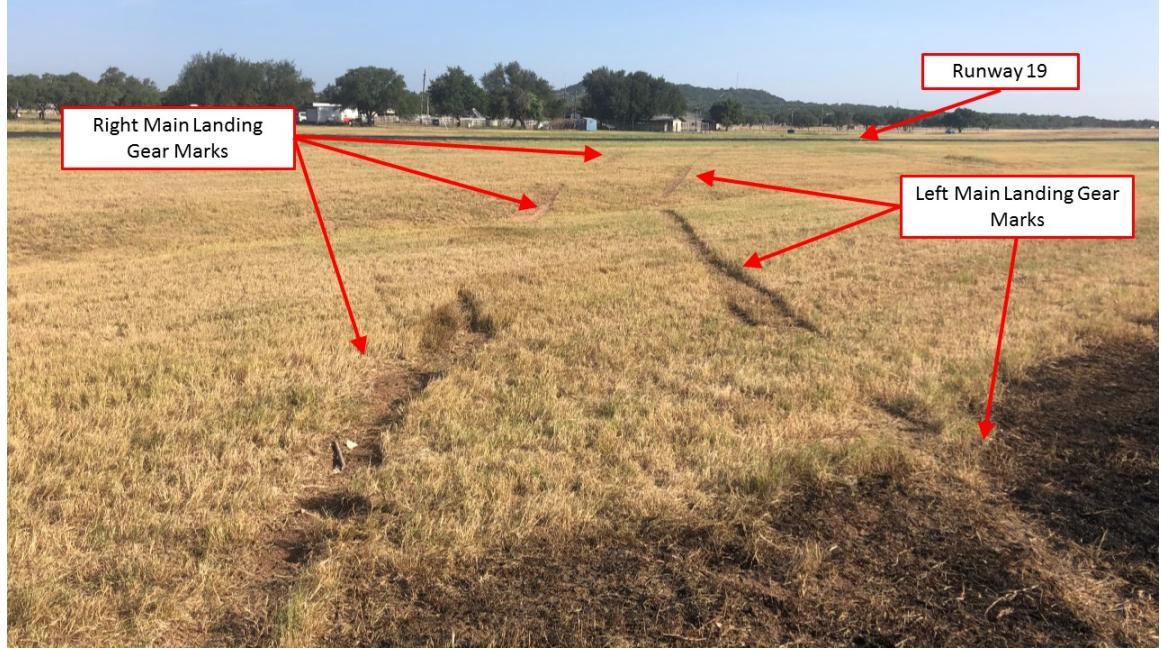
About 2,436 feet from the approach end of the runway was an area of displaced dirt, consistent with the right main landing gear. The impression was observed about 12 feet, 10 inches to the

right of the left wheel impressions. The right main landing gear impression extended parallel to the left main landing gear impression, and the distance between both impressions decreased to about 10 feet, 11 inches immediately near the main wreckage, as seen in figure 5. The main wreckage came to rest about 2,638 feet from the approach end of the runway.

Figure 5: View of tire marks next to runway 19, extending to the main wreckage.

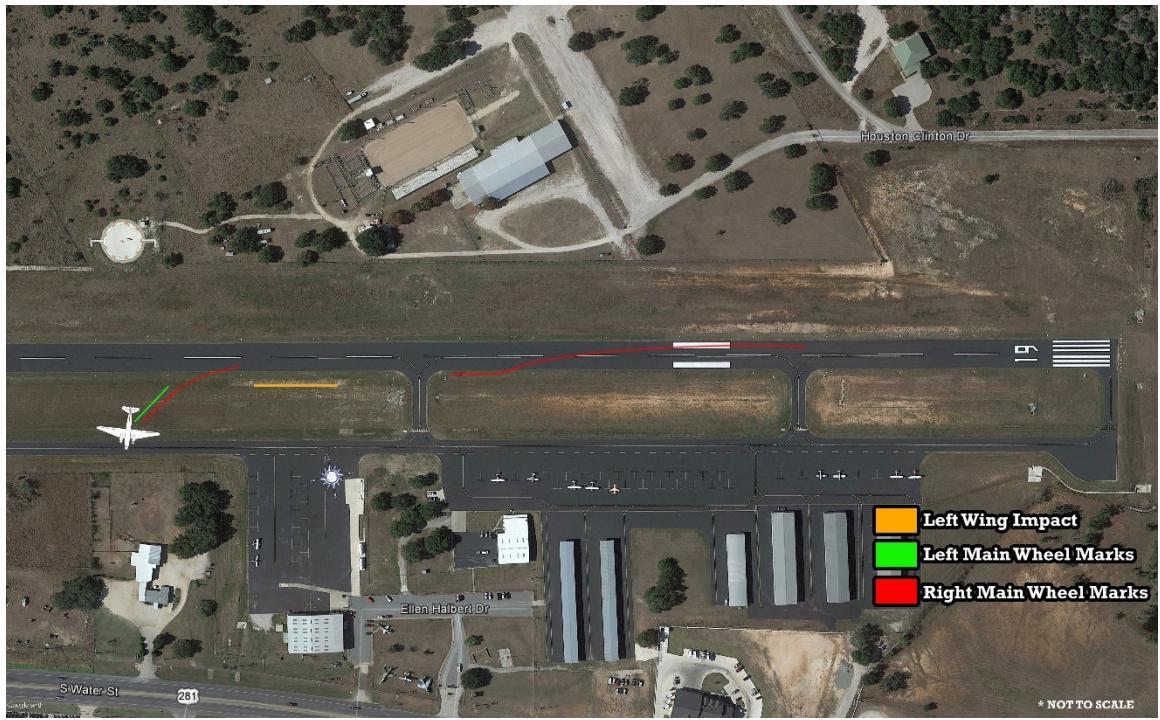
Figure 6: Tire and wing marks overview.

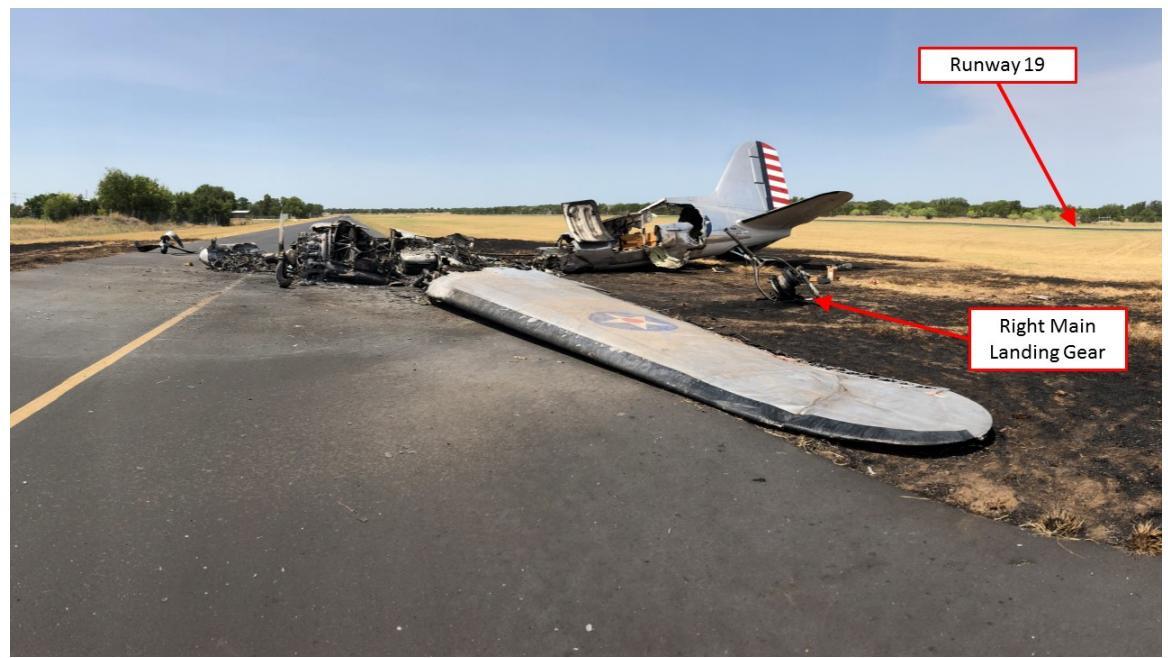
Vegetation (grass) within about 200 feet of the main wreckage was burnt from a post impact fire. The post impact fire consumed the fuselage from the nose cone aft to about 3 feet forward of the left side cargo door. The wing center section of the fuselage was mostly consumed by fire and extended outboard to the right wing attach point and about 2 feet outboard of the left wing attach point. All of the cabin seating, luggage, storage containers, cockpit seats, controls, and instrument panel was mostly consumed by the post impact fire. Multiple instruments were located near the cockpit area, however, were destroyed by fire. The throttle quadrant was observed, and all cables remained attached despite the thermal/fire damage. The tailwheel lock engagement handle was not located. All three fuel tanks exhibited fire damage and were breached.

Figure 7: View of the main wreckage.

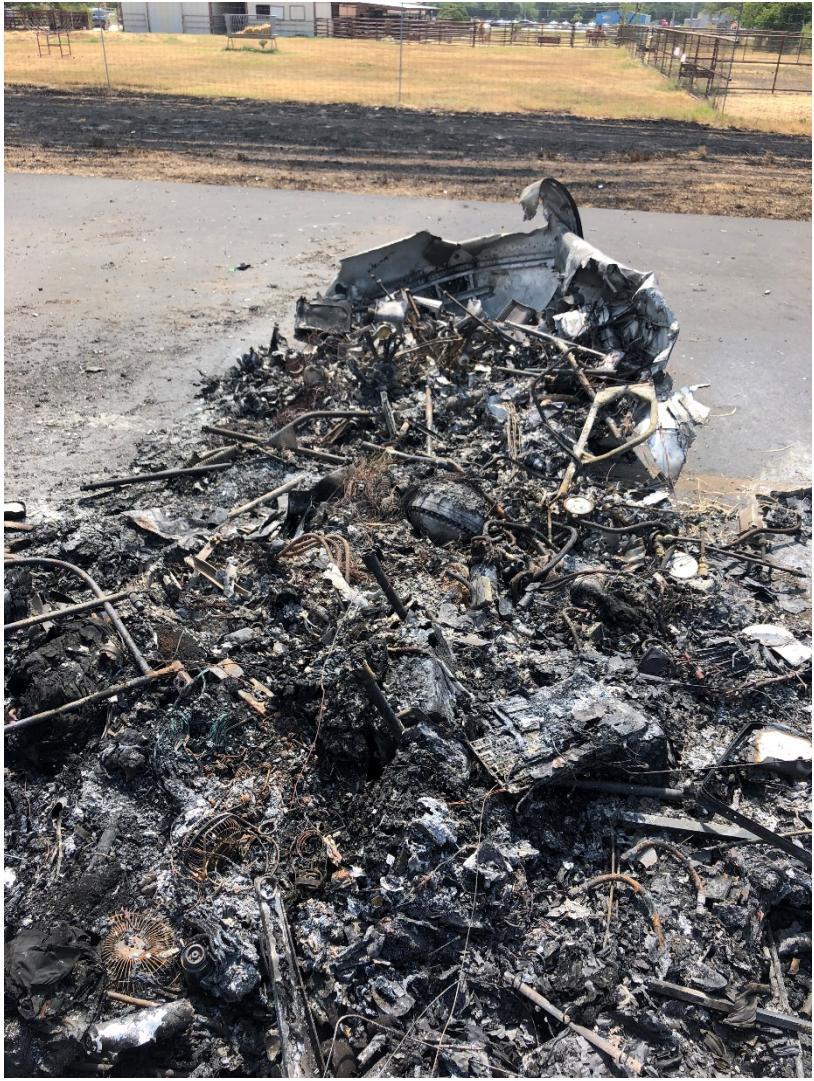
Figure 8: View of the cockpit area and forward portion of the fuselage.

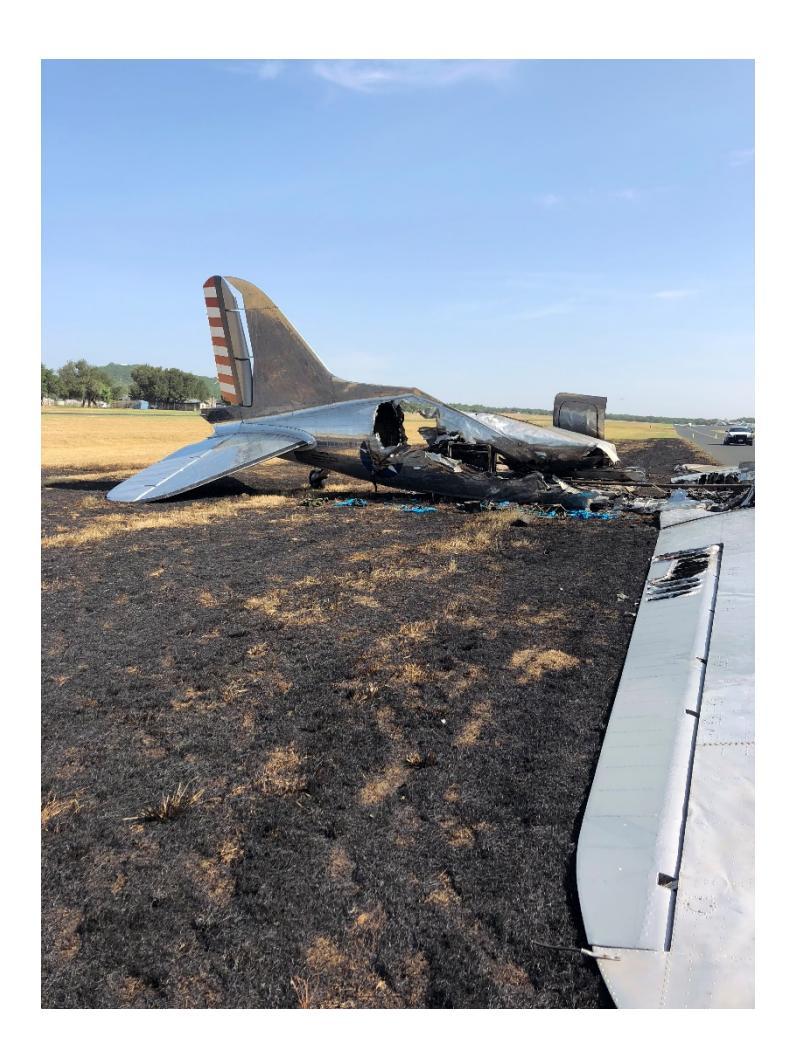
The empennage remained mostly undamaged. The structure surrounding the tailwheel exhibited some slight buckling. The tailwheel remained attached to the airframe and was oriented about 45° left of the centered position. The tailwheel locking mechanism appeared to be in the locked position. The tailwheel locking cable remained attached to the mechanism and was continuous to about the area of the fuel tanks. The tailwheel locking shear pin remained within the tailwheel strut assembly, however, the outboard portions of the aluminum shear pin were severed and located in fuselage within the vicinity of the tailwheel assembly. Damage to the pin was consistent with a shear fracture. The rudder, vertical stabilizer, horizontal stabilizers, and elevators remained attached via their respective mounts and were undamaged. The rudder and elevator trim tabs remained attached and appeared to be in the neutral position.

Figure 9: View of the empennage, and portion of the right wing.

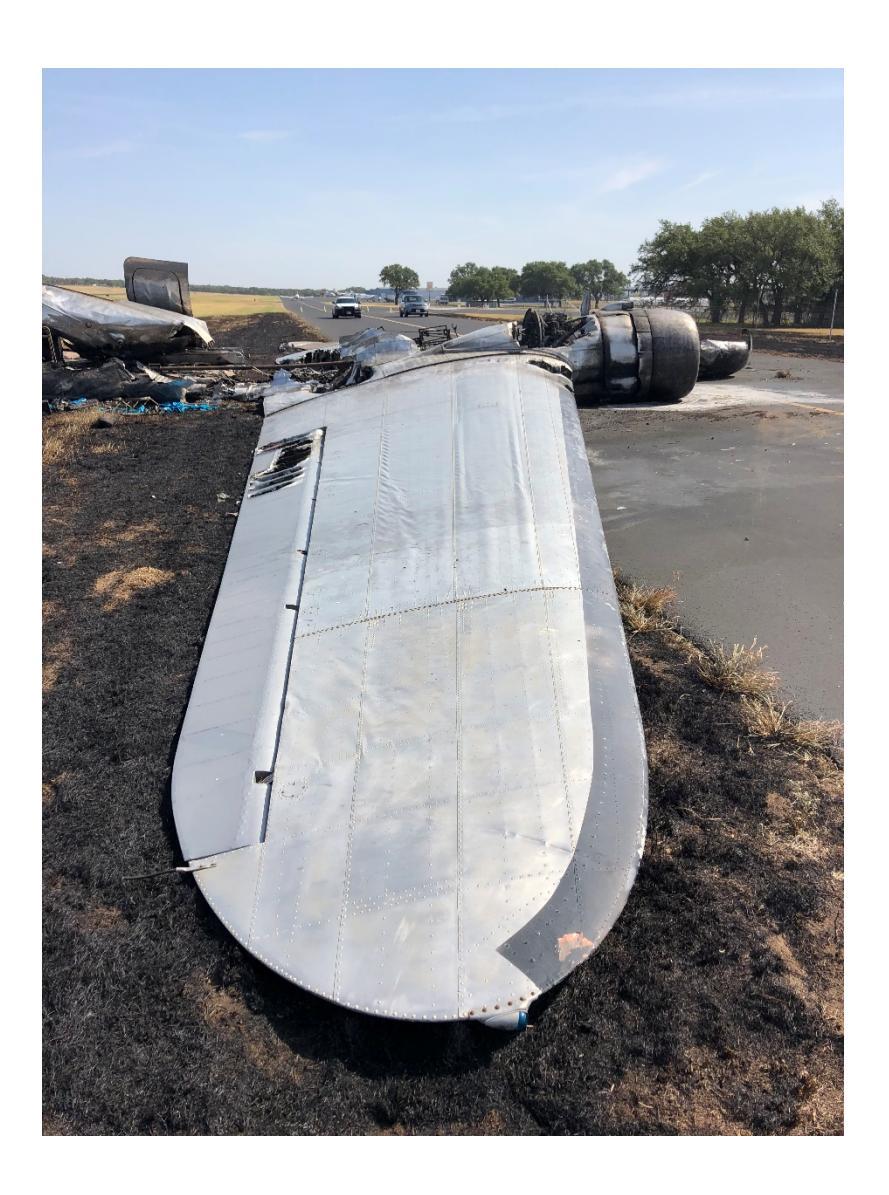
The right wing was mostly intact and exhibited some wrinkling of the wing structure near the wing root. The aileron remained attached and exhibited fire damage to the inboard third of the aileron. The flap remained attached and was in the "up" position. The right landing gear was separated from the engine nacelle and was located aft of the left-wing flap/aileron junction. The engine remained attached to its mount and exhibited fire damage.

Figure 10: View of the right wing.

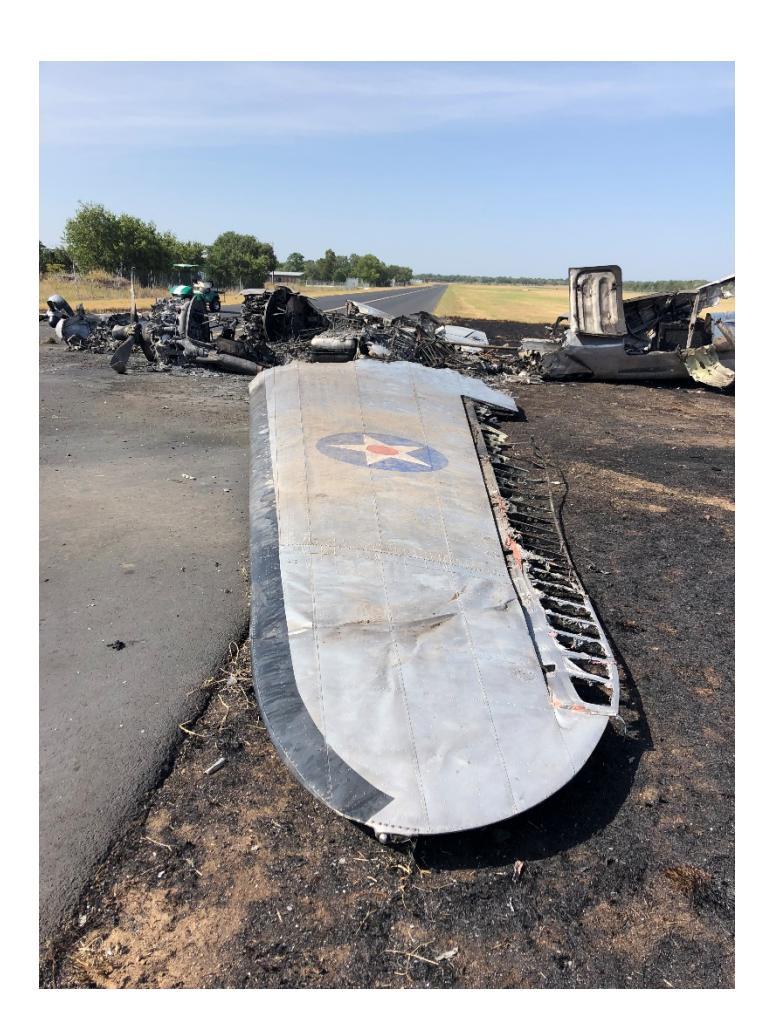
The left wing was separated from the center section, however the control cables remained continuous to the aileron. The outboard 48 inches of the left wing was bend upward about 5 to 10° . The aileron remained attached via its mounts and exhibited fire damage. The flap appeared to remain attached via its mounts and in the "up" position. The engine remained attached to the nacelle structure. The landing gear remained attached to the wing structure.

Figure 11: View of the left wing.

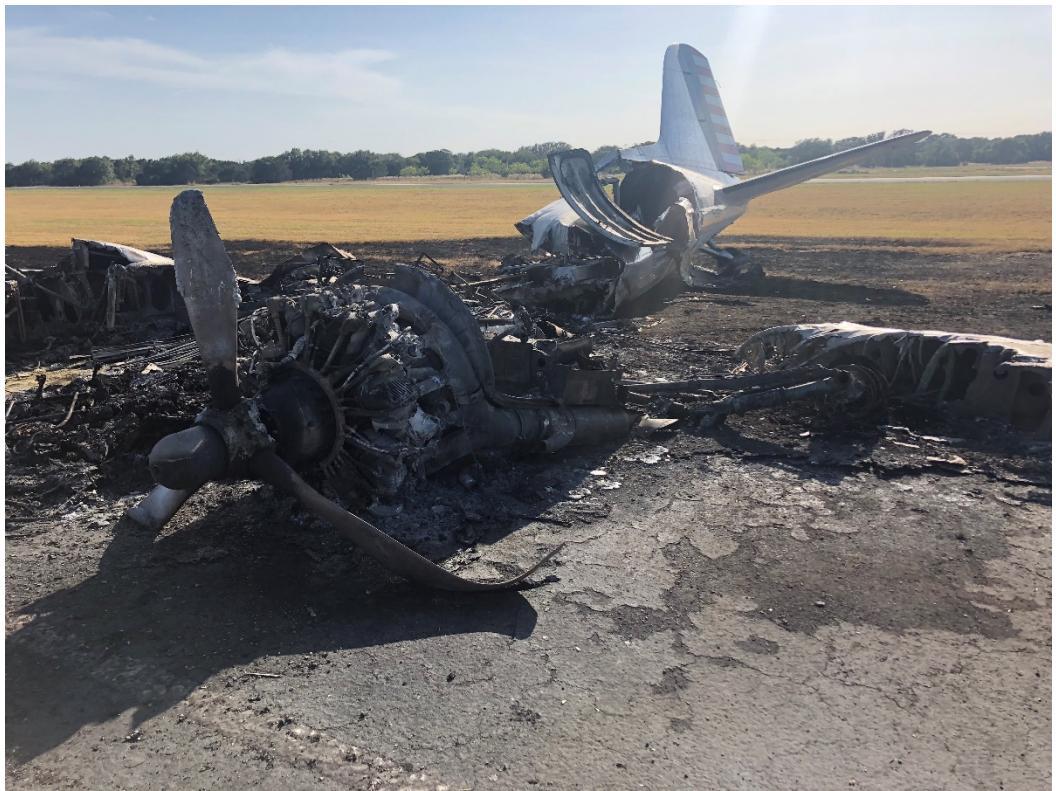
The left engine displayed fire damage throughout. Multiple rocker box covers exhibited thermal damage with partial melting. All three propeller blades remained attached to the propeller hub. Two of the propeller blades exhibited melting of the blades near the blade tip. One blade was bent aft about 6-8 inches inboard from the blade tip.

Figure 12: View of the left engine and propeller.

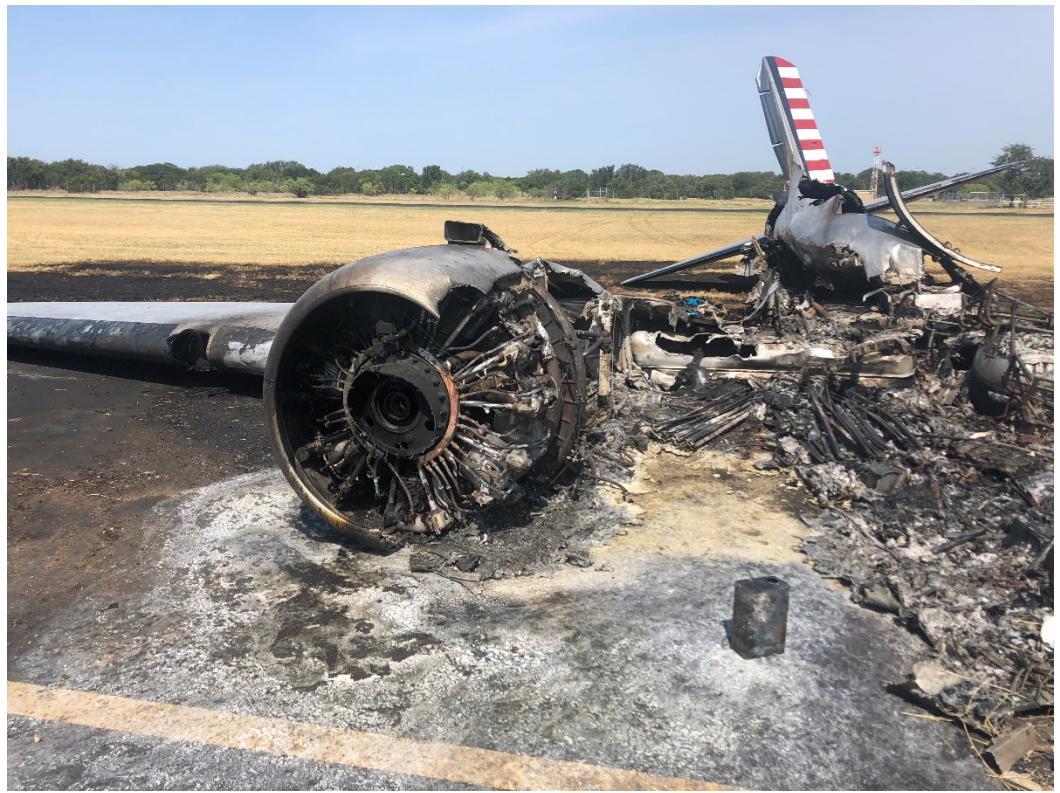
The right engine displayed fire damage throughout. The forward section of the nose case was separated and remained attached to the propeller assembly. Multiple rocker box covers exhibited thermal damage with partial melting. The right propeller exhibited "S" bending on all three propeller blades, which remained attached to the propeller hub. All three propeller blades were bent opposite direction of rotation. Two propeller blades exhibited leading edge gouging and one propeller blade exhibited blade polishing on the forward face of the propeller blade from about mid span to the blade tip.

Figure 13: View of the right engine.

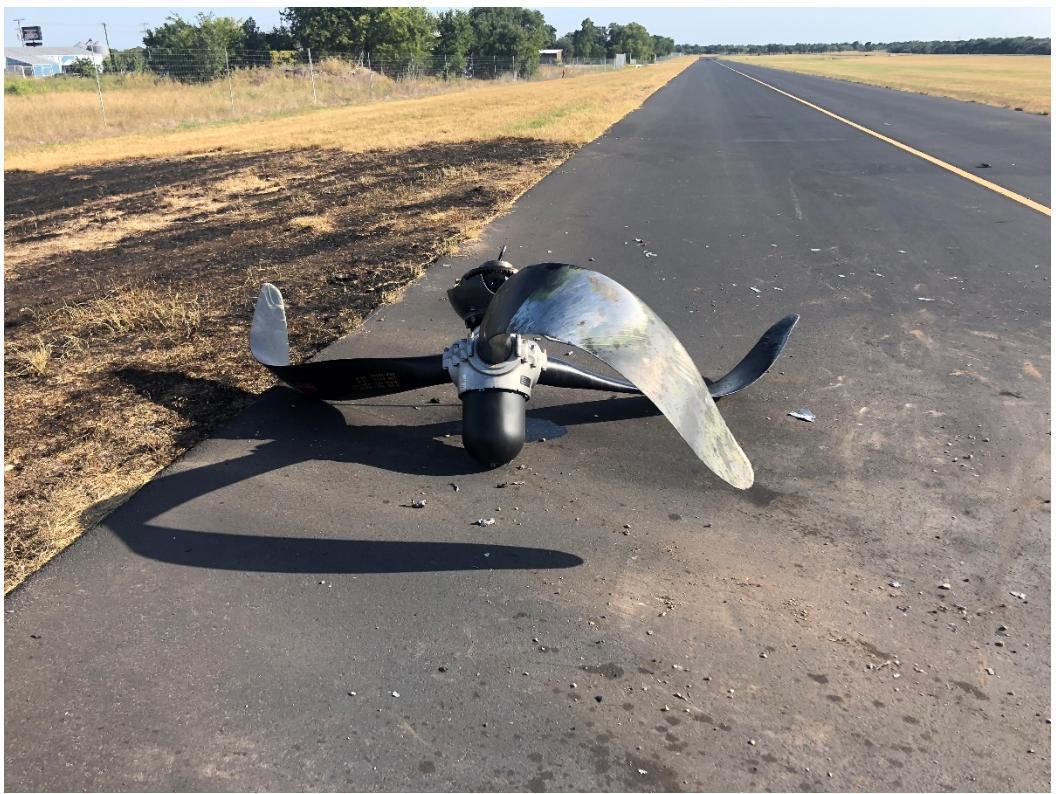
Figure 14:View of the right propeller.
