Inst. Date : 12-Mar-2022
Job No. : NY-M53-0816
Report No. : 1
Report Date : 10-Jun-2022

ABL USA Inc.
100 Wall Street, Suite 2202
New York, NY 10005, USA

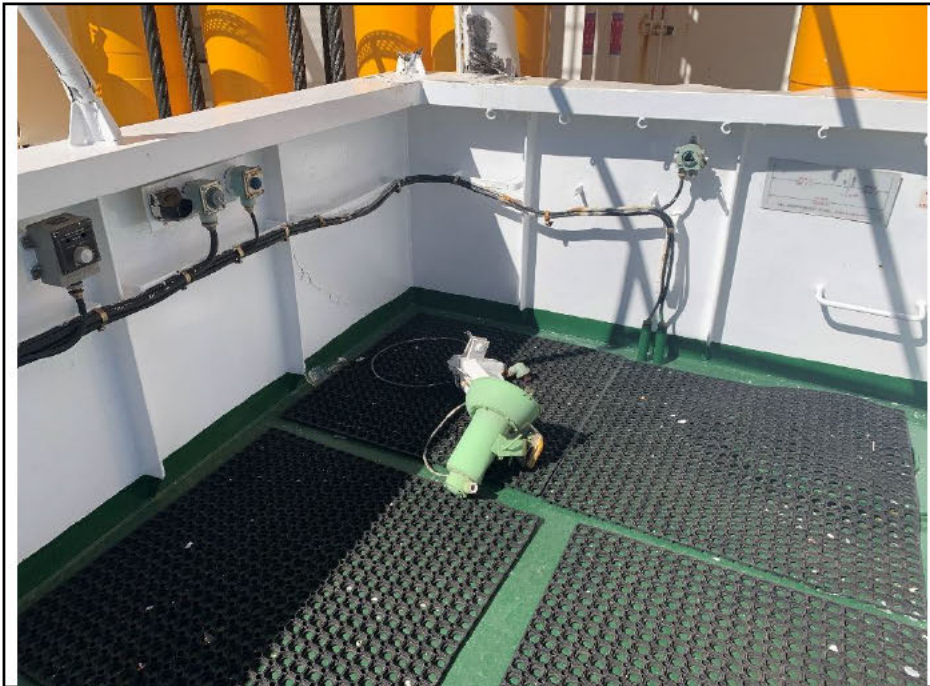
7. Projector lamp broken & adrift

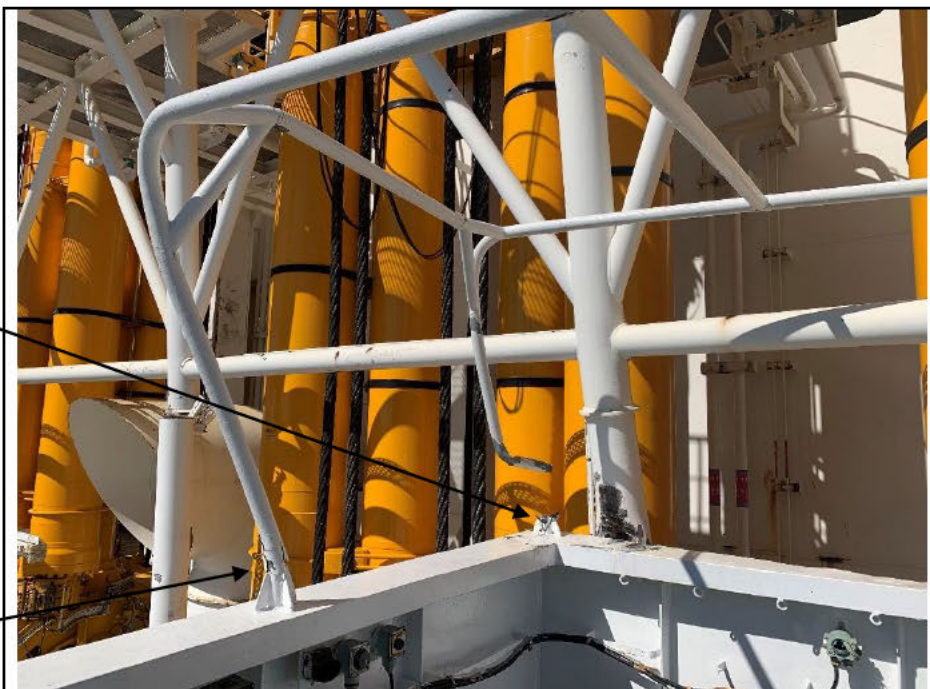
8. Starboard bridge wing awning fractured and bent

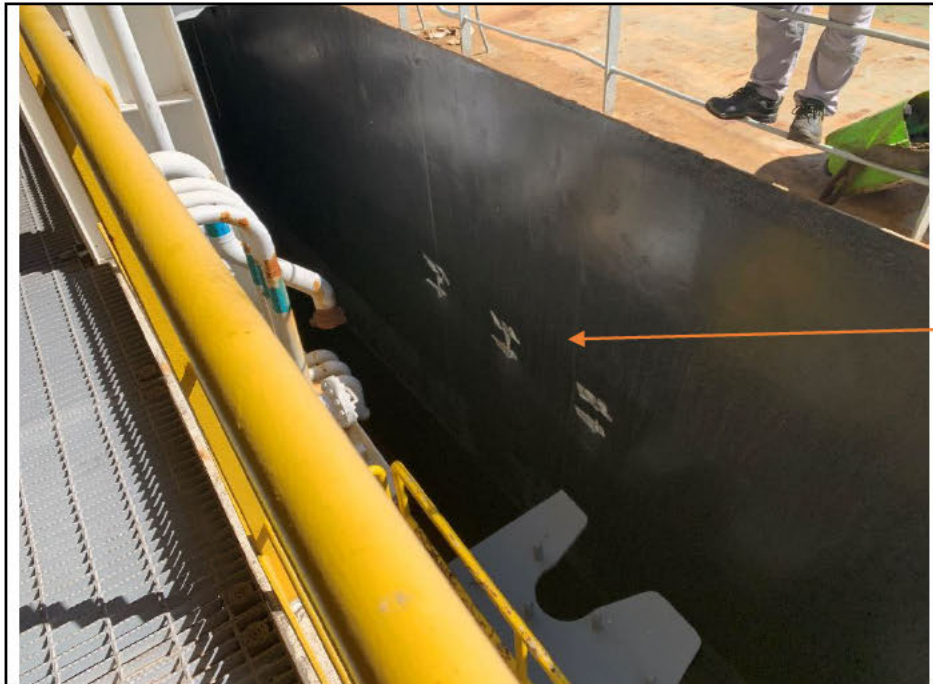
| 9 | Indentation in shell plating in way of No. 4 topside tank (S) – viewed externally |

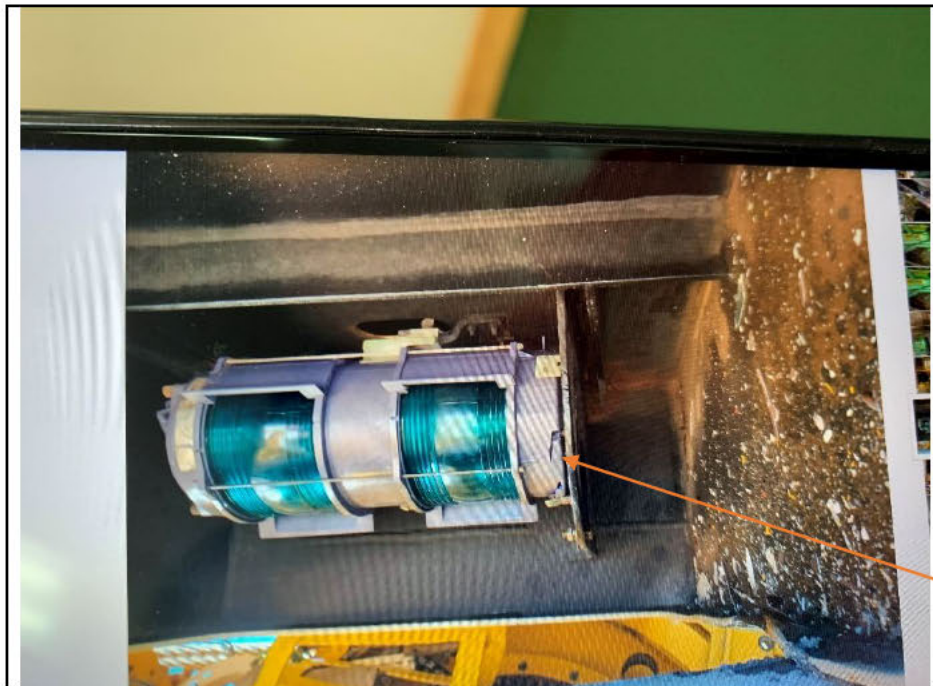
13 Starboard side navigation light casing broken

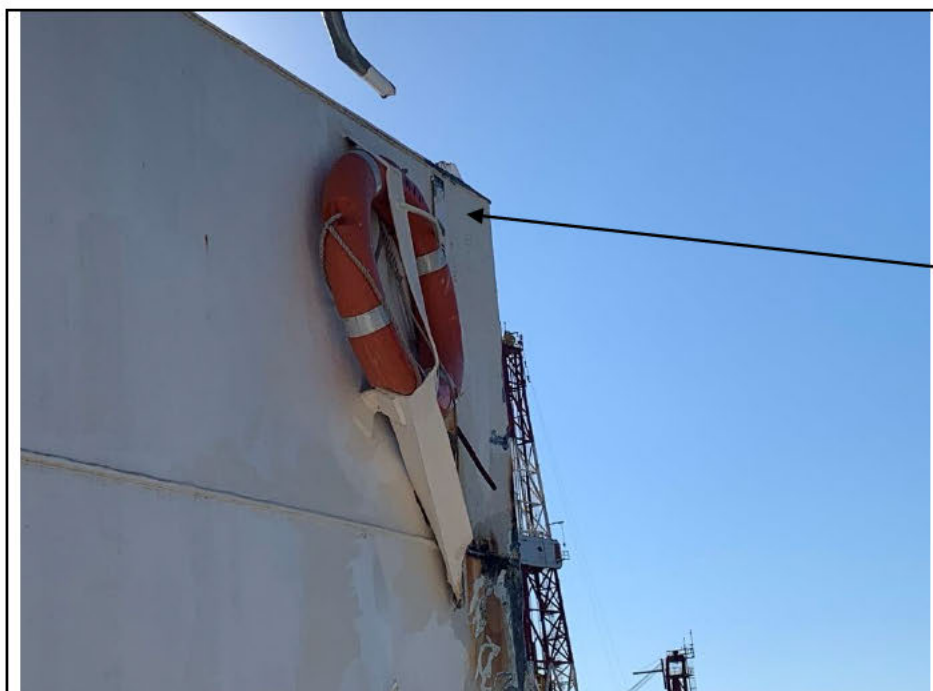
14 Bracket for Man overboard lifebuoy distorted
