NATIONAL TRANSPORTATION SAFETY BOARD

Weather Study

ERA19FA116

Location: Fellsmere, Florida
Date: March 5, 2019
Time: 0703 eastern standard time 1203 Universal Coordinated Time (UTC)
Airplane: Piper PA28; Registration: N556PU

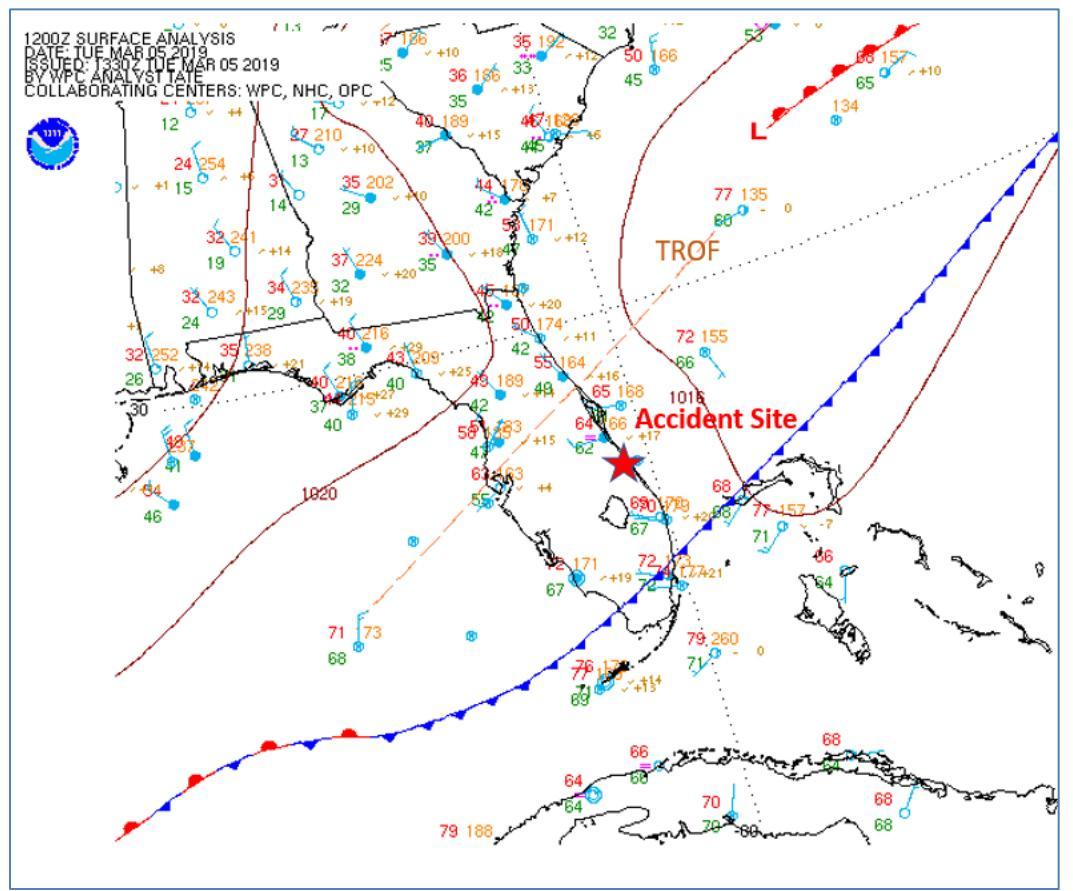
Figure 1 - Southeast section of the Surface Analysis Chart for 0700 EST

The southeast section of the NWS Surface Analysis Chart for 0700 EST is included as figure 1 with the approximate accident site marked by a red star. The chart depicted a cold front extending across southern Florida south of the accident site. A low-pressure system at 1013-hectopascals (hPa) was located off the South Carolina coast with a trough of low pressure extending southwestward across central Florida parallel to the front and north of the accident site. The accident site was located in the cold airmass north of the front in an area of a weak pressure gradient with westerly wind speeds of 10 knots or less over the area.

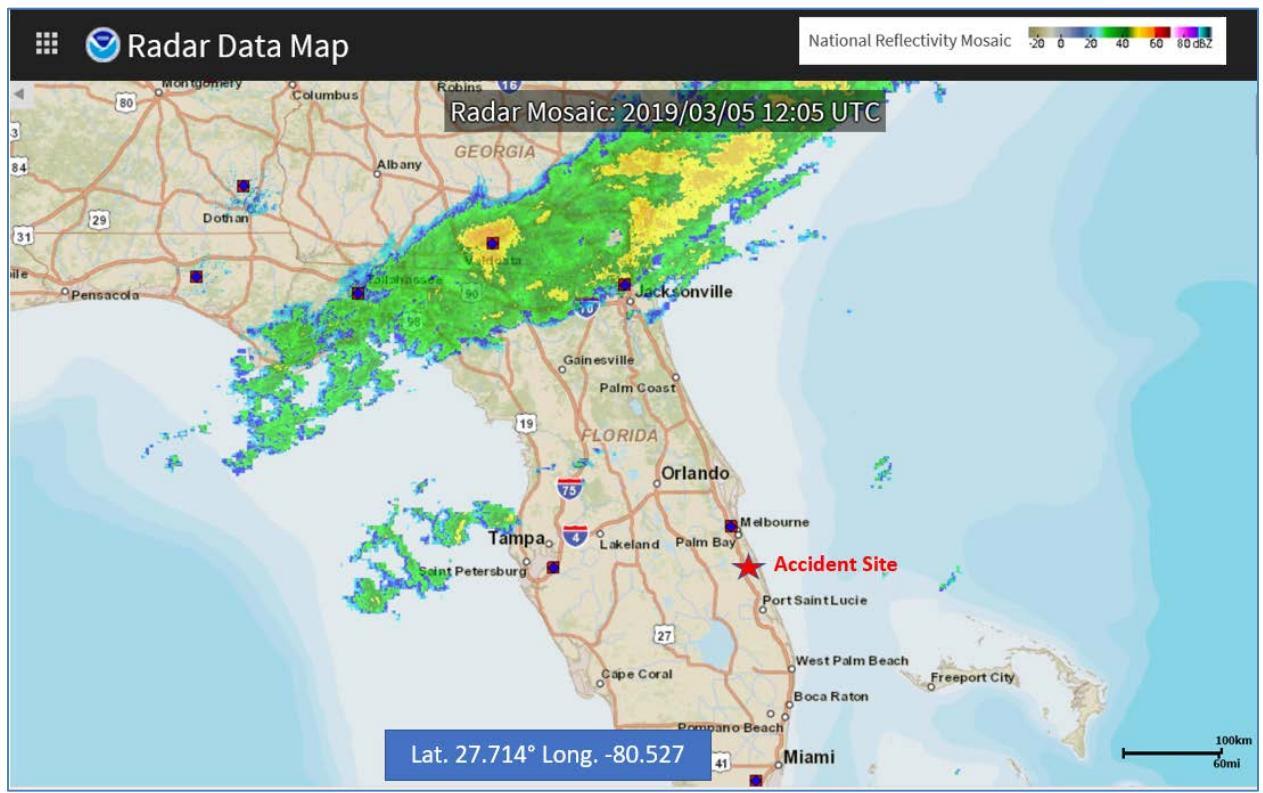
Figure 2 - National Composite Radar Mosaic for 0705 EST

The southeast section of the National Composite Radar Mosaic for 0705 EST is included as figure 2 with the approximate accident site marked by a red star. The image depicted an extensive band of precipitation extending from South Carolina, southeastern Georgia, northern Florida, into the Gulf of Mexico. Another area of scattered precipitation was noted over and west of the Tampa Bay area. No precipitation echoes were depicted in the area of the accident site.

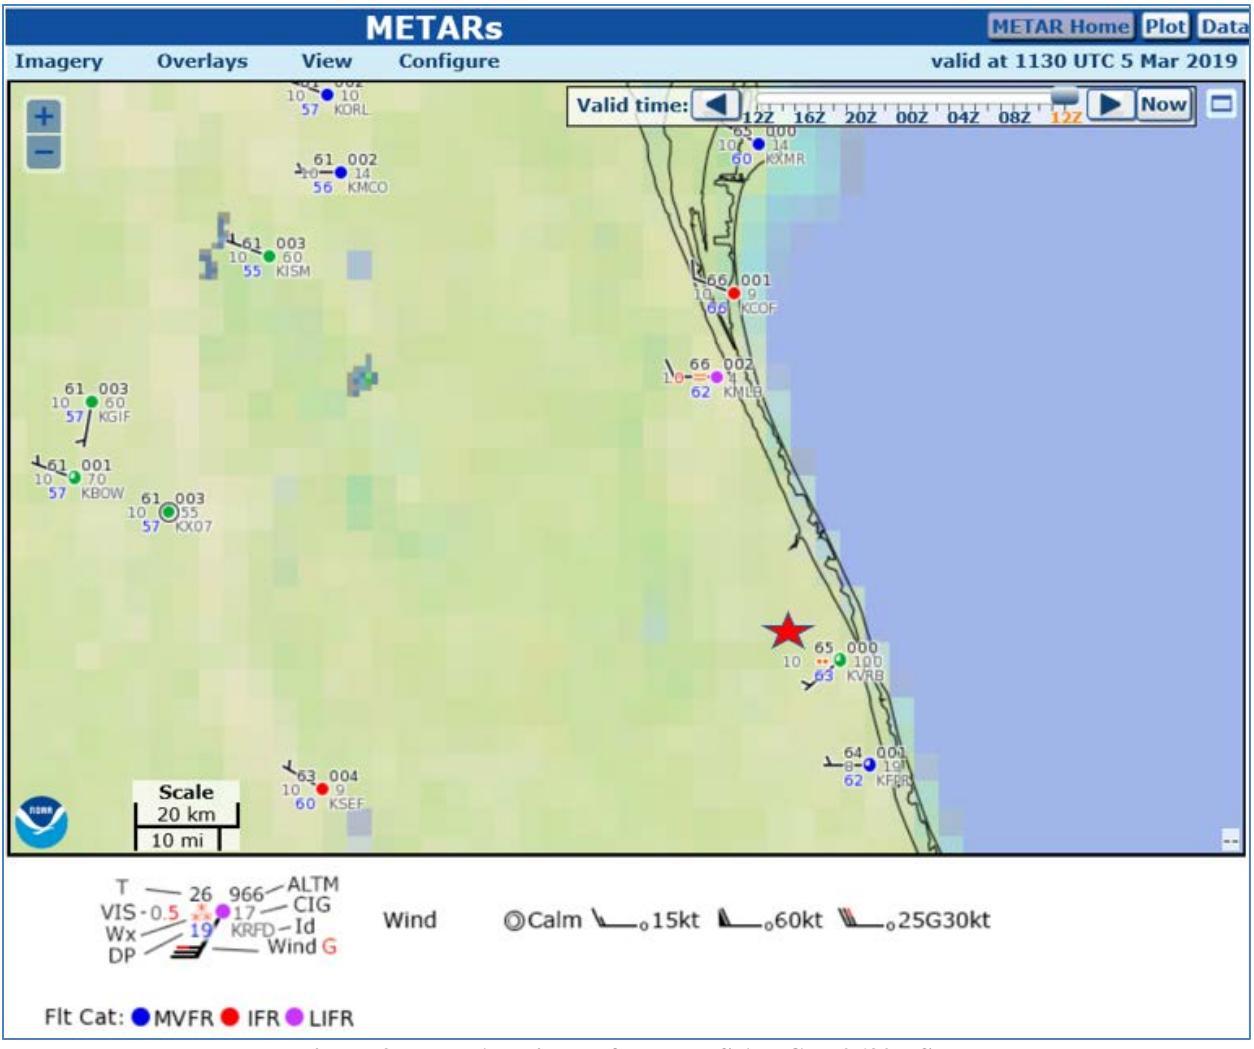
Figure 3 - METAR display form NWS AWC at 0630 EST

A display of the METAR observations with the radar overlaid was obtained immediately after the accident from the NWS Aviation Weather Centers website² for 0630 EST and 0730 EST and are included as figure 3 and 4 respectively. The approximate accident site is marked by a red star, and temperature and dew point temperatures are provided in °F. The displays show VFR conditions reported at KVRB at 0630 EST prior to the flight's departure with stations immediately north at KMLB and KCOF³, and KSEF⁴ reporting LIFR and IFR conditions due to mist and low ceilings.

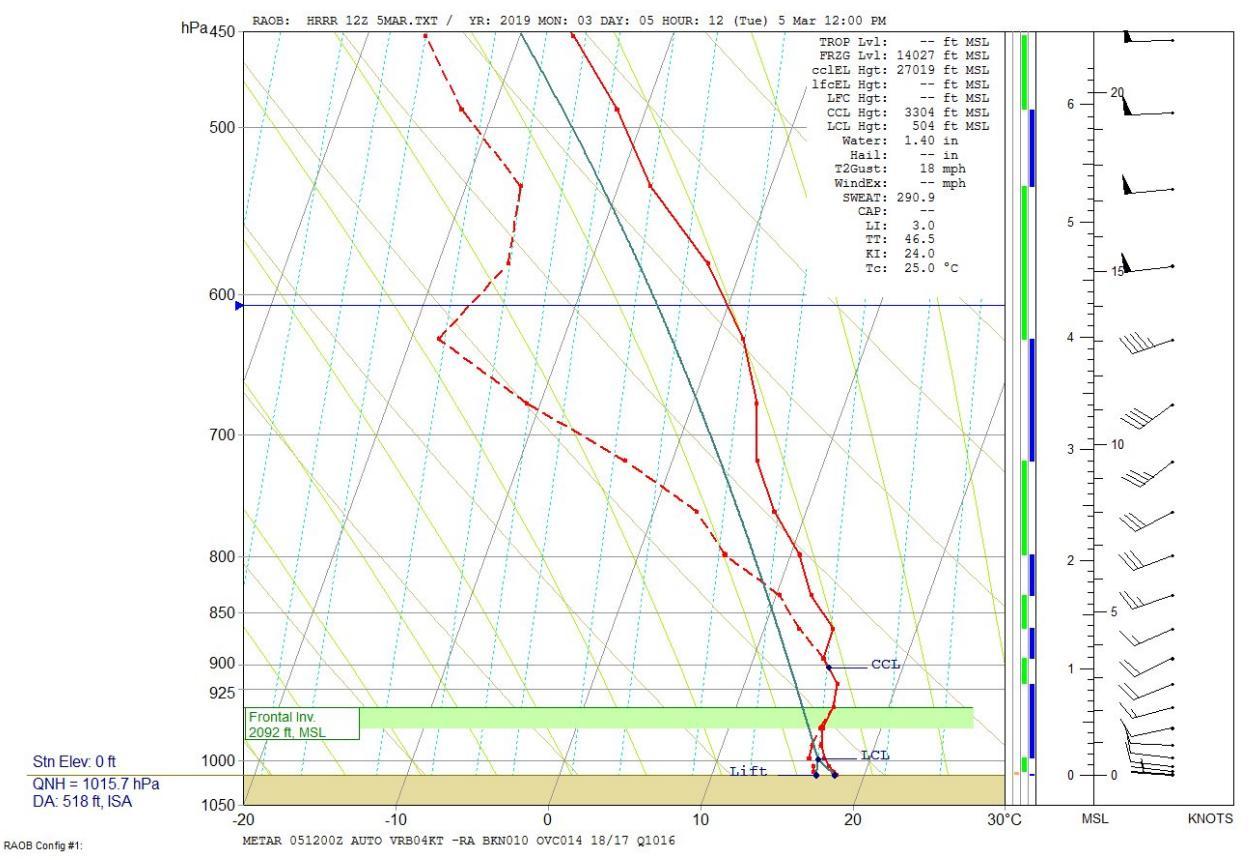
Figure 5 - HRRR numerical model sounding over the accident site for 0700 EST

The HRRR 0700 EST model sounding depicted a surface temperature of 18.1° C (64.4° F), with a dew point temperature of 16.9° C (62.4° F), with a relative humidity of 93%. A defined frontal inversion was noted immediately above the surface to approximately 2,092 ft where temperature increases or remained constant with height. The lifted condensation level (LCL) was identified at

504 ft agl, with convective condensation level (CCL) at about 3,300 ft. The sounding had a relative humidity greater than 90% from the surface to approximately 4,500 ft with the sounding characterized as stable with a lifted index of 3.0 the that support low stratiform clouds and fog formation. The freezing level was at identified above 14,000 ft with no threat of low-level icing or frost formation.

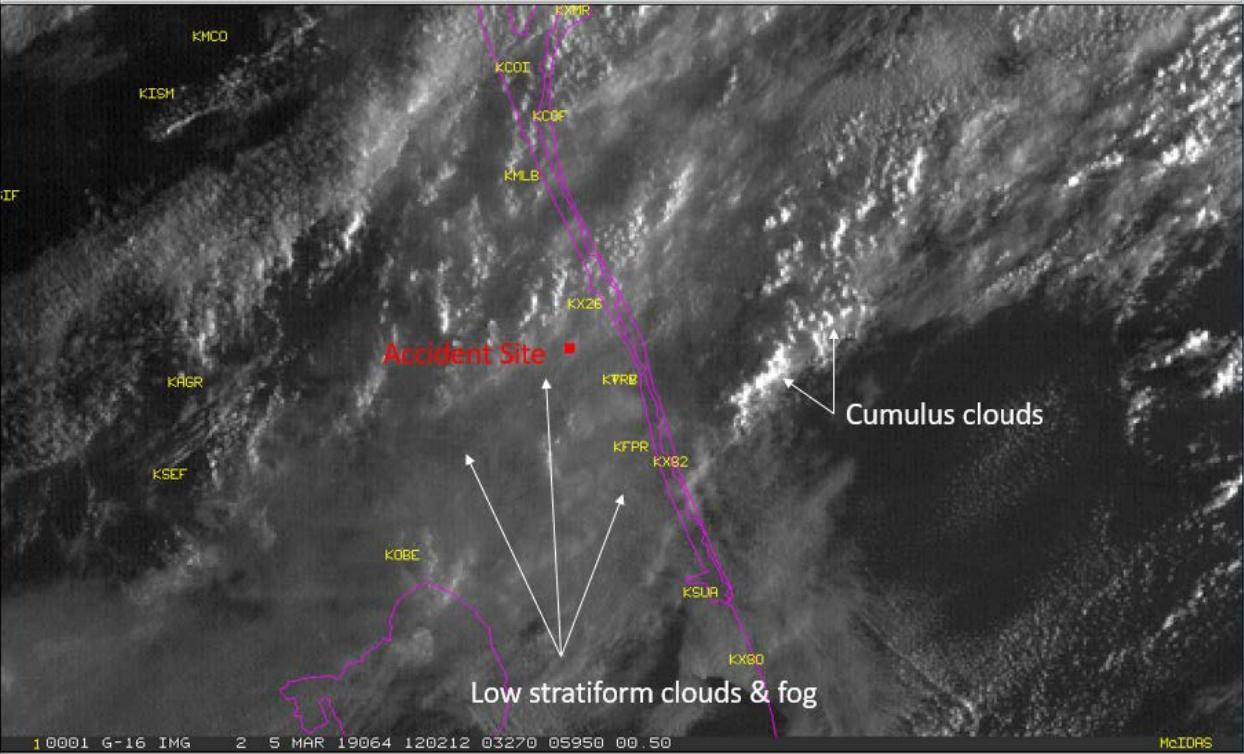
Figure 6 - GOES-16 visible image at 0702 EST

Figures 6 and 7 are the GOES-16 visible images at 2X magnification for 0702 and 0707 EST respectively, which depicted an extensive layer of low stratiform type clouds over the coastal section of central and southern Florida and extend over the accident site. The GOES-16 infrared image during the period indicated a radiative cloud top temperature of 287° Kelvin or 13.84° C, which corresponded to cloud tops near 4,800 ft based on the HRRR sounding.

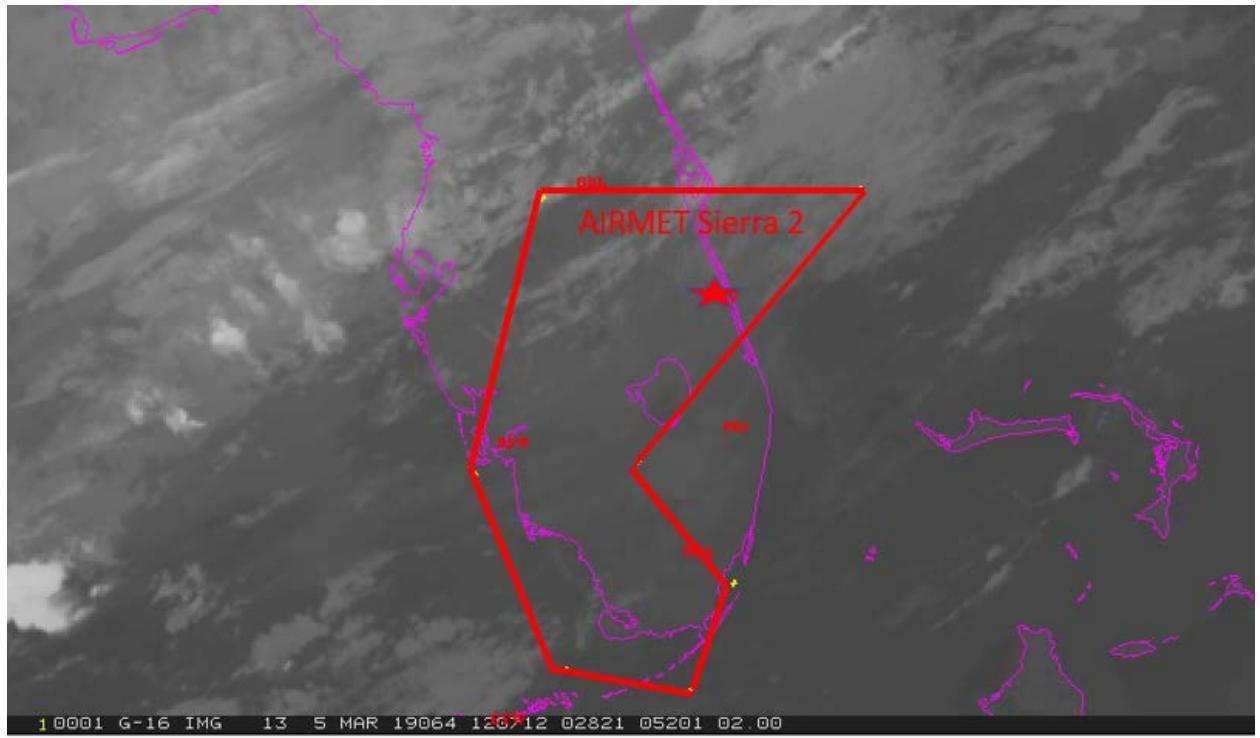
Figure 12 - Plot of AIRMET Sierra 2 issued at 0358 EST and valid until 1000 EST

The advisory warned of ceilings below 1,000 ft and visibilities below 3 miles in mist, with conditions ending between 0700 and 1000 EST (figure 12).

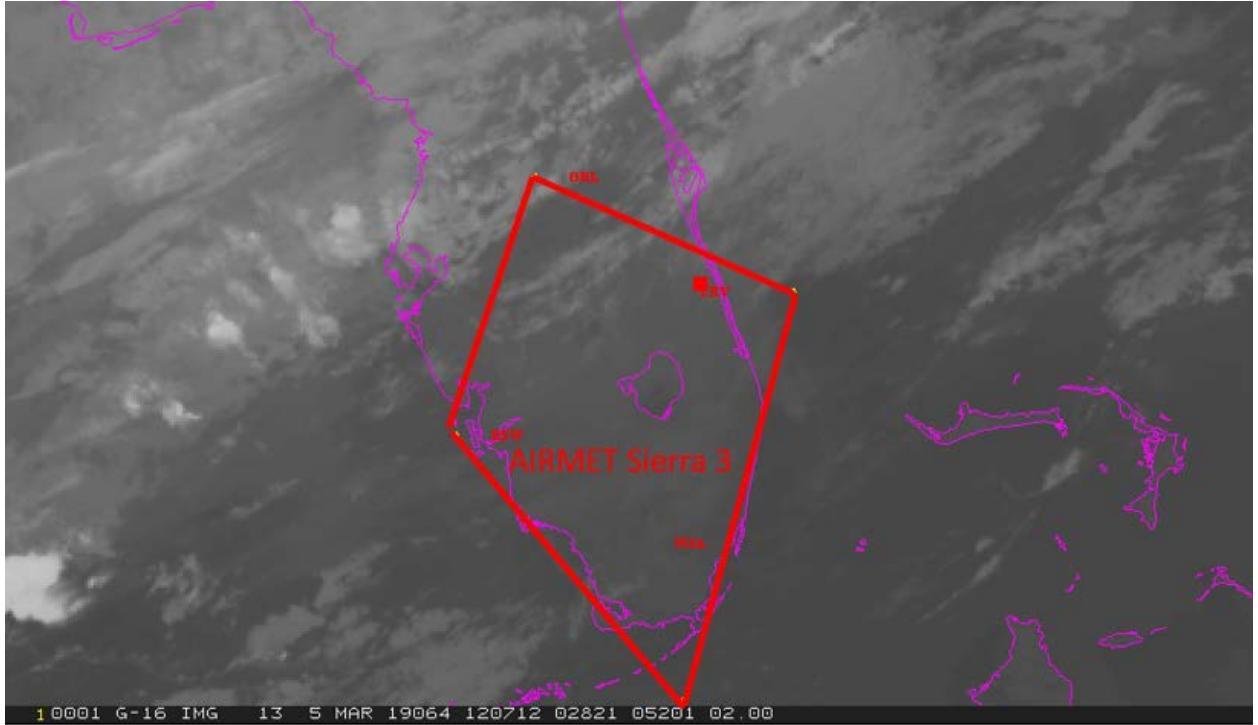
Figure 13 - Plot of AIRMET Sierra 3 issued at 0558 EST and valid for 1000 EST

AIRMET IFR...FL AND CSTL WTRS...UPDT FROM 20W ORL TO 30E TRV TO 70S MIA TO 20W RSW TO 20W ORL CIG BLW 010/VIS BLW 3SM BR. CONDS ENDG 12-15Z.
