# NATIONAL TRANSPORTATION SAFETY BOARD

# **AIRFRAME EXAMINATION**

# WPR19FA115

Location:	Fullerton, California
Date:	April 18, 2019.
Aircraft:	Beech B60, N65MY, SN P-314
NTSB IIC:	Eliott Simpson

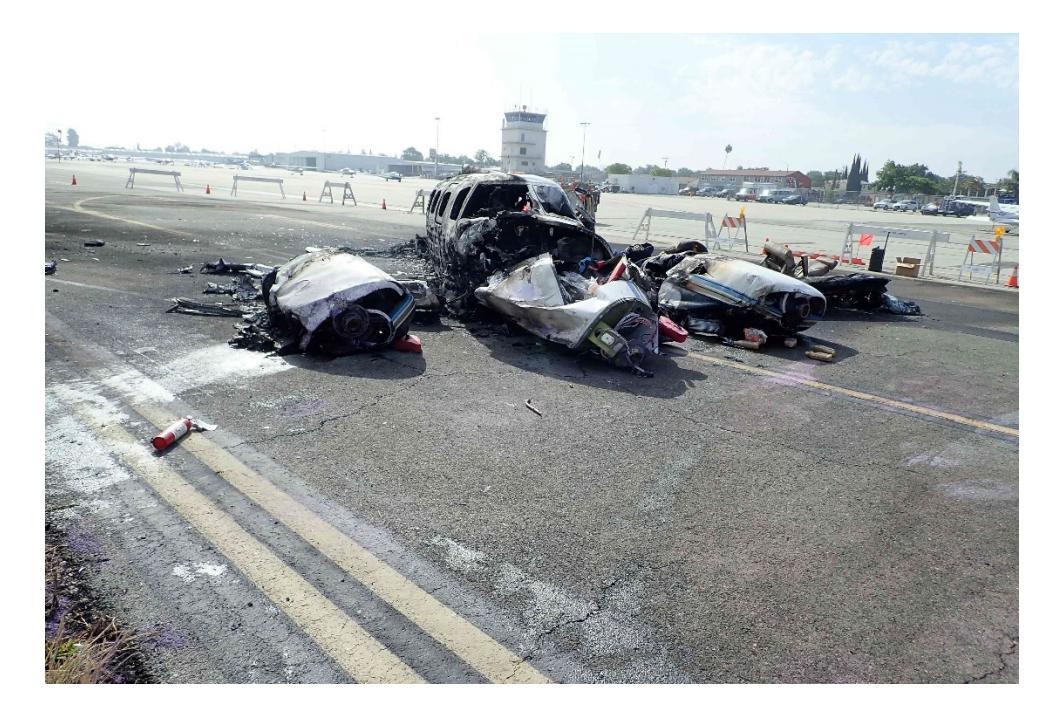
Photo 1 – Airplane at the Accident Site

The pressurized section of the main cabin sustained extensive thermal damage (Photo 1). The outer skins on the right side had been consumed, and the skins on the left side were extensively charred. The landing gear switch was in the down position, and its knob had melted. All windows on the right side of the cabin along with the right windshield were consumed by fire. The left windshield was partially consumed, and all windows on the left side of the cabin were melted and crazed.

Most of the right wing structure was consumed from the tip to the root, exposing the landing gear actuators, engine control cables, and fuel selector valve (Photos 1,4). Flap remnants were still attached to the rear spar; the flap actuator was partially consumed, which prevented an accurate assessment of its extension. The fuel tank was consumed.

The left wing remained attached to the fuselage, the main spar was intact along its full length, and the aft spar and trailing skins were mostly consumed by fire (Photo 1,4). The fuel cap was intact and in place at the filler neck, and remnants of the fuel tank bladder were exposed. The engine remained partially attached to the forward spar. The flap remained attached to the aft spar, and its actuator displayed 3.3 inches of extension, which corresponded with the flaps set to about 10  $^{\circ}$ .

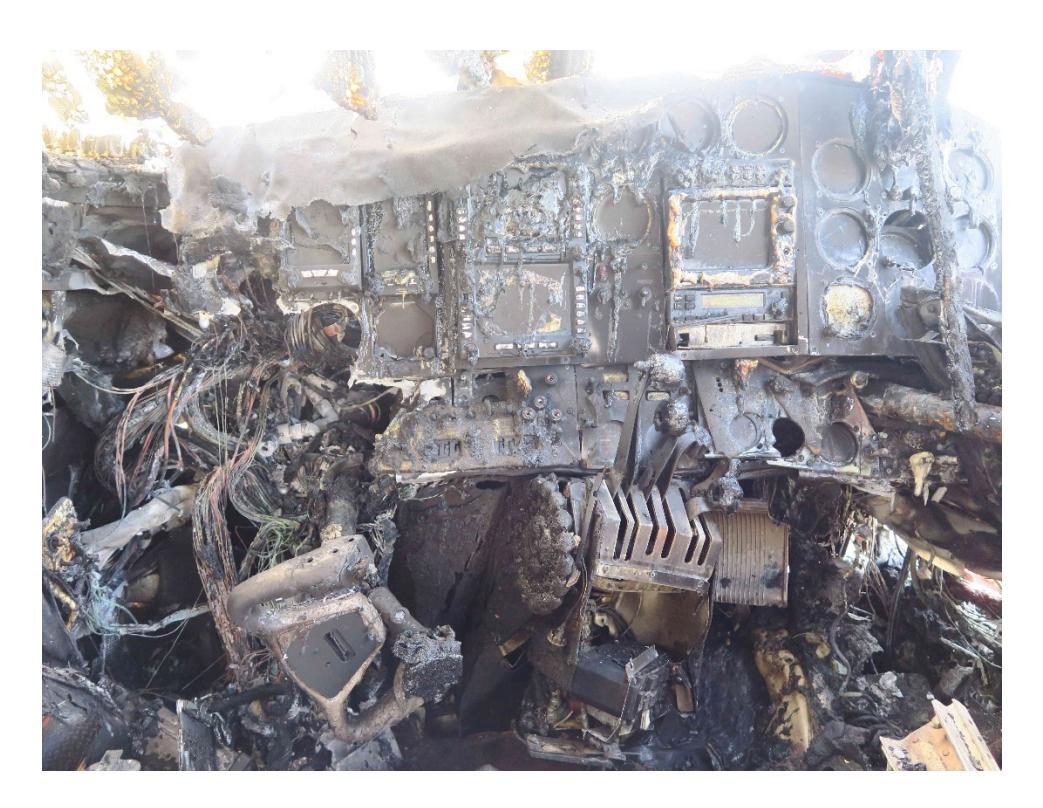
Photo 2 – Instrument Panel

The cockpit instruments and circuit breakers were all fire damaged, precluding an accurate assessment of their readings and positions, and the lower left section of the panel along with the left control yoke was detached and folded down into the foot well (Photo 2). The throttle and propeller engine controls were all in the full forward position, the right engine mixture control was in the full forward position, the left control was about 1.5 inches aft of full forward (Photo 2). At the accident site, the left fuel selector handle was in the ON position and the right handle was in the "CROSSFEED" position, however the right handle felt loose and did not appear to be connected to its control cable. Further examination of the right fuel selector handle revealed the fuel selector cable had been pulled from the handle assembly. A flight control lock (Photo 3) was found resting in the aft cabin, against the carpeted back face of the main wing spar. The lock did not appear to have sustained any damage, and its chain was found wrapped around the locking pins. Subsequent examination revealed that this was not the control lock for the accident airplane type. The needle for the pitch trim indicator was at the edge of the green scale, corresponding to about the 5 ° nose-up position.

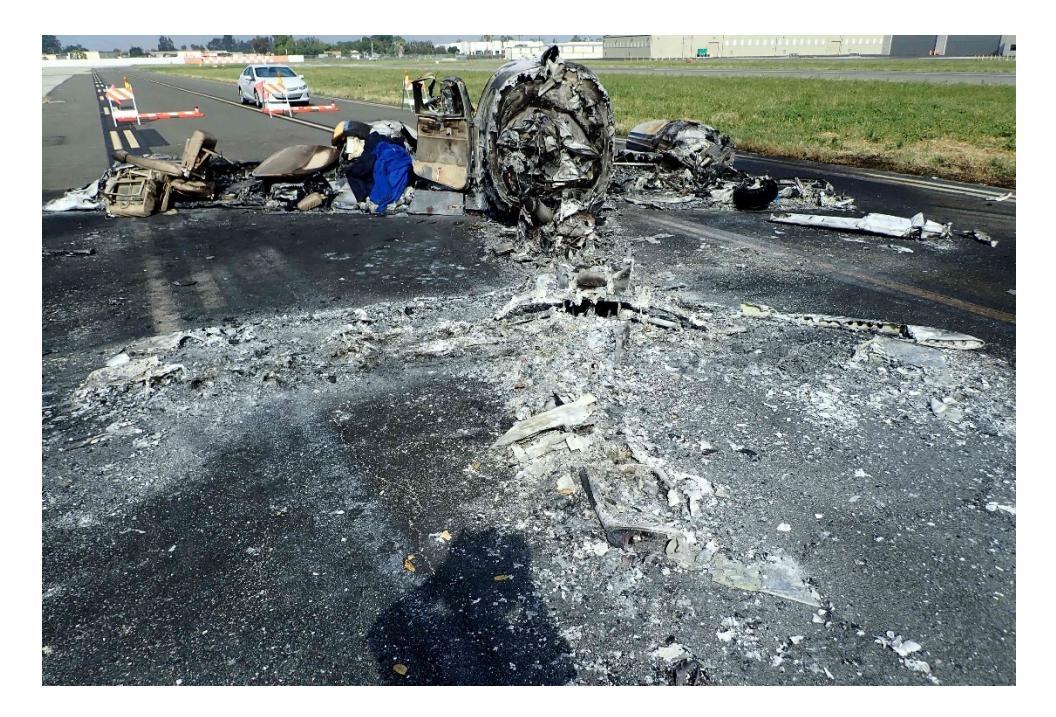
Photo 4 - Tail Section at Accident Site

The entire tail structure aft of the pressure bulkhead was consumed, with only ash remnants of vertical and horizontal stabilizer and flight controls remaining on the ground (Photo 4).

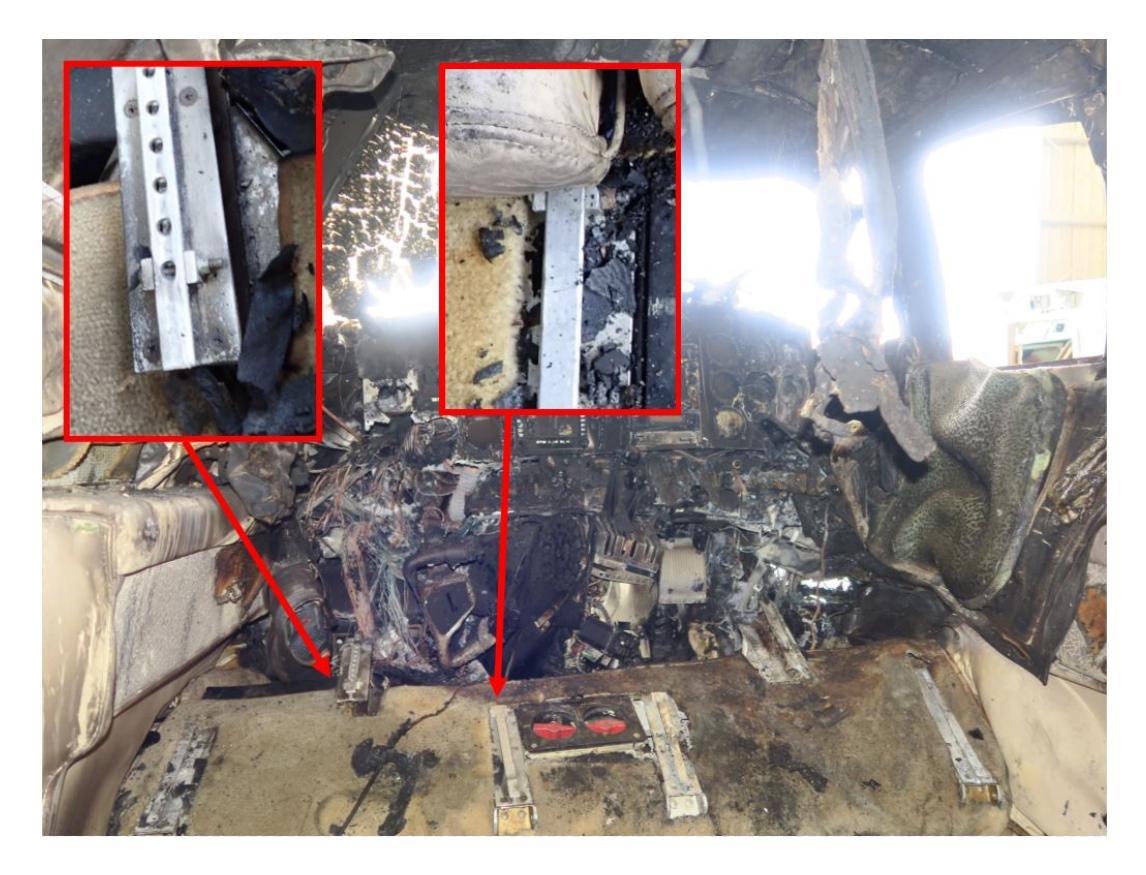
Photo 5 – Pilot Seat Rails and Locks

The pilot seat had separated from the airframe, and the seat back had detached from the base. The three seat rails remained attached to the airframe structure. The rails were intact, and the aft seat stop was in place on the center rail, and the forward seat stop was in place on the right rail (Photo 5). The seat base frame and rail assemblies were still attached, and the rollers were in place. The center slide locking mechanism was functional, and its left securing tab had bent out slightly (Photo 6).

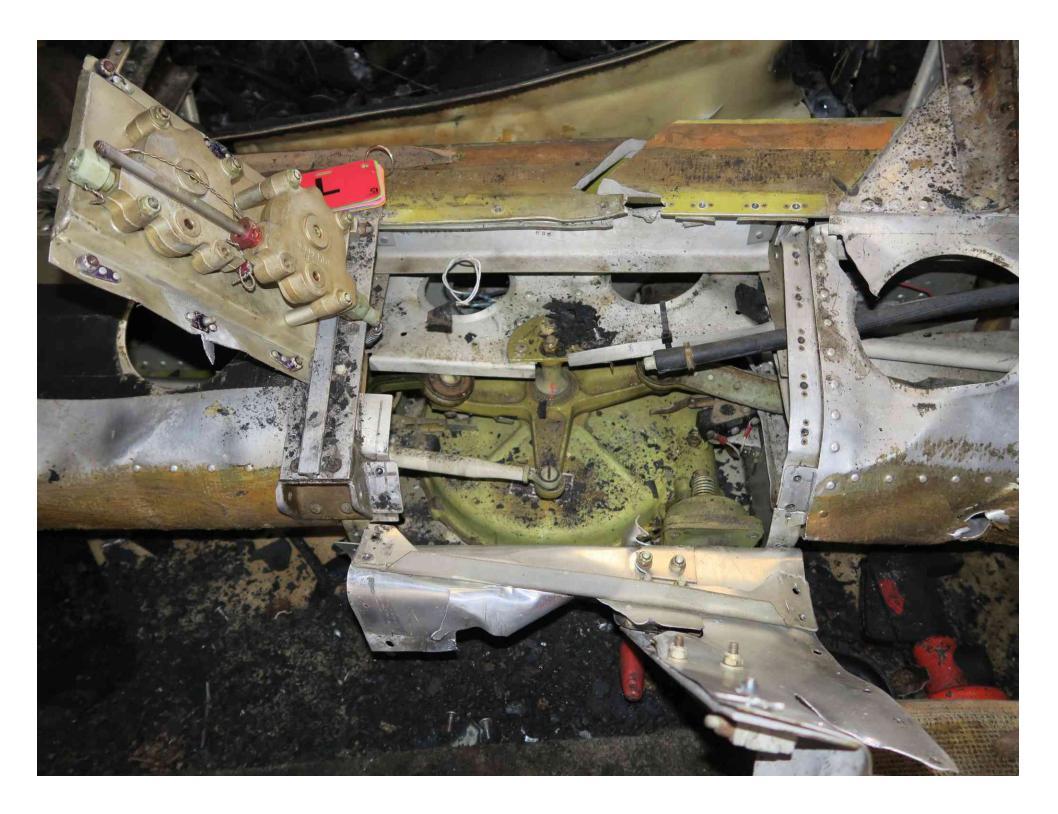
Photo 7 – Landing Gear Actuator

The landing gear actuator was in a position that corresponded to the landing gear being fully extended (Photo 7). The roll servo remained attached to the lower airframe structure, its bridle

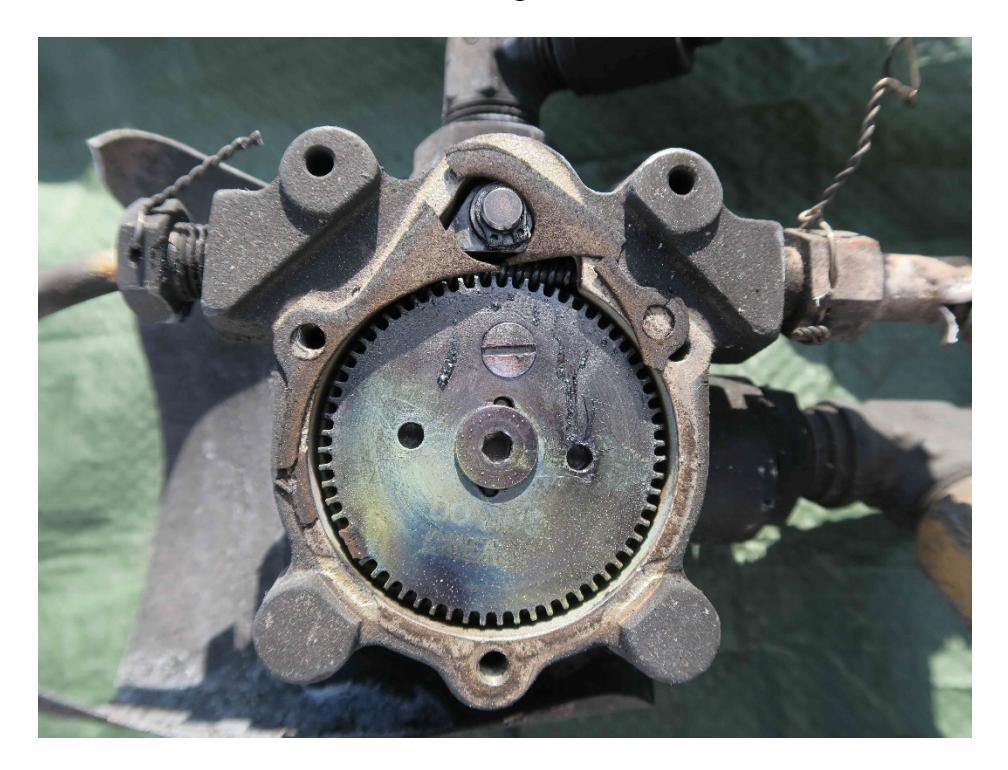
Photo 8 – Left Fuel Selector Valve

The engine remained partially attached to the remnants of the forward spar. The fuel selector valve was charred, and still connected to its actuation cable. Melted plastic was observed within the valve when viewed through the fuel inlet port, and disassembly revealed that the valve was in the, "ON" position (Photo 8).

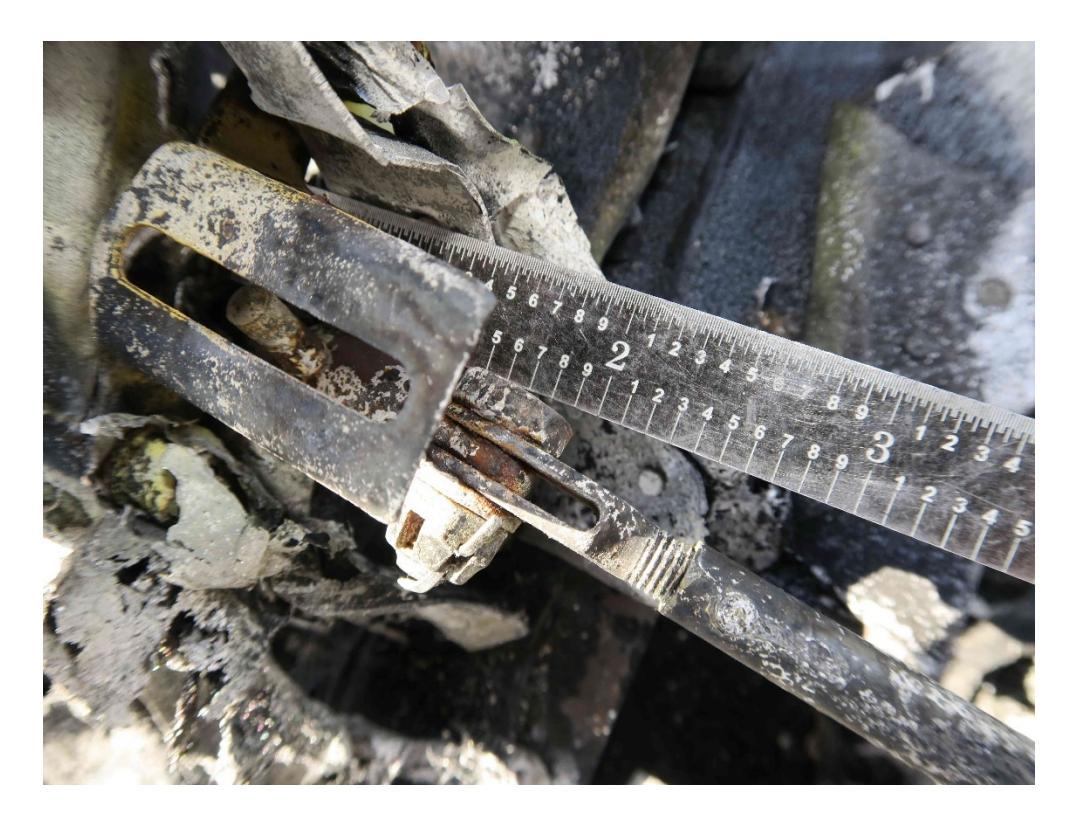
Photo 9 – Aileron Trim Actuator

The aileron trim actuator exhibited 1.65 inches of extension (Photo 9), which corresponded to 1  $^{\circ}$  tab up. The tab range was 11.5  $^{\circ}$  up and 11.5  $^{\circ}$  down.

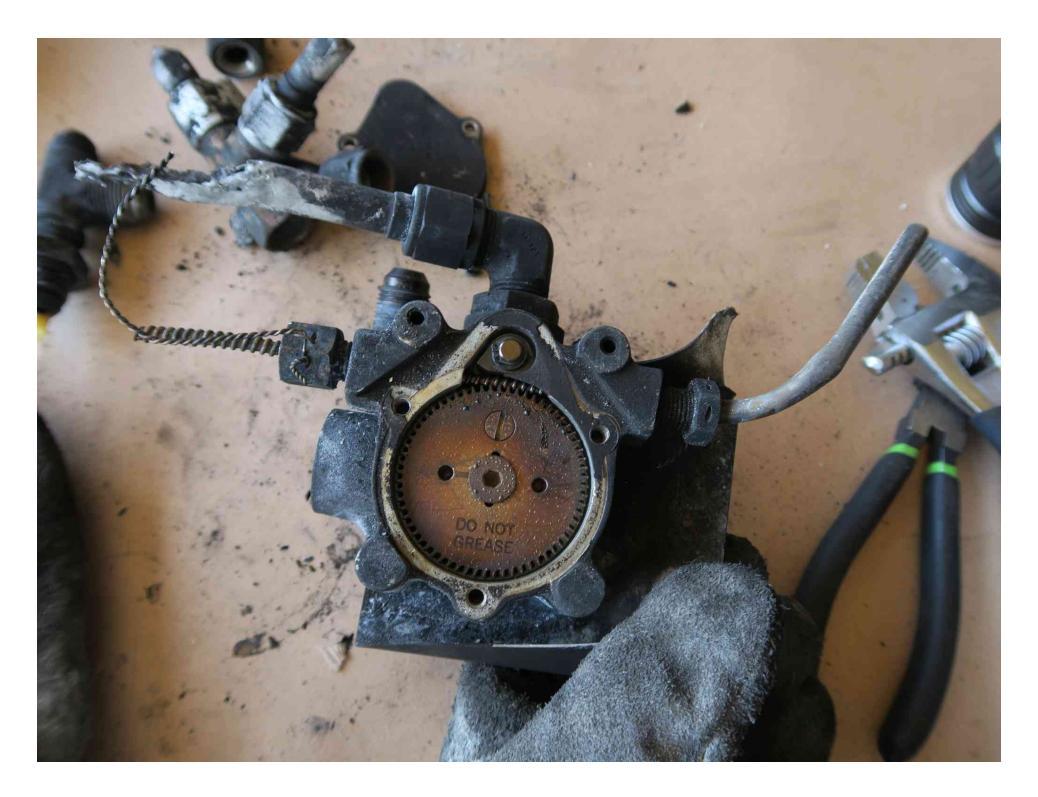
Photo 10 - Right Fuel Selector Valve

The fuel selector valve was charred, and still connected to its actuation cable. Disassembly revealed that the valve was in the, "ON" position (Photo 10).

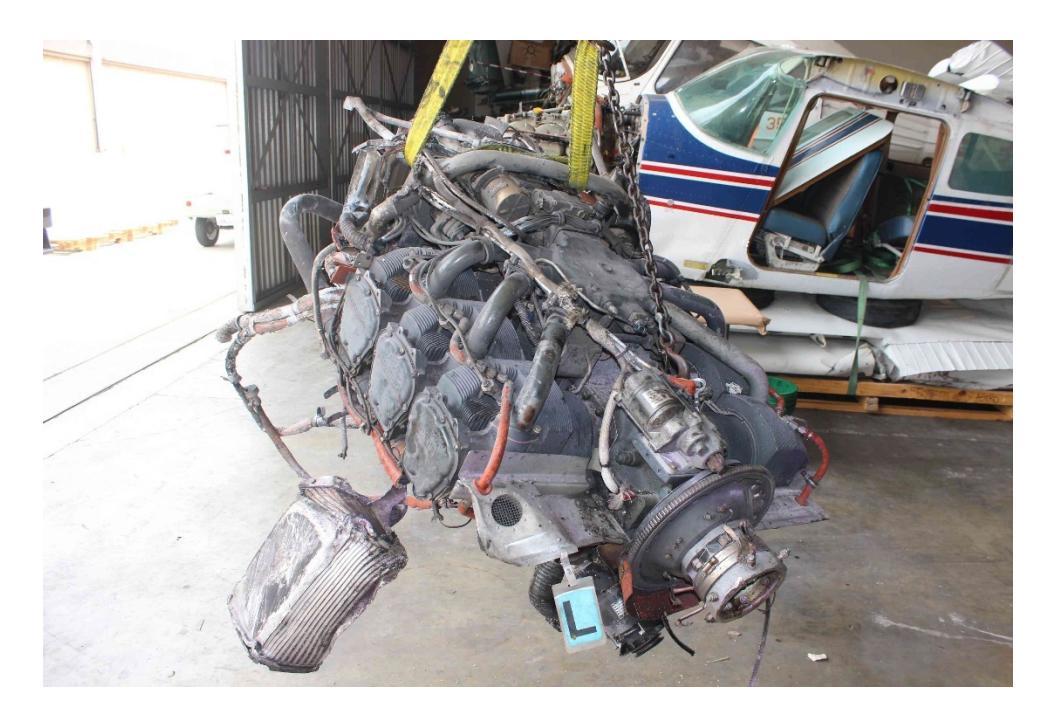
Photo 11 – Left Engine

The engine appeared generally intact, and had sustained thermal damage to the accessory area. The exhaust outlet pipe was crushed, and had detached from the turbocharger housing. The alternator and intercooler, which were crushed, had separated from their attach points, and were dangling from the underside of the engine. (Photo 11)

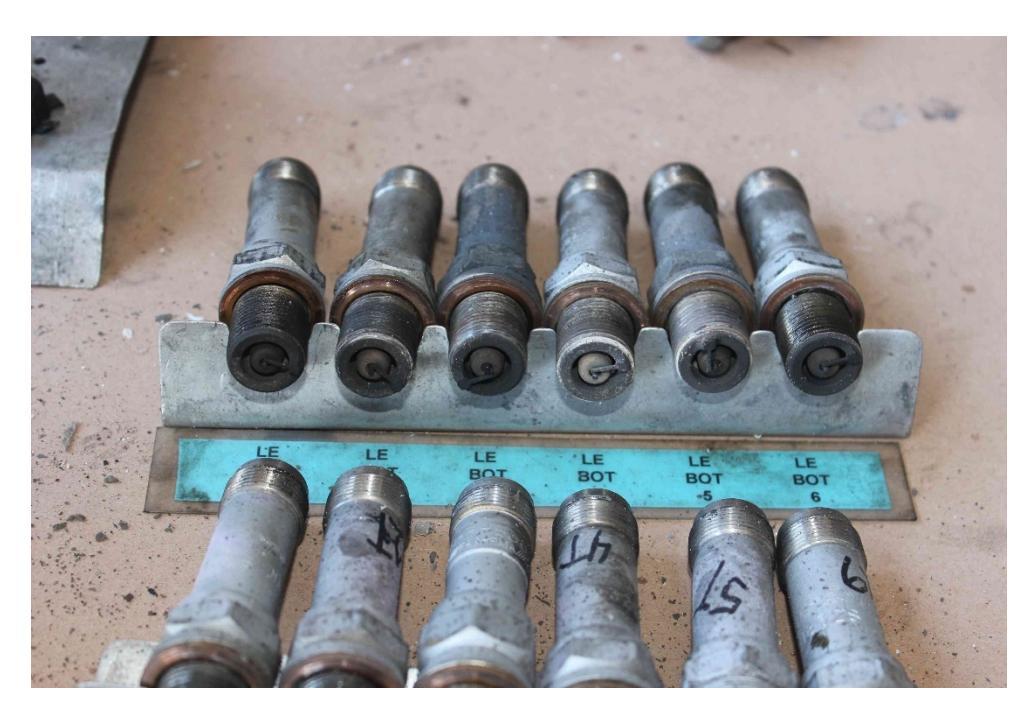
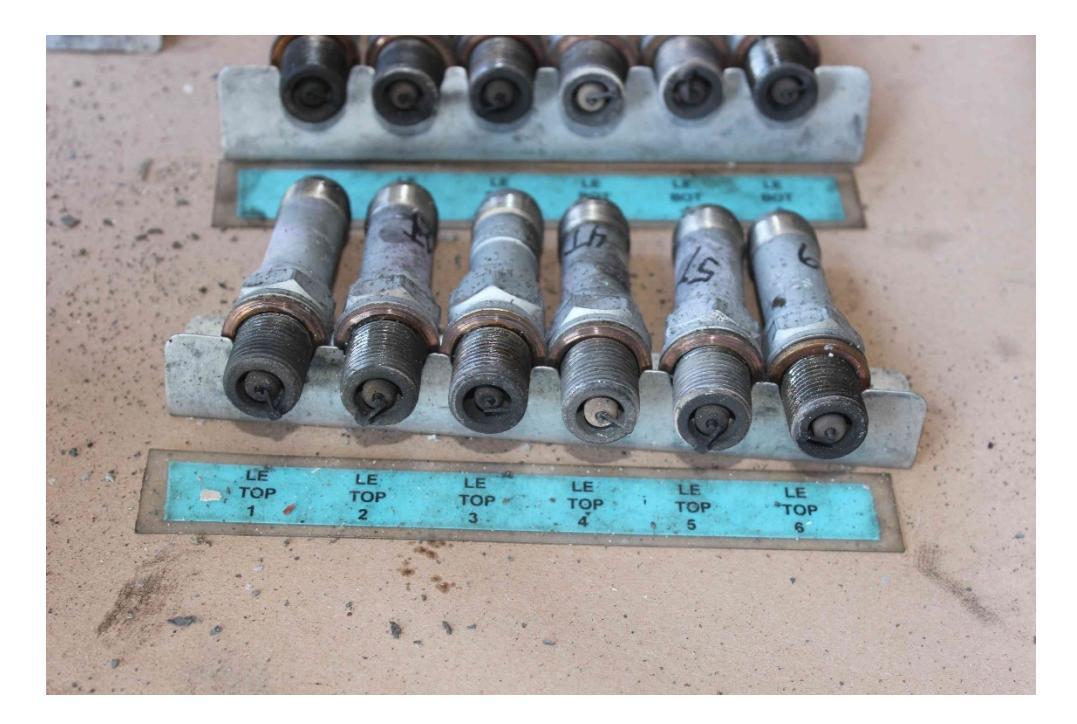
The top and bottom spark plugs were removed. All were of the fine wire type, and did not exhibit any evidence of catastrophic failure. The plugs exhibited normal wear signatures when compared to the Champion AV-27 Check-A-Plug chart. The top and bottom plug electrode and insulator faces for cylinder No 4 were coated in light grey soot. All remaining plugs exhibited black

colored sooting to their combustion-exposed surfaces (Photo 12, 13). The top plug heat range was 36, the heat range for all remaining plugs was 32.

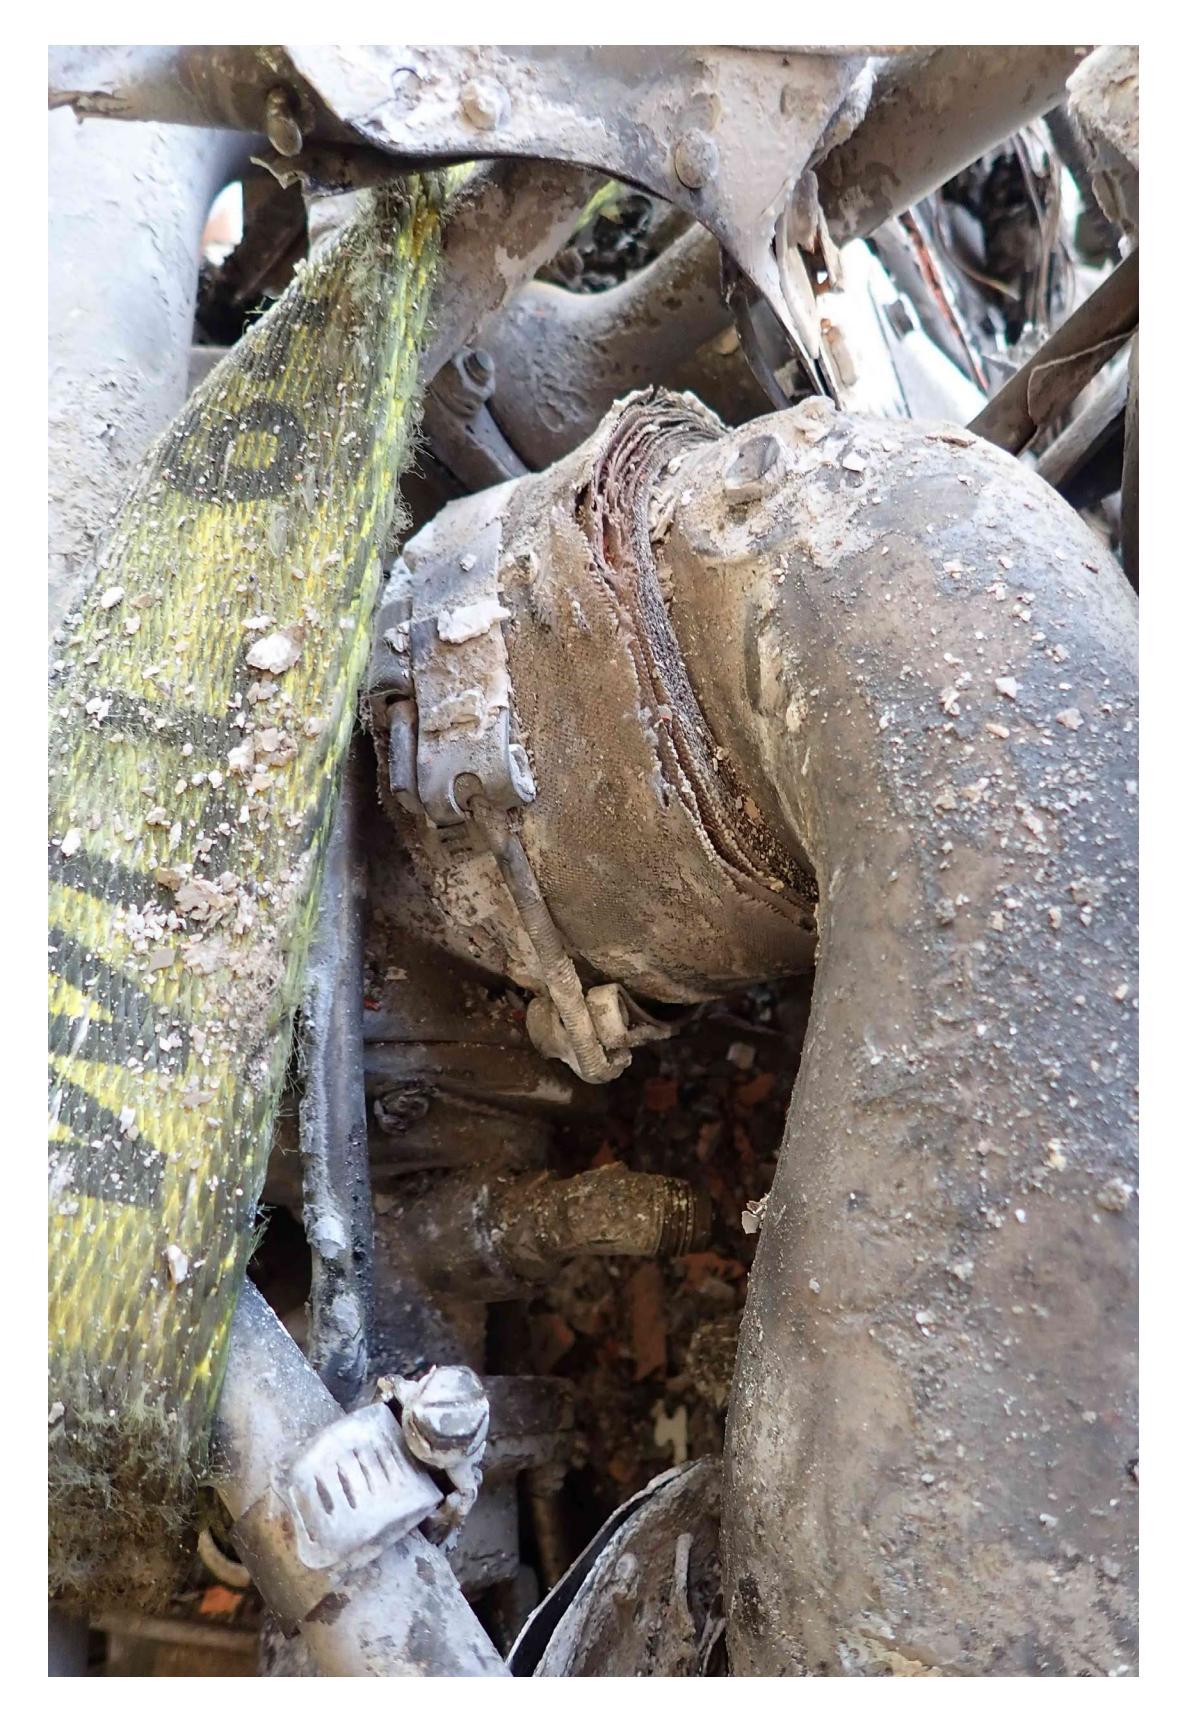
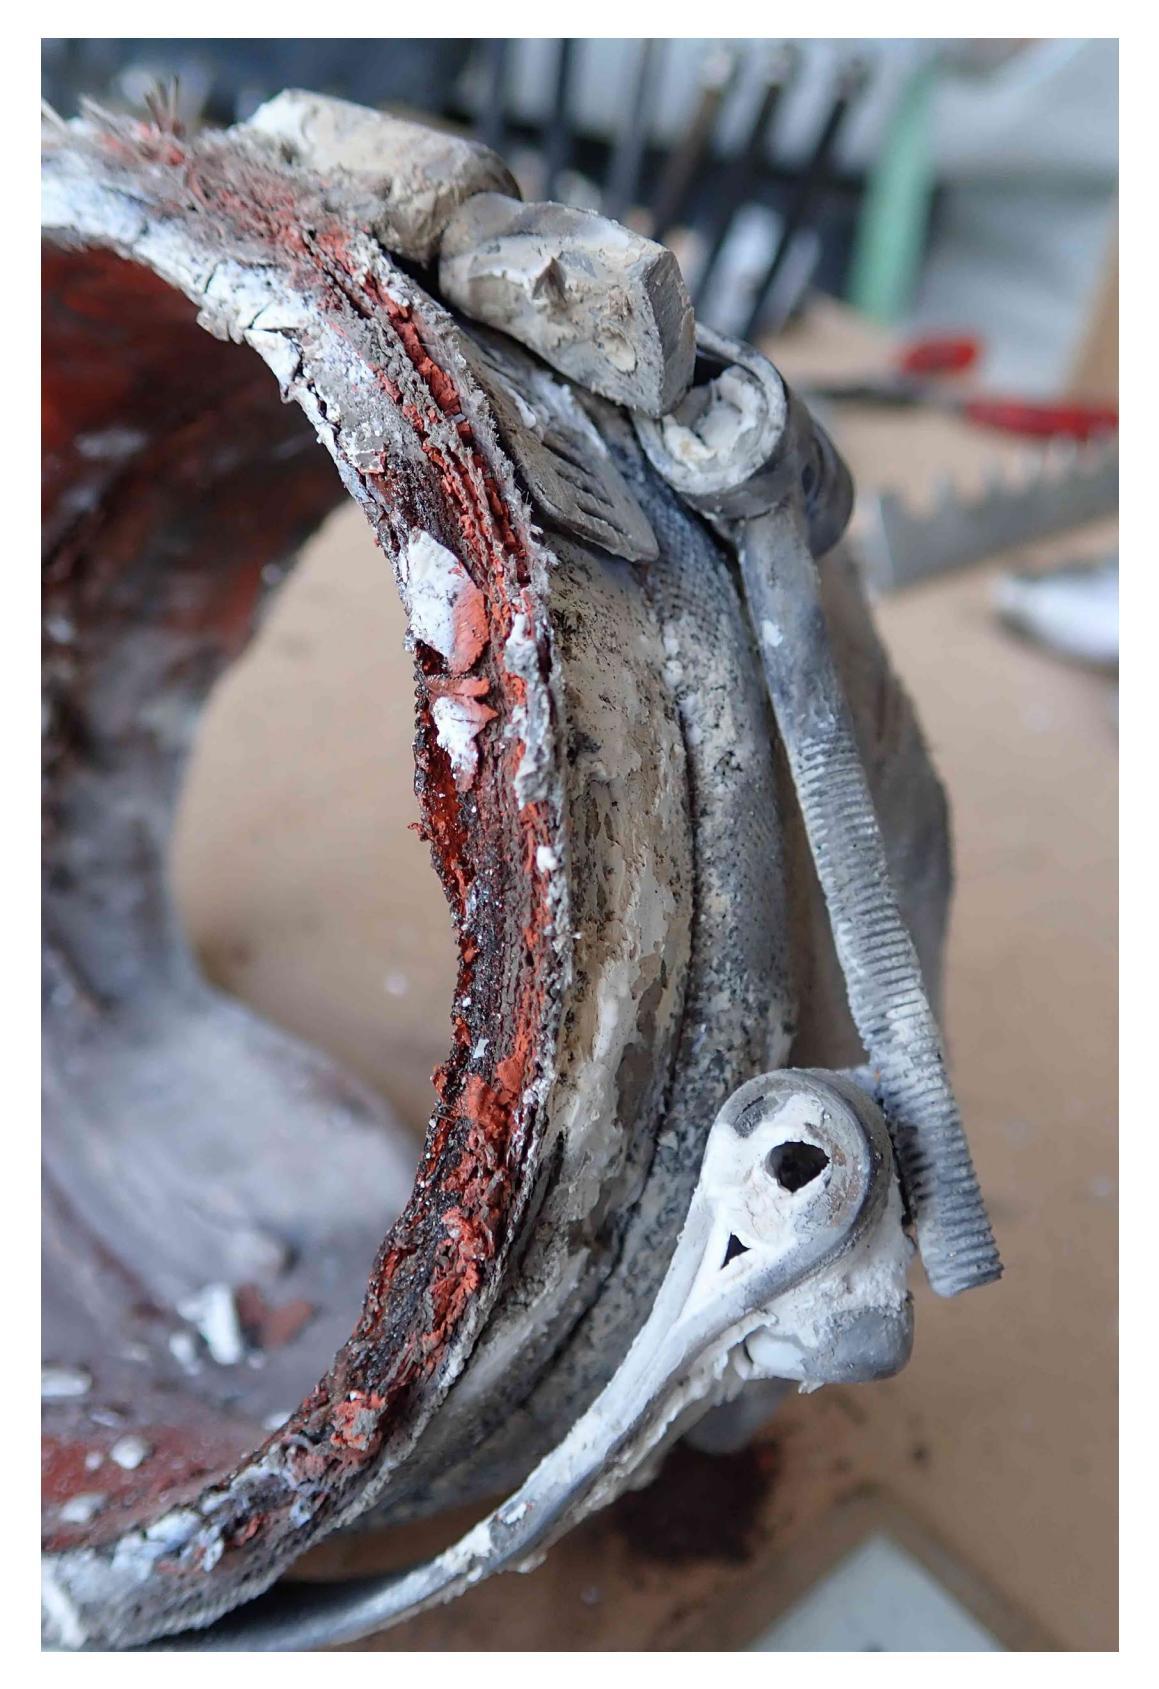
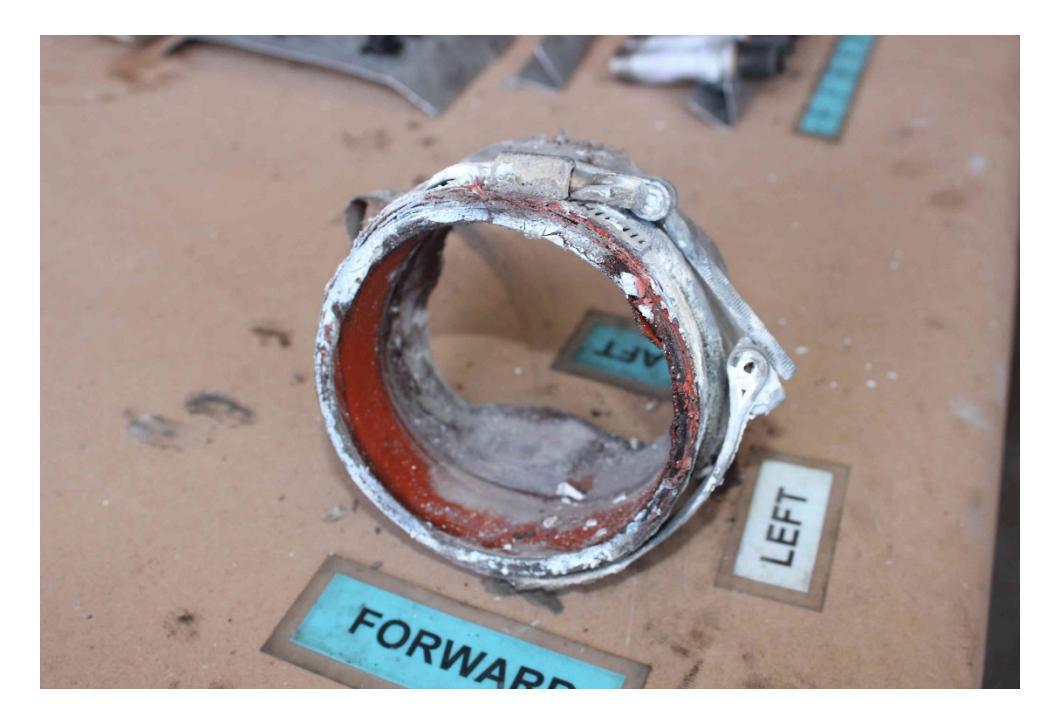
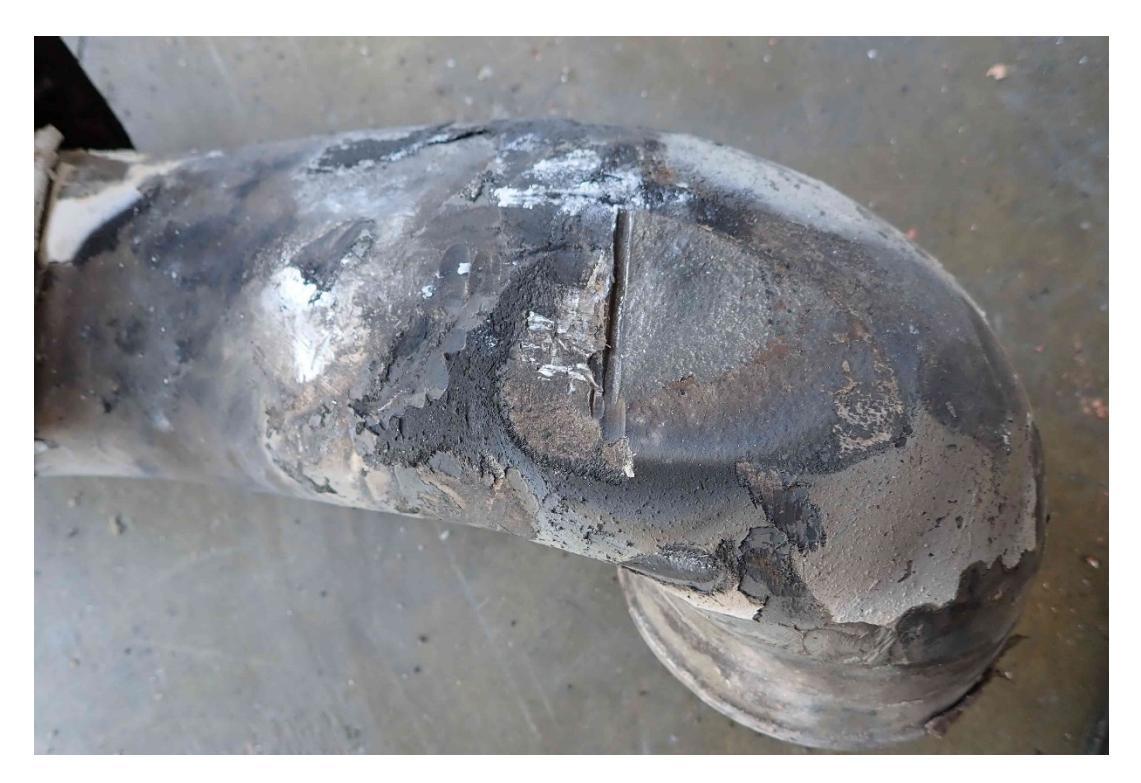
The hose connecting the absolute pressure relief valve to the intercooler inlet elbow was intact. Its forward clamp remained firmly in place, however the aft clamp appeared to be of a different type and had detached (Photo 14). The threaded portion of the clamp appeared undamaged, and the nut was not located (Photo 15). Removal of the tube revealed that its forward clamping surface was bright orange in color and pliable (Photo 15,16). The inner surface of the aft end was dark in color and frayed (Photo 16). The forward side of the intercooler elbow exhibited rubbing marks consistent with contact with the turbocharger assembly (Photo 17), the elbow had not been breached.

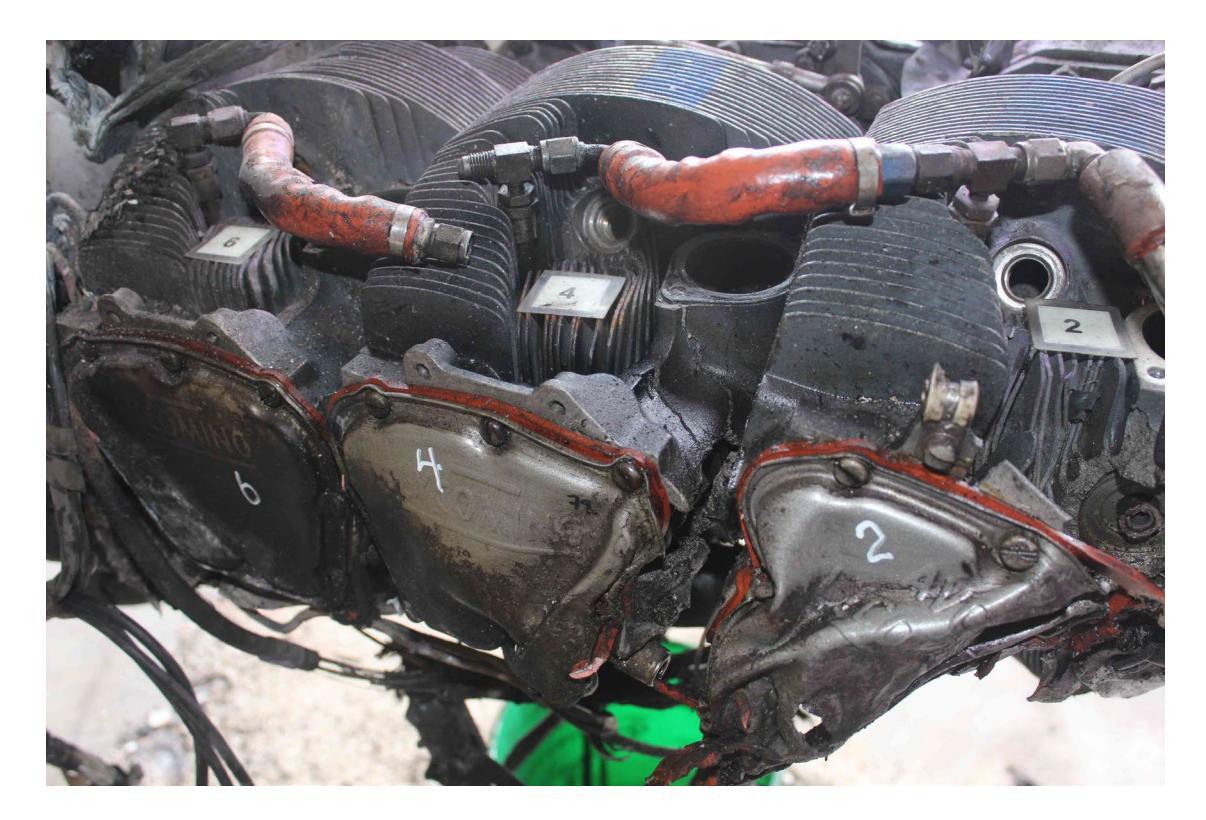
Photo 18 – Right Side of Right Engine

The engine sustained impact damage to the front right side, liberating the No 2 cylinder rocker assembly and pushrods, and the inlet rocker assembly of cylinder No 4. The No 4 intake valve spring had become impinged against a broken section of the cylinder casing (Photo 18). The accessory area exhibited thermal damage, and the exhaust outlet pipe was crushed, and had detached from the turbocharger housing.

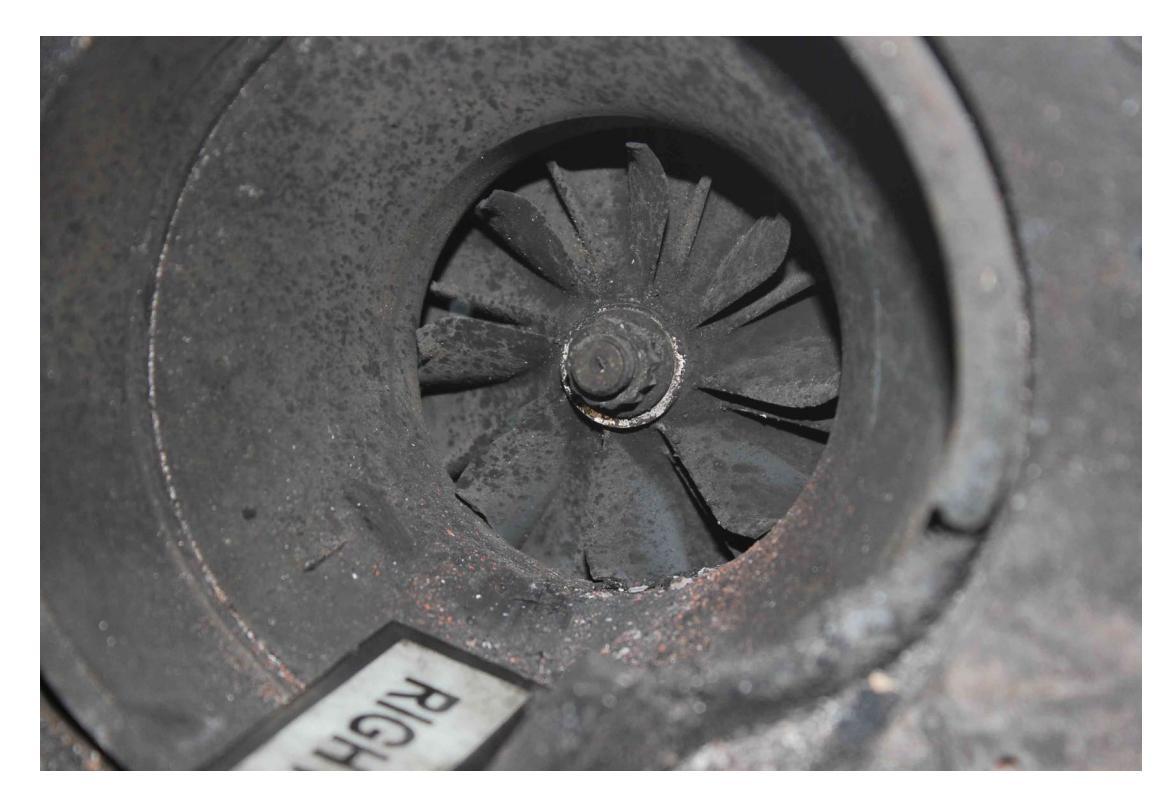
Photo 19 - Right Turbocharger Impeller Wheel

The turbocharger ladder assembly had displaced upwards, and had partially pulled away from the accessory case. The turbo impeller and compressor wheels remained interconnected, and could be rotated freely. The compressor wheel was undamaged, and the impeller wheel sustained damage to its tips, opposite the direction of travel (Photo 19).

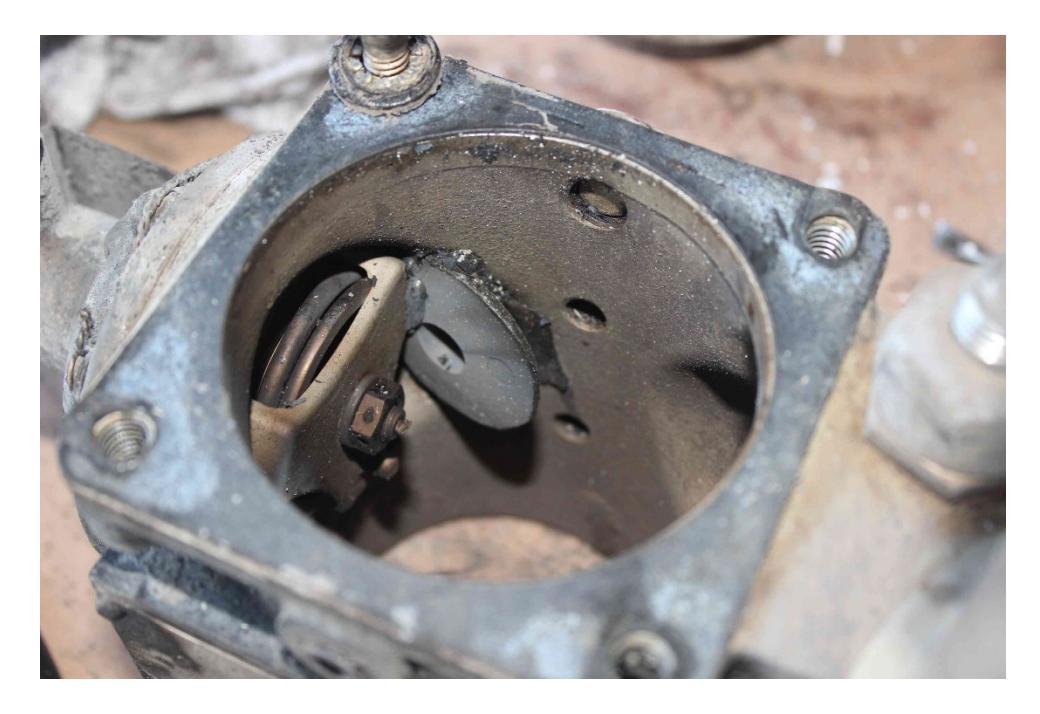
Photo 20 - Left Engine Pressure Relief Valve Head

The lower right bolt of the turbocharger ladder assembly had fractured, and the lower left bolt was loose. The turbo impeller and compressor wheels remained interconnected, could be rotated freely, and neither exhibited any evidence of damage. The plastic valve head of the absolute pressure release valve had melted, and was located resting against the spring of the absolute pressure relief controller within the assembly lock manifold (Photo 20), remnants of the head remained around the valve seat.

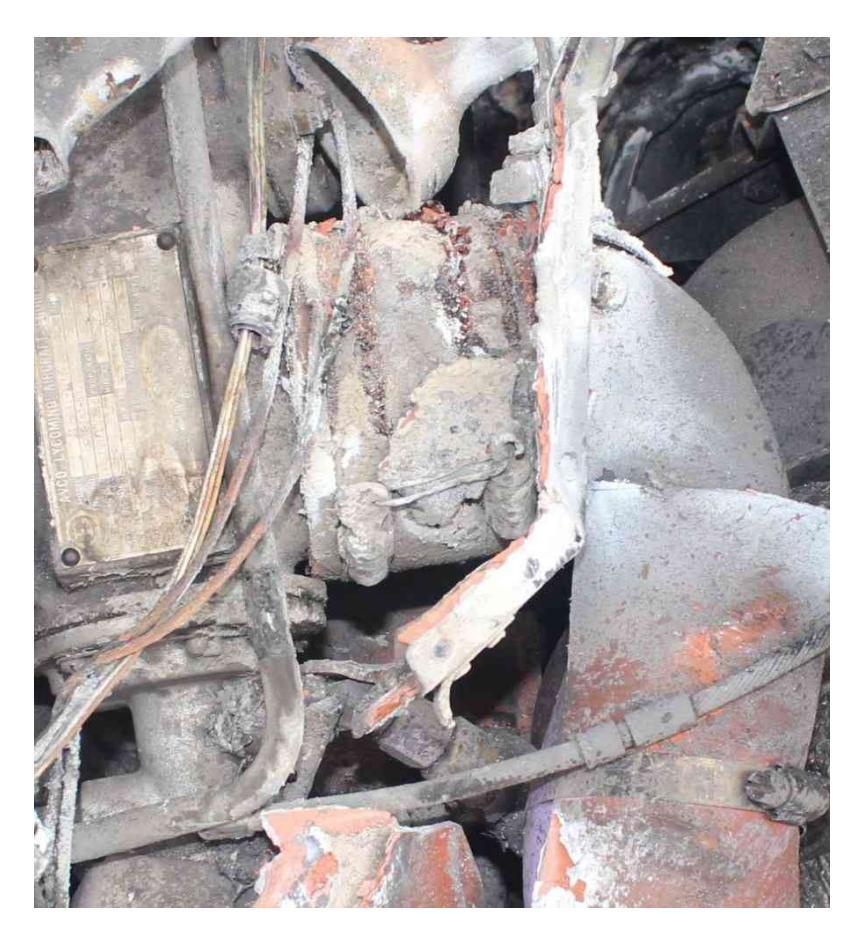
Photo 21 - Right Engine Absolute Pressure Relief Valve-to-Intercooler Elbow Hose and Clamps

The hose connecting the absolute pressure relive valve to the intercooler inlet elbow was intact and clamped securely at its forward and aft joints. Both clamps were secured to each other with safety wire (Photo 21).

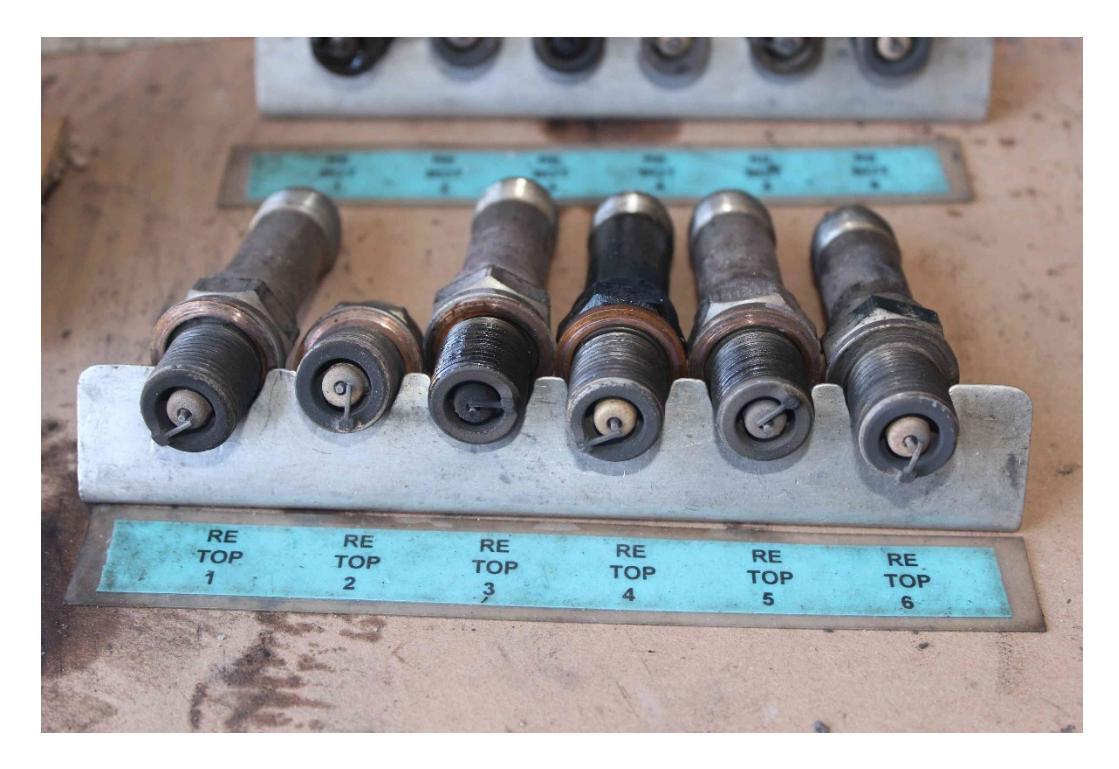
Photo 22 – Right Engine Top Spark Plugs

The top and bottom spark plugs were removed. All were of the fine wire type, and did not exhibit any evidence of catastrophic failure. The electrodes and insulators for plugs No 1, 2, 4, 5 and 6 were coated in light tan deposits (Photo 22). Similar coloration was observed on the bottom plugs for No 2, 4, 5, and 6 cylinders (Photo 23). Plug No 1 was coated in oil, and plug No 3 exhibited dark sooting. All plugs had a heat range of 32, and all exhibited normal wear signatures when compared to the Champion AV-27 Check-A-Plug chart.
