West Reading, PA - Investigative Update

¹ DuPont uses the trade name Delrin for its polyacetal material.

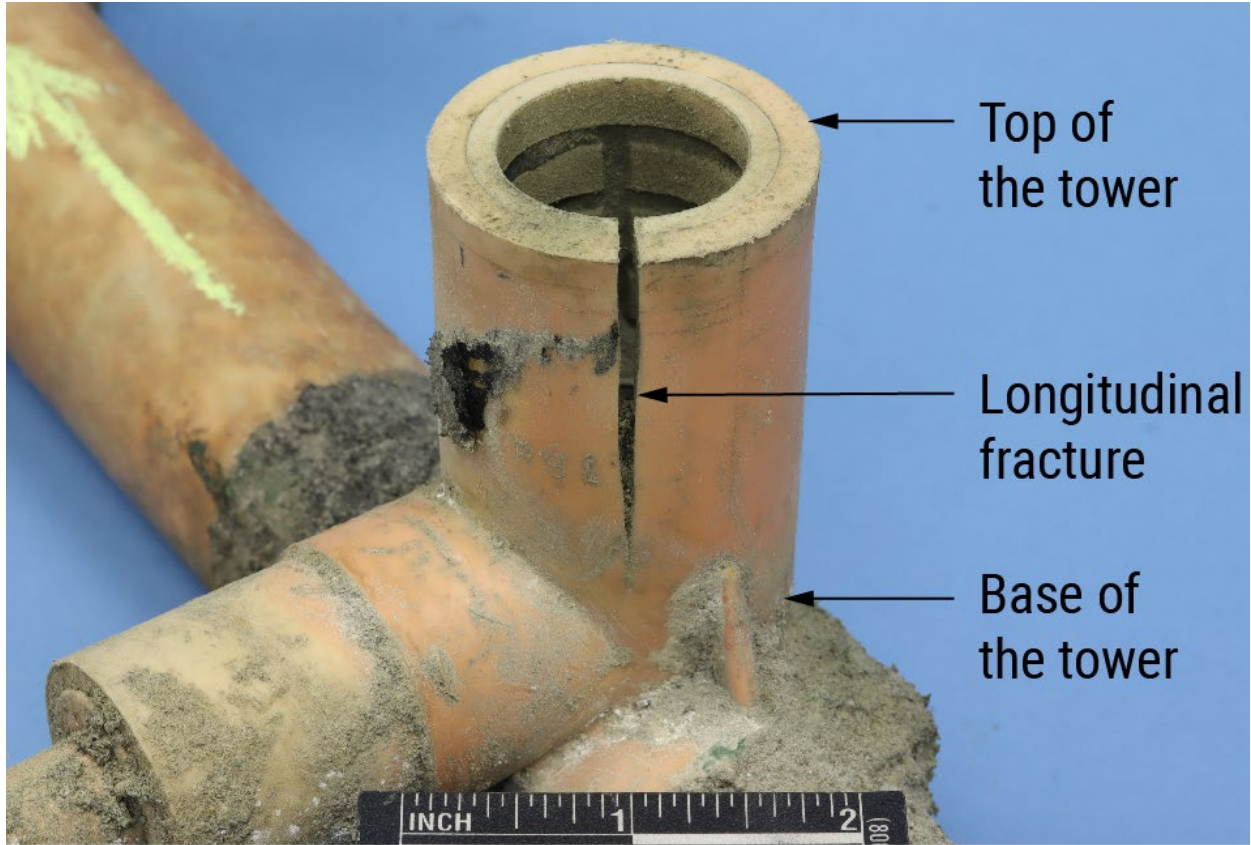
Figure 1. DuPont Aldyl A service tee installed in 1982 longitudinal facture along the tower, July 3, 2023.
