Molent Aerostructures

My Doc ID: MAC 3b Mar22¹

Piper PA-28R-201 Spar Cracking: Preliminary Observations and Comments

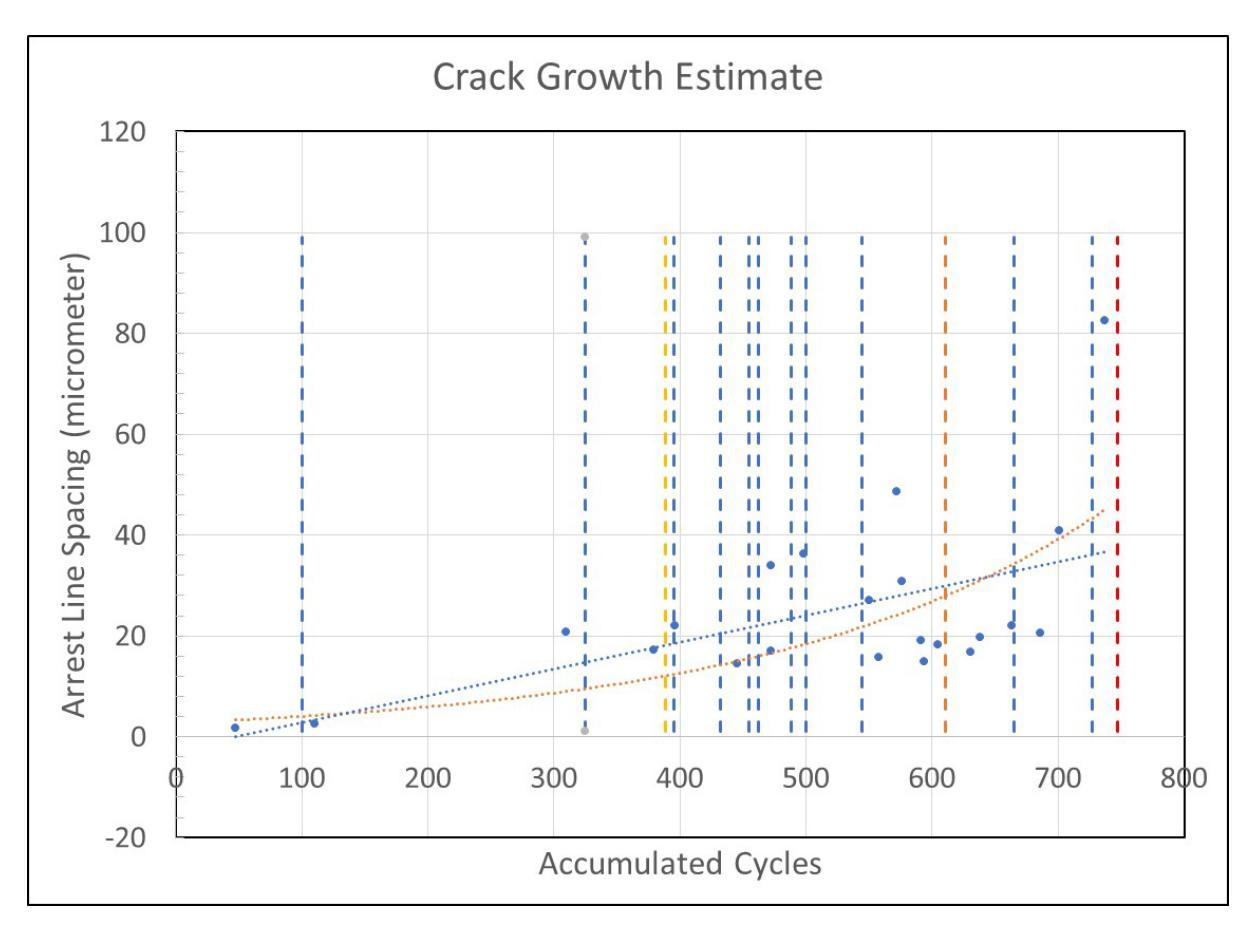
The Ref 1 related analyses of striation spacing supports the premise of exponential crack growth, see Figure 1. However, a linear growth curve is also possible in this case (see Figure 1) given some of the observations reported above. For the purposes of conservatism an exponential growth model is used below.

Figure 1: Striation spacing versus accumulated cycles on the fracture surface of Spar B, from Fox, Ref 1. The red line represents the best fit exponential curve and the blue dashed line the best fit linear line.

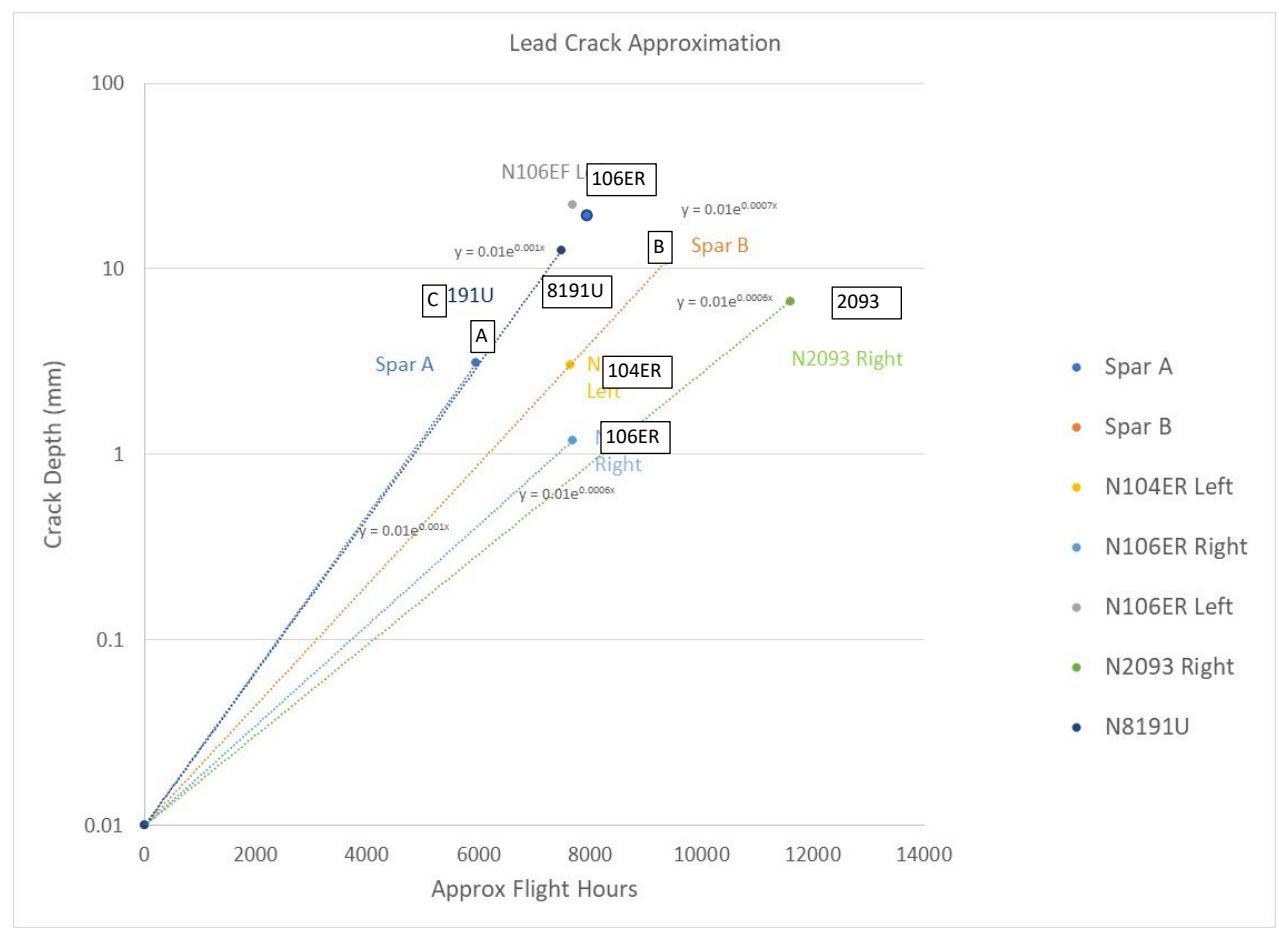
Using the available estimated flight hours versus maximum crack depth (See Table above), the lead crack framework has been applied (with caveats as outlined above) to produce Figure 2.

Given the uncertainties in the load/stress/weight history of the aircraft considered, in this author's opinion the level of scatter in the crack growth is low. It is instructive to note the

similar crack growth estimated behaviour of Spar B and Aircraft N104ER left wing, and Spar A, N8191U and N106ER left.

It is important to note that there may be a faster crack growth rate in the fleet of aircraft in service. However, given the view on scatter, the crack growth curve for Spar A may be appropriate for in-service actions.

It is noted that Spar B appears not to be the fastest growing crack found to-date.

Figure 2: Preliminary estimates of crack growth curves for available cases.
