# Grounding of Articulated Tug and Barge *Cingluku/Jungjuk*

**Figure 1.** ATB *Cingluku/Jungjuk* on unknown date before the grounding. (Source: marinetraffic.com)

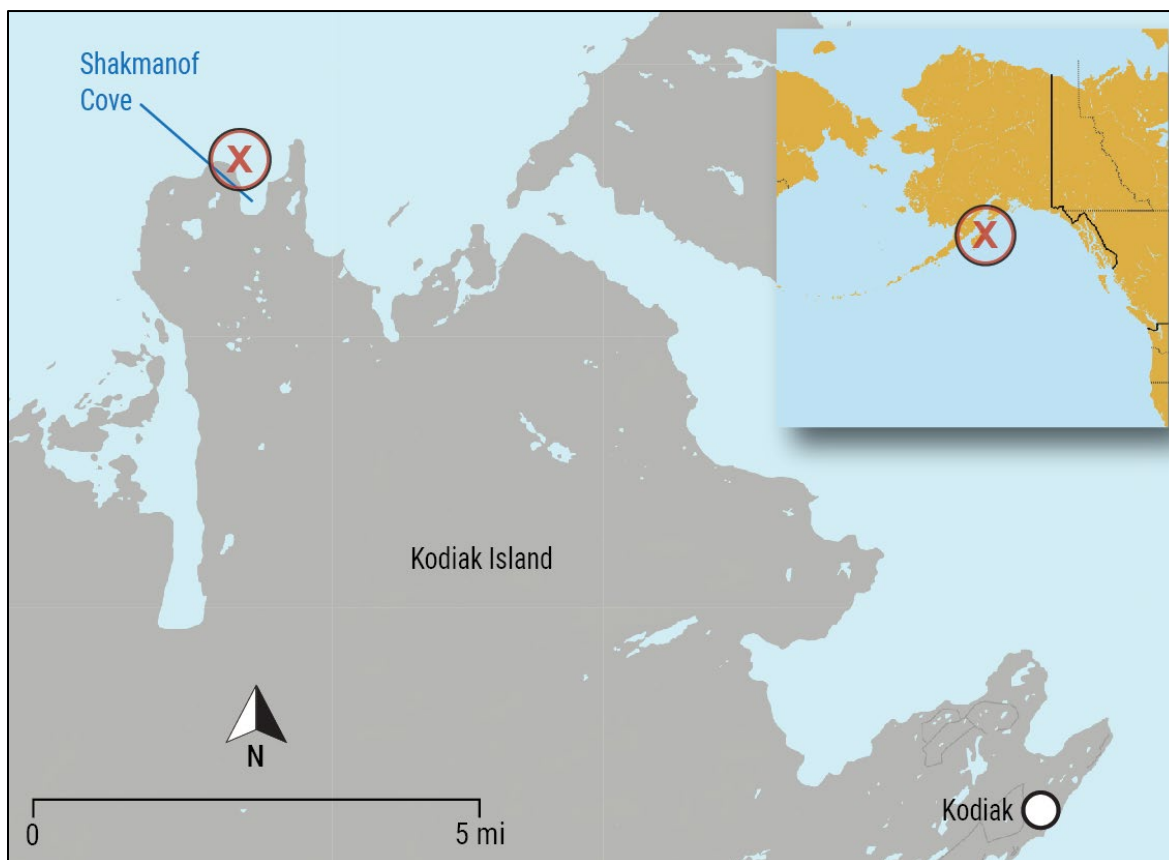
**Figure 2.** Area where the *Cingluku/Jungjuk* grounded, as indicated by a circled X. (Background source: Google Maps)

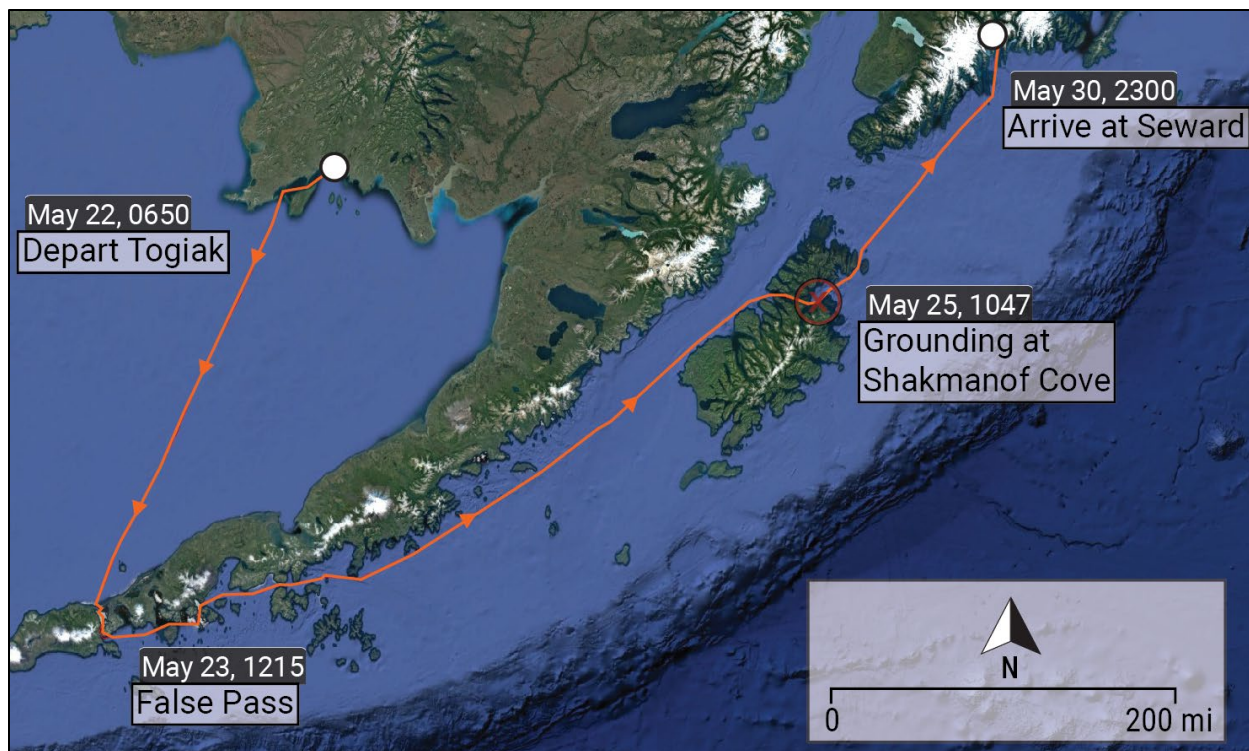
**Figure 3.** Approximate voyage trackline of the *Cingluku/Jungjuk*. (Background source: Google Earth)

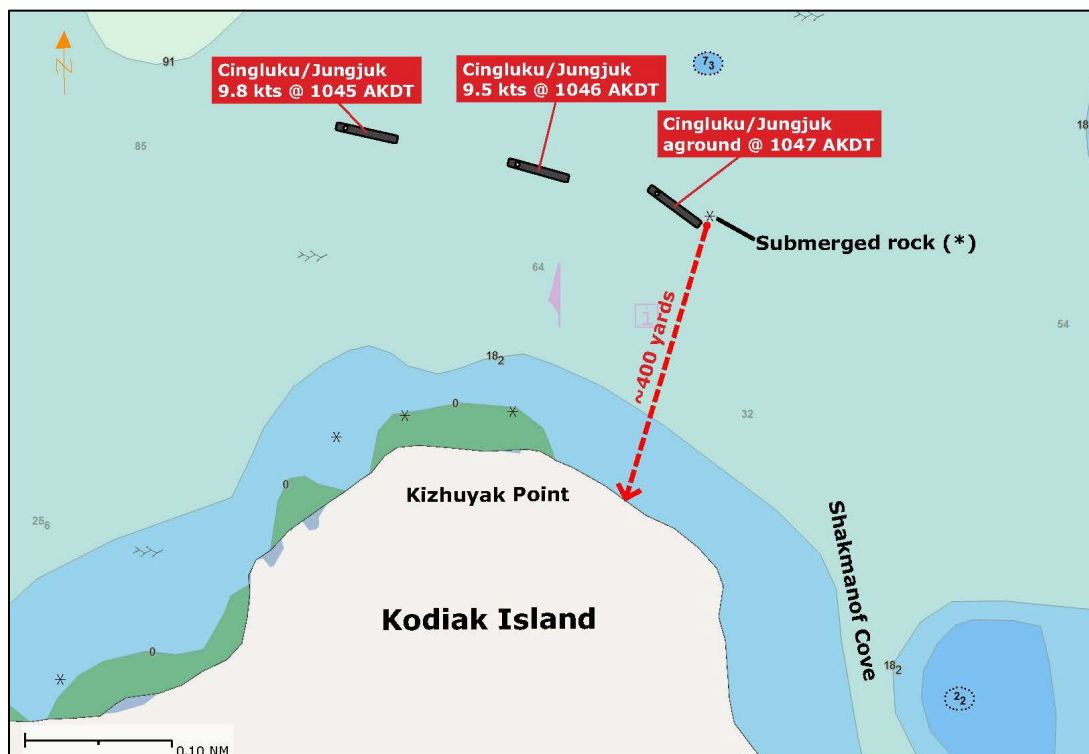
**Figure 4.** Track of the *Cingluku/Jungjuk* as it approached Shakmanof Cove, overlaid on NOAA ENC US4AK5PM. (Background source: NOAA ENC as viewed on Made Smart automatic identification system)

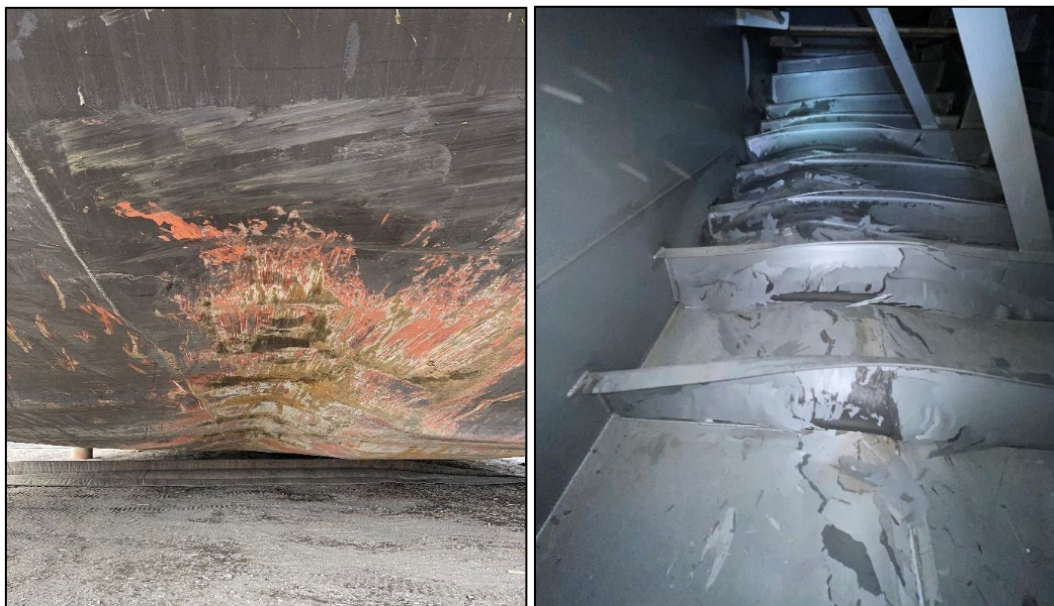
**Figure 5.** Left to right: Damage to the bottom of the *Jungjuk's* hull looking aft along the centerline and damage to the barge's internal structure and framing. (Source: Coast Guard)

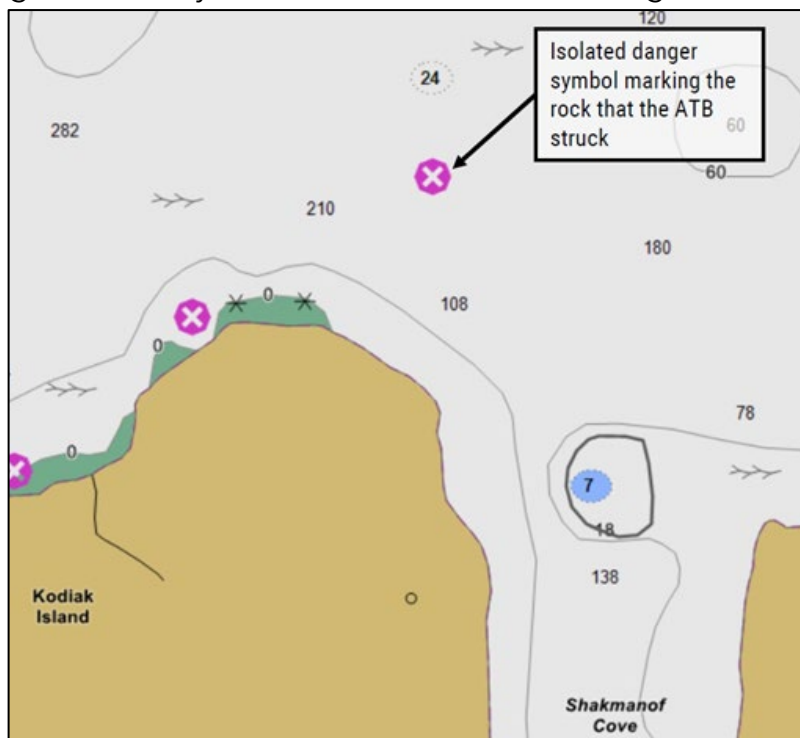
**Figure 6.** ENC US4AK5PM, as viewed by investigators using an equivalent ECS. The chart shows an isolated danger symbol over the rock that the ATB struck. (Background source: NOAA ENC as viewed on Rose Point ECS)

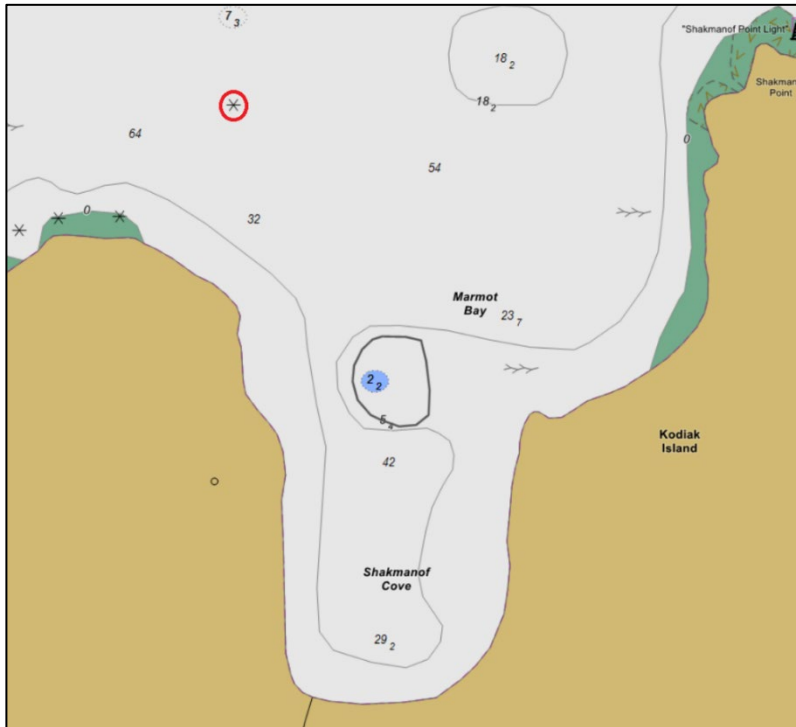
**Figure 8.** ENC US4AK5PM, for the area near Shakmanof Cove, as viewed by investigators using an equivalent ECS. The asterisk symbol for the rock in the area of the grounding is indicated by a red circle. (Background source: NOAA ENC as viewed on Rose Point ECS)
