From: [Hiller Michael](#)
To: [Antonio Perez](#)
Cc: [Joshua Coran](#); [Turpin Ted](#); [Rhine Don \(Joey\)](#); "[Gary Fairbanks](#)"
Subject: NTSB Information Request RRD18MR001 DuPont, WA
Date: Monday, July 16, 2018 1:45:00 PM
Attachments: [image001.png](#)

August 3, 2018

Laboratory Testing of Sample Straps

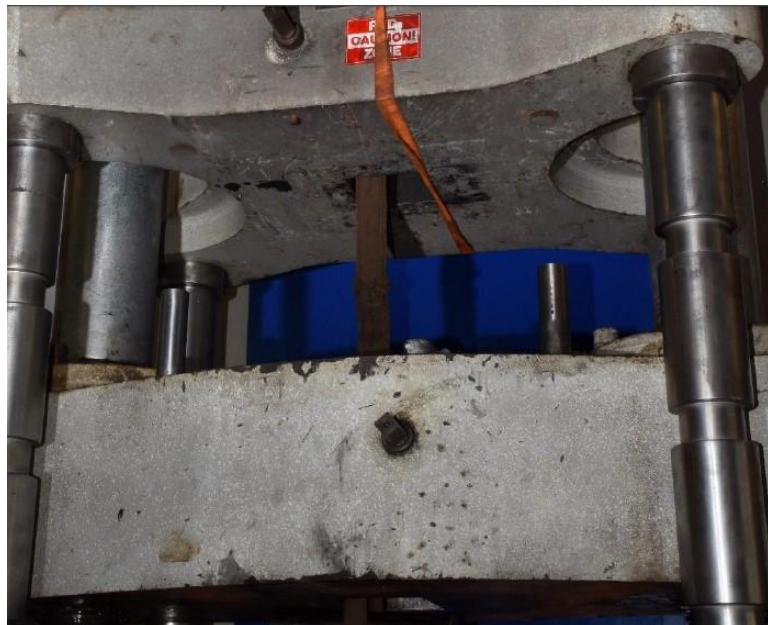
The way the safety straps were tested (as shown in “Materials Laboratory Factual Report 18-042”) is not comparable to the way in which they were applied to the rolling assemblies. In the lab, the straps were tested in simple tension as shown in the photo below, taken from the report.

Lab setup loading the strap in simple tension

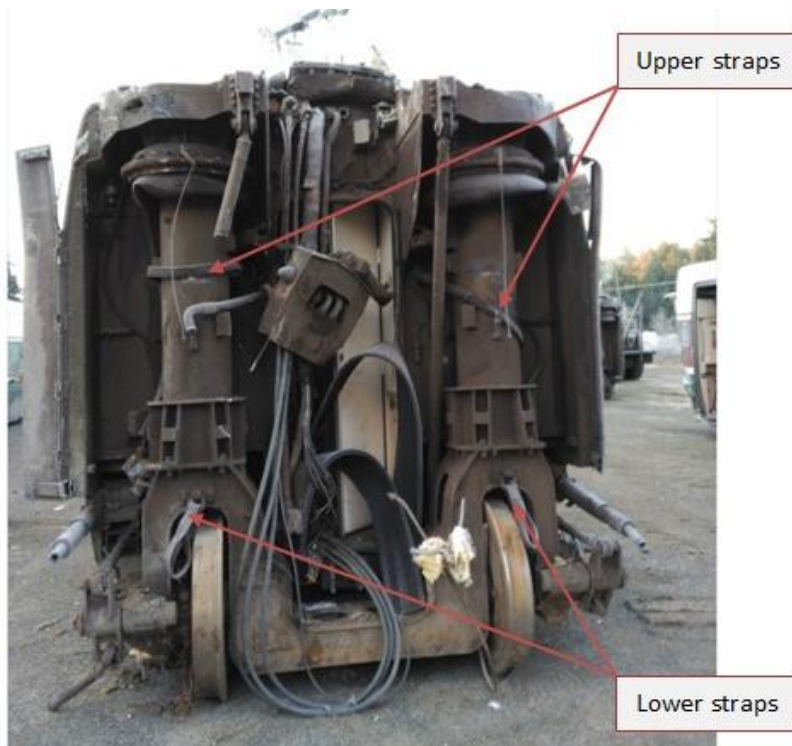
In the actual application the upper straps surround the tower, and the lower straps surround the hooks attached to the rolling assembly. These applications can be seen in the photos below.

Safety strap attachment

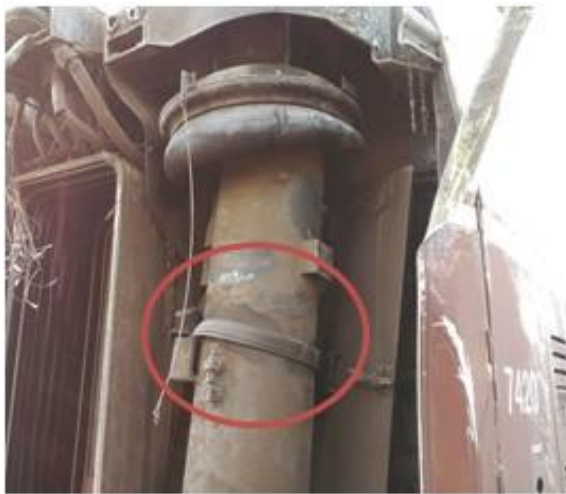
Upper strap detail

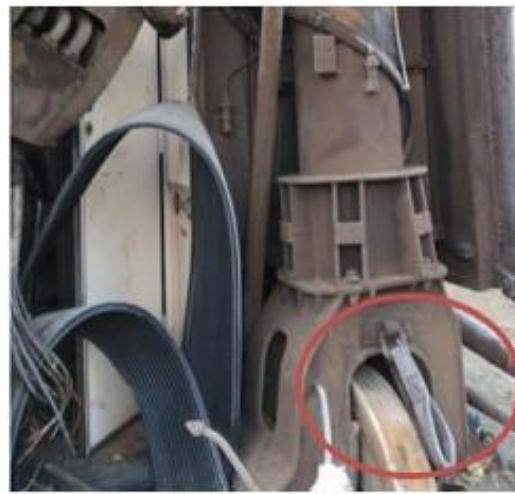
Lower strap detail
