National Transportation Safety Board

Office of Railroad, Pipeline and Hazardous Materials

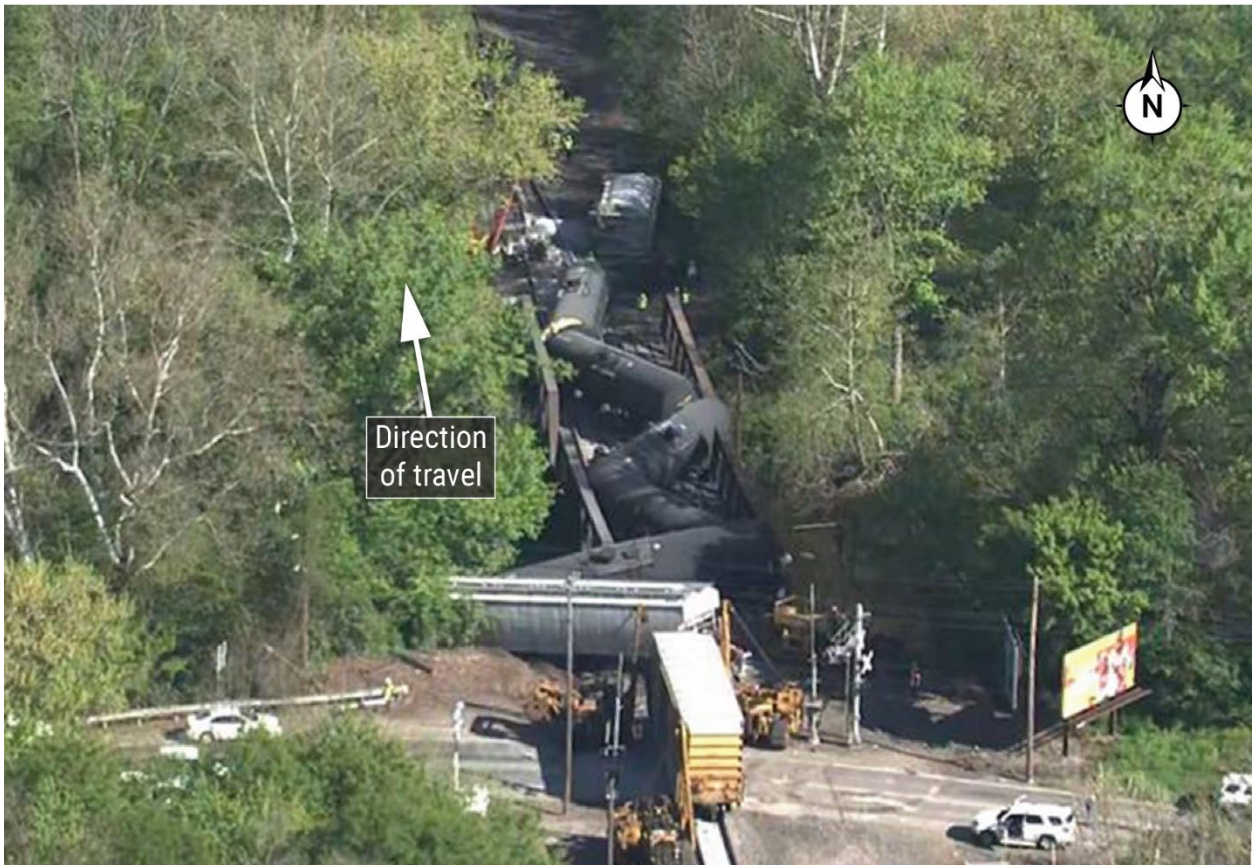
Figure 1. Aerial photograph of derailment site. (Source: WPXI Pittsburgh.)

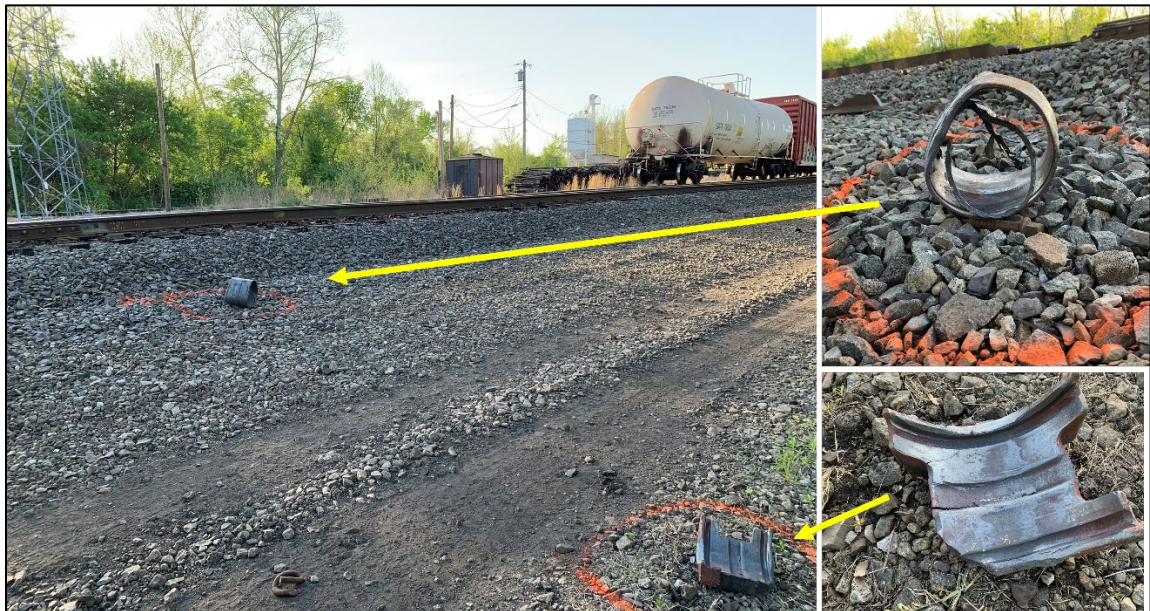
Figure 2. Journal components marked by Norfolk Southern. (Source NTSB).

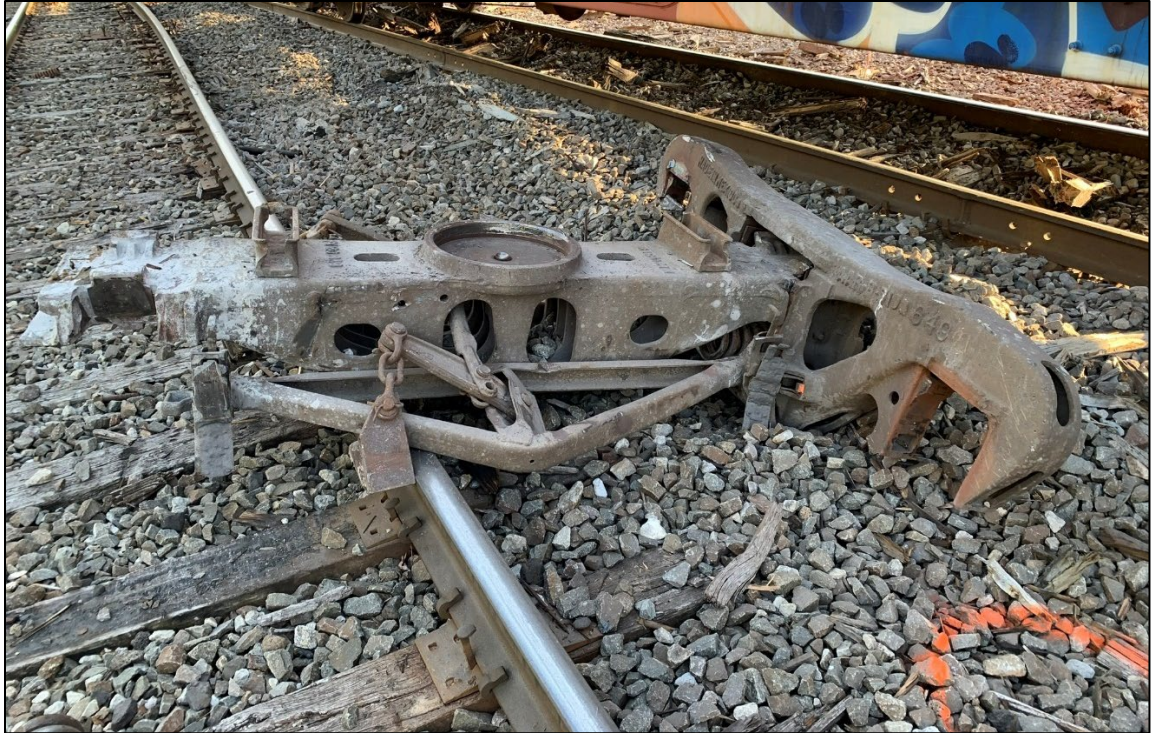
Figure 3. Truck frame with heat marks. (Source NTSB)

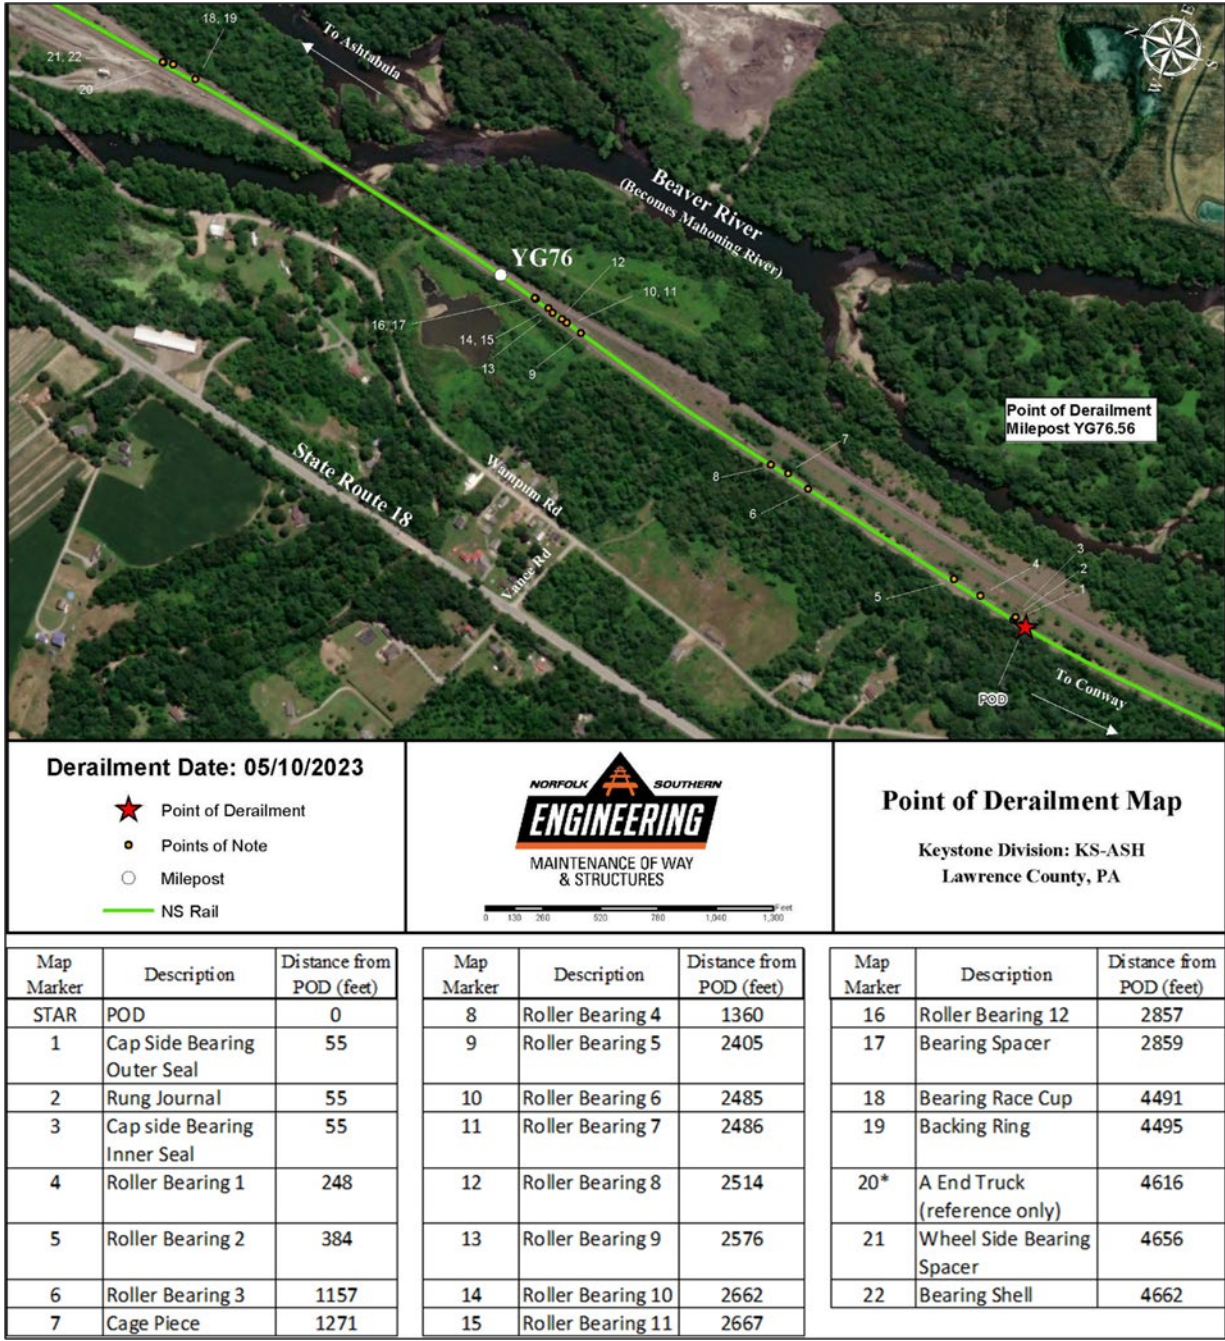
Figure 4. Norfolk Southern derailment component location map and index.
