Investigation of the UGI Corporation Natural Gas-Fueled
Explosion and Fire at Building 2 of the R.M. Palmer Company
on March 24, 2023

NTSB Docket PLD23LR002

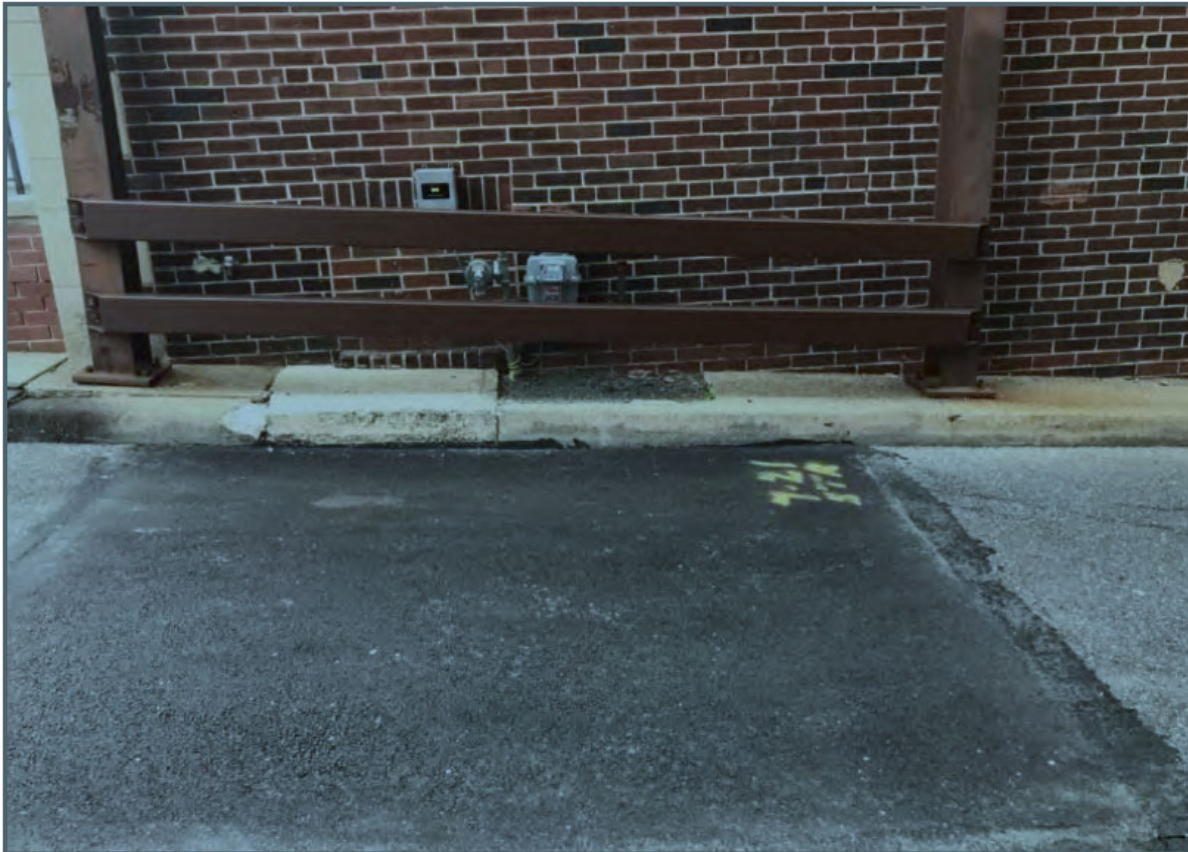
Figure 4. Building 2 meter set (Source: Palmer, taken after 2021 meter relocation project, date unknown)¹¹

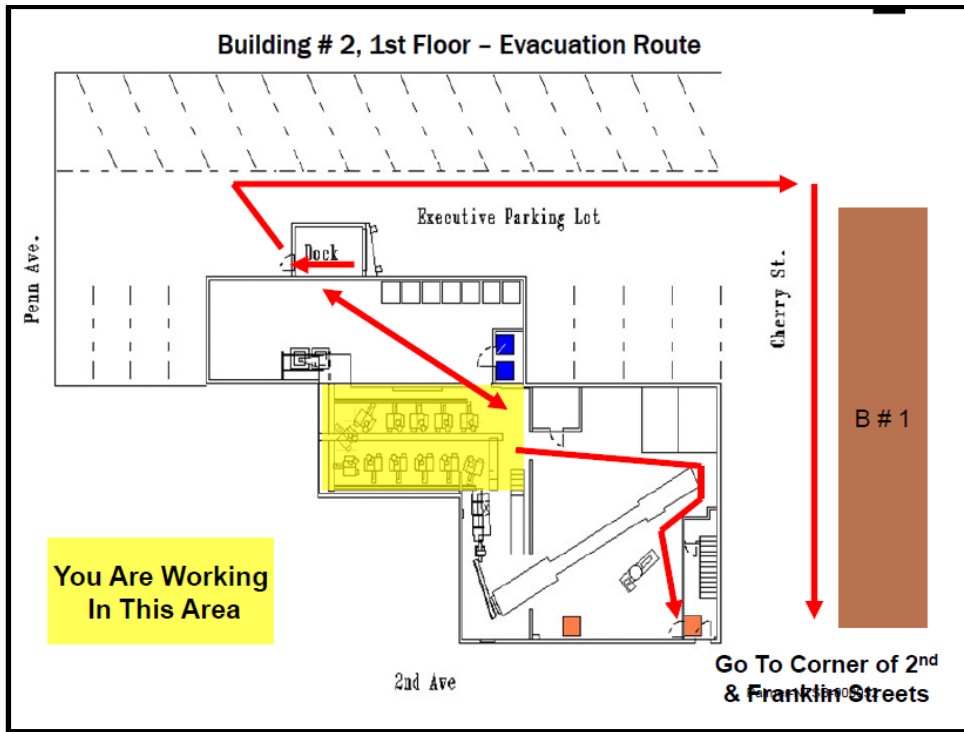
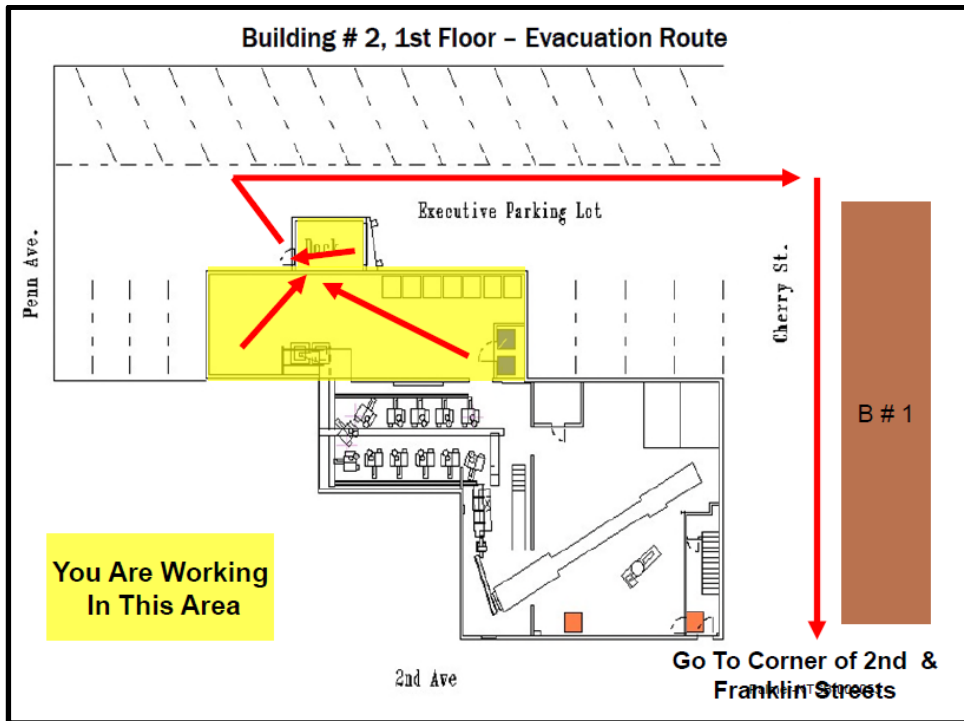
Had employees evacuated pursuant to this plan, they would have been placed directly in harm's way of the subsequent explosion, including walking down Cherry Street and directly over the source of the natural gas leak. Even the muster point at 2nd Ave and Franklin was less than a
