National Transportation Safety Board

RRD23FR003

SIGNAL AND TRAIN CONTROL

Specialist's Factual Report

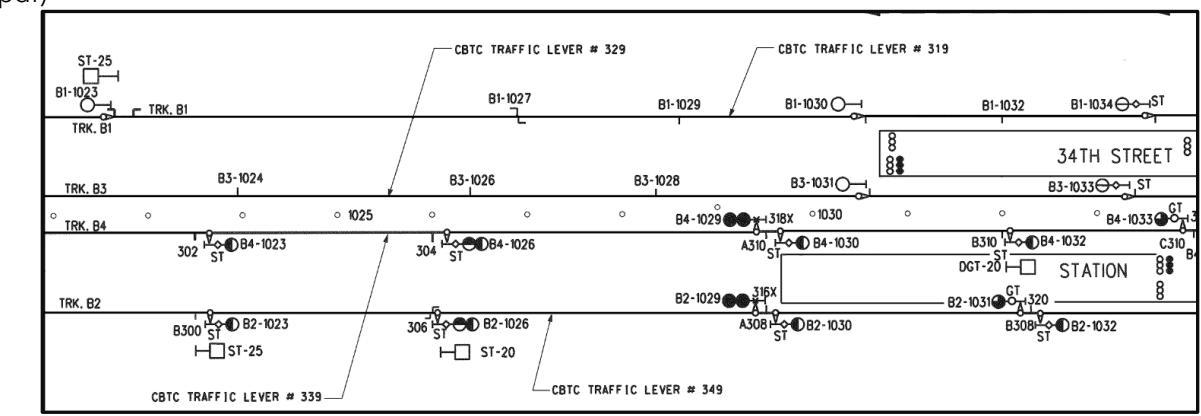
Picture 1: Line drawing of track layout as approaching 34th street station (from MW7B-1022-SL 055.pdf)

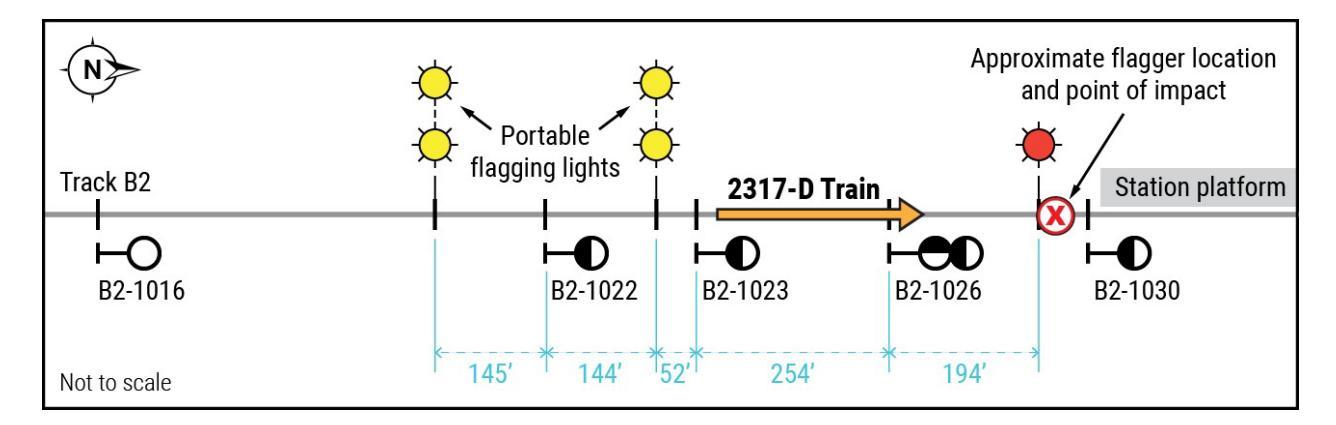
The primary focus for the Signal group was to determine the relationship between the placement of the portable flagger light placements and the track circuit defining insulated joints. This was measured by NYCT due to the third rail having to remain energized during the temporary track outage. This was also performed in conjunction with the ongoing re-enactment with the track and operations working group, staging the lights as they were found on the night of the incident, as the flagger light locations were marked in spray paint on the tunnel wall. (See Illustration 1)

Illustration 1: Measurements noted as per field visit and measured by NYCT staff in support of investigation.

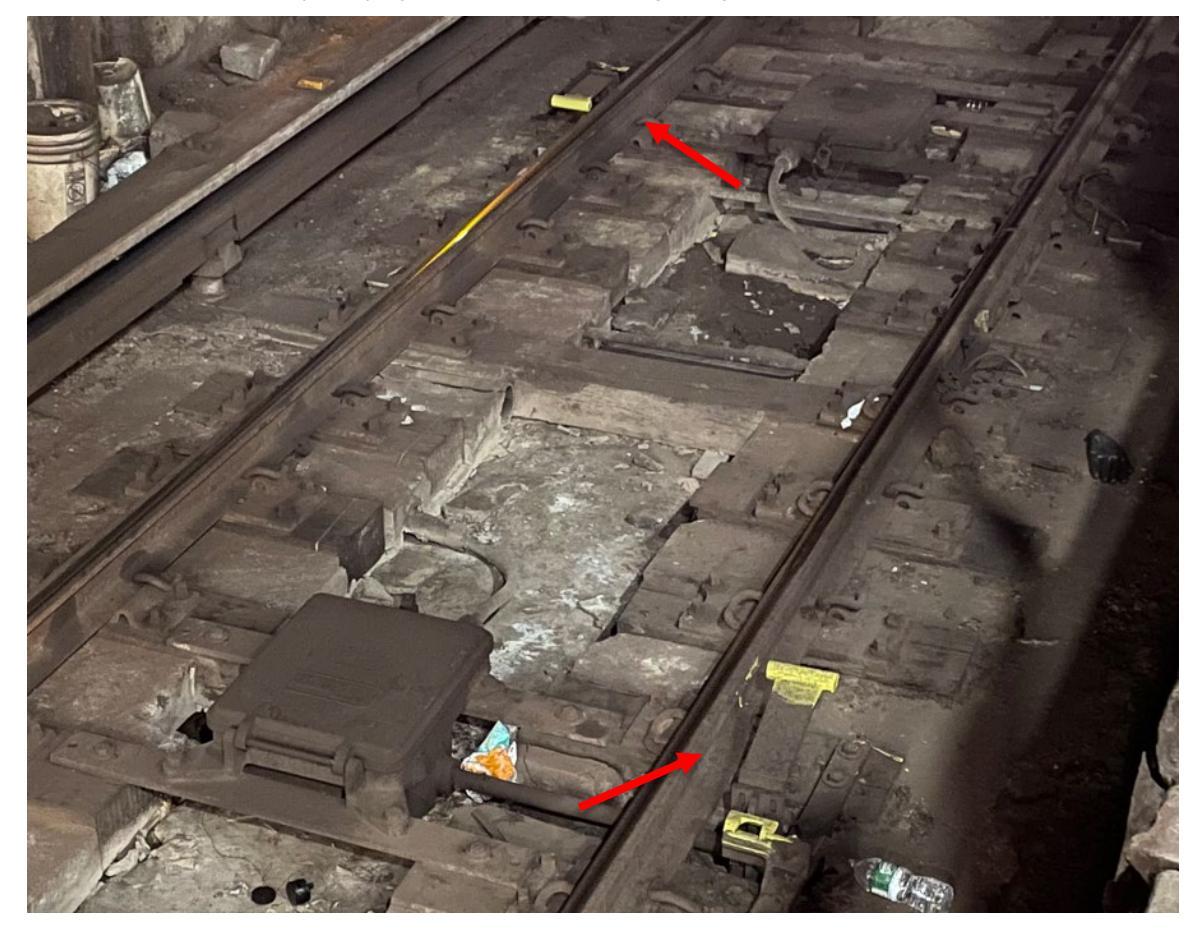
Picture 2: In-track automatic trip/stop system tied into the signal system.
