# National Transportation Safety Board

Office of Railroad, Pipeline and Hazardous Materials

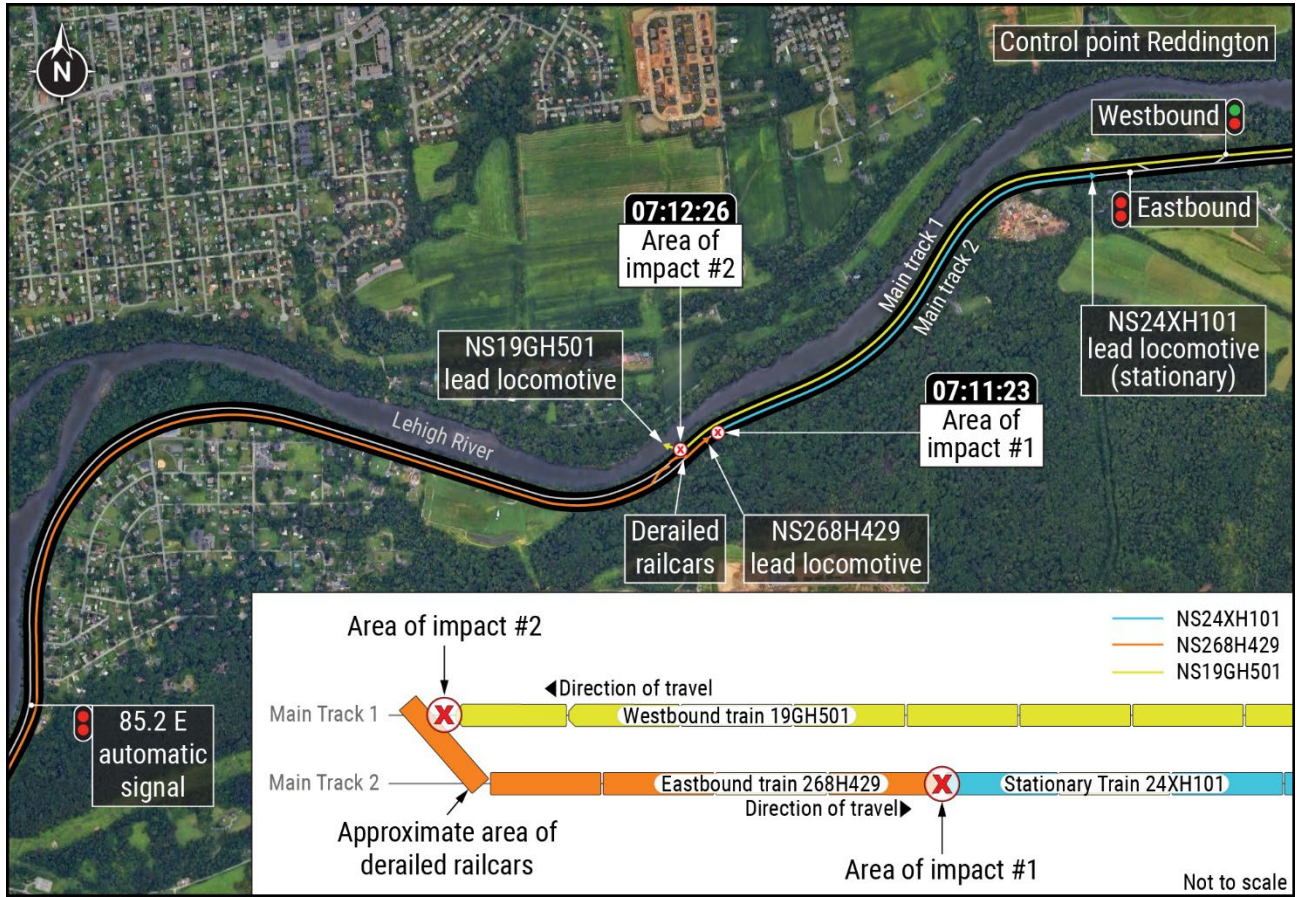
## 2.3 Derailment Pictures
