**BEECHCRAFT  
Bonanza 35**

Docket No. 98-CE-61-AD; Amendment 39-11061; AD 99-05-13

Airworthiness Directives; Raytheon Aircraft Company 17, 18, 19, 23, 24, 33, 35, 36/A36, A36TC/B36TC, 45, 50, 55, 56, 58, 58P, 58TC, 60, 65, 70, 76, 77, 80, 88, and 95 Series Airplanes

**99-05-13 RAYTHEON AIRCRAFT COMPANY** (All type certificates of the affected airplanes previously held by the Beech Aircraft Corporation): Amendment 39-11061; Docket No. 98-CE-61-AD.

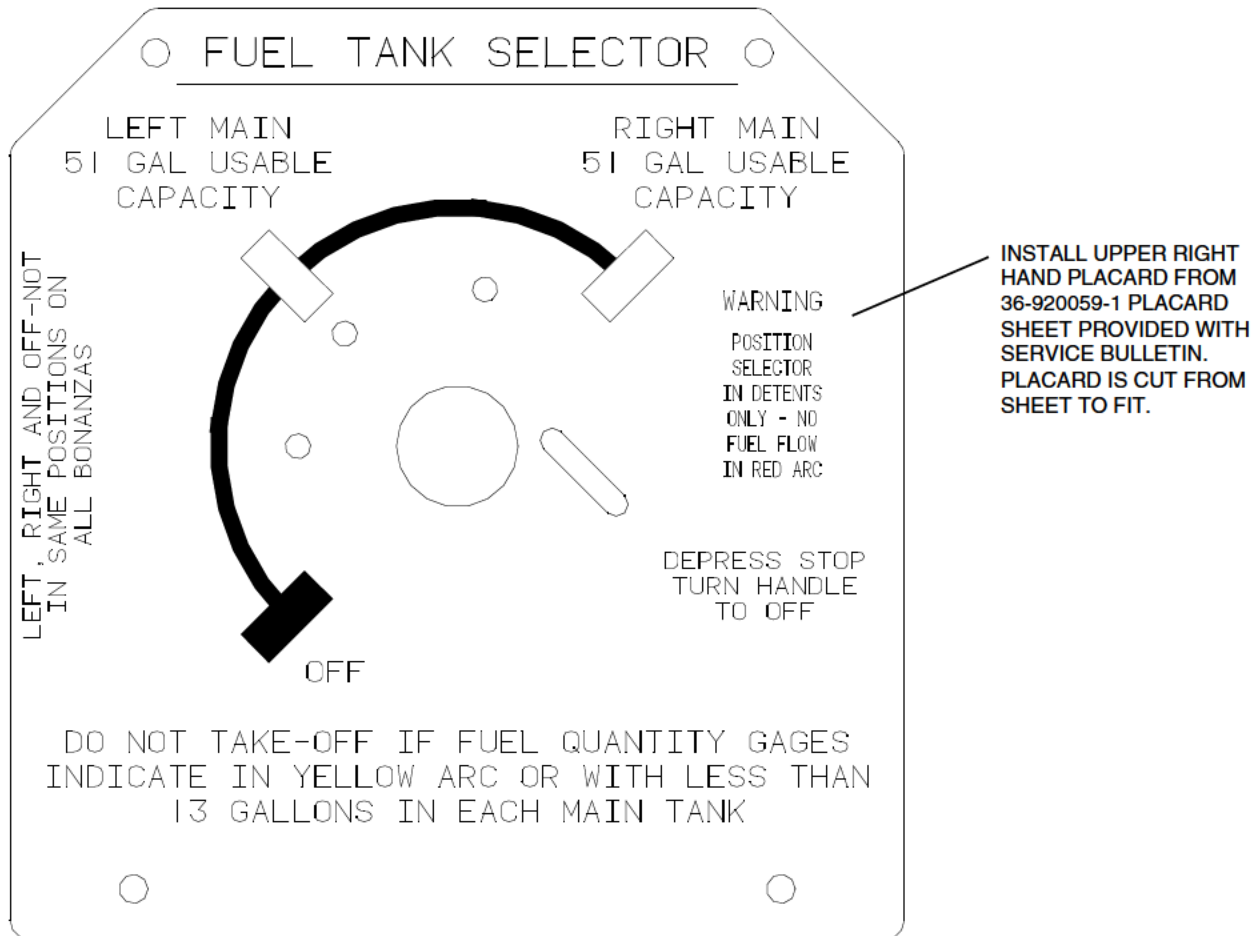
Figure 1

FUEL SELECTOR VALVE  
(B36TC SHOWN, A36TC SIMILAR)

EFF: A36TC SERIAL EA-1 THRU EA-241 AND EA-243 THRU EA-272 WITH BEECH KIT NO. 36-9008-1 INSTALLED, KIT SERIAL NUMBERS 101 THRU 389 ONLY. B36TC SERIALS EA-242 AND EA-273 THRU EA-591.

(a) Install a placard, part number 36-920059-1, on the fuel tank selector to warn of the no-flow condition that exists between the fuel tank detents. Accomplish this installation in accordance with Raytheon Mandatory Service Bulletin No. 2670, Revision No. 1, dated May, 1998.

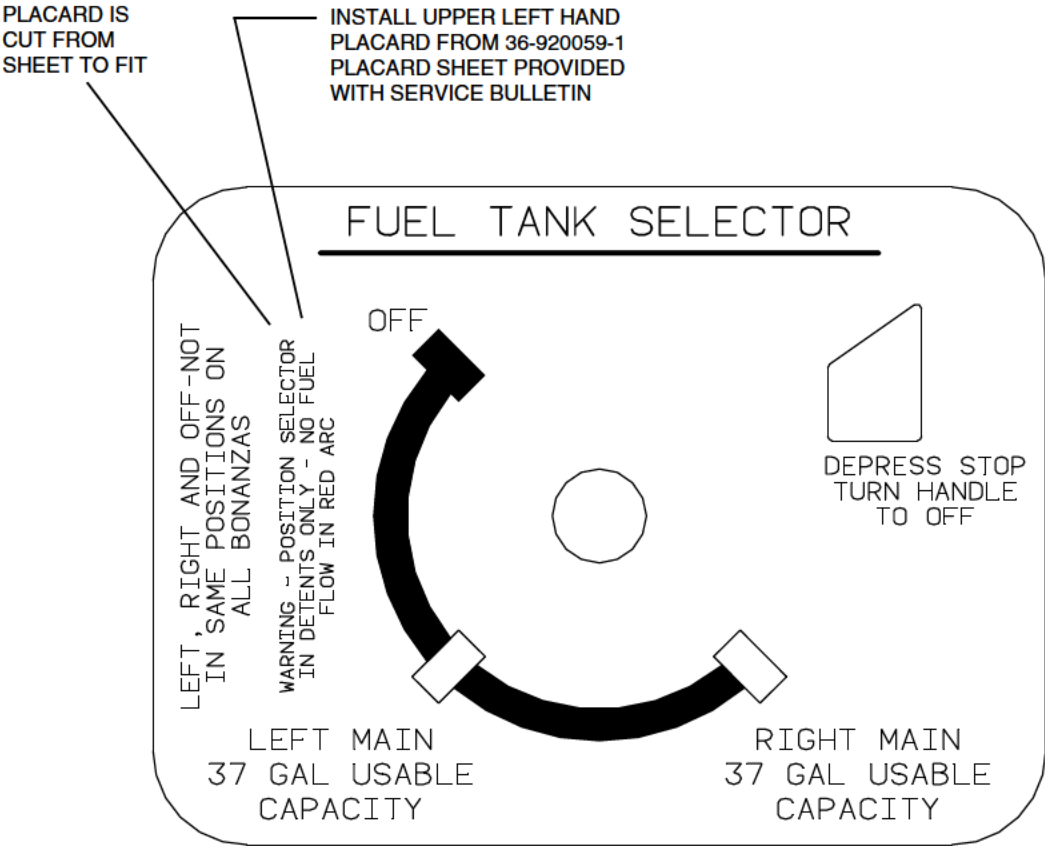
FUEL TANK SELECTOR COVER  
EFF: F33A - CE-1014 THRU CE-1791  
F33C - CJ-156 THRU CJ-179  
A36 - E-2062 THRU E-3046
