NATIONAL TRANSPORTATION SAFETY BOARD

Airframe and Engine Examination Report

WPR18FA211 This document contains 2 embedded photos.

Location: Santa Ana, CA Date: August 5, 2018 Aircraft: Cessna 414, Registration Number: N727RP, Serial #: 414-0385 NTSB IIC: Albert Nixon

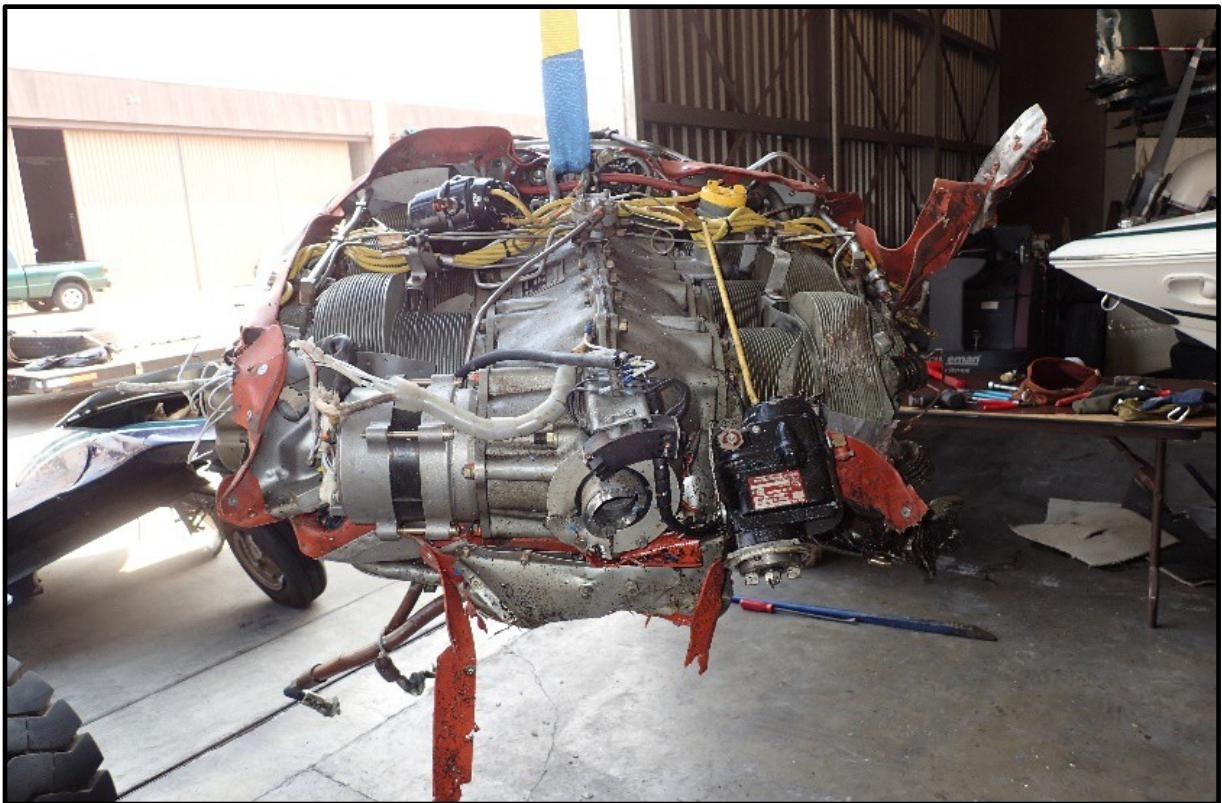
Impact damage was observed to the front, bottom, left side of the engine, and cylinders Nos. 2, 4, and 6 were noted. Cylinder Nos. 4 and 6 rocker box covers were separated. Manual rotation was attempted by using a hand tool but was unable to be accomplished. A borescope inspection of the cylinders revealed normal operational conditions. Both magnetos sustained impact damage and were separated from the engine but remained partially attached to the ignition harness. The magnetos were removed and manually rotated and spark was observed at all leads. The oil sump sustained extensive crush damage. The top spark plugs were removed and exhibited normal wom out wear signatures when compared to the Champion Check-A-Plug comparison chart. The fuel flow divider lines were attached at all cylinder fuel injectors and examination of the fuel nozzles revealed no anomalies. The fuel pump was observed to have impact damage and examination of the pump revealed no anomalies.

The turbocharger remained attached to its respective housing. The turbocharger displayed impact damage and the compressor blades were observed bent.

The three blade, constant speed propeller remained attached to the propeller flange but had separated from the crankshaft. One propeller blade had separated at the hub, and all three blades exhibited impact damage signatures.

Figure 1: Left engine being prepared for examination (Left side).

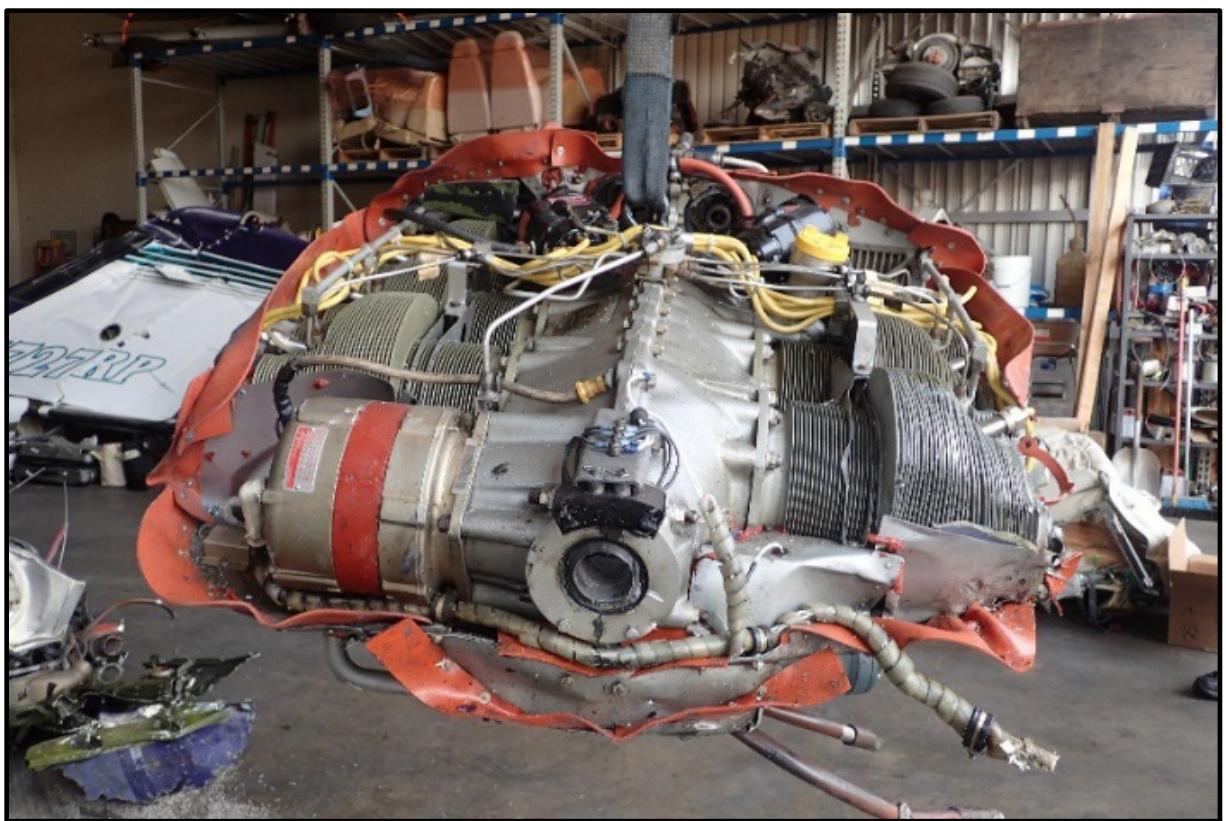
The engine sustained impact damage to the front, left, and bottom portions of the engine. The No. 6 cylinder sustained impact damage. The No. 6 rocker cover was separated. Both magnetos were separated from the engine but remained attached to their respective ignition harness. All spark plugs were removed and exhibited normal worn out wear signatures when compared to the Champion Check-A-Plug comparison chart. The fuel flow dividers lines remained attached at all cylinder fuel injectors. Examination of the fuel pump and fuel nozzles revealed no anomalies.

Both magnetos were manually rotated, and spark was observed at all leads. The turbocharger remained attached to its respective housing. The turbocharger blades were observed bent but no other anomalies were noted during its examination.

The three blade, constant speed propeller remained attached to the propeller flange; however, the propeller flange had separated from the crankshaft. All three blades remained attached to the propeller hub and displayed impact damage signatures.

Figure 2: Right engine being prepared for examination (Top front side).
