National Transportation Safety Board

Memorandum

Date:	November 28, 2018				
To:	Stephen Stein Air Safety Investigator, Western Pacific Region WPR18MA087 Investigator in Charge (IIC)				
From:	John O'Callaghan National Resource Specialist – Aircraft Performance WPR18MA087 Aircraft Performance Specialist				
Subject:	Plots of Appareo Vision 1000 data for May 4, exemplar Papillon flight from KBVU to QMB; testimonies of Papillon pilots re: winds on approach to QMB; Airbus Helicopters yaw control simulations				
References:	 Appareo Vision 1000 electronic data files from May 5, 2018 flight of N836GC from KBVU to Quartermaster Base, provided by Papillon on May 10, 2018.

WPR18MA087: Airbus Helicopters EC-130 B4, N155GC, Peach Springs, AZ, 02/10/2018

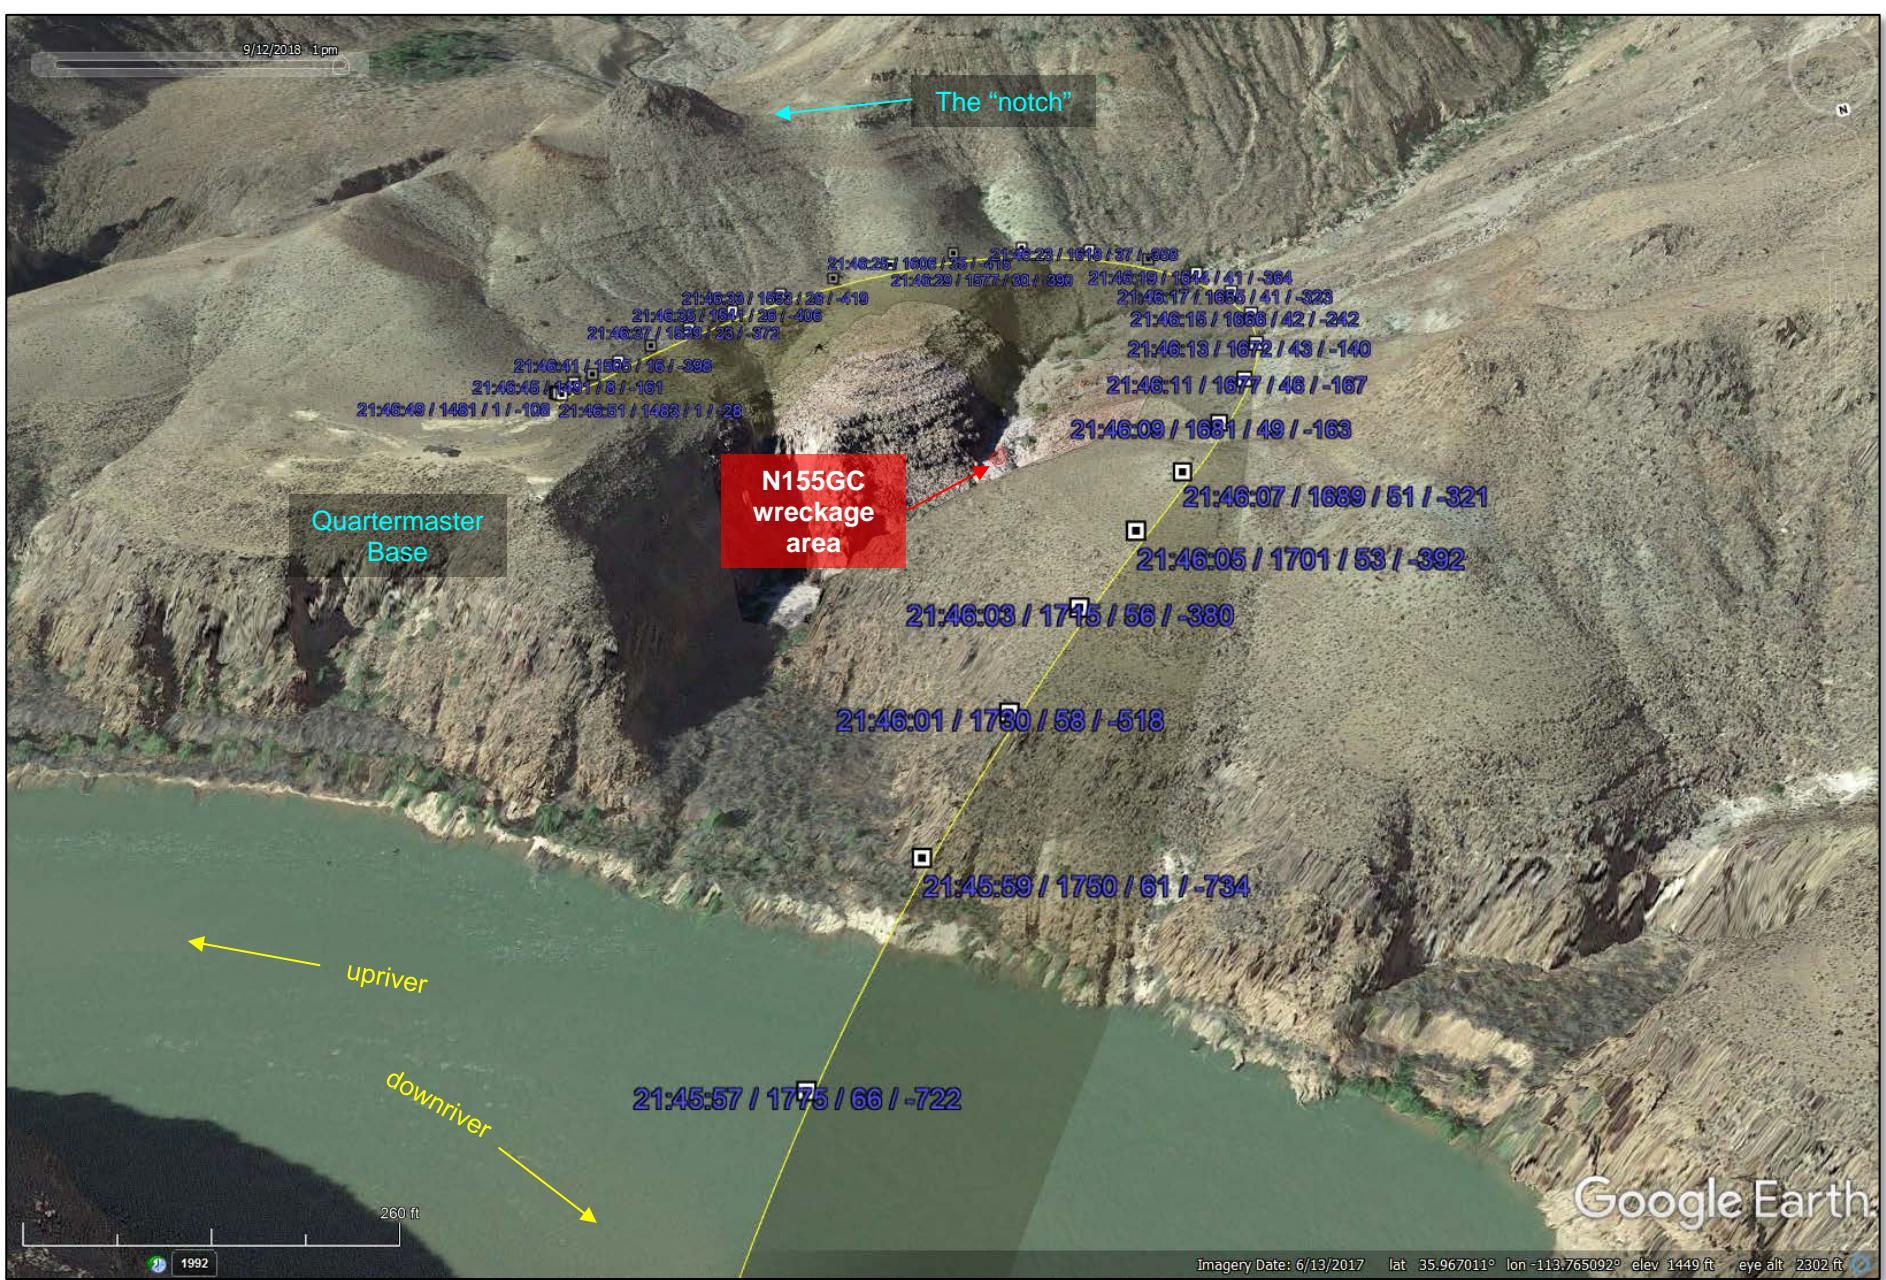
Figure 6. Perspective view of May 4, 2018 exemplar approach into QMB. Data labels are: time (UTC); altitude (ft.); groundspeed (kt.); and rate of climb (ft./min.)

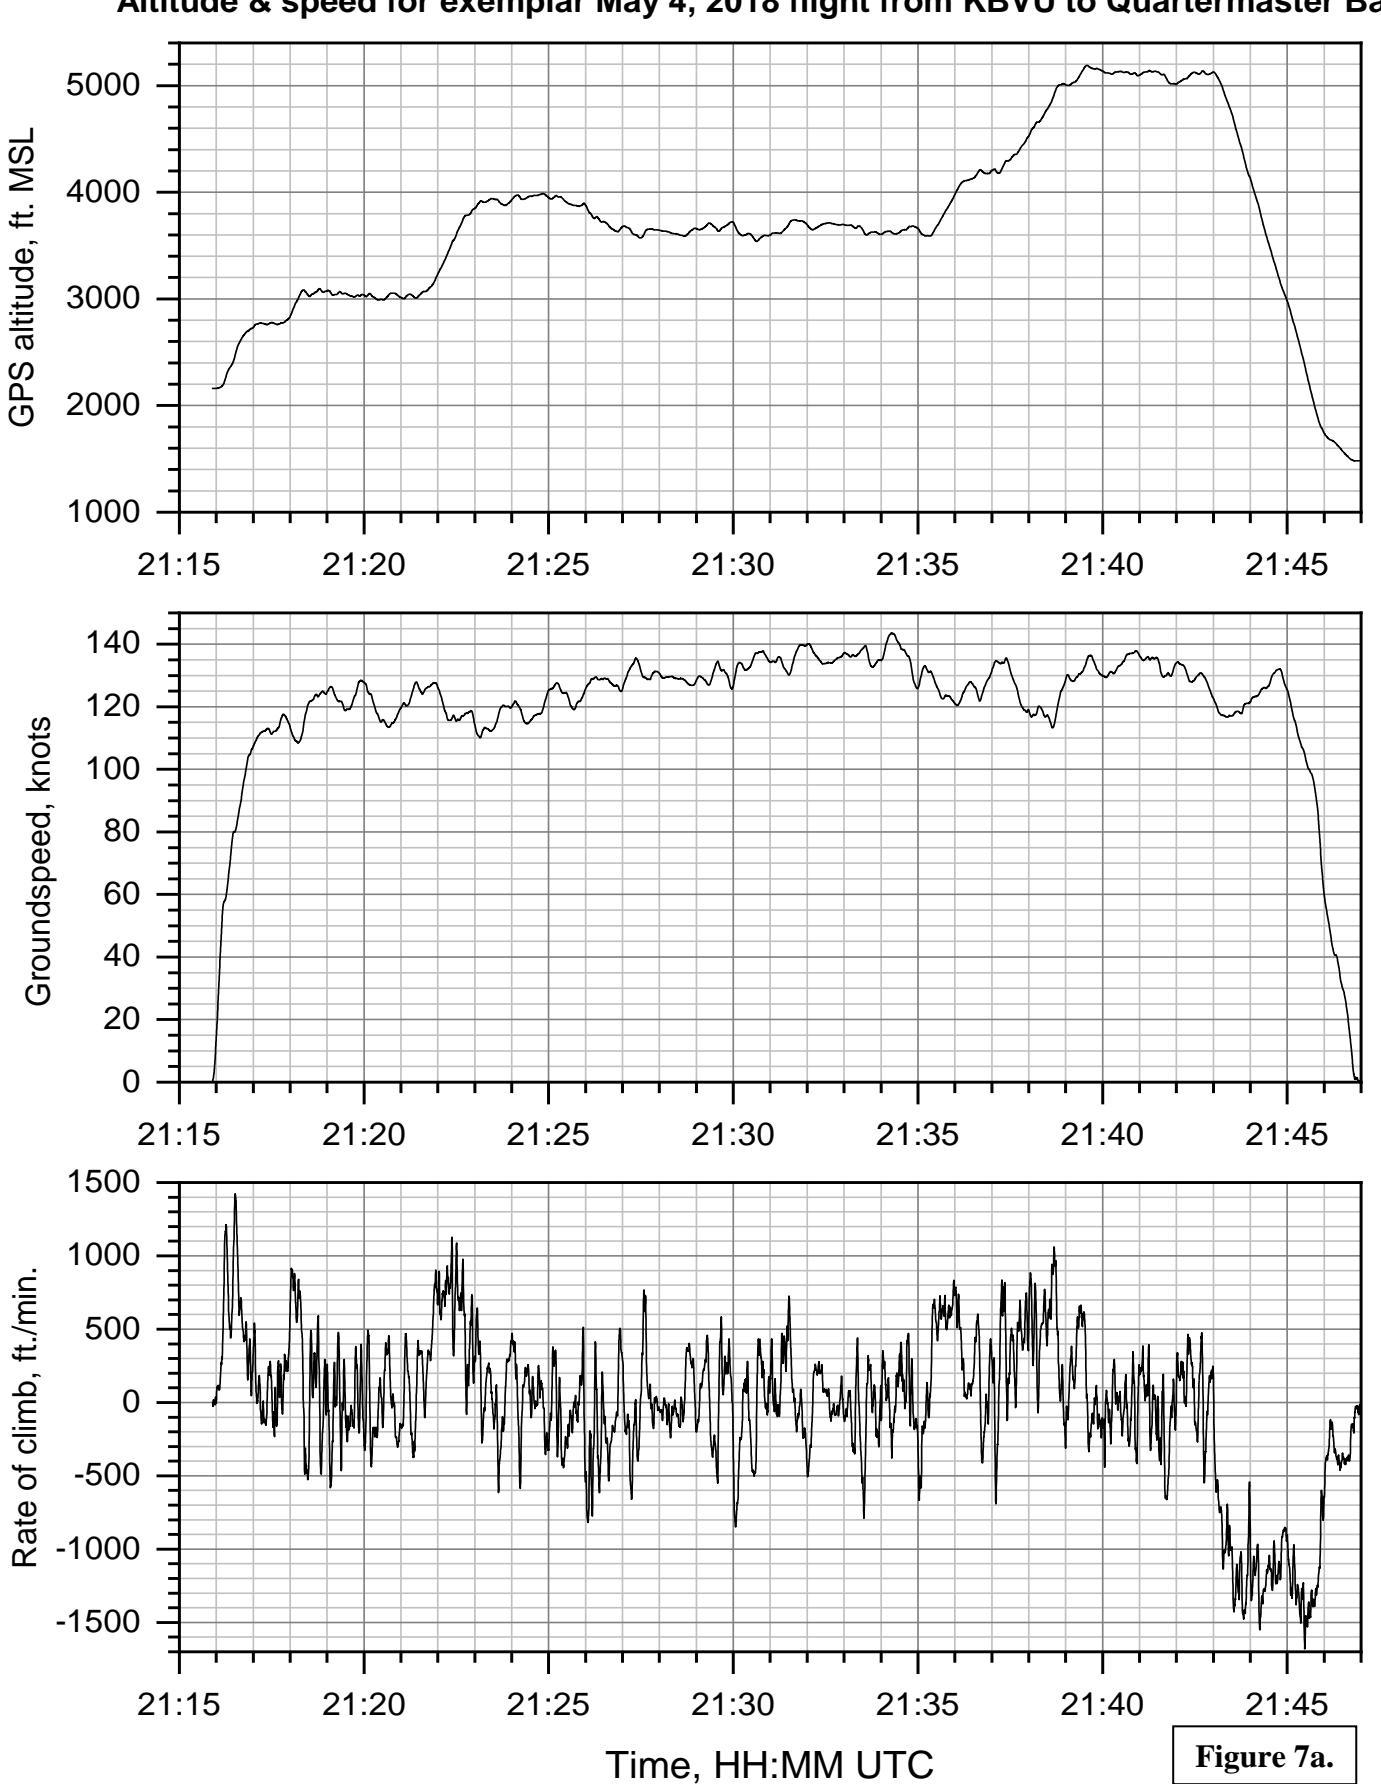
WPR18MA087: Airbus Helicopters EC-130 B4, N155GC, Peach Springs, AZ, 02/10/2018 Altitude & speed for exemplar May 4, 2018 flight from KBVU to Quartermaster Base

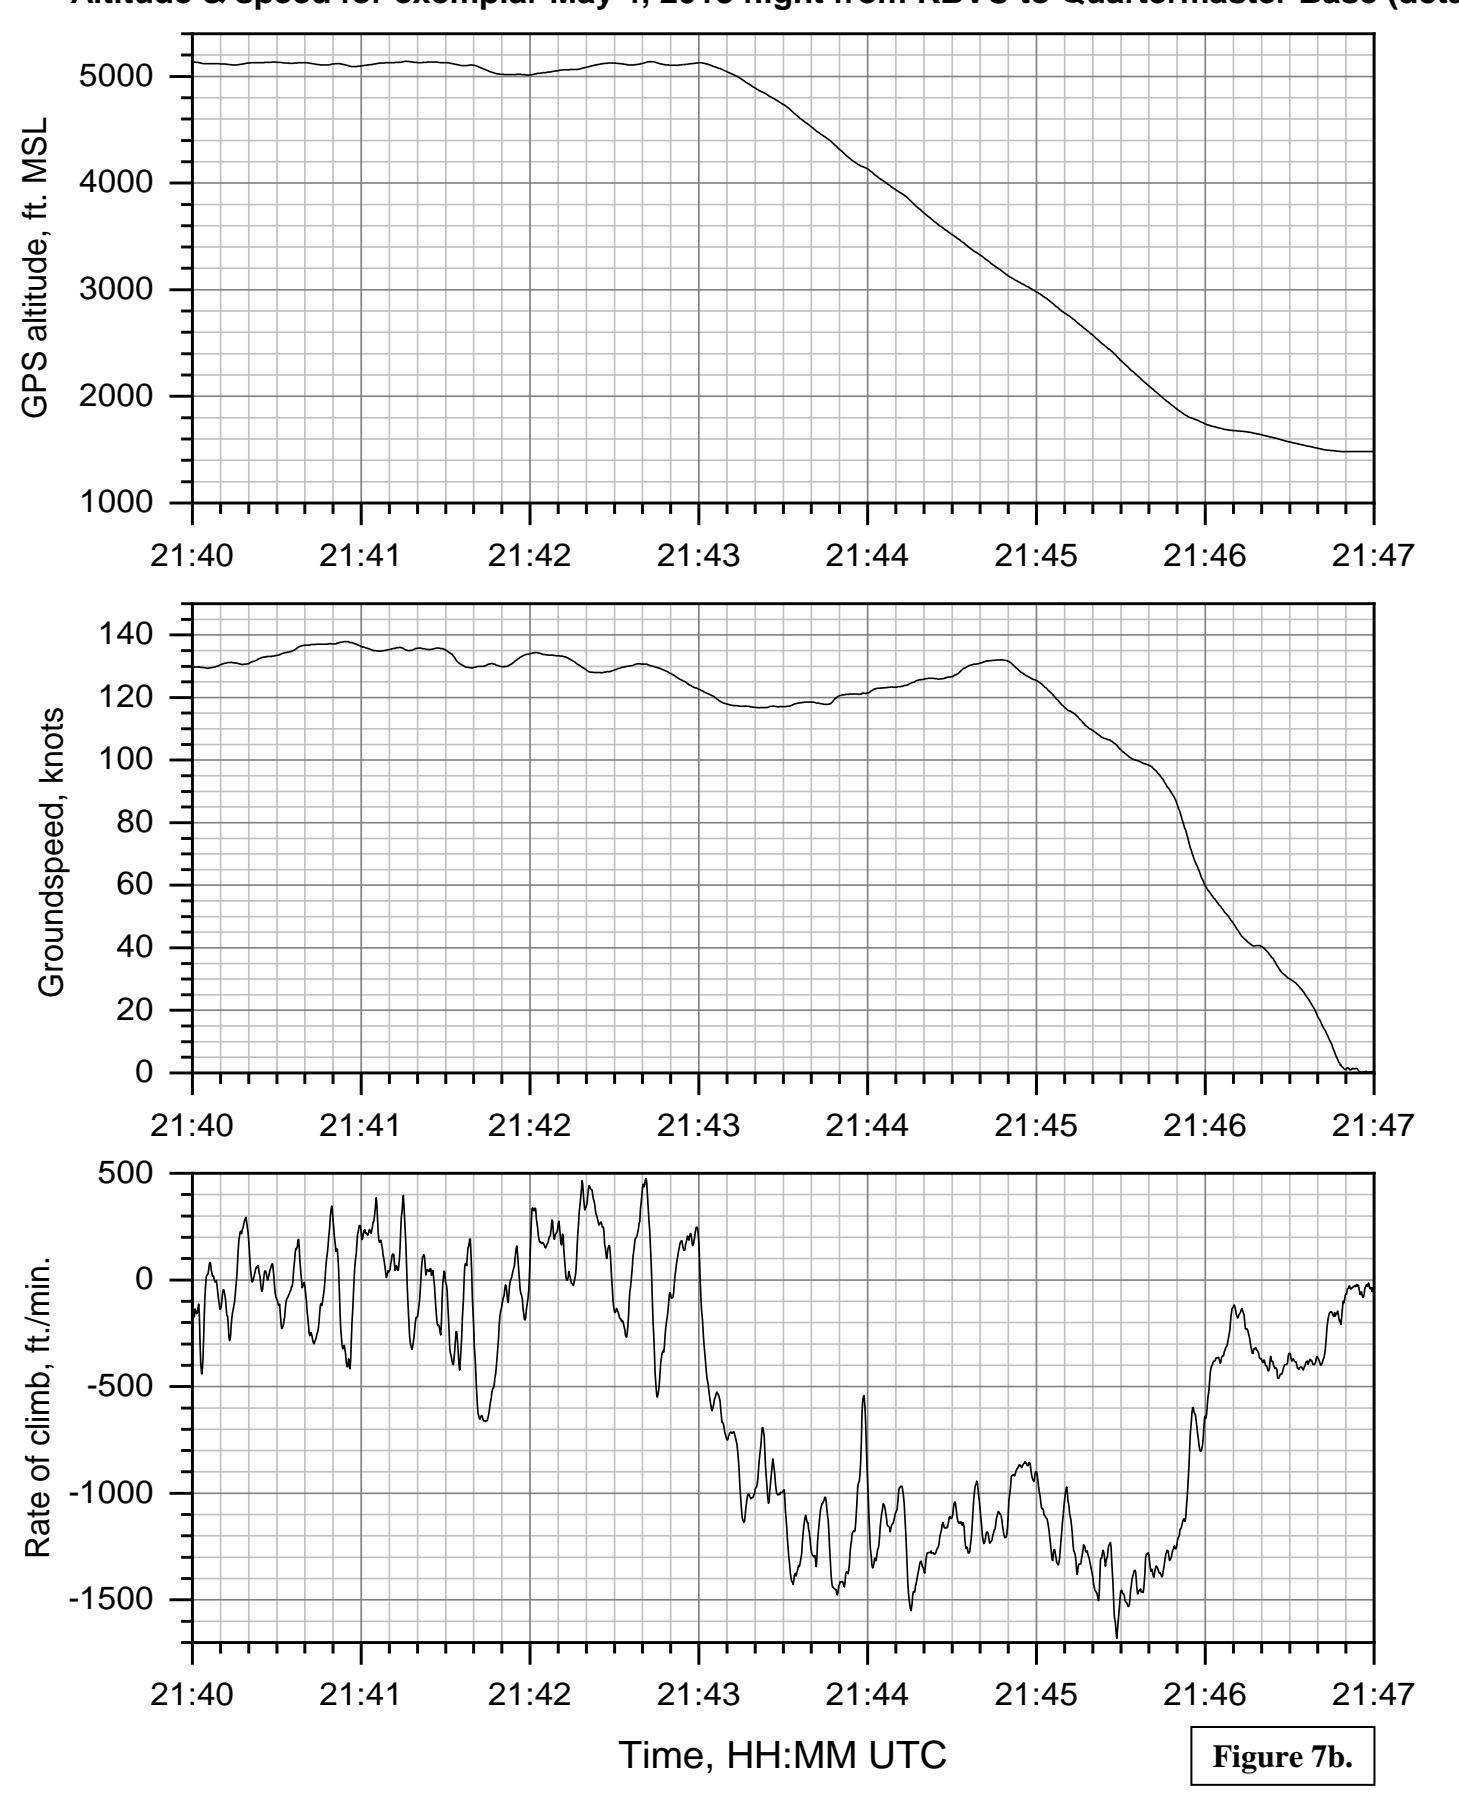
19 WPR18MA087: Airbus Helicopters EC-130 B4, N155GC, Peach Springs, AZ, 02/10/2018 Altitude & speed for exemplar May 4, 2018 flight from KBVU to Quartermaster Base (detail)

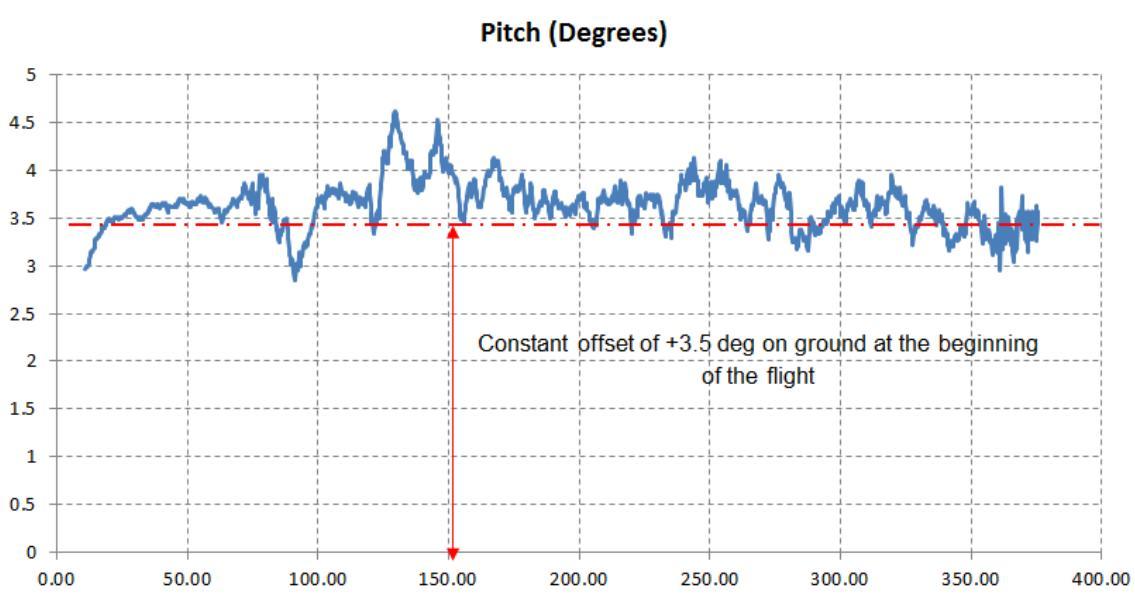
Based on these comparisons, a 3.5° offset in the recorded pitch angle while the aircraft was on the ground was observed. This offset is erroneous, and when removed resulted in a good match between the Vision 1000 and simulation pitch angles. The simulation match of the other recorded parameters was also satisfactory, though a trade-off between matching the recorded Euler angles and matching the recorded trajectory was observed. If the simulation targeted the recorded Euler angles, the match of the Euler angles was very good (per design), but the match of the trajectory was not as good. If the trajectory was targeted, then the match of the trajectory was very good, but the match of the Euler angles deteriorated (see pages 11-12 of Reference 9). These observations are likely partly the result of imperfections in the simulation model itself, but can also be the result of uncertainties in the winds at the time (the simulations of the May 4 flight assumed a constant wind from the north at 4 knots). Nonetheless, the simulations of the May 4 flight matched the recorded data well enough to conclude that the simulation was the best tool for examining the controllability margins of the helicopter in various wind conditions for the accident flight.

The offset observed has been corrected for comparisons with simulation
