Date of Accident:	February, 3, 2019
Location:	Yorba Linda, CA
NTSB File No.:	WPR19FA079
Aircraft:	Cessna 414A
Registration No.:	N414RS
Serial No.:	414A0821 (Year of Manufacture 1982)
Operator:	(Per registration certificate found in aircraft, FAA database indicates registration not valid) AIR 20 CORP Gardenville, NV 89410-7327
Written by:	Les Doud - Air Safety Investigator
Report Date:	March 11, 2019
Contents:PagePropeller Examination Report2Accident Synopsis2Summary and Analysis of Findings3Conclusions4General Information7Propeller Examination Factual Findings8Left Propeller8Right Propeller22Photo List37

PROPELLER EXAMINATION REPORT

Date of Examination:	February 6-8, 2019	
Location:	Air Transport	
	Phoenix, AZ 85034	
Propeller Model(s):	PHC-C3YF-2UF w	ith FC7693DFB blades
Representatives:	Les Doud Maja Smith Eliott Simpson Ricardo Asensio	Hartzell Propeller Inc. ASI NTSB Investigator in Charge NTSB Sr. Air Safety Investigator Textron Air Safety Investigator

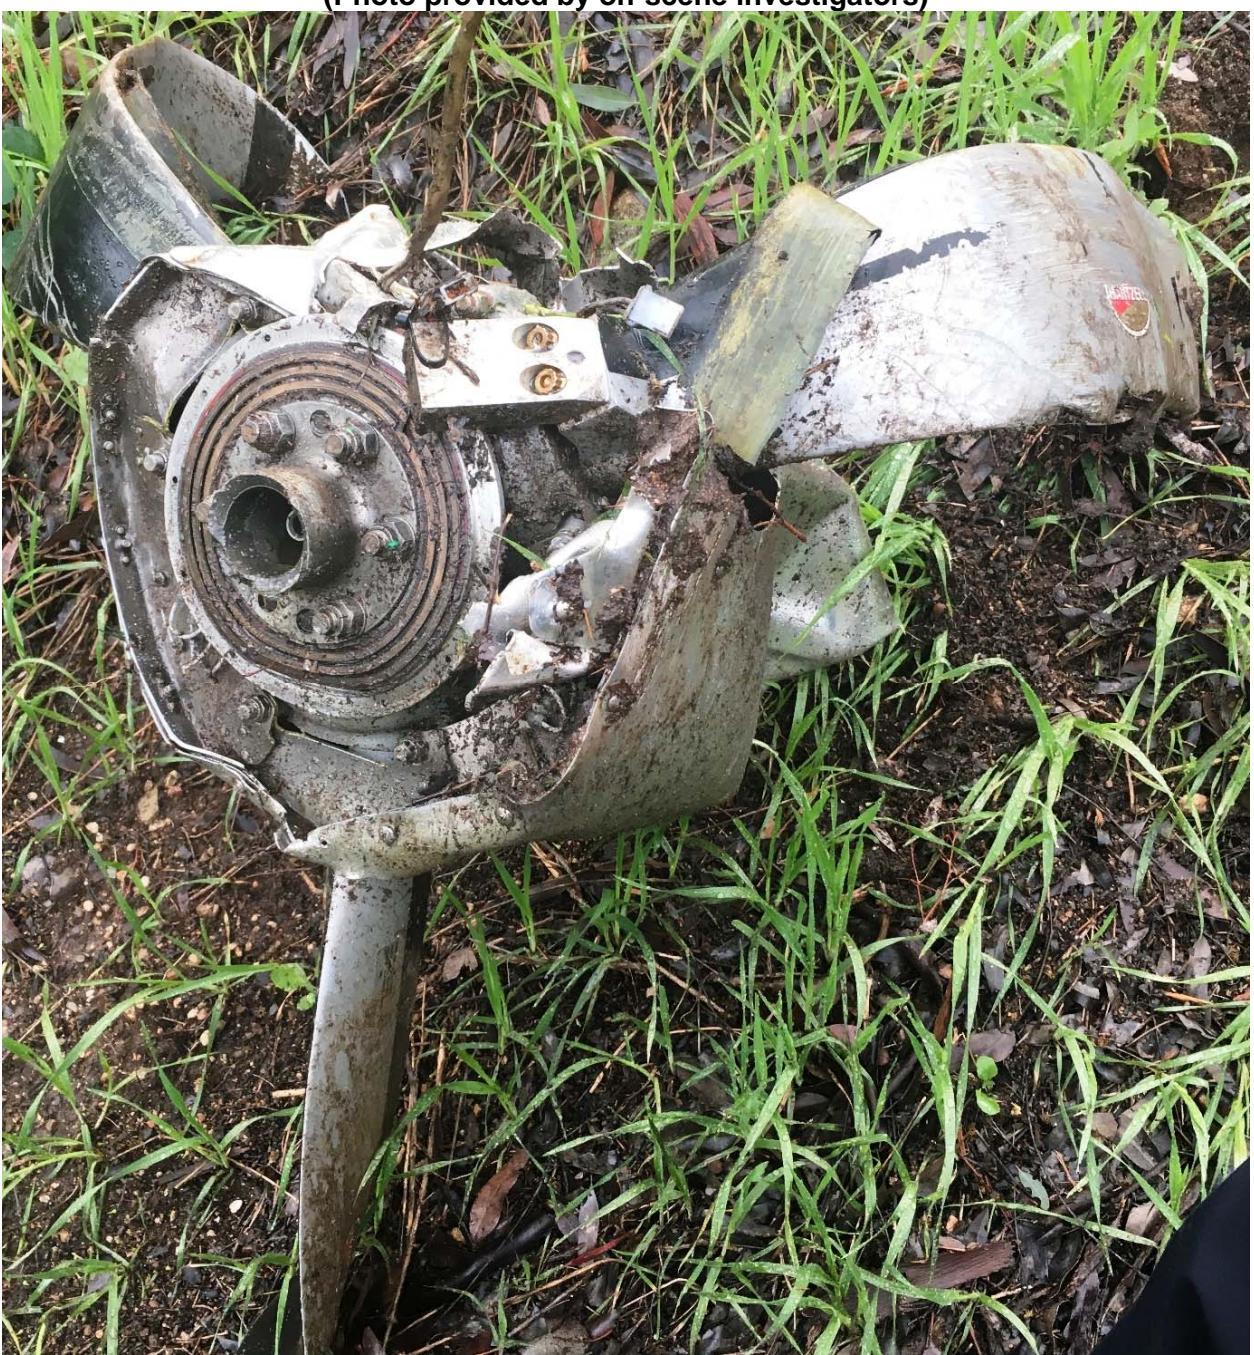
As Received Condition: The left propeller fractured-separated from the engine during the impact sequence and was found lodged into the soil behind the residence at 19912 Canyon Dr. (near where fuselage came to rest) as shown in Photo #1. The propeller was presented for examination as shown in Photo #2. The spinner dome was crushed and torn but remained attached to the propeller assembly. The engine crankshaft fractured behind the flange which remained attached to the propeller; one of the six studs fracture-separated and was missing. All three blades remained attached to the propeller assembly. Blade L1 had a large wave-bend in the mid-blade area and was at a high pitch, almost feathered position. Blade L2 was bent aft and rotated in the high pitch direction approximately 180° from a normal operating position; it was beyond the feather stop and the counterweight was on the aft side the propeller assembly. Blades L3 was bent forward and in a normal operating blade angle range. Blades L2 and L3 rotated by hand force suggesting fractured pitch change knobs. There was distinguishable chordwise/rotational scoring on the camber side of blade L1. Blades L2 and L3 exhibited some chordwise/rotational scrapes on the face side. There were varying degrees of dents, gouges and tears in the trailing edges of all three blades. The propeller had various amounts of dirt and vegetation in and around the hub including pine needles. leaves, grass and wood pulp. Photo #3 shows the propeller with the spinner dome removed prior to disassembly.

Photo #1 – Left propeller in-situ (Photo provided by on-scene investigators)

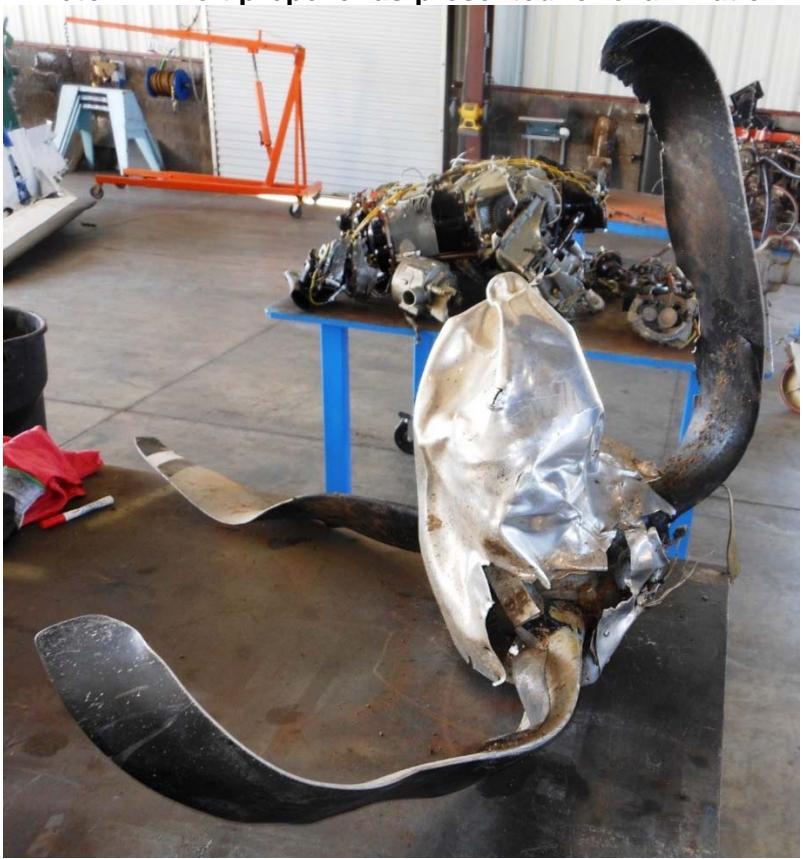
Photo #2 – Left propeller as-presented for examination

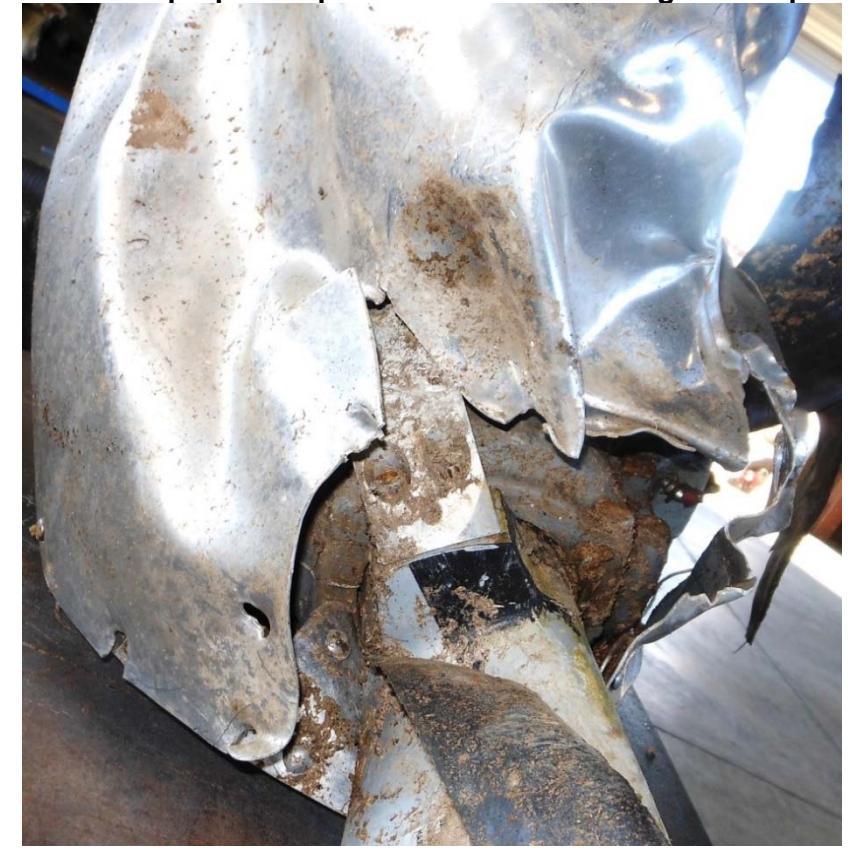
Spinner Dome: The spinner dome was crushed and torn with no remarkable spiral deformation. There was a counterweight cut/puncture/impression at the L3 blade position with an angle of approximately 25-27° (Photo #4). This equates to a blade angle of approximately of 13° which corresponds to the low pitch stop position. The forward bulkhead debonded and was found loose inside the dome.

Photo #4 – Left propeller spinner dome counterweight mark/puncture

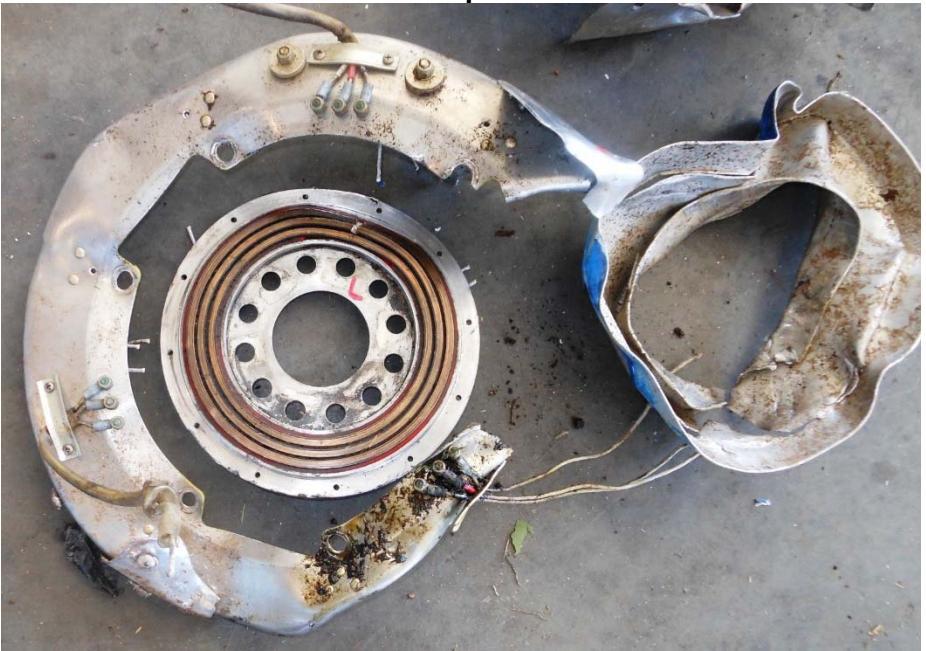
Spinner Bulkhead: The spinner bulkhead was bent and torn. The de-ice slip ring remained intact but bent and gouged adjacent to the L1 blade arm (Photo #5).

Photo #5 – Left spinner bulkhead

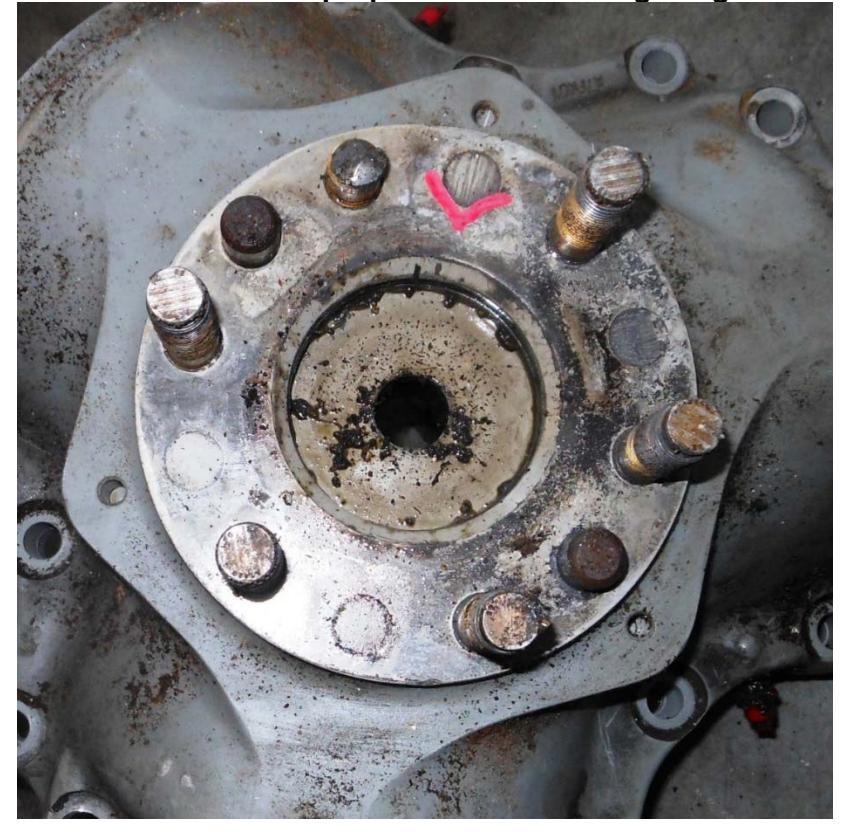
Engine/Propeller Mounting: The crankshaft flange remained attached to the propeller flange and one of the six mounting studs was fracture-separated; the remaining five studs/nuts were tight. The mounting flange appeared intact and there were no indications of fretting/galling on the mating surfaces (Photo #6). The crankshaft flange fracture is shown in Photo #7.

Photo #6 – Left propeller/hub mounting flange

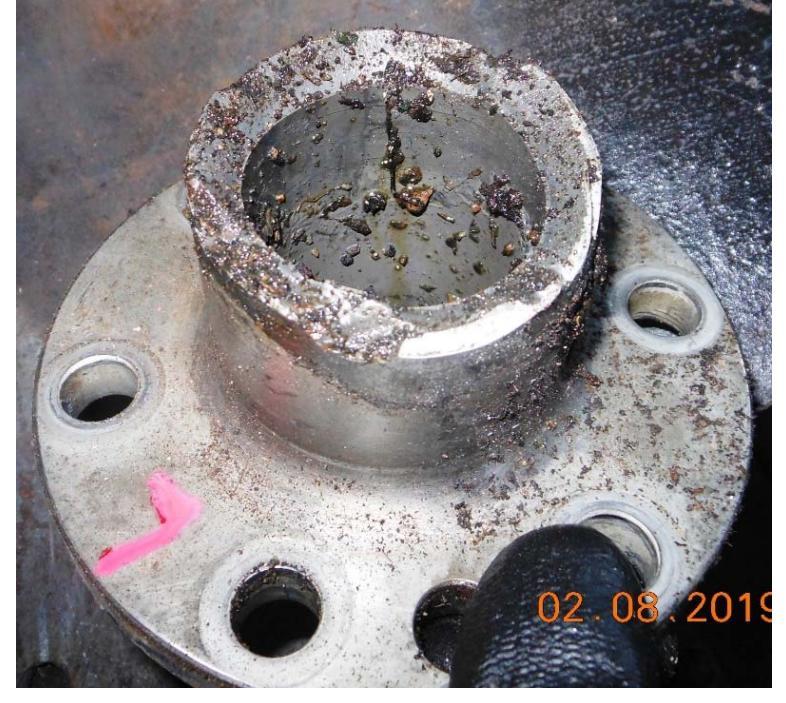
Photo #7 – Left crankshaft fracture surface

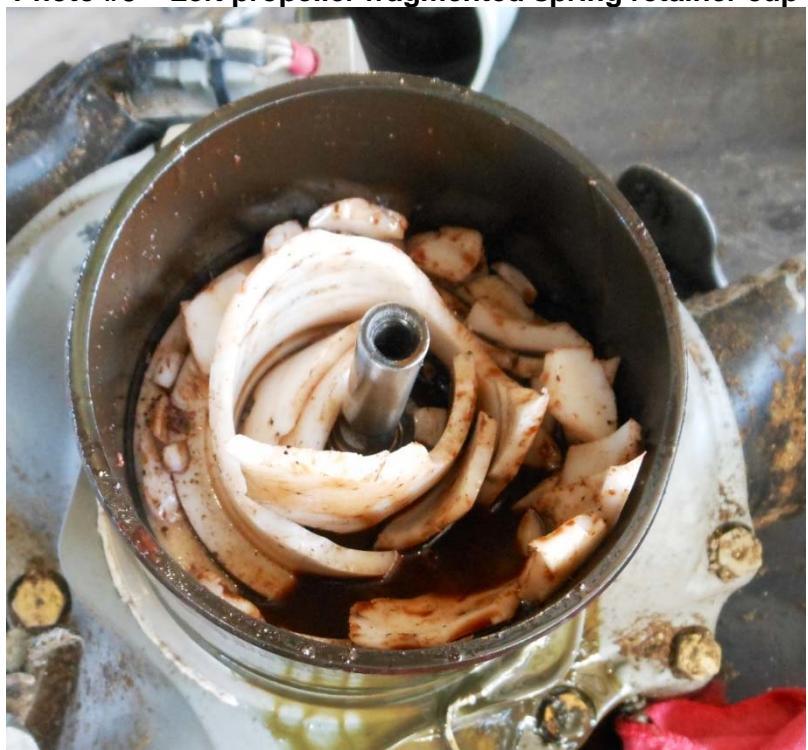
The cylinder was intact with a dent on one side with no apparent oil leaks at the attachment or into the hub. When the cylinder was removed, oil was present on the pressure side of the piston with no evidence of leakage past the piston or into the hub. The feathering spring retainer cup was shattered with many small fragments in the air chamber of the cylinder (Photo #8).

Photo #8 – Left propeller fragmented spring retainer cup

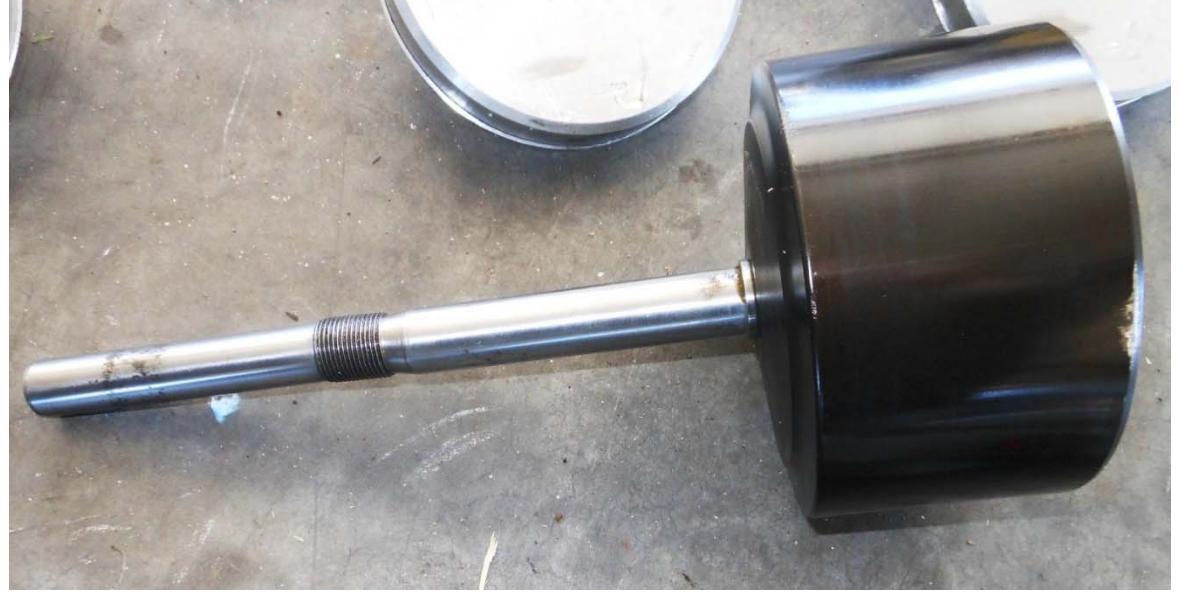
The piston was intact with a dent adjacent to the location of the dent in the cylinder. The pitch change rod was intact but bent in the area that threads into the fork (Photo #9). The fork had one forward tank fractured due to forceful rotation of the blade in the low pitch direction (Photo #12).

Photo #9 – Left propeller piston and pitch change rod

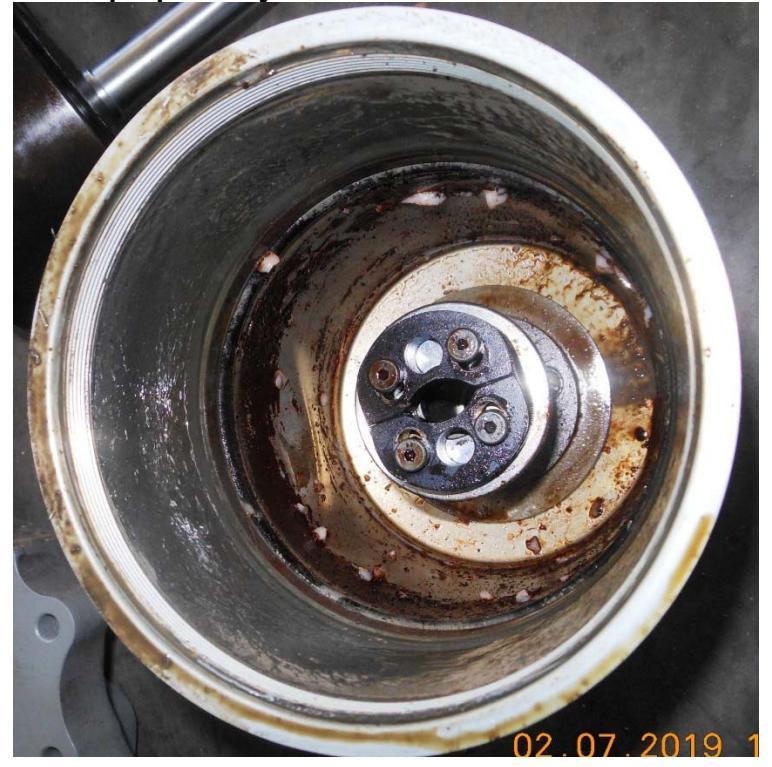
The start lock assembly appeared intact and undamaged (Photo #10). When removing the low pitch stop it appeared the pitch change rod was at a position higher/past than the start lock. The low pitch stop had normal contact wear with no apparent forceful impact with the pitch change rod (Photo #11). The start lock sleeve and feathering stop appeared intact and undamaged. The feathering spring and forward spring guide appeared intact and undamaged.

Photo #10 - Left propeller cylinder internal surface and start lock weights

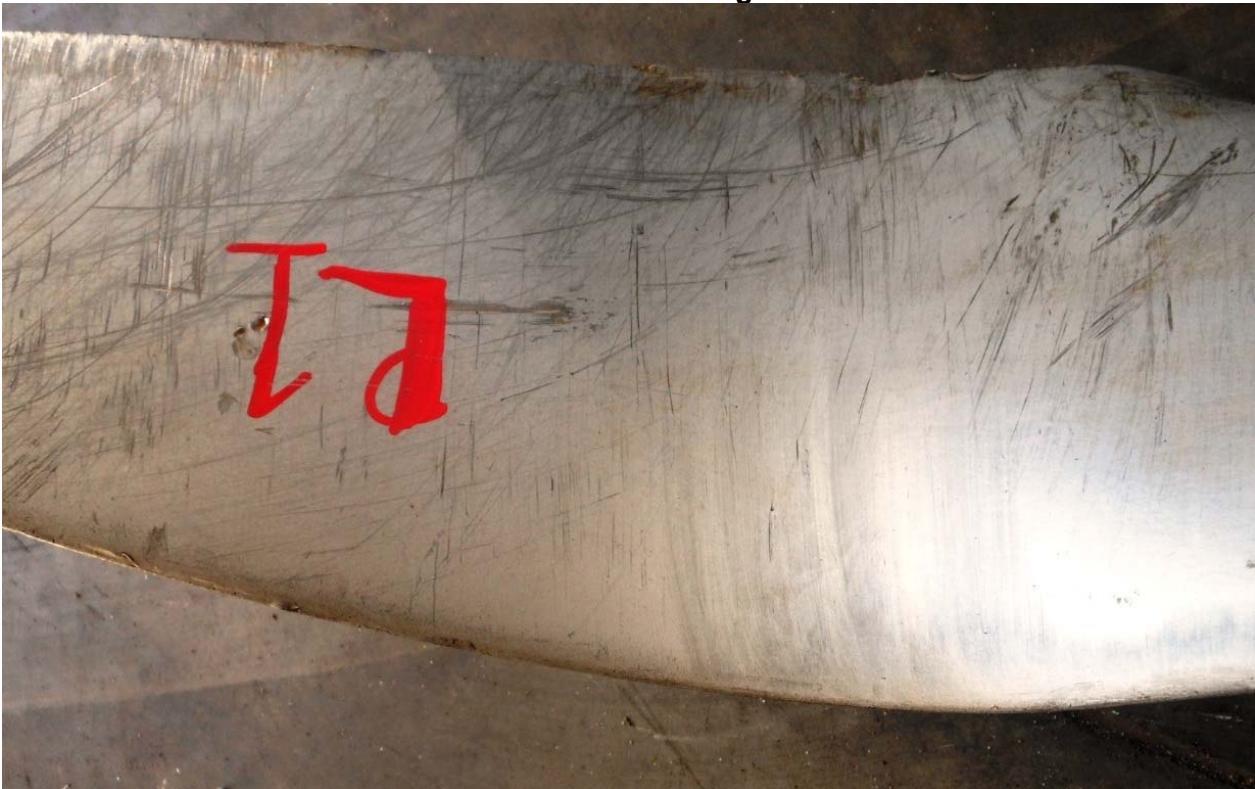
Photo #20 – L1 chordwise/rotational scoring in mid-blade camber-side

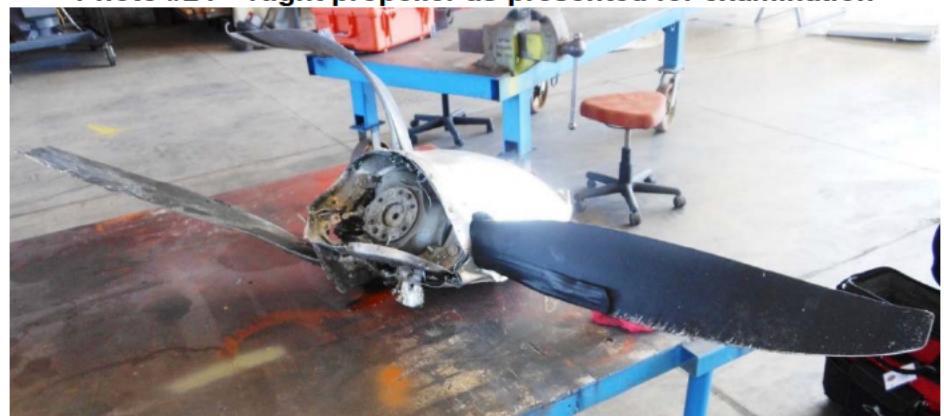
Photo #24 - Right propeller as-presented for examination

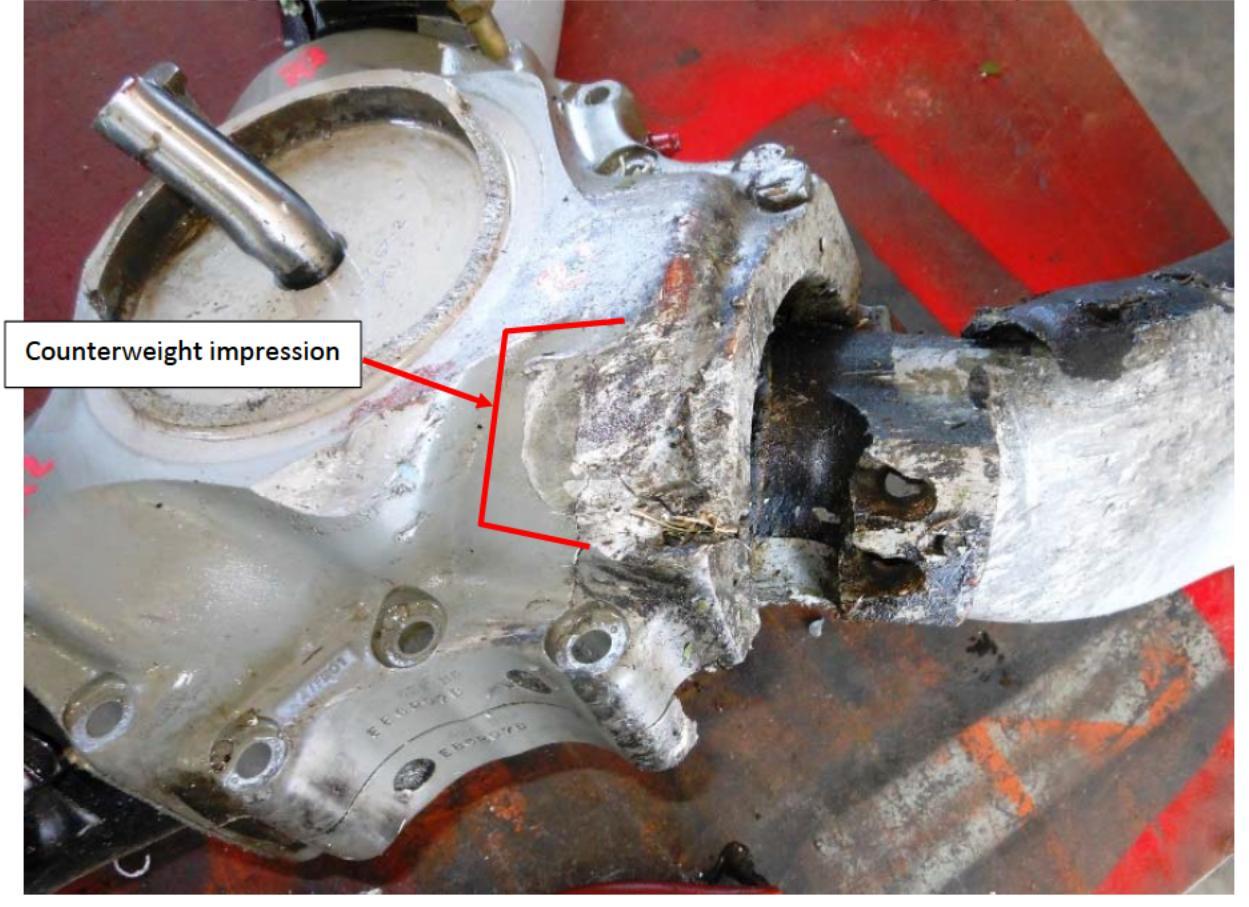
As Received Condition: The right propeller fractured-separated from the engine during the impact sequence and was found in the residential driveway of 19761 Crestknoll Drive as shown in Photo #22. The propeller and engine initially impacted the asphalt street in front of this address and left impact marks corresponding to one blade edge and spinner/cylinder dome shape (Photo #21). The propeller was presented for examination as shown in Photos #23 and #24. The propeller mounting studs were pulled from the hub and all six studs/nuts remained in the crankshaft flange. The spinner dome was flattened on one side only, consistent with the impact marks in the asphalt. R1 and R3 blades rotated in the hub by hand force indicating fractured pitch change knobs. Blade R1 was bent aft, the tip was fractured and the aft hub pocket wall was fractured and the blade bearings were missing. Blade R2 had little remarkable bending and twisting; only leading edge damage. Blade R3 was bent forward. There was a distinct counterweight puncture in the spinner dome at blade R1 (Photo #25).

Photo #25 – Right propeller spinner dome removed, counterweight impression at R1

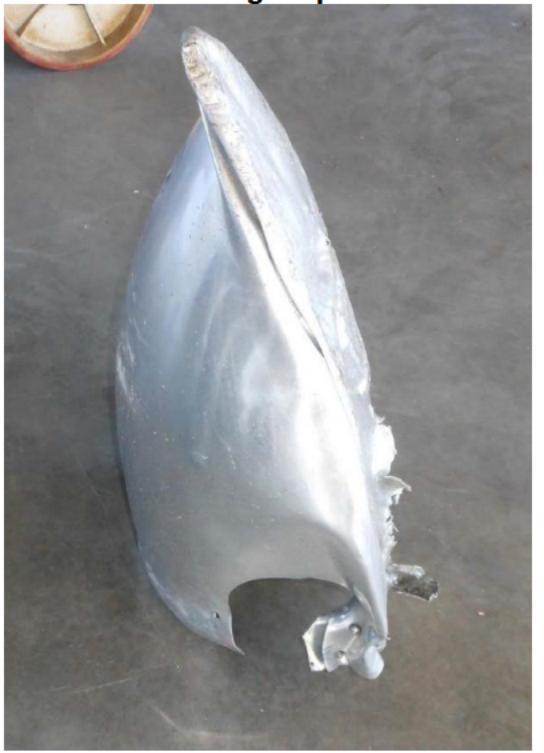
Spinner Dome: The spinner dome crushed on one side only with no remarkable rotational scoring or deformation (Photo #26). There was a distinct counterweight puncture mark at the R1 blade position at approximately 32° (Photo #27). This equates to a blade angle of approximately of 19°. There were also counterweight scuff marks on the internal surface at blade R2 and R3 positions between a low pitch position and a feather position (Photo #28).

Photo #26 – Right spinner dome

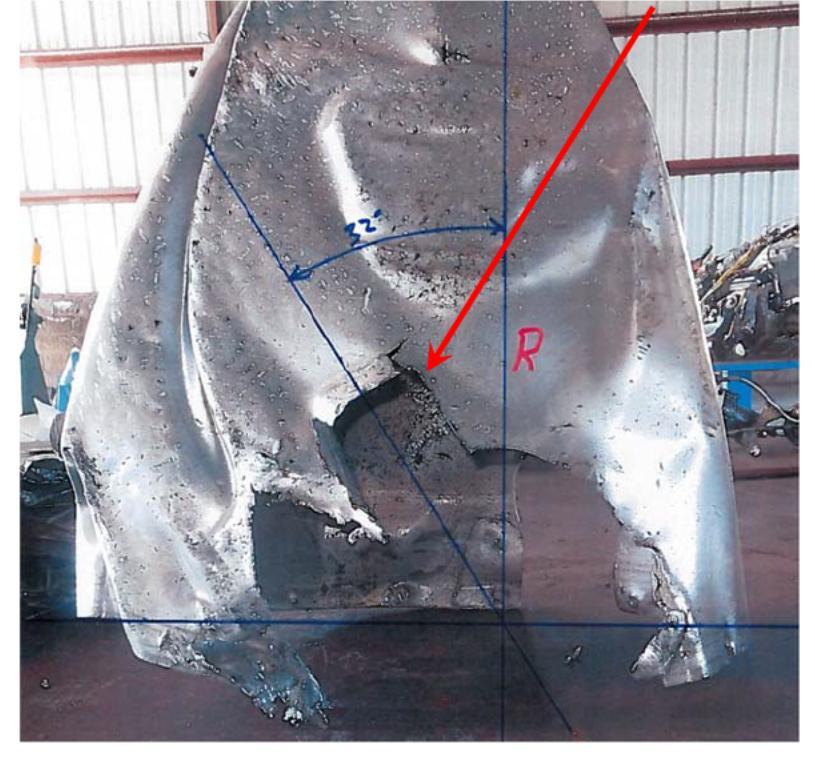
Photo #27 – Right spinner dome, counterweight puncture at R1

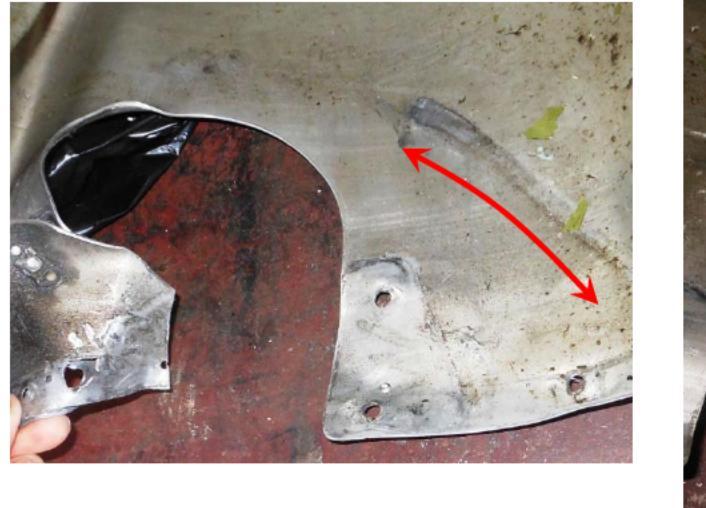
Photo #28 – R2 and R3 counterweight scrape marks on inside of spinner dome

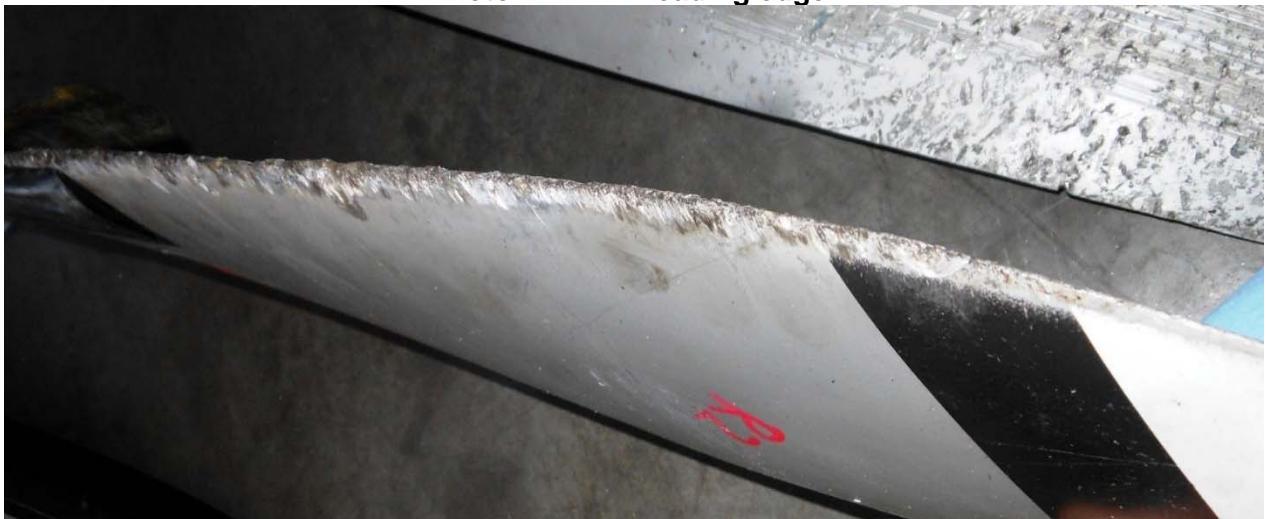
Blade II I LE	
Camber side	Random scratches
Face side	Not remarkable
Bend	Not remarkable
Twist	Not remarkable
Lead edge damage	Gouges and nicks consistent with asphalt strike
Trail edge damage	Not remarkable
Knob condition	Fracture-separated from blade, loose in hub cavity. Block fractured.
	Fracture appears shear/overload.
Counterweight	Intact and removed to facilitate disassembly
Blade bearings	Intact
Butt/shank impact	Not remarkable
marks	
De-Ice boot	Cut along leading edge

Photo #42 – R2 leading edge

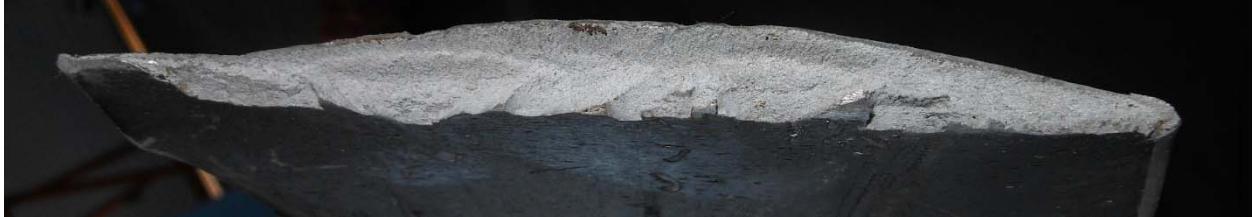
Blade # R1 – Approximately 6" of tip fractured and not recovered from accident site

Photo #43 - R1 tip fracture

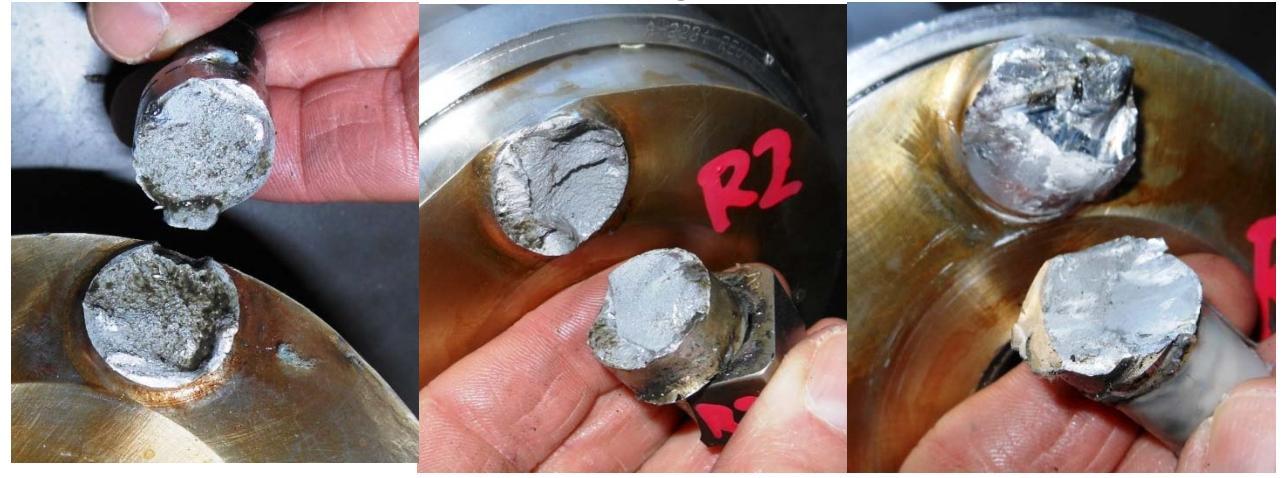
Photo #44 – Pitch change knob fractures
