NTSB File No. WPR19FA079 Cessna 414A N414RS, Yorba Linda, CA 2/3/19

Hartzell Engine Technologies Turbocharger Examination Field Notes

Turbocharger Examination

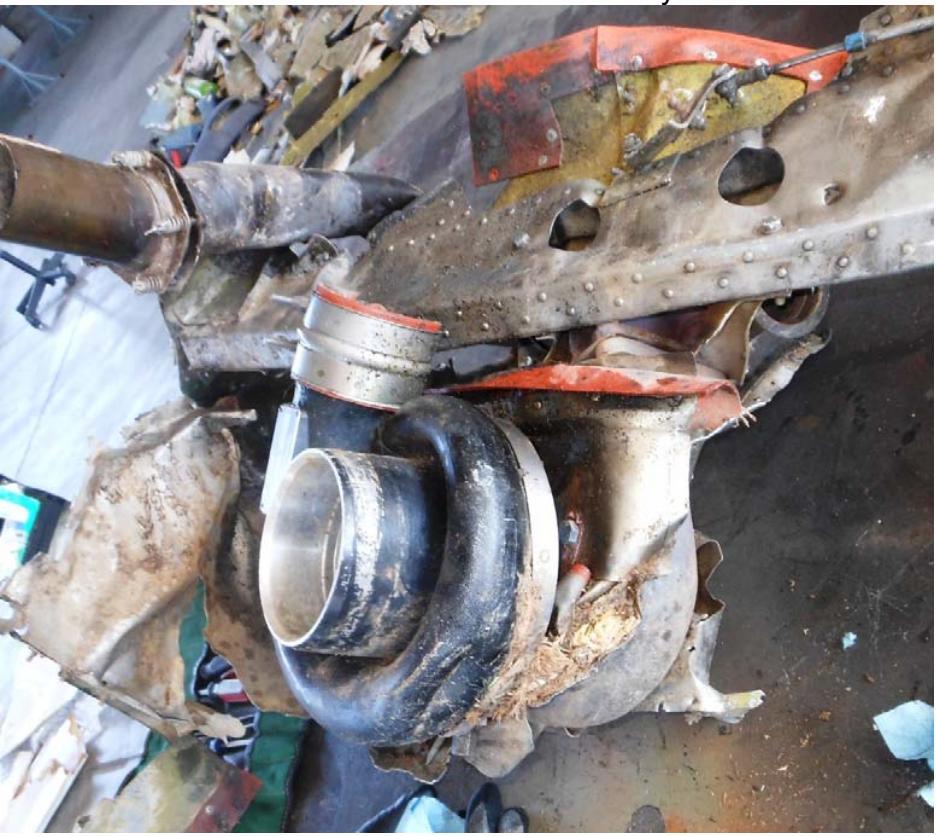
Photo #1 – Left turbo assembly

The left turbocharger remained mostly intact and attached to the turbine inlet exhaust duct and some aircraft structure (Photo #1).

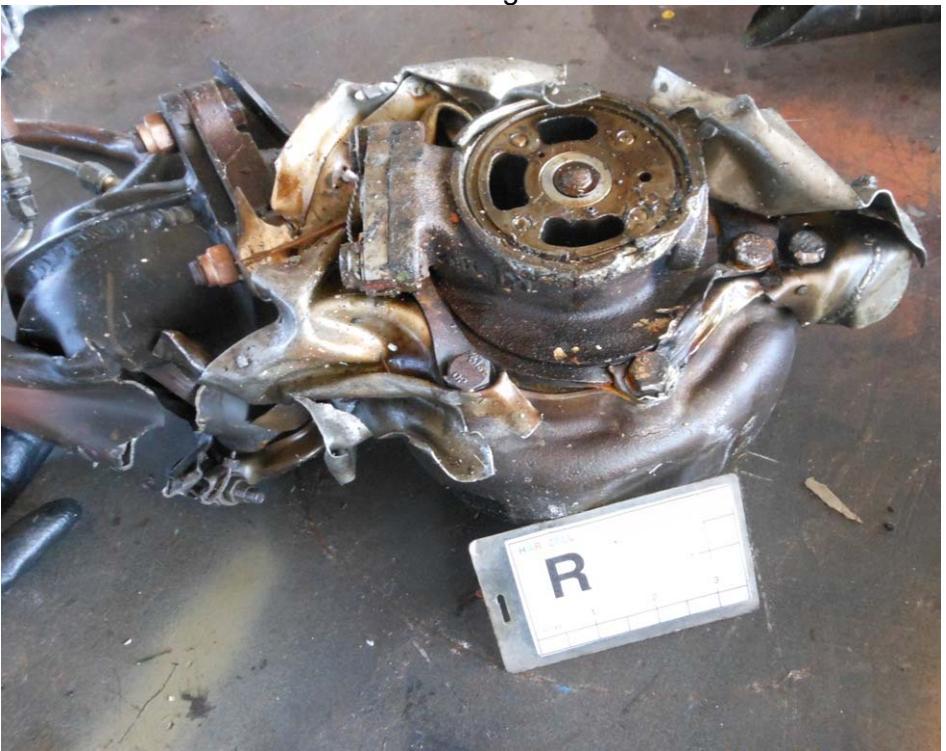
Photo #2 – Right turbo

The right turbocharger fractured into several pieces during the impact sequence (Photo #2). The main components were the turbine and center housings still connected to each other, the compressor housing that separated and the compressor wheel that fracture-separated with the forward end of the shaft still attached. The turbocharger data tag was found in the debris recovered at the crash scene.

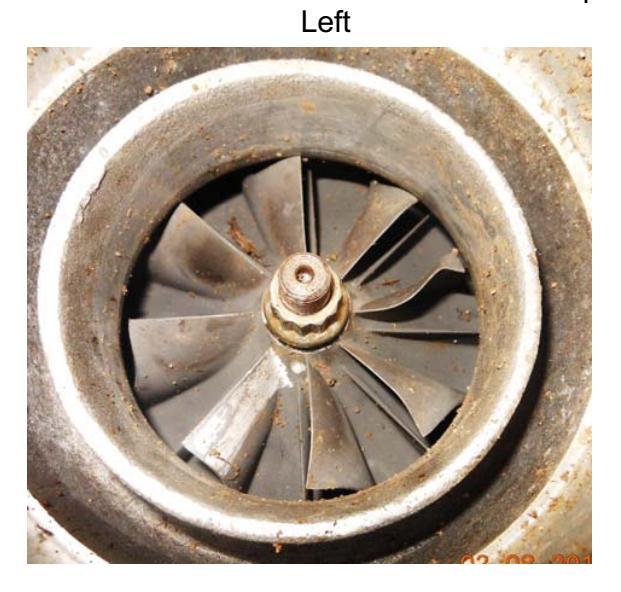
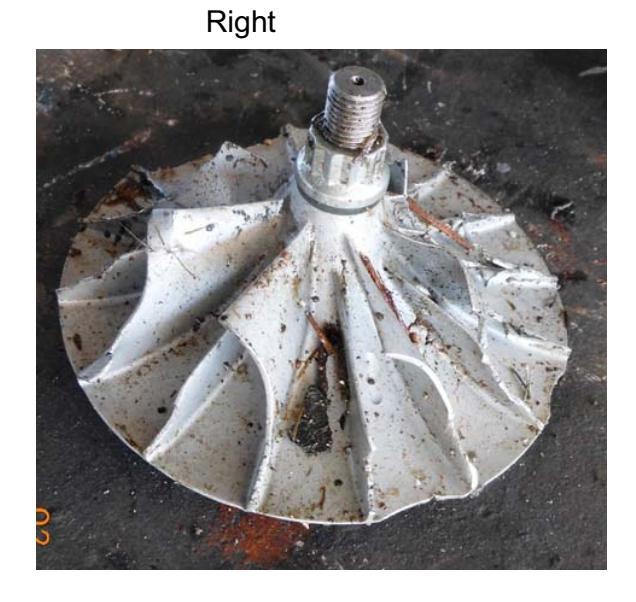
Photo #3 – Compressor inlet/wheels

- 3. Balance cuts were present on the turbine wheel hub of each turbocharger.
- 4. There was some evidence of compressor wheel contact/rub on both turbochargers; the compressor housing had light rub marks and there was evidence of light rub on some compressor blade tips.

- 6. Both compressor wheel nuts were present.
- 7. There was NO visible FOD damage on either the compressor or turbine side on both turbochargers.
- 8. There was NO excessive exhaust build-up on the turbine housing walls or wheel surfaces of either turbocharger.

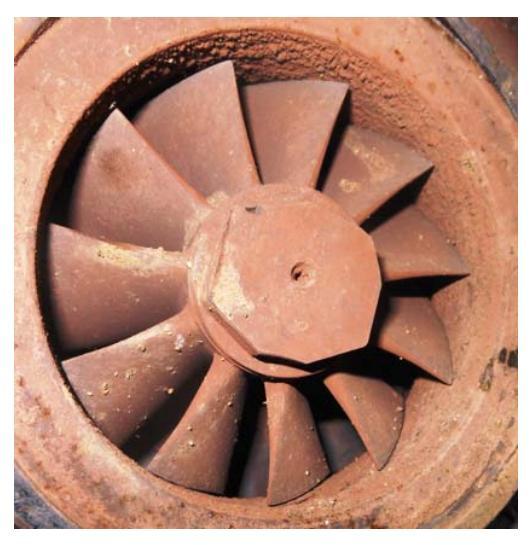
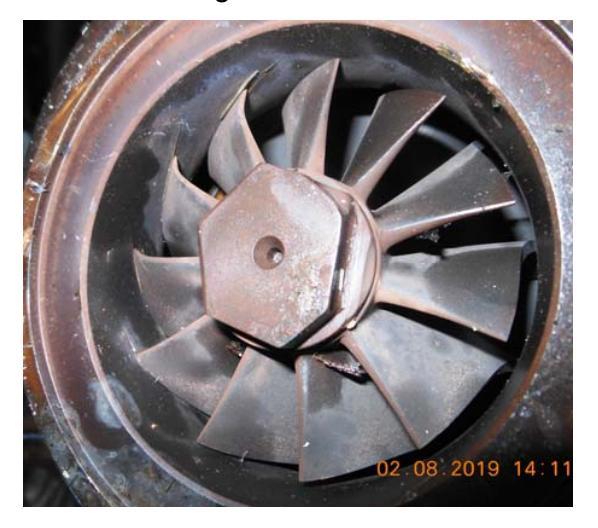
Photo #4 –Turbine exit/wheels

- 1. Both turbo chargers had fractured compressor backplates (right was fractureseparated, left was cracked around the mounting circumference).
- 2. The left turbo rotor group was intact; turbine and compressor rotated together by light finger force. Blade clearances varied on both the compressor and turbine housings. There appeared to be light rub indications in the compressor housings and the compressor blades appeared to have a bur opposite rotation on the tips. The right rotor was not intact. The right compressor wheel fracture-separated from the assembly where the shaft exits the center housing. The turbine housing had dislodged from the center housing and was impinging on the turbine wheel; it could not be rotated. Some turbine blades contacted the turbine housing and appeared to "plow" material in the direction of rotation.

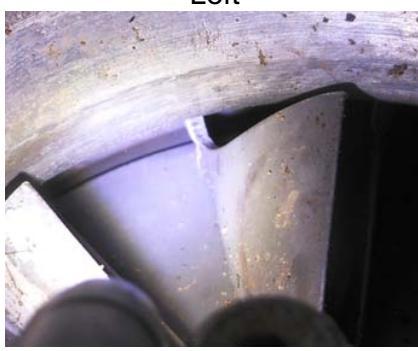
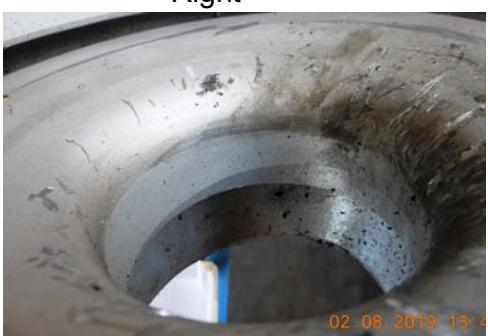
- 5. There were also what appeared to be stationary blade impact marks on the right compressor housing. Both compressor wheels had blade impact damage indicating contact with the housing.

Photo #5 – Compressor housing rub and wheel impact marks Left Right

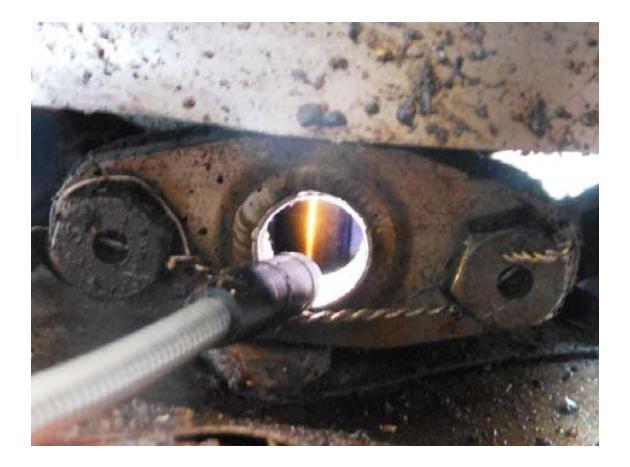
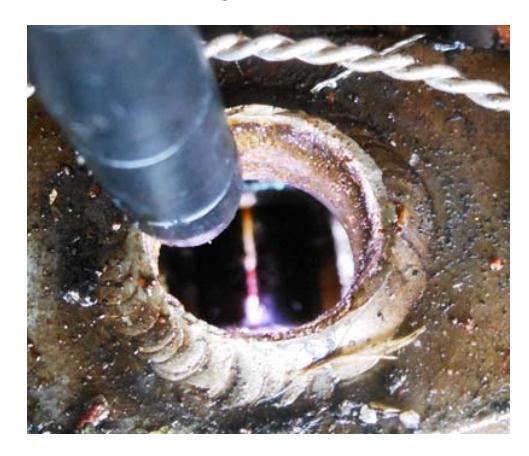
- 10. When viewing the internal cavity of the Center Housings after disassembly, the following was observed:
 - a. There was evidence of sufficient oil/lubrication

- b. There was NO evidence of coking
 - c. There was NO evidence of excessive heat.
 - d. There was NO evidence of FOD in the oil prior to impact with terrain.

- e. There was NO evidence of lubrication blockage prior to impact with terrain and all oil passages and radial holes were clear.

Photo #6 – Center housing internal condition Left Right

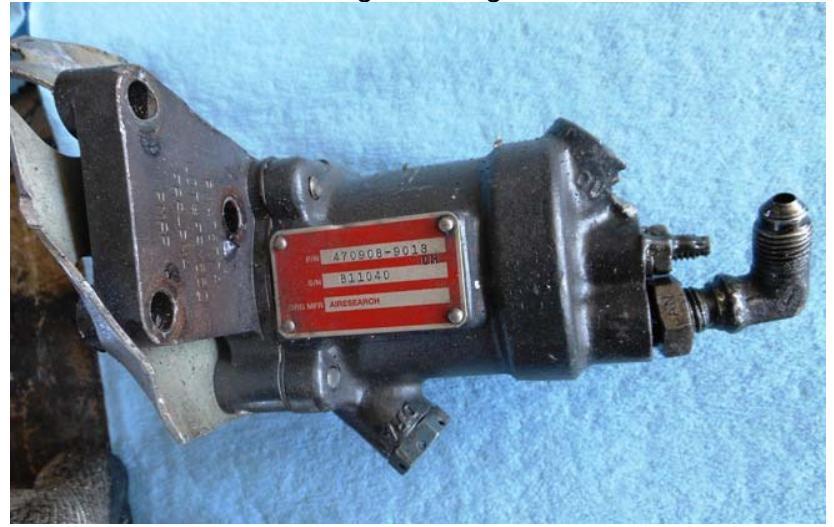
Photo #7 – Right wastegate actuator

The right wastegate actuator was fracture-separated from the wastegate assembly and one of the fitting ports was fractured.

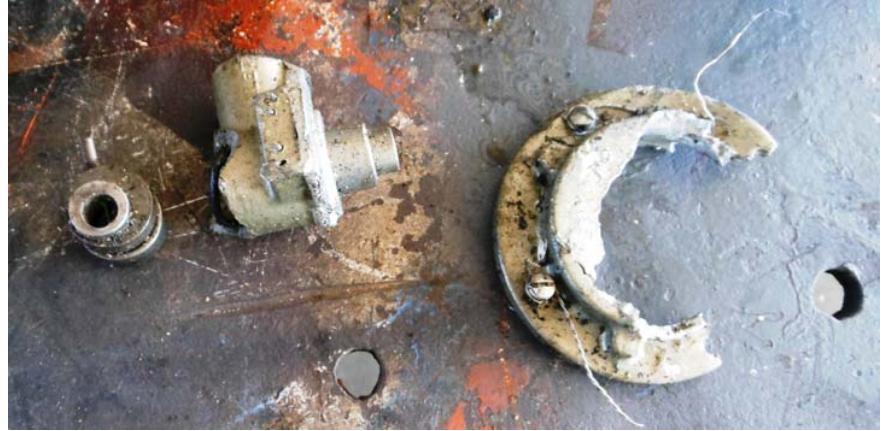
Photo #8 – Right Turbocharger Controller

<u>Turbo Controller (Photo #8</u> The right controller was fractured and only some pieces were found in the recovered debris. A data plate was not found.

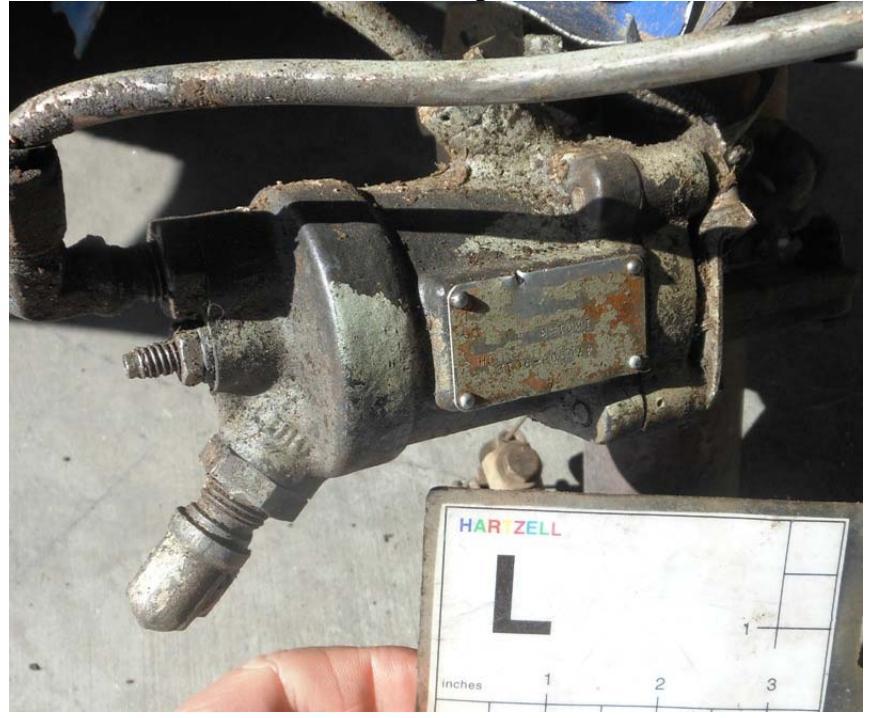
Photo #10 – Left wastegate and actuator

The left wastegate actuator remained attached to the valve shaft. The valve shaft could not be turned by hand force
