# Hazardous Liquid Pipeline Strike and Subsequent Explosion and Fire Aboard Dredging Vessel Waymon Boyd

Corpus Christi, Texas August 21, 2020

Accident Overview: Hazardous Liquid Pipeline Strike and Subsequent Explosion and Fire Aboard Dredging Vessel Waymon Boyd

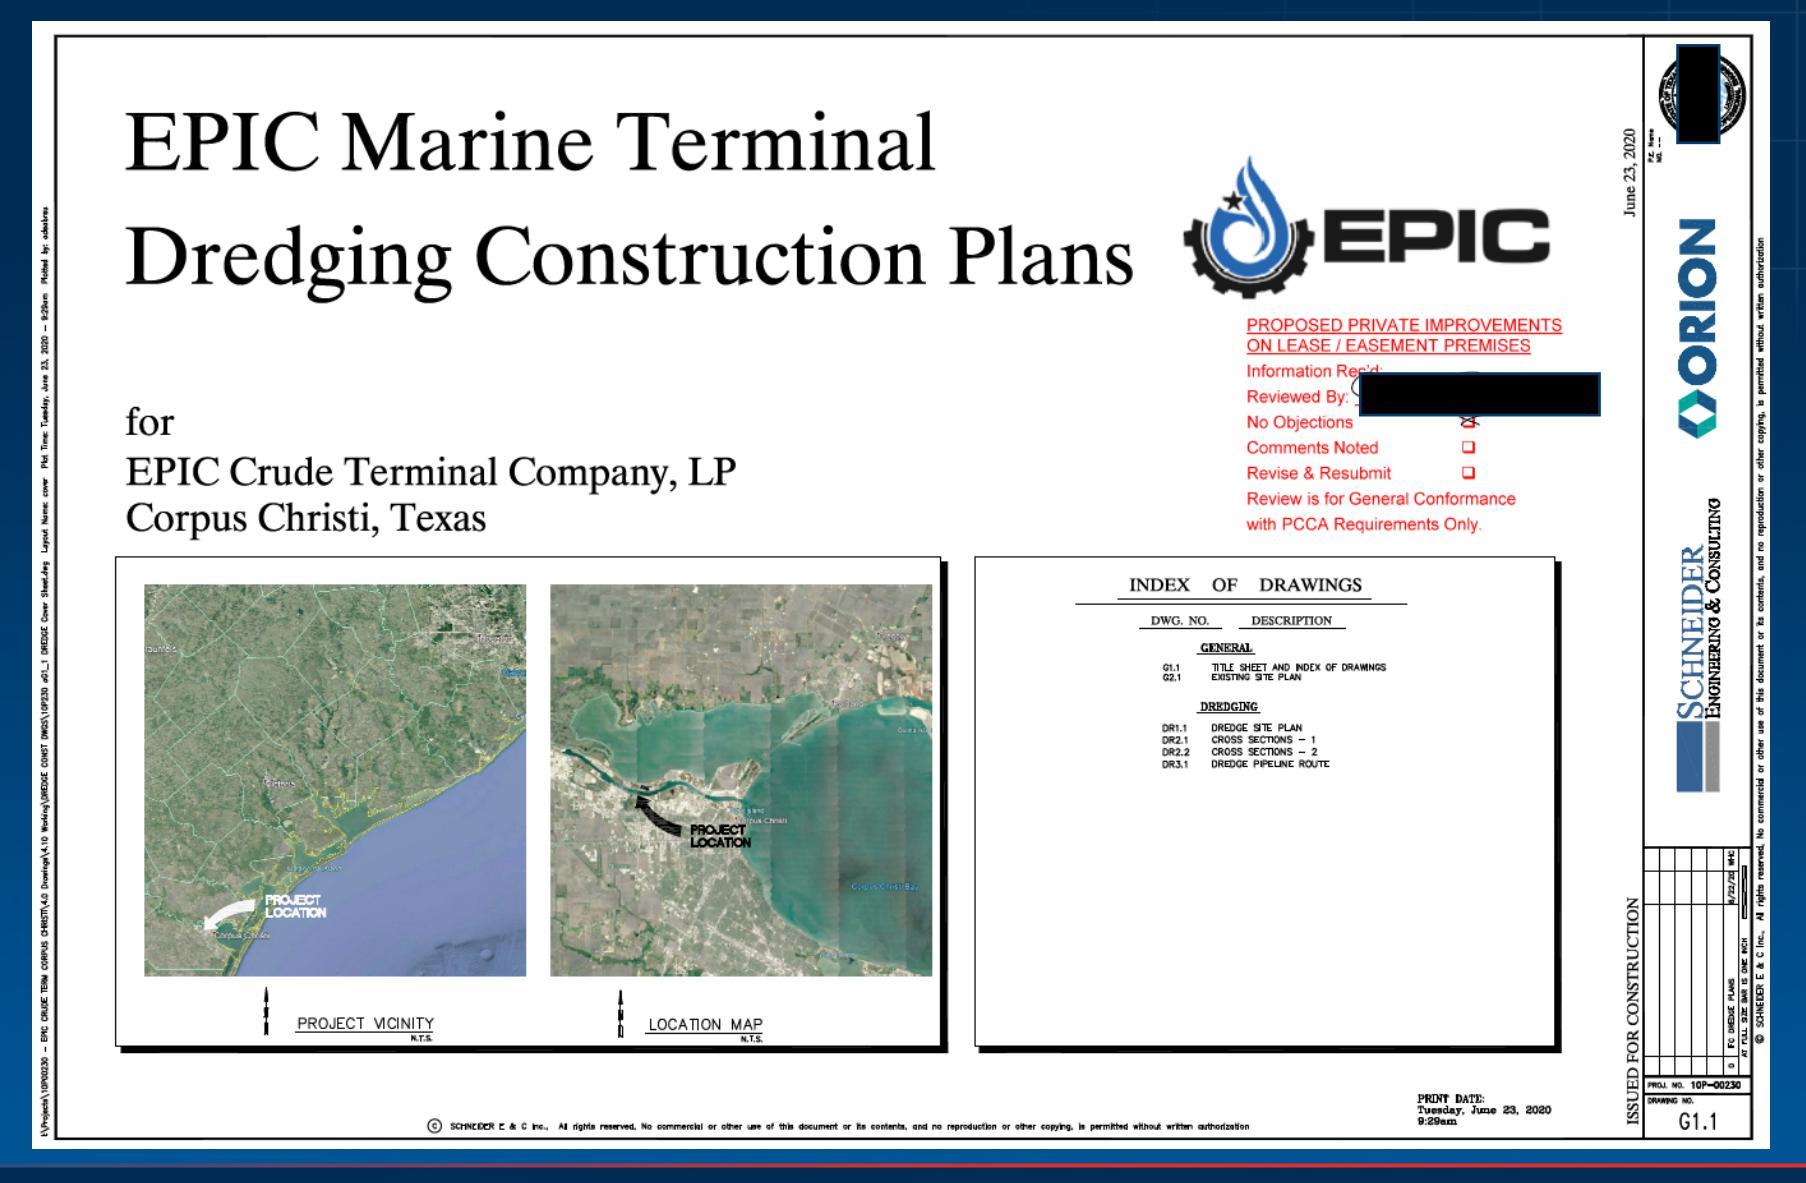
#### Dredge Project Engineering Plans

- Plans for the EPIC dock project did not clearly reflect the proximity of the pipeline to the full dredging area
- Schneider Engineering and Consulting did not have specifications, quality control measures, or best practices for including pipeline hazards and tolerance zones in engineering plans and drawings
- What we propose:
  - One recommendation to Orion Group Holdings

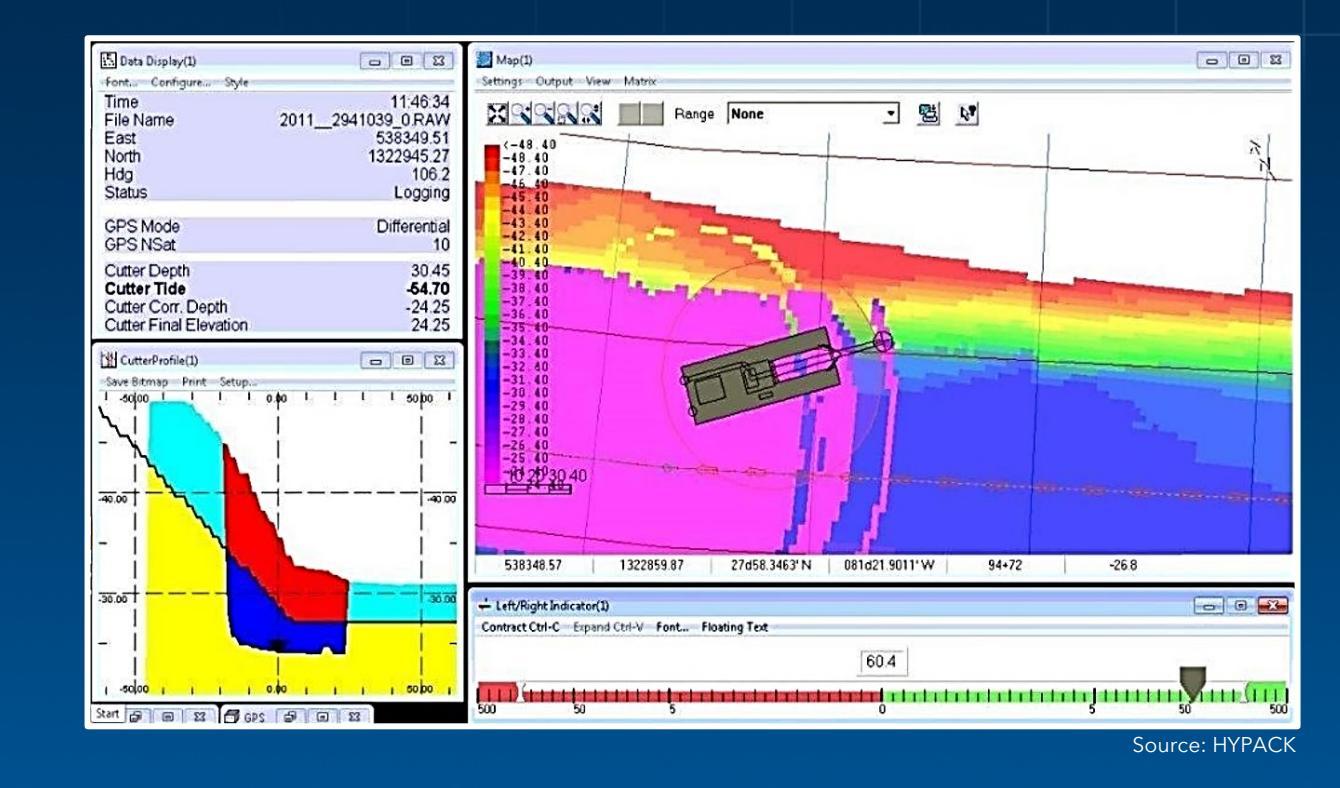
## DREDGEPACK Software

- Incorporation of accurate pipeline location data into dredging software on board is a critical tool for avoiding pipeline strikes and other potential hazards
- Orion had no written procedures requiring pipelines or other utilities be entered into DREDGEPACK software
- Although location data was provided to the company, it was not included in the DREDGEPACK dredge template used by the Waymon Boyd
- Orion Marine Group did not have written policies or procedures for planning dredging operations near pipelines

- Orion Marine Group did not have adequate procedures to require that pipelines be identified and included in DREDGEPACK
- Waymon Boyd's leverman was unaware how close he was operating the cutterhead to the pipeline
- Written policies and procedures could have eliminated confusion about the pipeline location and minimum tolerance distances
- What we propose:
  - One recommendation to Orion Group Holdings

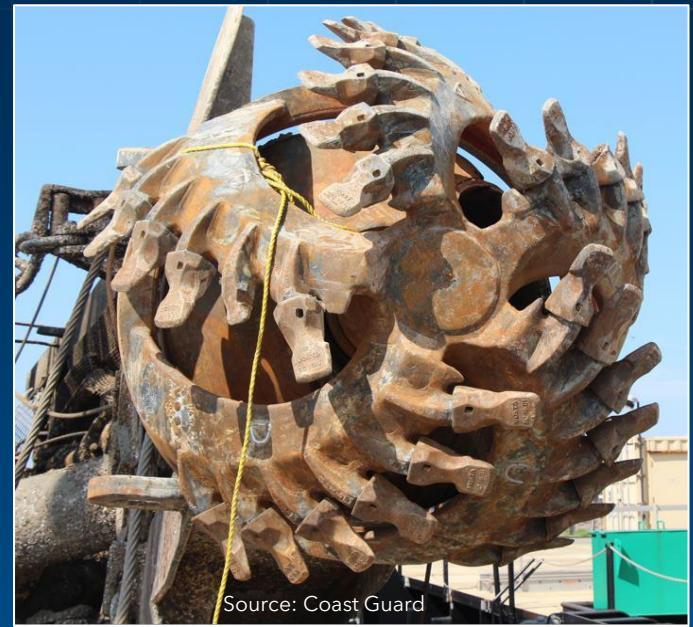
Waymon Boyd cutterhead

- Leverman stated that he did not operate the cutterhead outside the template
- Pipeline about 1' outside of dredge template
- Leverman reliant on DREDGEPACK for position of cutterhead relative to dredge template and any hazards
  - GPS accuracy: 1 meter (3.3 feet)
  - Accuracy of cutterhead position relative to GPS antenna and depth dependent on manual/auto inputs
  - Display resolution accuracy and symbology
- "It's not scalpel surgery"

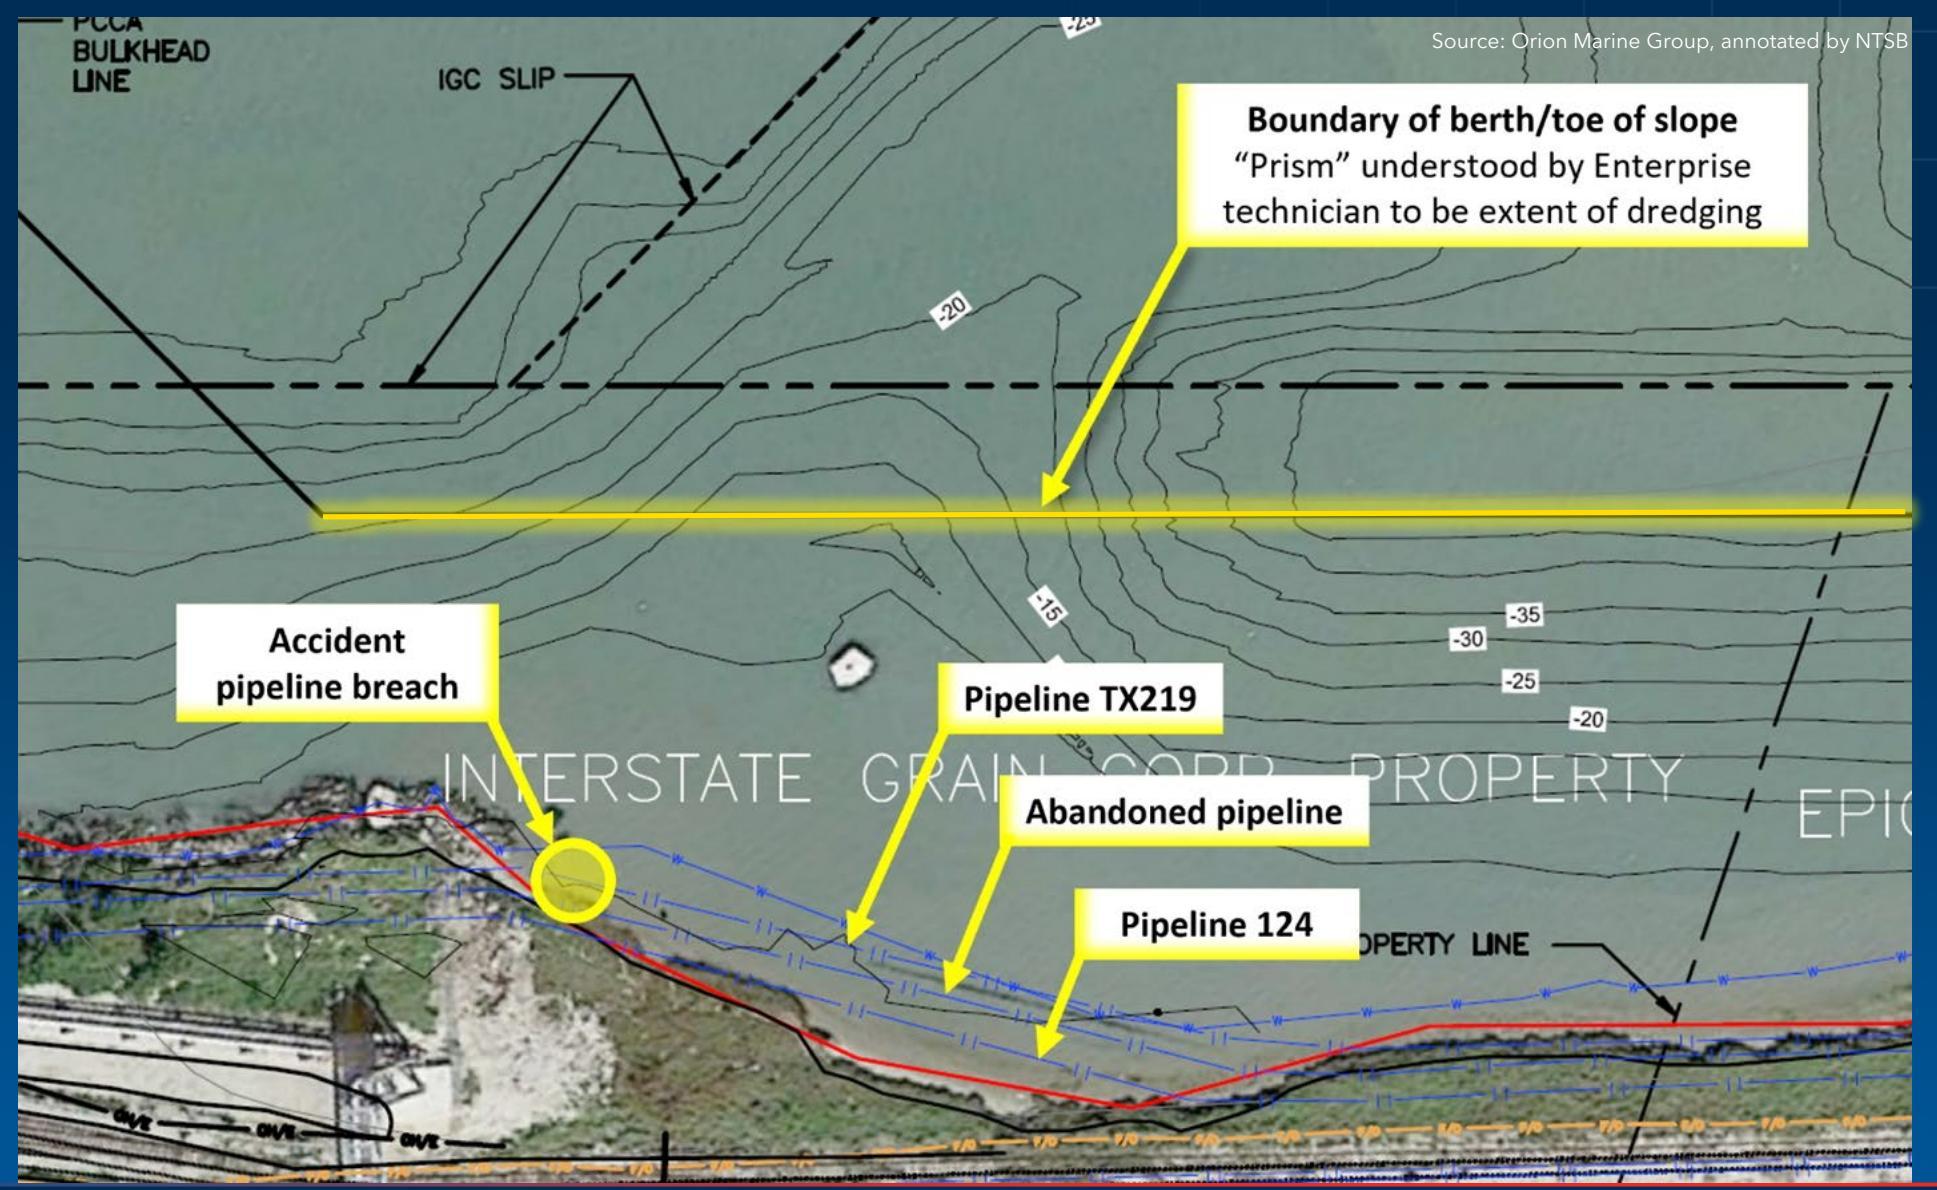
#### Misleading Dredging Plans

- Orion Marine Group project engineer misinterpreted drawings
- Project engineer communicated incorrect dredging boundaries
  - Dredging would be 60 feet from pipelines
  - Dock platform (near shore) dredging already completed to grade
  - "Shouldn't be a need for concern"

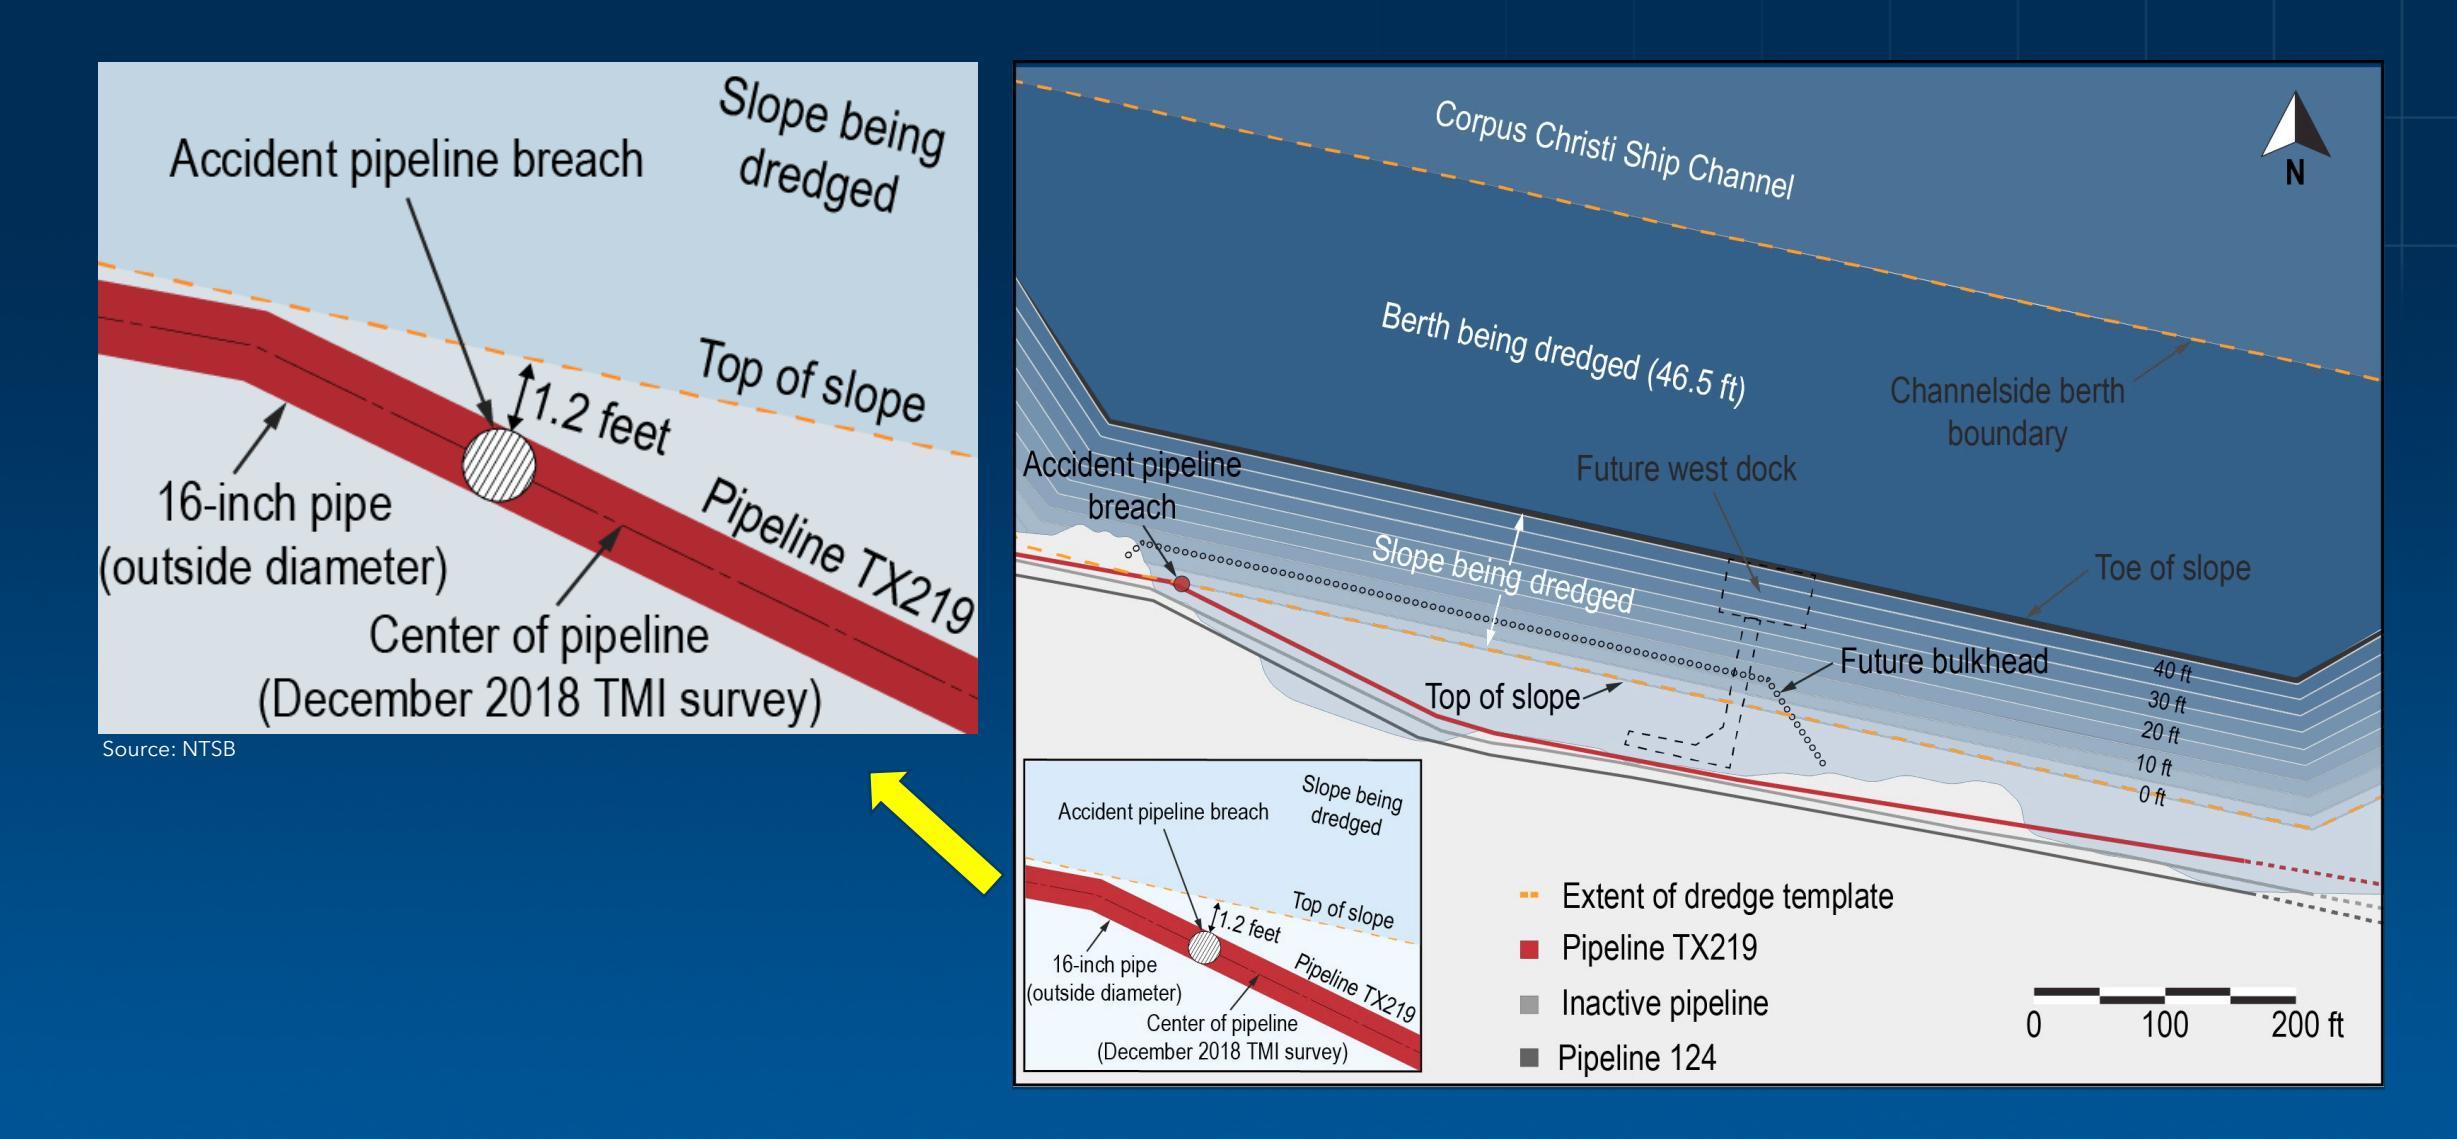
#### Dredging Plan Analysis

- Believed pipeline TX219 would be clear of project
- Determined dredging boundary exceeded 50-foot limit for mandatory marking

### What We Found: One-Call for Dredging Projects

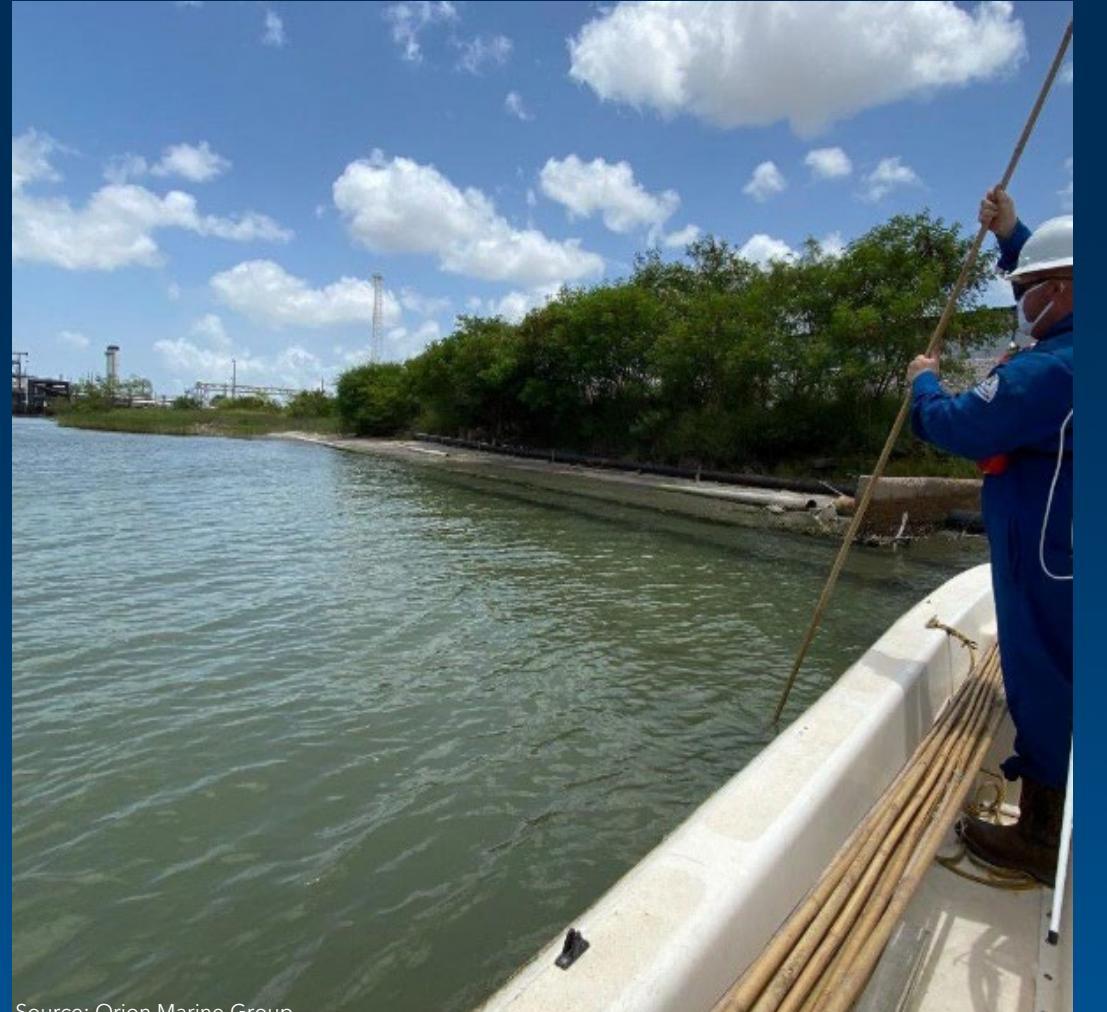
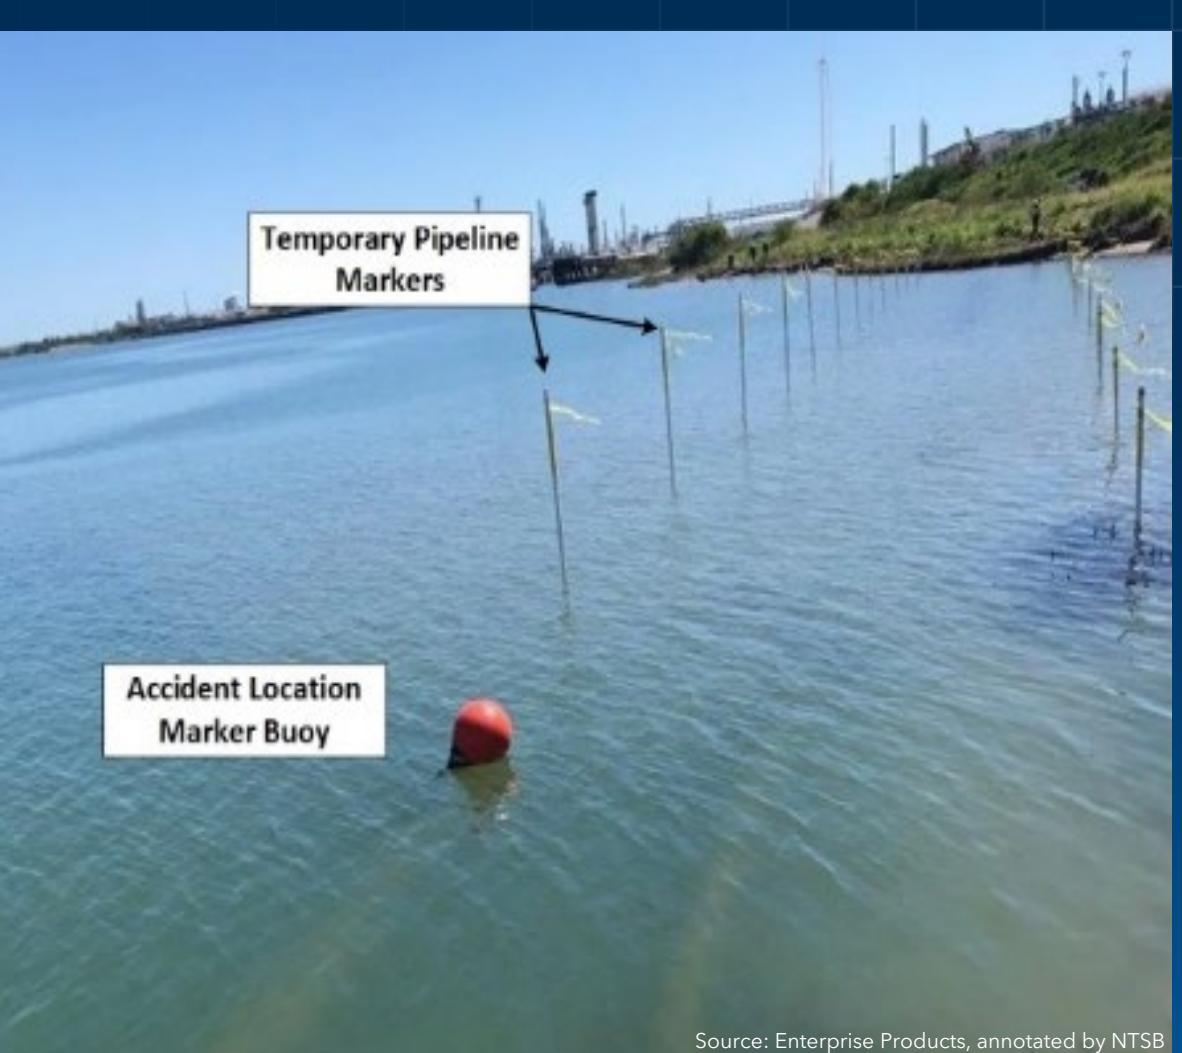
#### **Pipeline Marking Options**

- Pipeline was not marked for excavation damage avoidance
- Follow up marking request for dredge anchor avoidance
- Courtesy marked with widely-spaced cane poles

#### Courtesy marking (pre-accident)

#### Mandatory marking (post-accident)

- Courtesy marking was not sufficient visual warning
- Project boundary pre-marking would provide visual confirmation of pipeline encroachment
- What we propose:
  - Recommendations to PHMSA, CAMO, and CDMCS
